**Report 97-004**

**Cessna 185F**

**ZK-PRM**

**wake turbulence encounter**

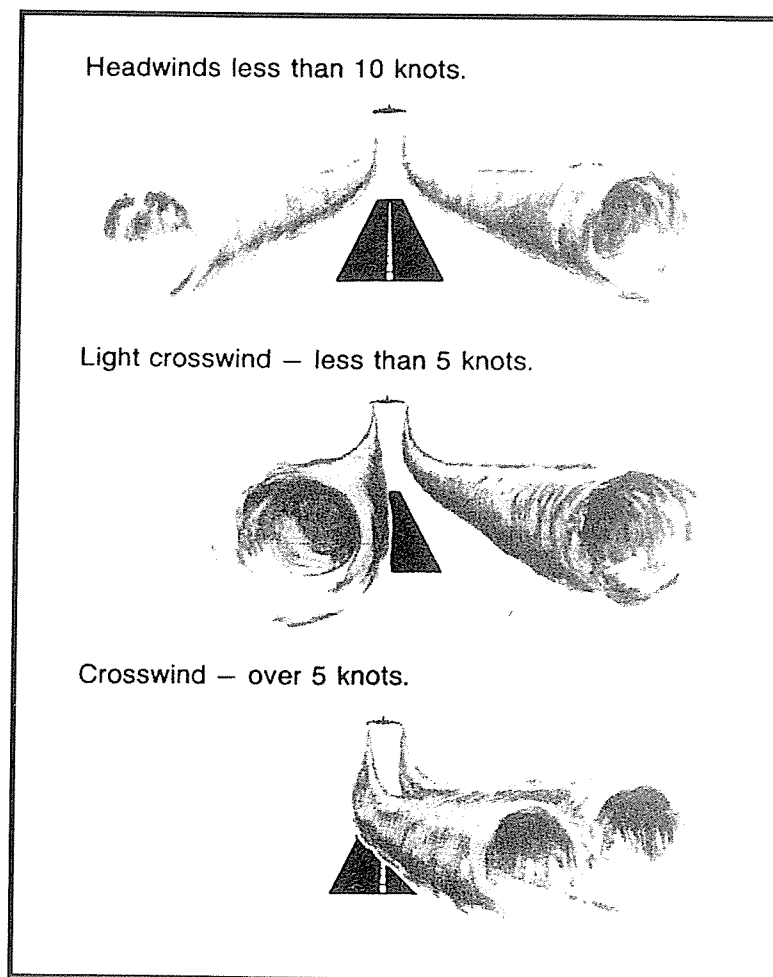
1.17 Much research has been carried out, and numerous flight safety articles have been published world wide, on wing-tip vortices and wake turbulence. It is not an unknown phenomenon. Wing-tip vortices generated by medium to large aircraft can be severe, especially after the generating aircraft rotates during take-off. Aircraft configuration can modify the vortex pattern and persistence. The vortices, one trailing behind each wing-tip, are violent spiralling air masses and rotate in opposite directions. The left wing-tip vortex, when viewed from behind the aircraft, will rotate clockwise and the right wing-tip vortex will rotate counterclockwise. Vortices descend behind the generating aircraft. At low altitude they approach the ground, and at a height usually about 15 m (50 feet) they curve outward and spread laterally away from the track of the aircraft. The vertical and lateral movement of the vortices will be affected by and move with the encompassing air mass. A cross wind will displace the vortices from the vertical in their downward travel and affect the lateral rate of travel. A crosswind component up to five knots is sufficient to cause one vortex to stay within the flight path, over the runway. The other vortex will travel at its own lateral rate plus that of the crosswind away from the flight path. Stronger crosswinds blow the wake across the flight path and quickly break it up. (See figure 1).

**Figure 1**  
**Wing-tip vortex patterns**
