**Report 97-102**

**Train 270**

**collision with roadroller**

## Rail Accident Report 97-102

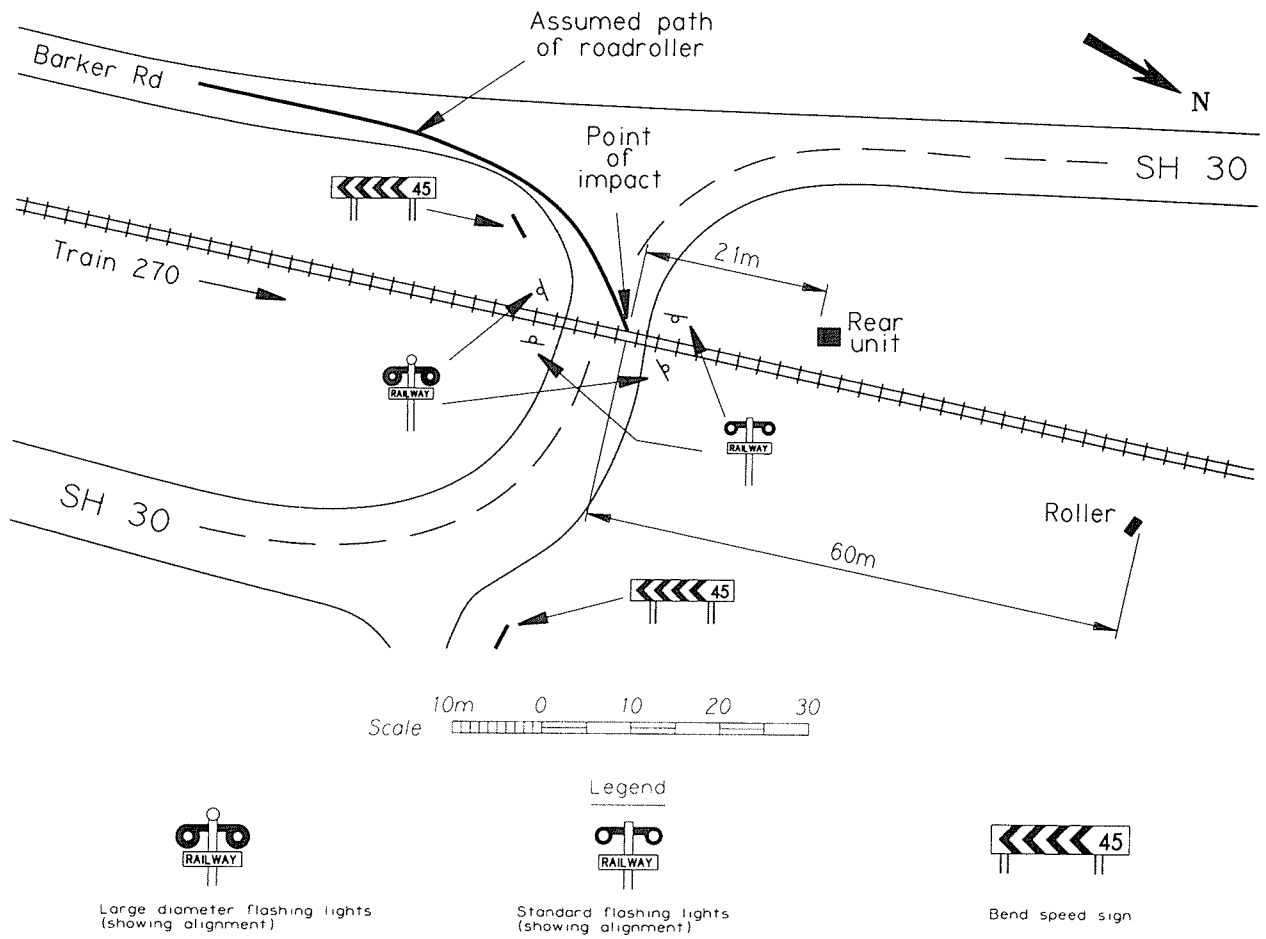
**Figure 1**  
**Site details**

- 1.1.4 The level crossing was protected with flashing lights and bells (FLBs). The two flashing light standards with a long road approach were equipped with 300 mm diameter lenses and the two with a short road approach with 200 mm diameter lenses in accordance with current Tranz Rail practice. Figure 1 shows the general layout of the level crossing.

- 2.3 Witness reports and road markings indicated a likely line of approach as shown on Figure 1. While the flashing lights were still visible from the driver's position their partial obscuration decreased their effectiveness.

- 3.5 The driver's actions indicated he did not hear or see the warning system or the approaching train.
- 3.6 The assumed approach line of the roadroller to the crossing, and the driver's height above road level, restricted the driver's view of the level crossing lights.

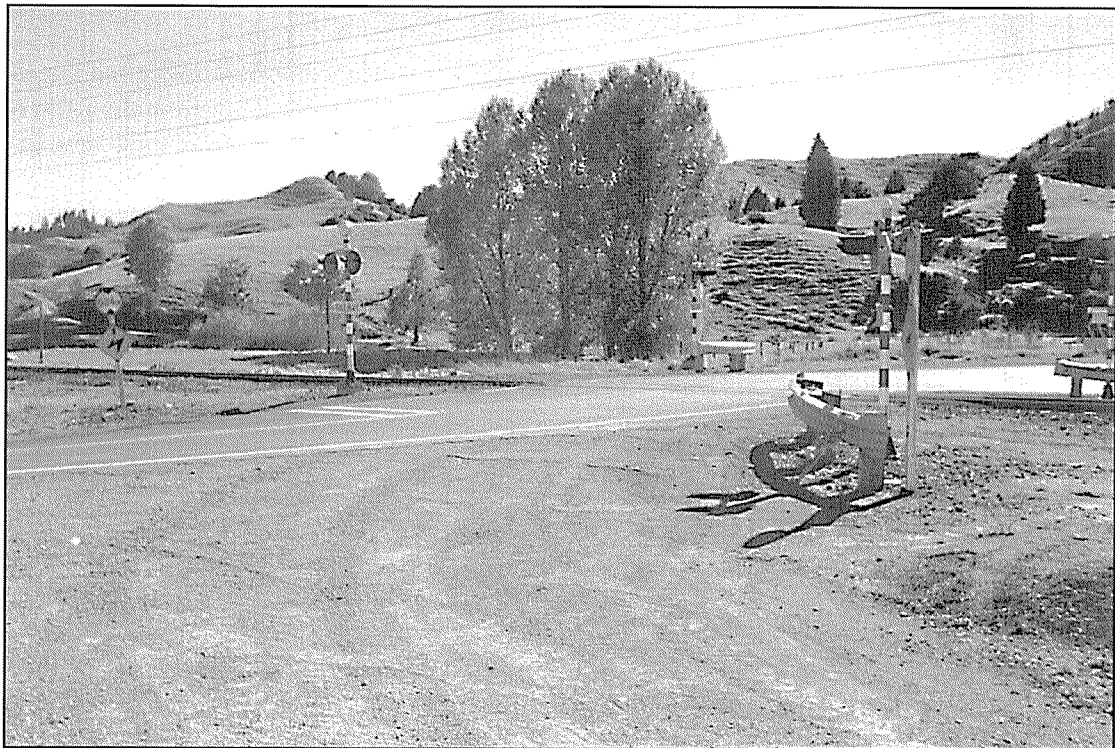
**Figure 2**  
**Roadroller driver's view from Barker Road**

- 1.4.1 Marks on the road indicated the roadroller was facing north-east at approximately 45° to the railway line at the POI. This line of approach, and the exit line from the east side of Barker Road which this inferred, was supported by recent tyre marks exiting Barker Road. Figure 2 shows the general view of the level crossing from Barker Road.
- 1.4.2 Site tests from three metres above road level on the assumed line of approach showed the visual impact of the level crossing lights on the north-west quadrant standard was decreased by their offset alignment and the hood over the lens, although the lights were still visible.
- 1.4.3 The weather was fine and the visibility good. The angle of the sun did not interfere with the roadroller driver’s view of the crossing.

- 3.4 Although the level crossing lights were positioned for traffic on SH 30 the view from a vehicle exiting Barker Road by the required approach line on the left side of the road was satisfactory.
