Report 97-107

Silver Fern RM24

collision with pedestrian

Rail Accident Report 97-107

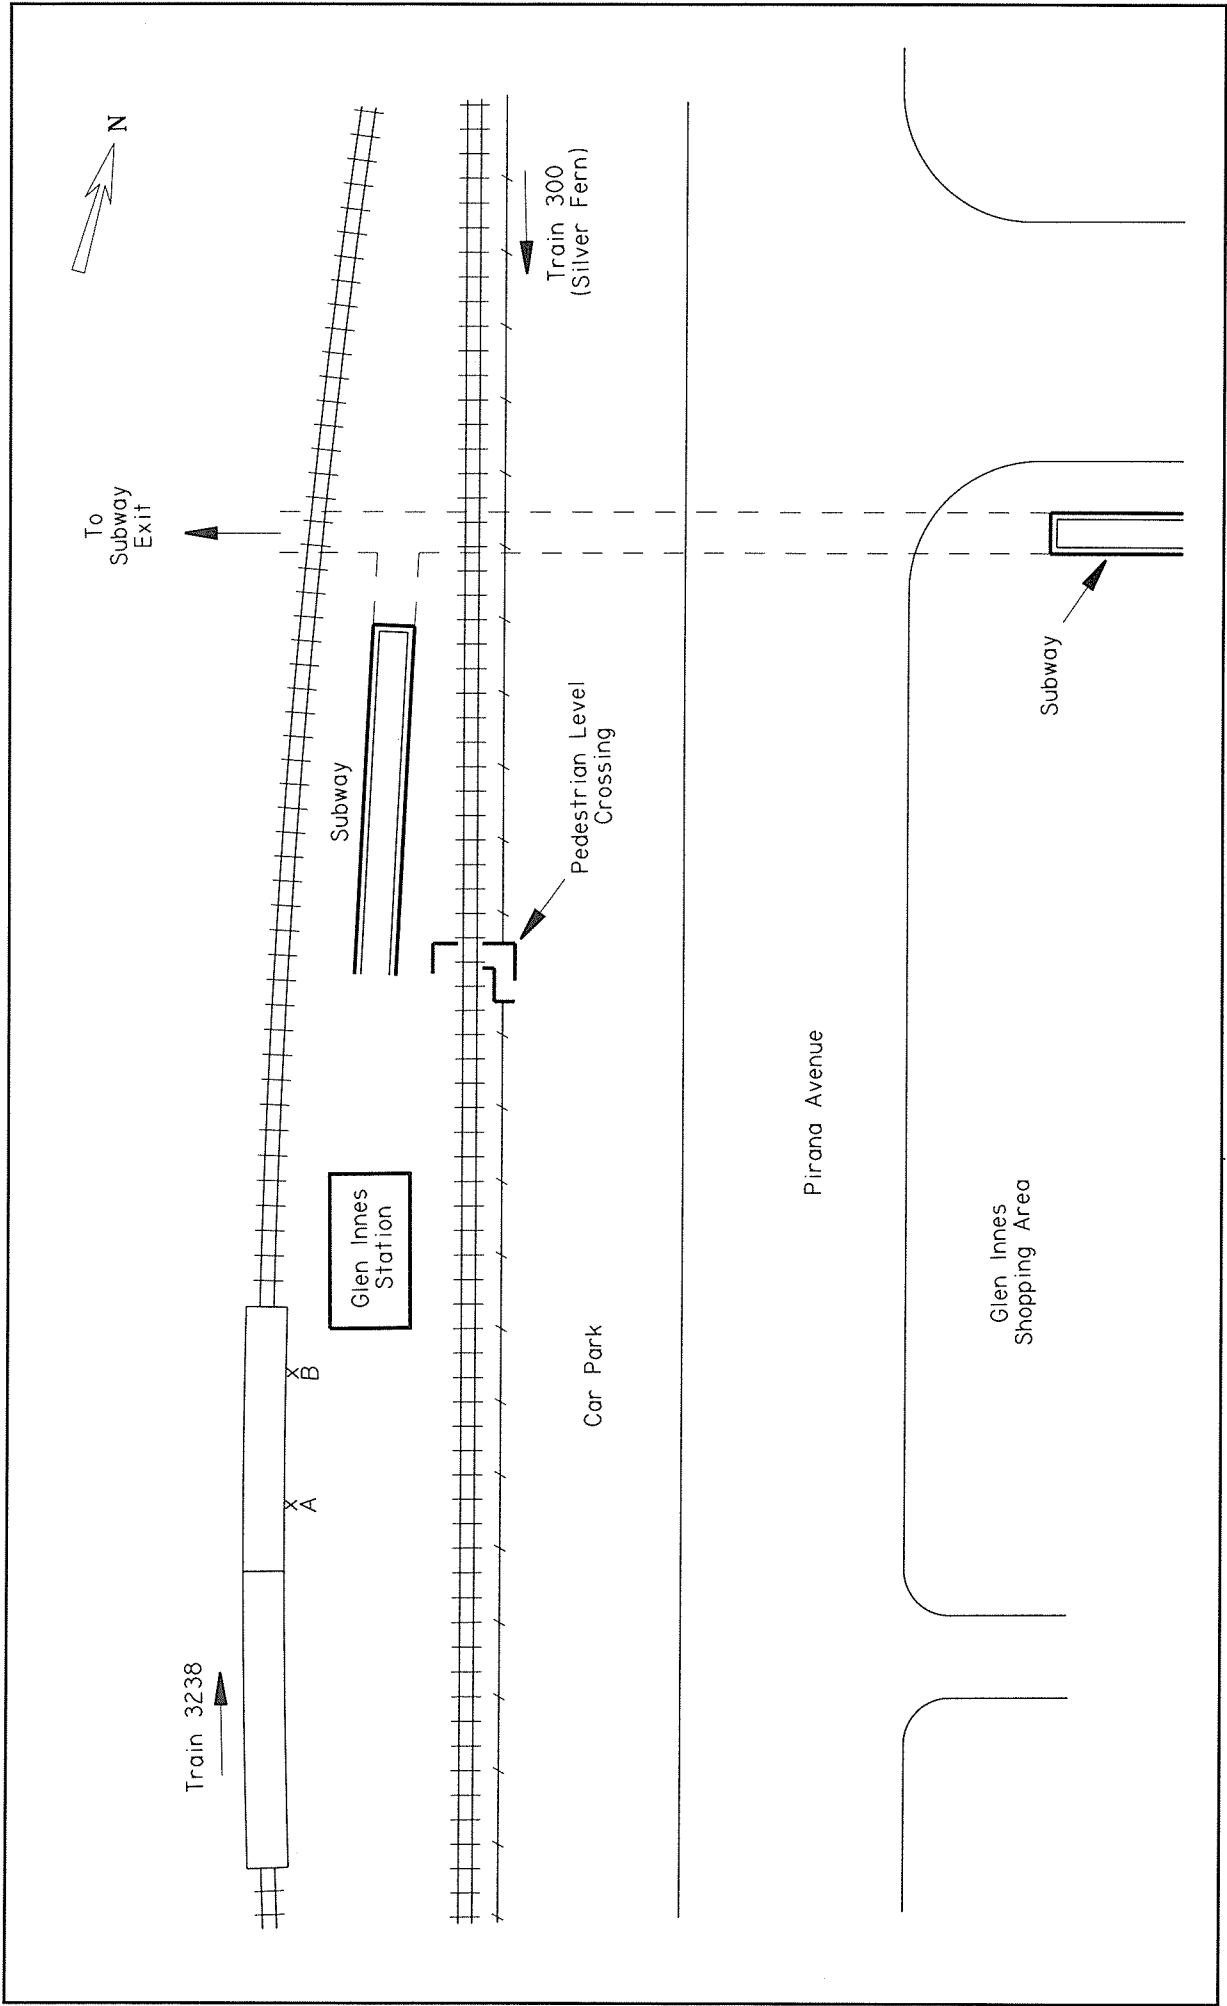
Figure 1
 Site details (not to scale)

- 1.1.3 An elderly woman also detrained at Glen Innes. Reports indicated the student used the rear door of the leading half of the unit. The other passenger exited by the front door. Figure 1 shows a layout of the station, the position of Train 3238, and the relative detrainment points.

- 1.2.1 Train 3238 was a scheduled Tranz Metro Diesel Multiple Unit (DMU) service comprising a single 40 m long unit, and was running to time.
- 1.2.2 The platform at Glen Innes Station to service DMUs is approximately 40 m long and therefore the position of Train 3238 on 18 June is known, as shown on Figure 1.

- 1.3.2 The decision to install a pedestrian level crossing at Glen Innes was prompted by persistent trespass over the down main due to passengers' aversion to using the subway and their desire to obtain direct access to the station car park at Glen Innes shopping area. The only other access to the island platform was by the subway which linked both sides of the track, (see Figure 1).

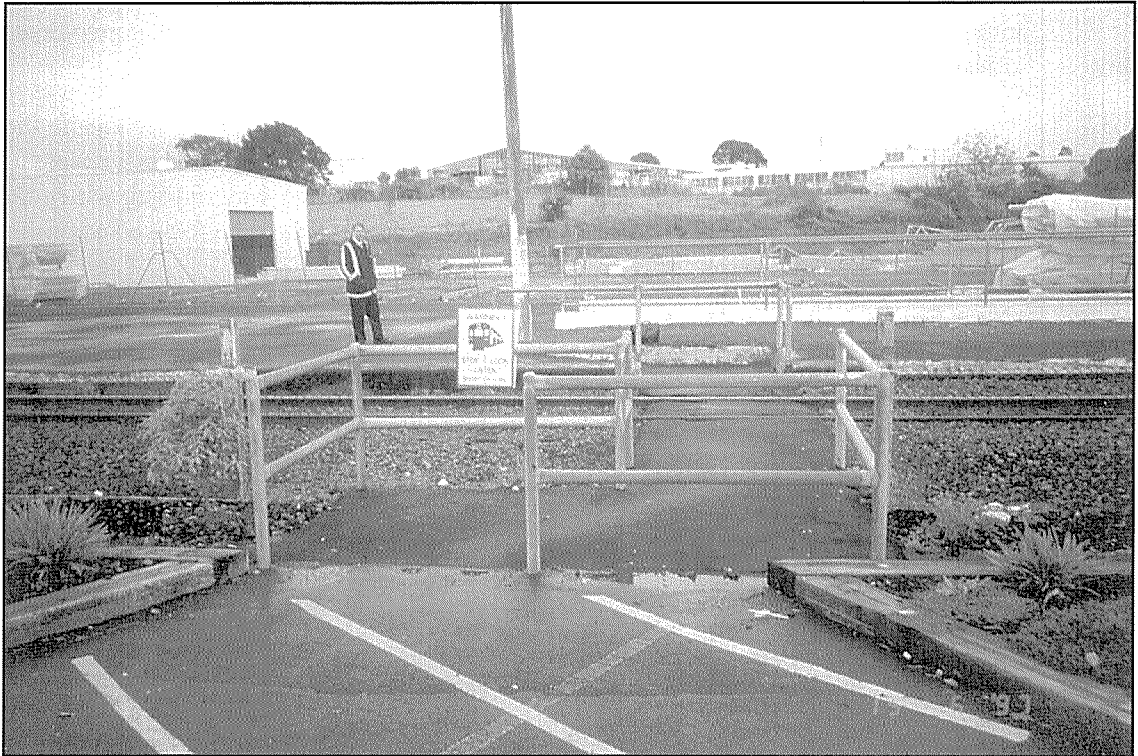
Figure 2
View of the pedestrian level crossing from the east side

- 1.3.11 The crossing was signposted on the east side with back-to-back notices bolted to the maze fencing. The signs read “WARNING, STOP-LOOK-LISTEN BEFORE CROSSING”, (see Figure 2).

- 2.2.3 Although the position and wording of the signs did not comply exactly with the guidelines reportedly used by Tranz Rail the differences were not considered to be a factor in this accident.

- 4.1 Following the accident the Auckland City Council repaired and improved the lighting in the Glen Innes subway and installed vandal-proof fixings.
- 4.2 Following the accident Tranz Rail installed warning signs at the end of the platform ramp approach to the crossing on the west side, similar in detail to the signs on the east side. In addition yellow lines were painted across the sealed pathway indicating a safe stopping point clear of the track.

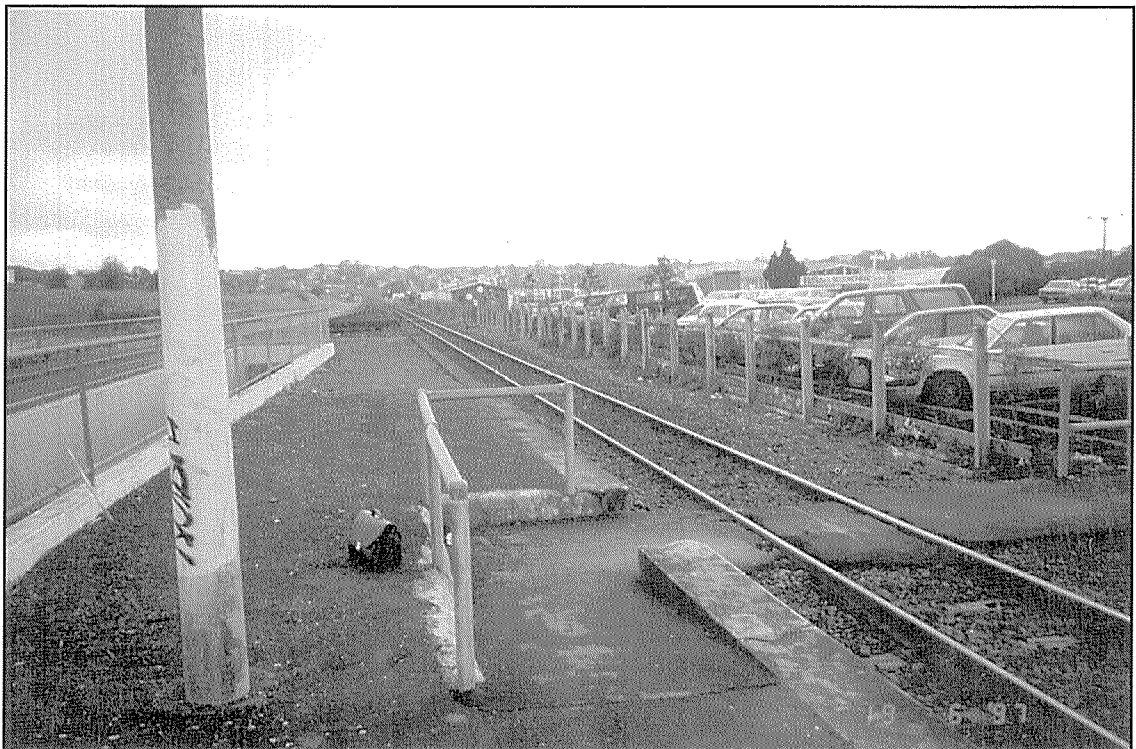
Figure 3
View of the entrance to the pedestrian level crossing looking north from the island platform

- 1.3.6 No maze had been erected on the west side of the crossing. All disembarking passengers intending to use the crossing were facing any oncoming traffic when they approached the crossing, (see Figure 3).

- 1.3.9 Glenn Innes was an example of a pedestrian level crossing over a single track which only allowed traffic in one direction. On the west side where the student entered the crossing there was fencing along the pedestrian approaches to direct pedestrians and clearly define the crossing point (Clause 7.5.1 (b) of the LTSA guidelines). Since all intended users of the crossing were facing oncoming rail traffic it was considered that there was no need for a maze and none was installed.

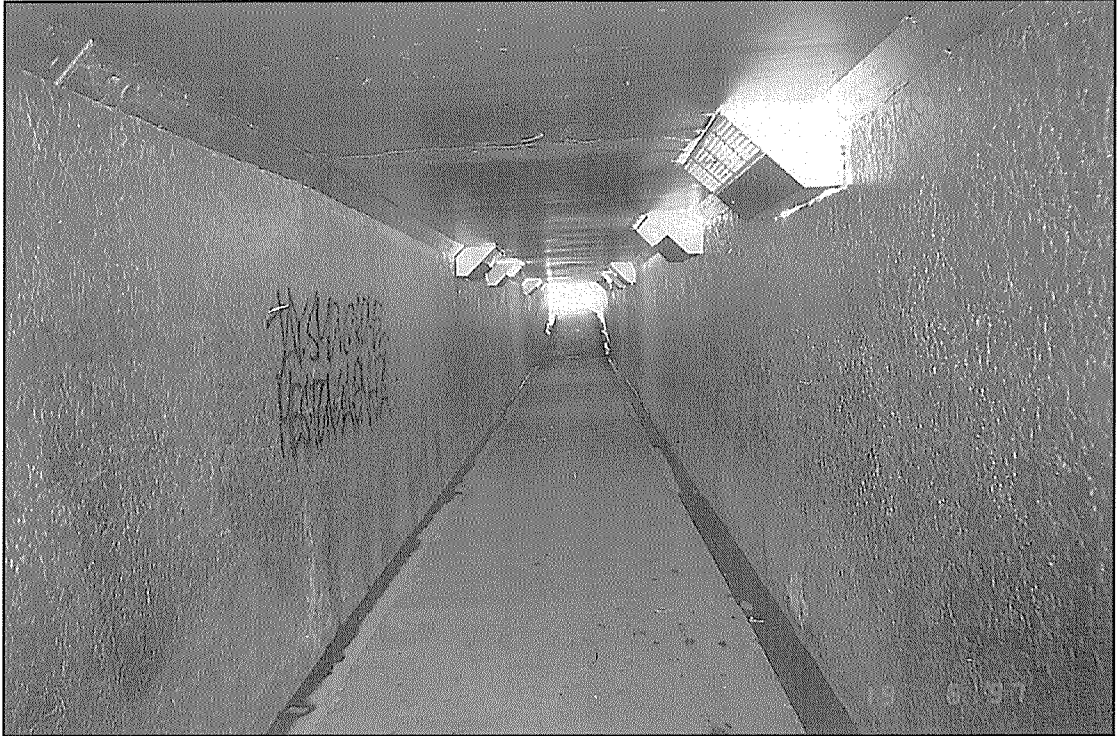
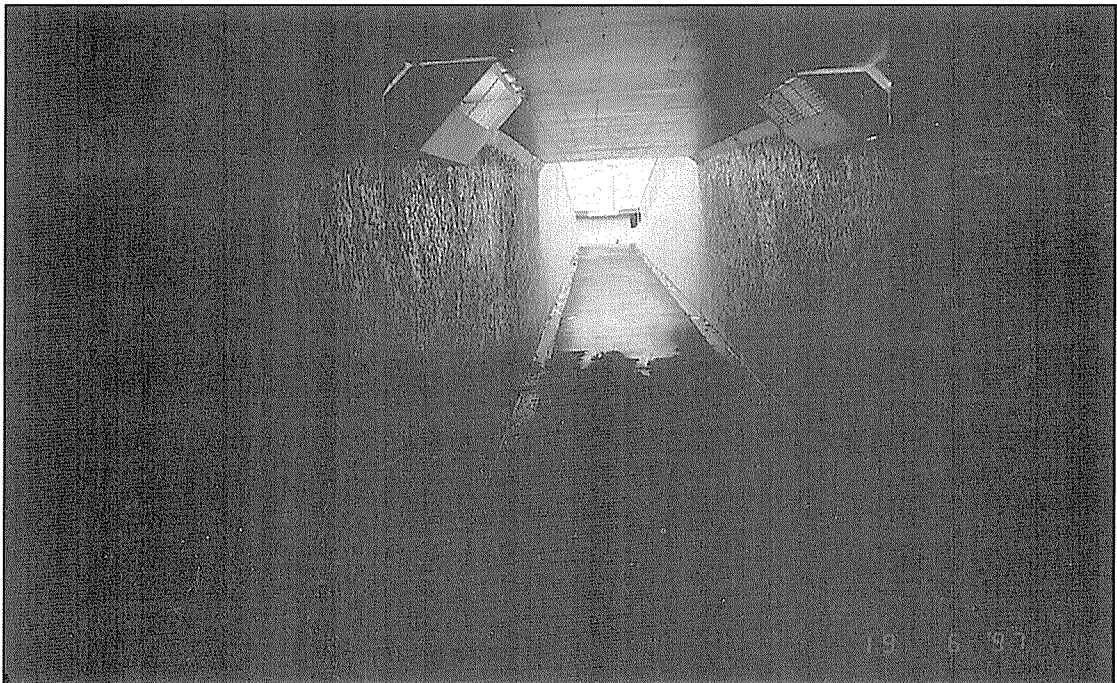
Figure 4
Pedestrian subway looking east to Glen Innes shopping centre exit

Figure 5
Pedestrian subway looking south to the island platform exit

- 1.4.2 The subway was clean, dry and reasonably well lit when inspected following the accident (see Figures 4 and 5), although some lighting was inoperative due to vandalism.
