Report 97-108

Train 320

container struck bridge

Rail Incident Report 97-108

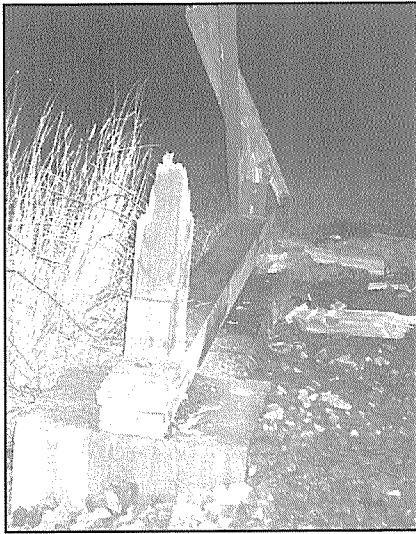
- 1.1.3 At approximately 0322 hours the train was passing Bridge 355, a footbridge serving Puhinui Station, at 659 km North Island Main Trunk, when an empty container on the train struck and partly demolished the bridge pier on the left side of the up main. Rail bracing on the pier prevented the footbridge span collapsing (see Figure 1).

**Bridge 355 (footbridge)
pier following collision**

- 1.2.1 Bridge 355 was a standard timber pier footbridge. The minimum clearance from centre line to the pier on the left hand side of the up main was 2.375 m.
- 1.2.2 The damaged pier comprised two timber columns braced with two crossed rails. Both columns were broken off and one rail brace removed. The remaining rail brace supported the adjacent spans until repairs could be arranged.

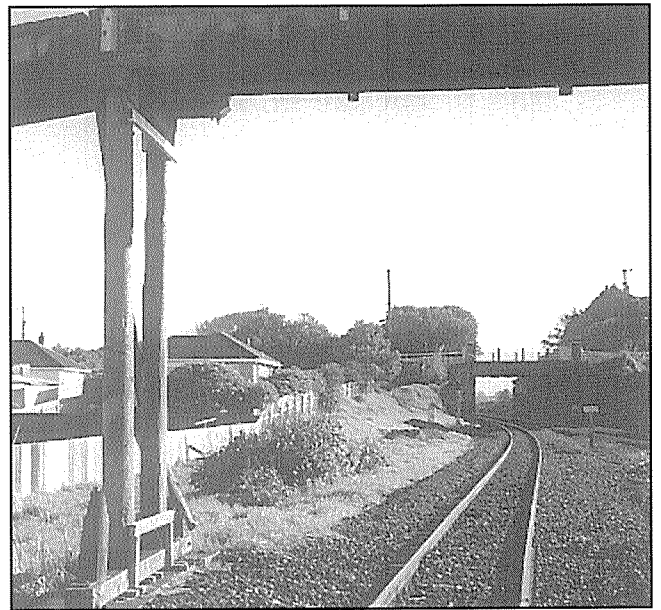
Figure 1

**Bridge 355 temporarily repaired
(Bridge 356 in the background)**

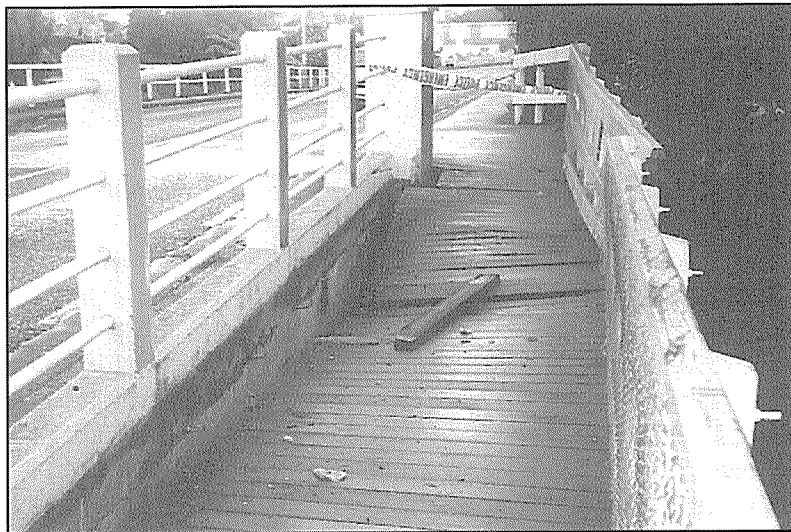
Figure 2

- 1.1.4 Approximately 113 m north of Bridge 355 was Bridge 356, a concrete road overbridge with a timber footbridge attached on the north side. The container struck the left hand abutment of the overbridge, rose and damaged the underside of the concrete spans, before severely damaging the timber footbridge (see Figure 2).

Damage to footbridge on Bridge 356

- 1.3.1 Bridge 356 was a standard single span concrete overbridge. The left abutment was 2.425 m from centre line, with damage marks 2.815 m from centre line and 900 mm above rail level and extending to 3.3 m above rail level.
- 1.3.2 The underside of the concrete beams were 4.46 m to 4.48 m above rail level. The beams had been struck by the container and concrete had broken out to the reinforcing.
- 1.3.3 Immediately north of, and attached to, Bridge 356 was a timber footbridge. The underside of the footbridge was 5 m above rail level. The footbridge had been struck by the container and severely damaged.

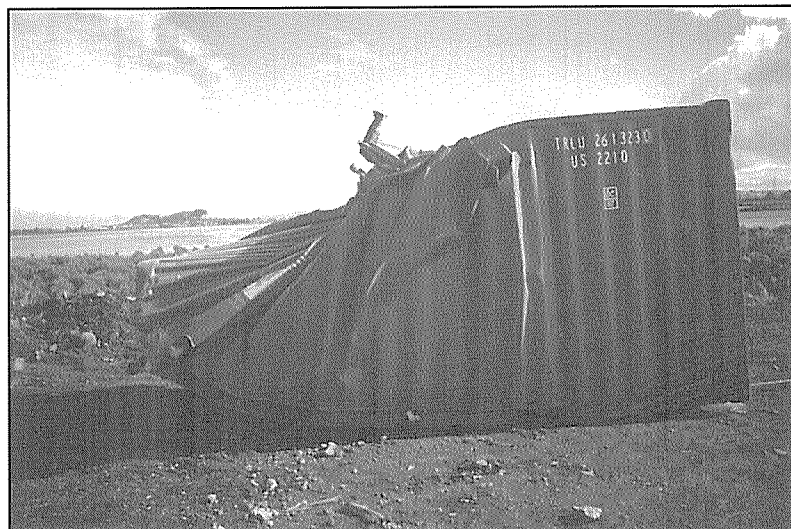
Figure 3

- 1.1.5 The container fell from the wagon, coming to rest approximately 120 m north of Bridge 356 straddling the adjacent down main and foul of the up main. The container was extensively damaged (see Figure 3).

Container damage

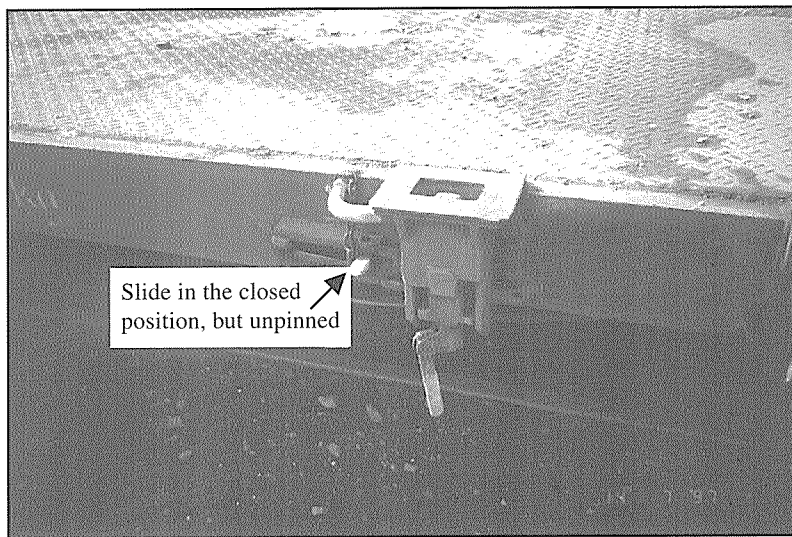
Figure 4

Twistlock in lowered position and slide closed, but not pinned (left rear of the container which fell)

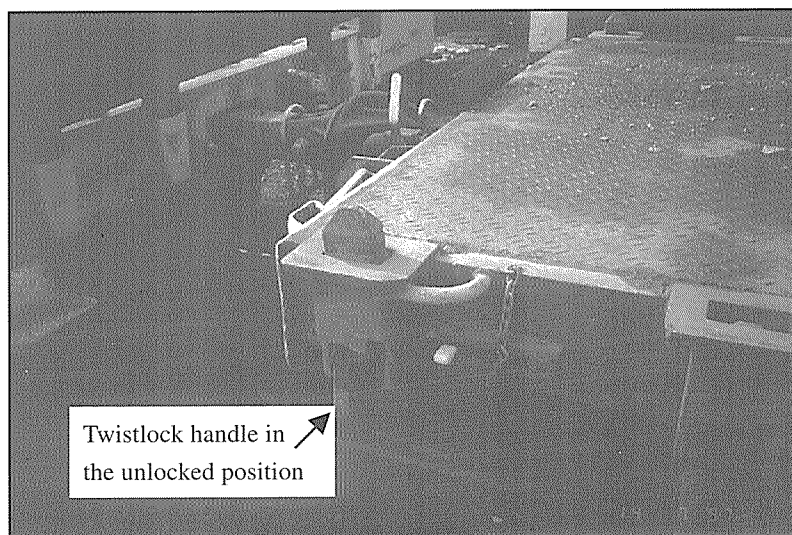
Figure 5

Twistlock raised, not locked, and slide closed but not pinned (left front of the container which fell)

left front (Figure 5)	twistlock raised slide in the closed position pin not inserted handle in the unlocked position
right front	twistlock raised slide in the closed position pin not inserted handle in the unlocked position
left rear (Figure 6)	twistlock lowered slide in the closed position pin not inserted (when the twistlock is lowered the handle can only be in the unlocked position)
right rear	twistlock lowered slide in the open position pin not inserted

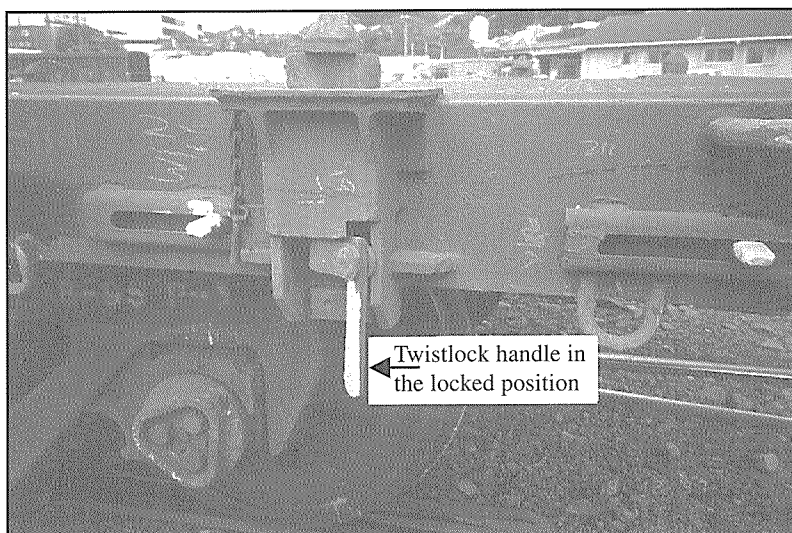
Figure 6

- 1.5.4 Tranz Rail have two versions of twistlocks currently in service on their container fleet. The standard version was installed on UK15276. In this version locking was achieved by a protrusion at the hinge of the twistlock handle which was intended to fit into a slot cut in the twistlock assembly (see Figure 6). However, once wear occurred in the pin and hole which located the handle, the handle could drop and lose its restraint. This can be seen in the example of a locked twistlock shown in Figure 6.

A typical twistlock showing the twistlock raised and in the locked position, slide closed but not pinned
