Report 97-204

Restricted-limit charter vessel *Amigo 1*

grounding

12 July 1997

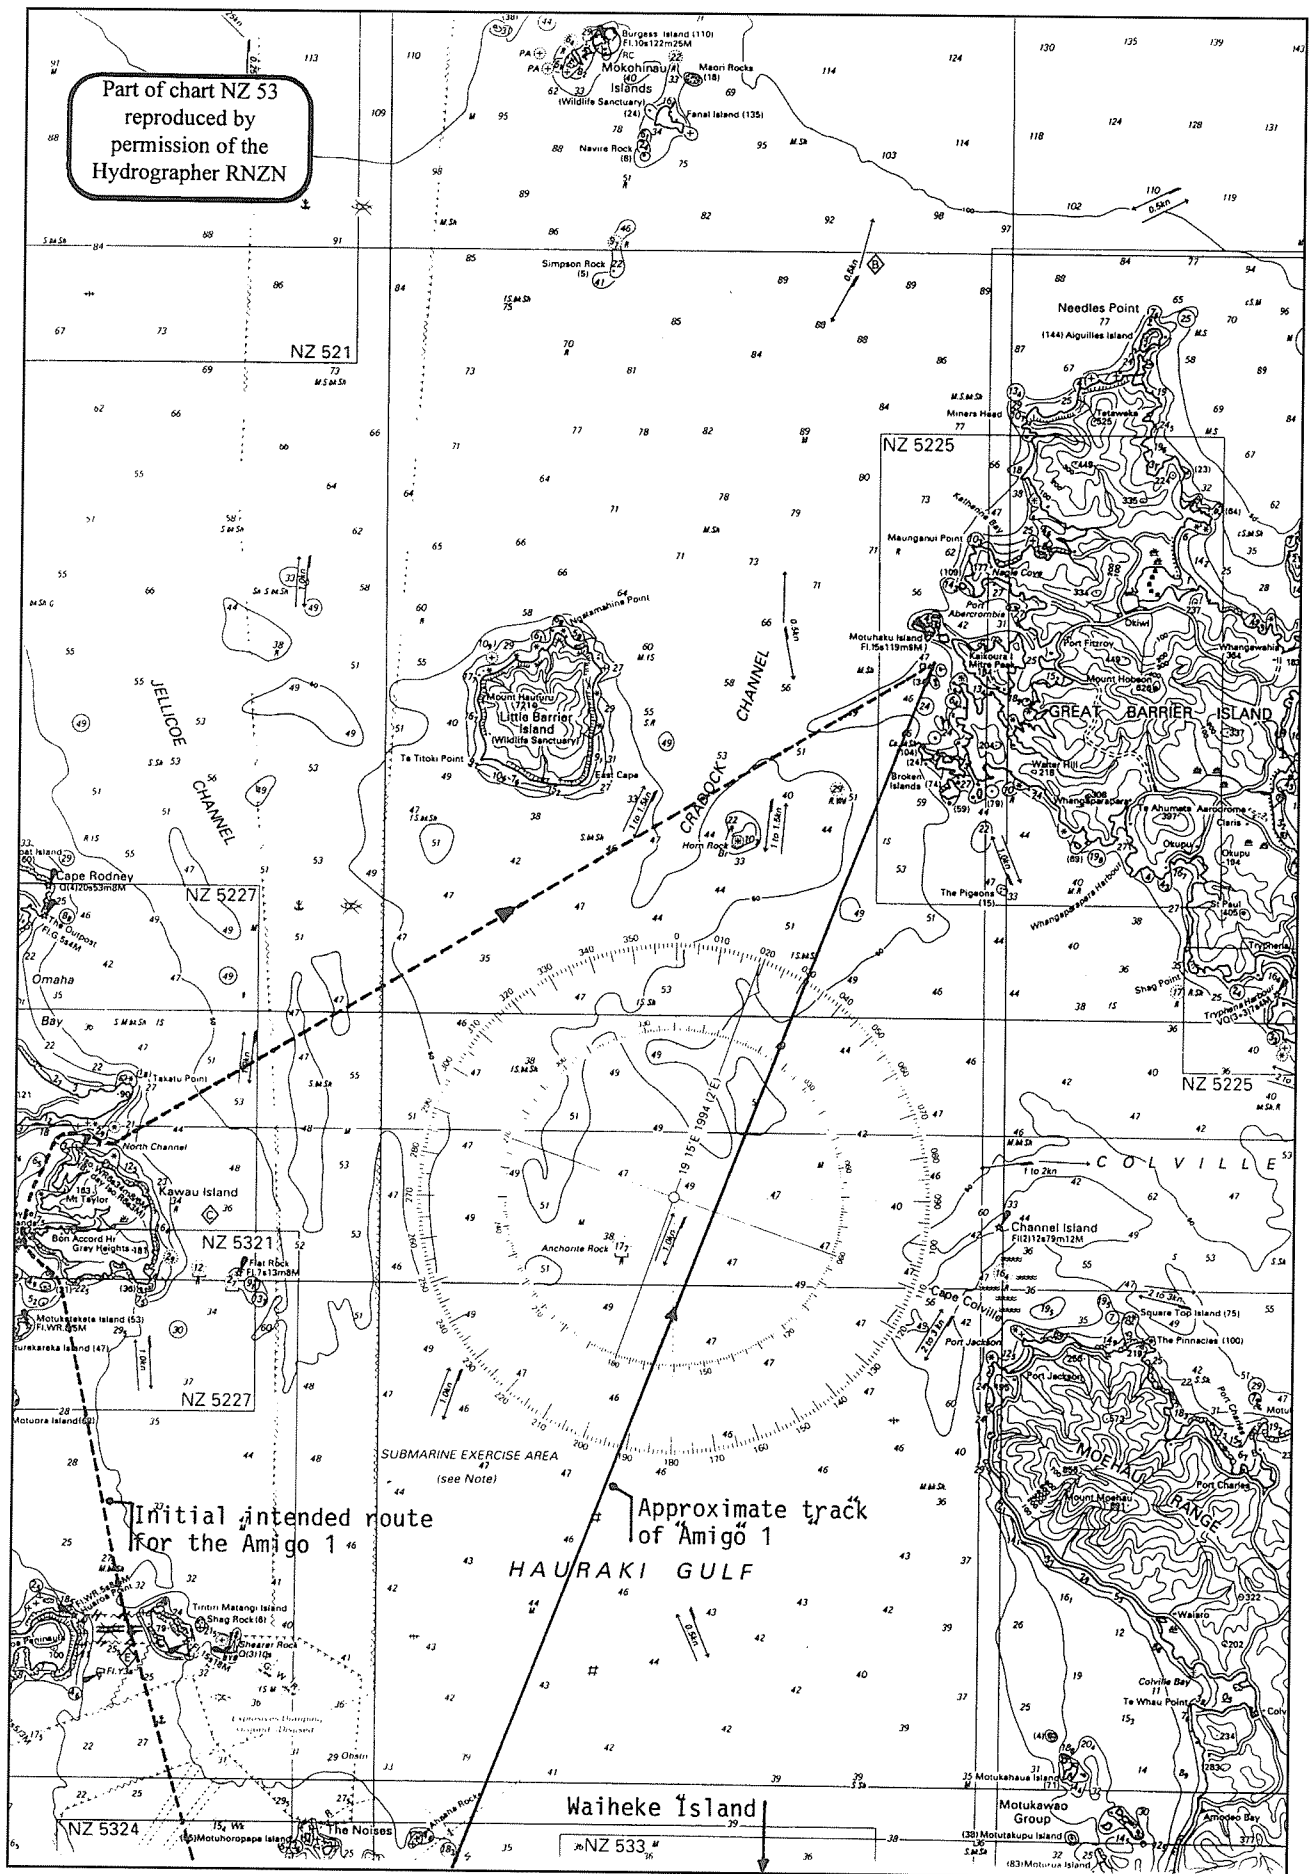
Figure 1
Part of Chart NZ 53 showing initial intended route and approximate track of the *Amigo 1*

- 1.1.7 At about 2200 the skipper shifted the *Amigo 1* to the fuel jetty, refuelled the vessel and departed the marina at about 2230.
- 1.1.8 While at the fuel jetty one of the passengers listened to a weather broadcast on the VHF radio. He recalled the forecast was for a south-west wind at 20 knots gusting to 30 knots, abating in the morning; reduced visibility in showers. The skipper and passengers decided to by-pass Kawau Island and head direct for Great Barrier Island with the contingency plan of spending the night anchored off the north coast of Waiheke Island if weather conditions were unfavourable. (See Figure 1.)

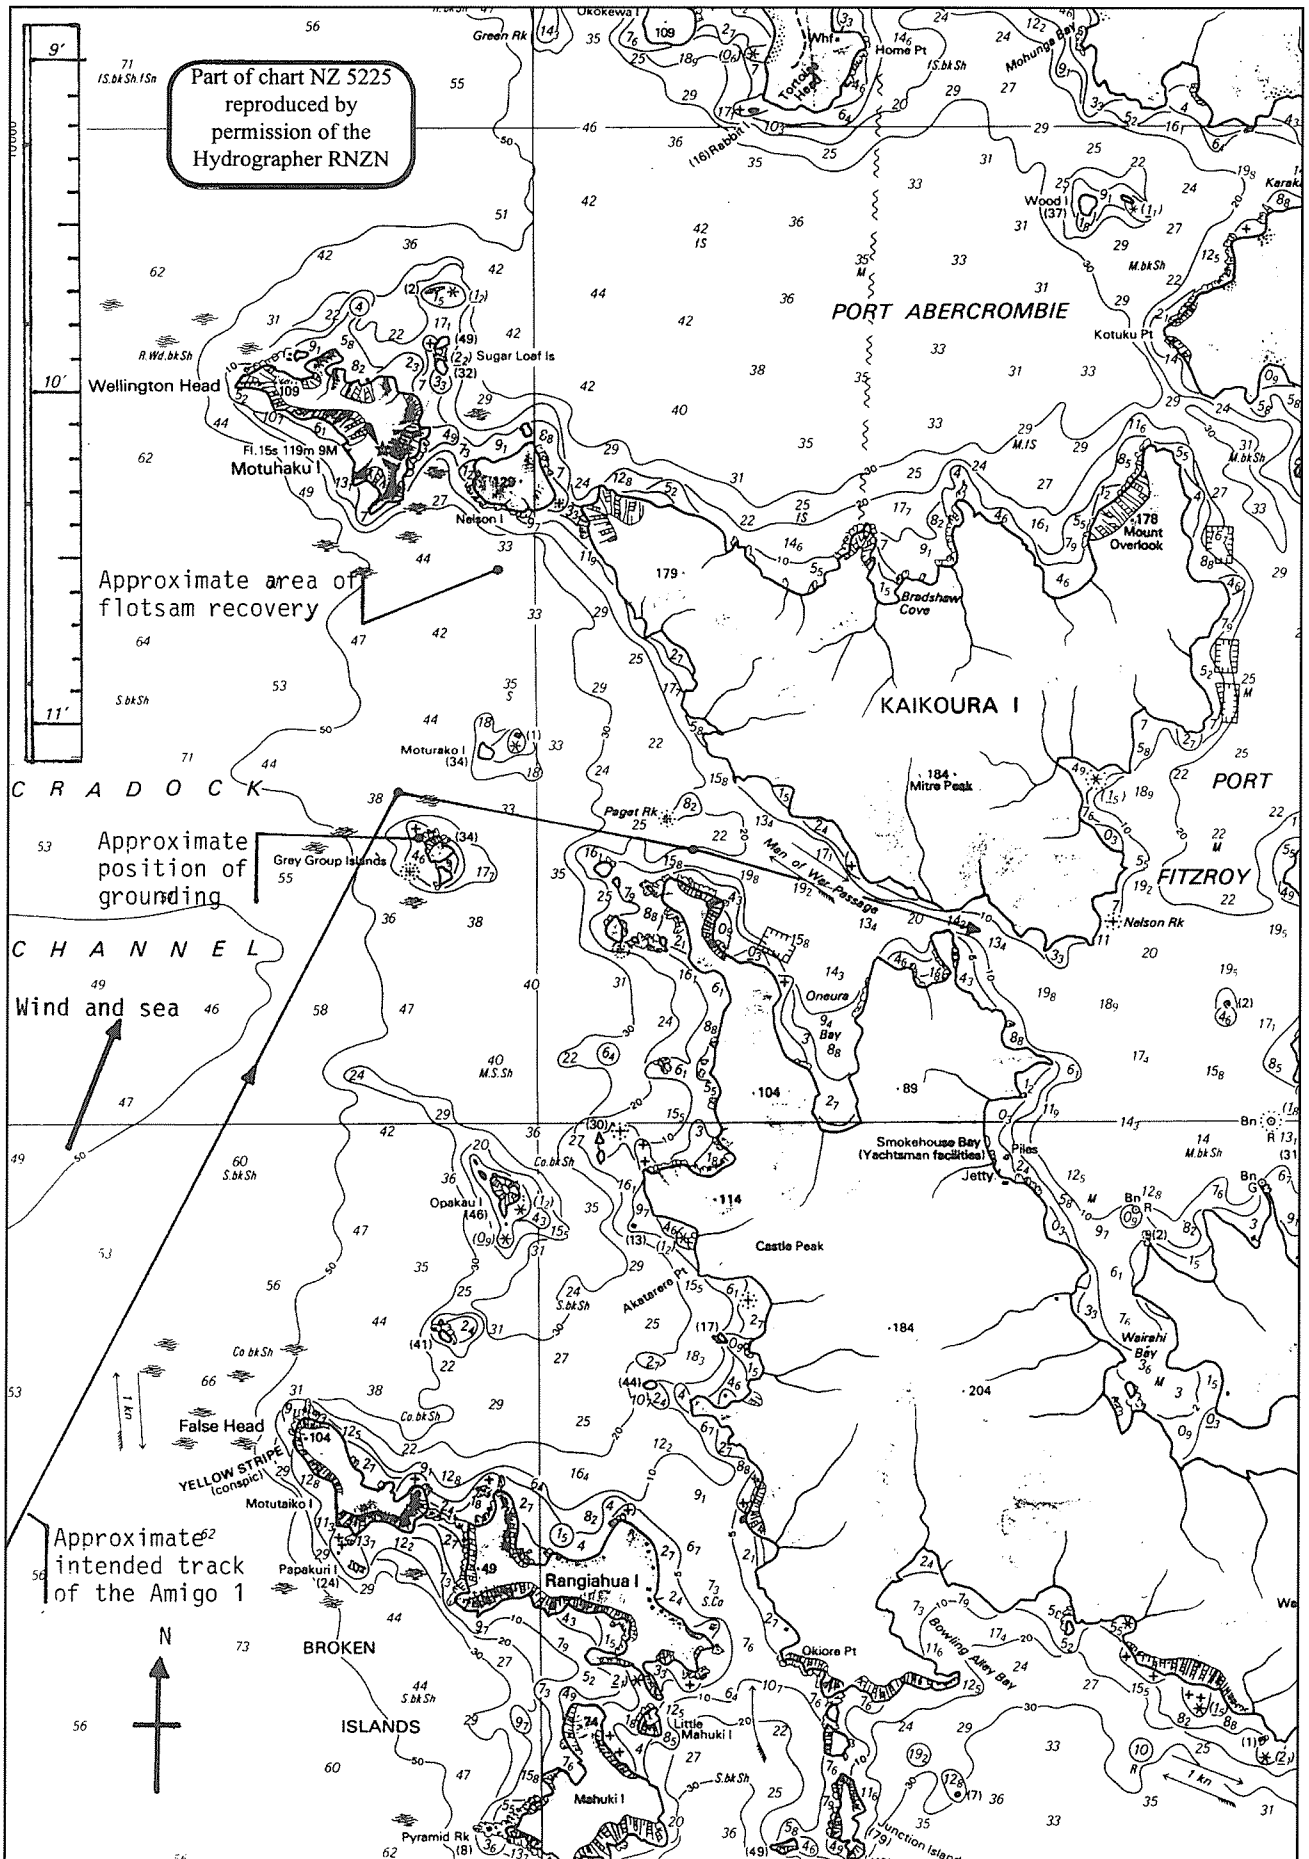
Figure 2
Part of chart NZ 5225, showing key information

- 1.1.14 The skipper appeared to have planned his route to Port Fitzroy via the Man of War Passage. He had programmed a way-point into the GPS which was about 1.5 cables north-west of the Grey Group Islands. (See Figure 2.)

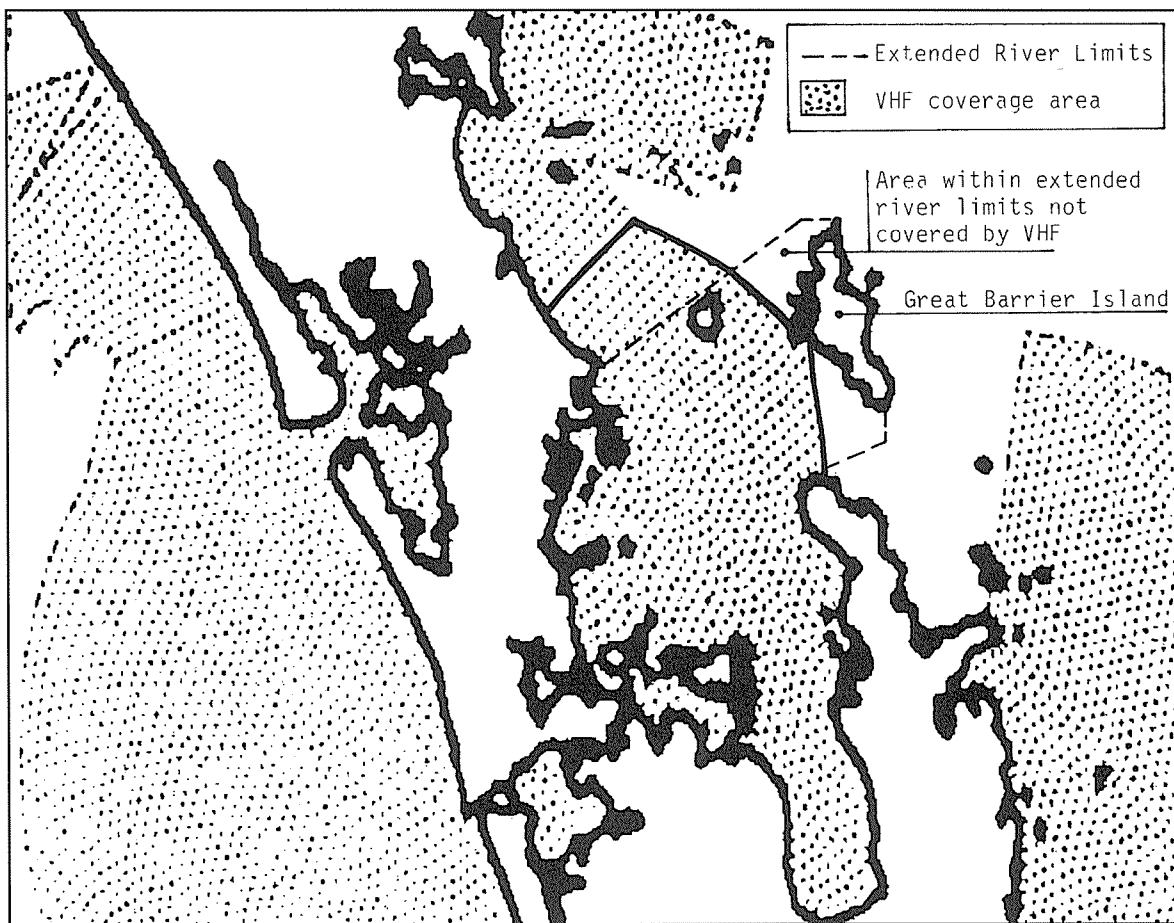
Figure 3
Part of the MSA/BCL 24 hour VHF coverage chart
with Auckland Extended River Limits added

- 1.4.23 Auckland Extended River Limits included all of the west coast of Great Barrier Island. The charted VHF Channel 16 area covered by Auckland Maritime Radio included the Hauraki Gulf and part of Bream Head to Cape Colville out as far as the southern side of the Broken Islands on the south-west coast of Great Barrier Island. MSA Channel 16 VHF coverage for distress and calling was not guaranteed for the remainder of the west coast of Great Barrier Island, including the area where the accident occurred. (See Figure 3.)

- 1.4.25 Figure 3 shows part of the MSA/Broadcasting Communications Ltd (BCL) 24 hour VHF coverage areas which are based on an International Maritime Organisation (IMO) formula which allows for mariners transmitting on a typical hand-held VHF with its antenna height at one metre above the water (a typical distress situation). A more powerful VHF set with a greater antenna height may be heard at greater distances. It was not uncommon for small vessels entering Port Fitzroy on Great Barrier Island to lose radio contact in the approaches to Port Fitzroy. For this reason mariners who were familiar with the area often sent their TR to Auckland Maritime Radio before making their approach to the port.

- 1.4.26 It could not be established if the skipper was aware that by taking the *Amigo 1* to Port Fitzroy he was operating outside the limits specified on the superseded MSA Certificate of Survey, or if he was aware that his LLL was not valid for Auckland Extended River Limits.

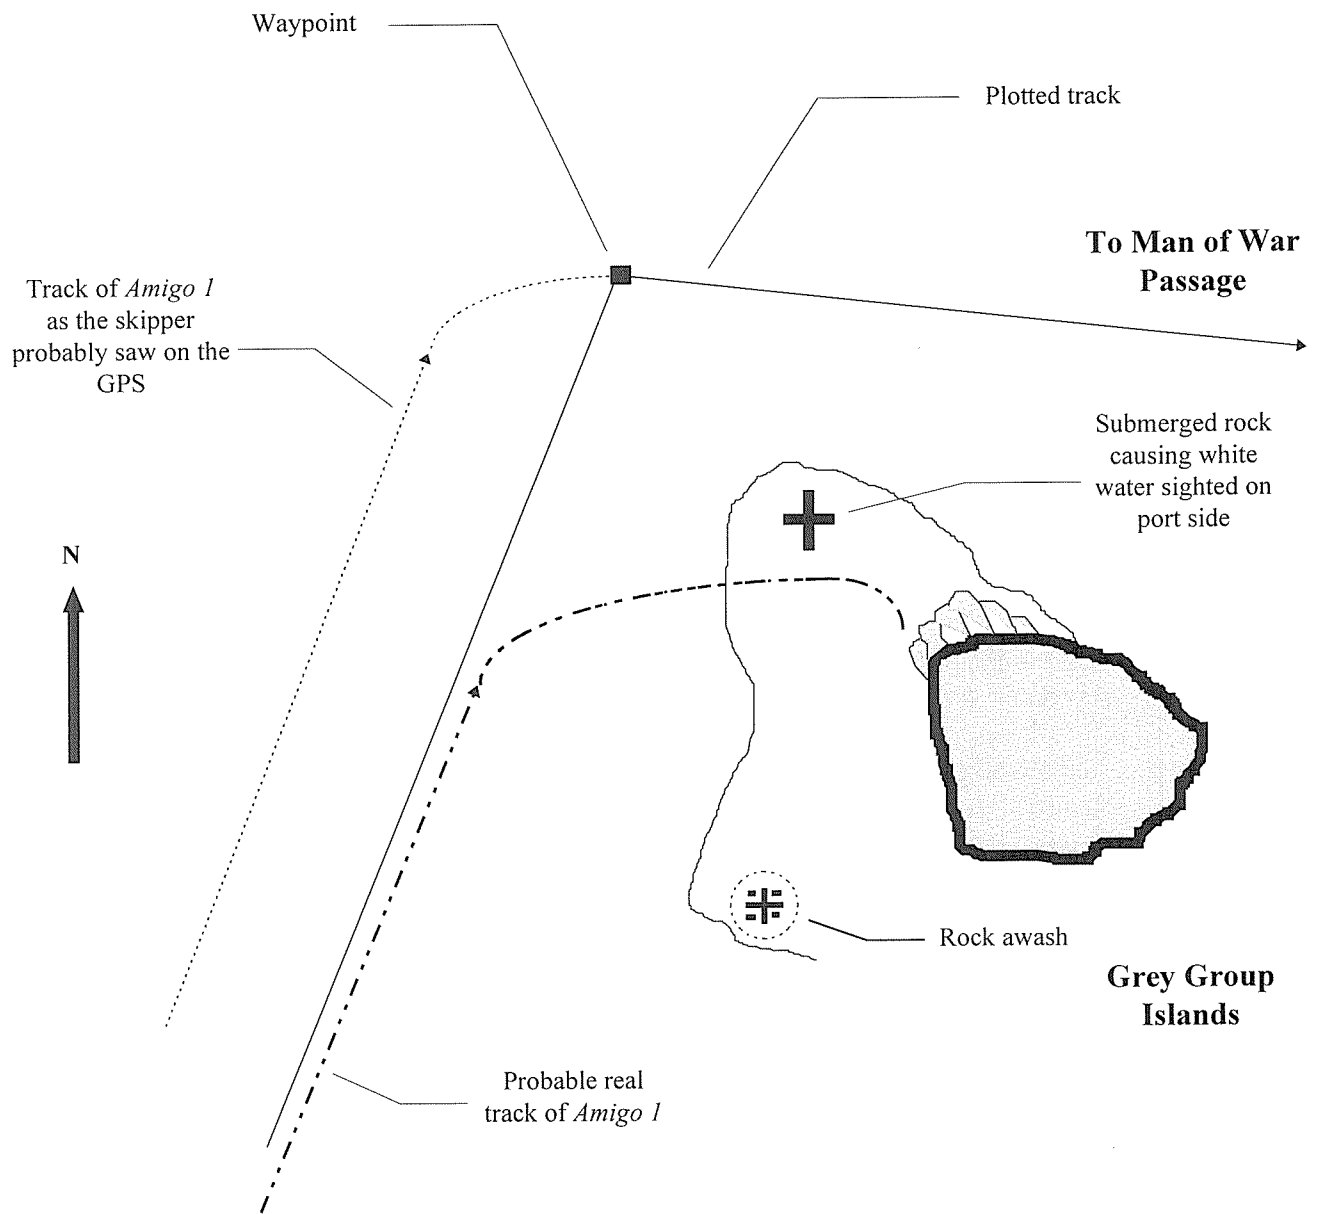
Figure 4
Diagram showing plotted, probable and perceived tracks of the
***Amigo 1* leading up to the grounding (diagram not to scale)**

- 1.1.21 On hearing the skipper’s comments the passenger who had been dozing on the wheelhouse bunk looked up at the GPS monitor and noticed that there were two lines; one line extending from the direction in which the vessel had come to the way-point off the Grey Group Islands (intended track), and the other was the past track of their vessel. He recalled that the GPS displayed position of the vessel and its past track was “. . . about half an inch outside the intended track”, but he did not know what scale was in use on the chart monitor. (See Figure 4 in Analysis.)

- 2.1.14 The possibility that an autopilot malfunction caused the vessel to veer to starboard unnoticed by the skipper could not be ruled out; however, the skipper's reported comments indicate that he made a deliberate turn to starboard based on misinformation from the GPS plotter.

- 2.1.17 The skipper's reported comments, "Where is this white water?" "Where are we?" "What's going on?" were a clear indication that he had lost situational awareness before the grounding. He apparently did not see the white water on the port side of his vessel. Relying on information from the passengers, his engaging the engine astern and turning to starboard would have been an instinctive reaction to stop his vessel proceeding further into a perceived dangerous situation, and to turn away from the reported source of danger.
