Report 97-205

Coastguard rigid inflatable rescue craft *UDC Rescue*

loss of buoyancy pontoons

11 October 1997

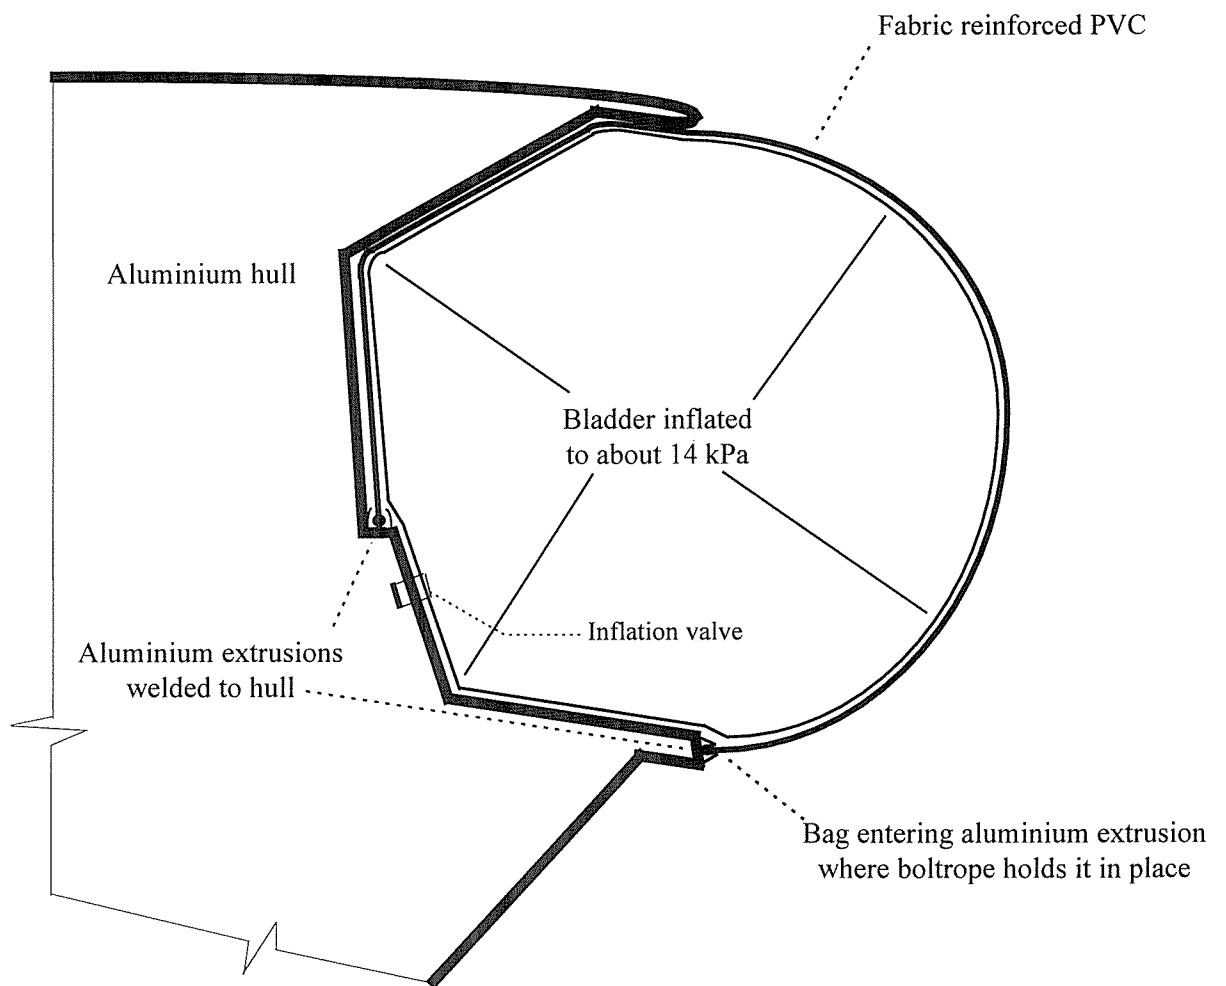
Figure 1
Cross section through pontoon arrangement near the bow
(diagram not to scale)

- 1.2.8 The bladders and bag arrangement (pontoons) were supported in an aluminium half-round recess at the bow and for about one metre on each side at the stern. The remainder of the pontoons rested in a quarter-round recess. (See Figure 1.)

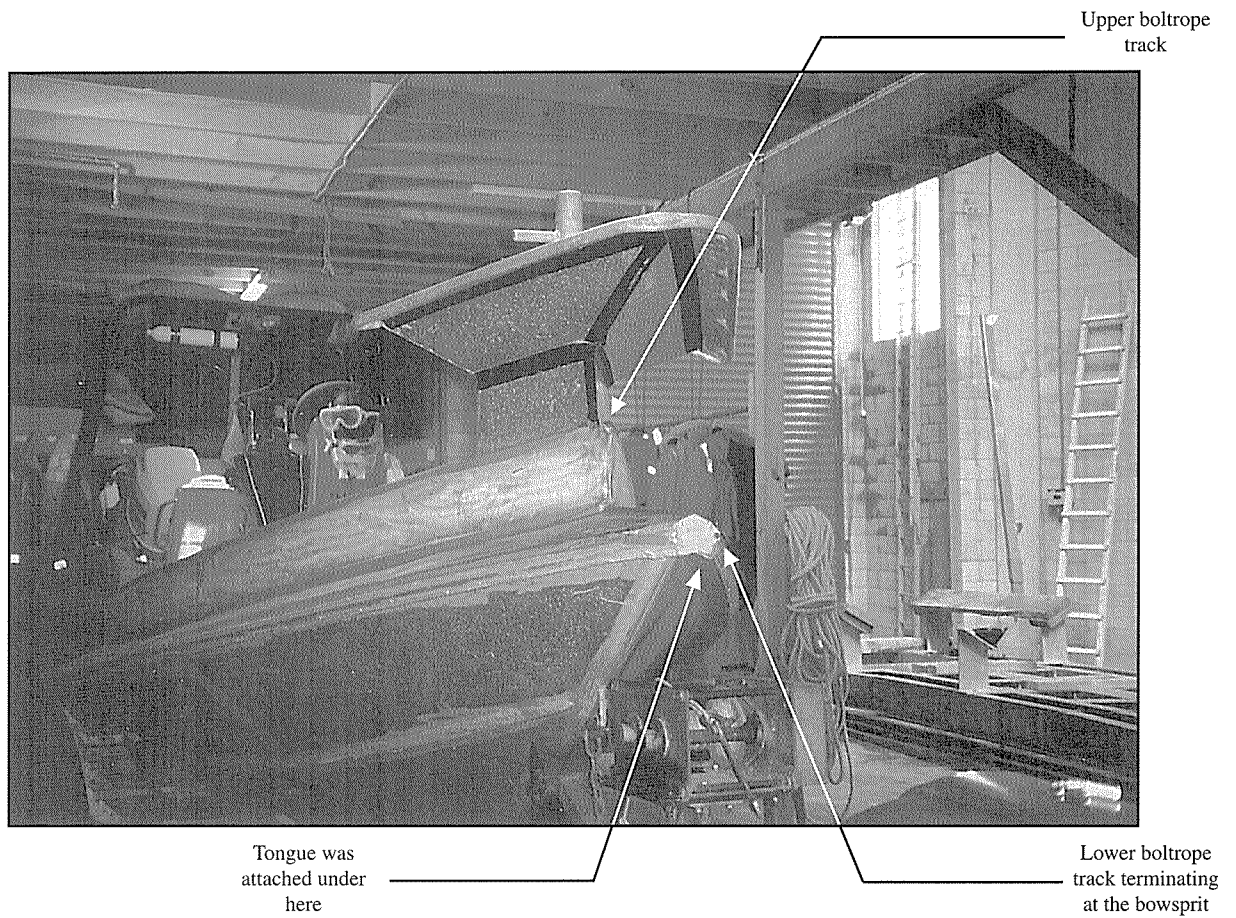
Figure 2
Photograph showing the arrangement at the bow of *UDC Rescue* without its buoyancy pontoons

1.2.11 If the tongue was not secure this would:

- remove a defence designed to deflect water away from the gap between the bag and the hull,
- allow the bags to creep forward,
- open a gap for water to force up into the bags, and
- allow more movement of the pontoons around the end of the extrusions.

1.2.12 A combination of the above factors would place more pressure on the bag fabric at the bow. (See Figures 2 and 3.)

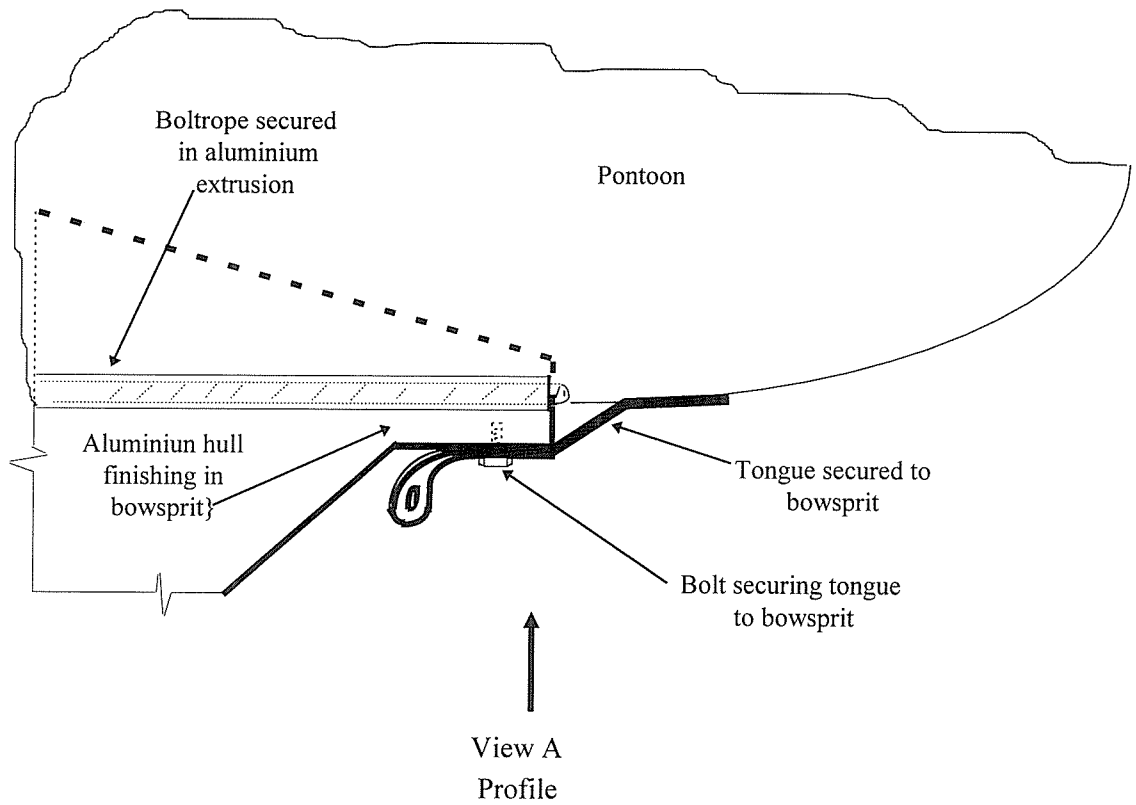
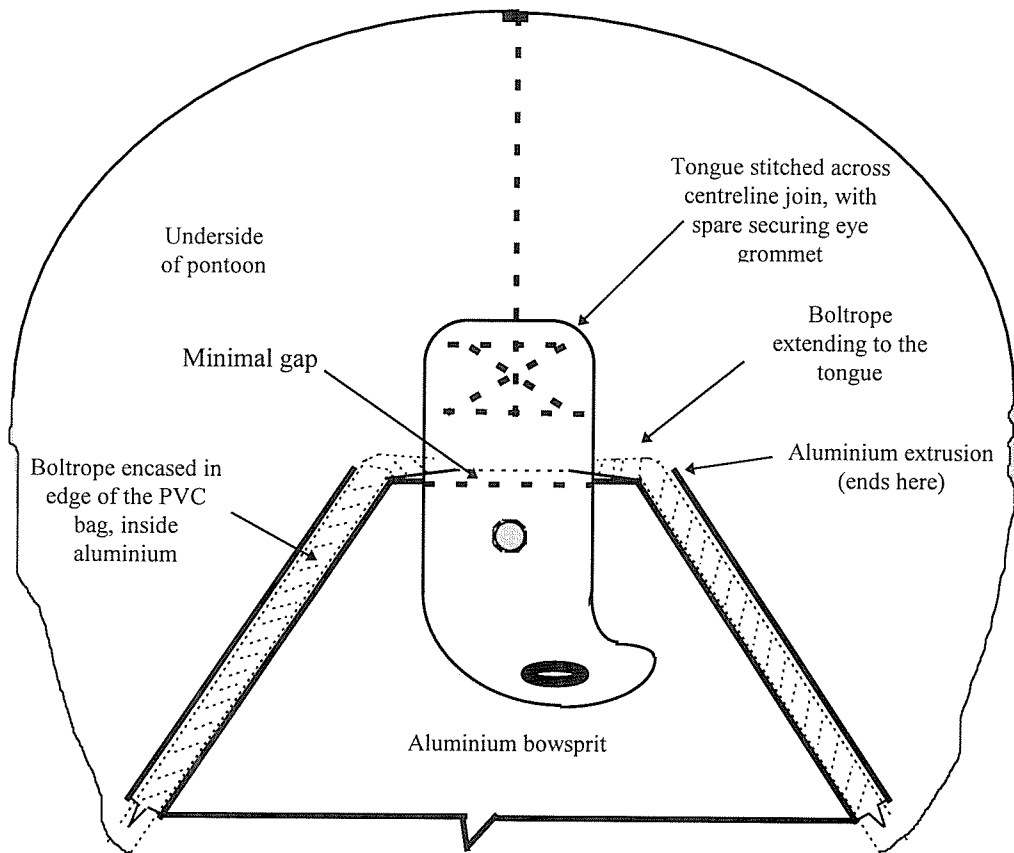
Figure 3
UDC Rescue bag securing arrangement at the bow (diagrams not to scale)

1.3.3 The aluminium plate under the bowsprit, onto which the tongue had been secured by a self-tapping bolt, was extensively corroded. The self-tapping bolt was missing. The two metal grommets that were normally set into the tongue, and through one of which the bolt was normally secured, were both missing. When the craft was new, the original bolt hole was tapped, with a normal bolt screwed into it.

View A looking up under the pontoons, at the bow

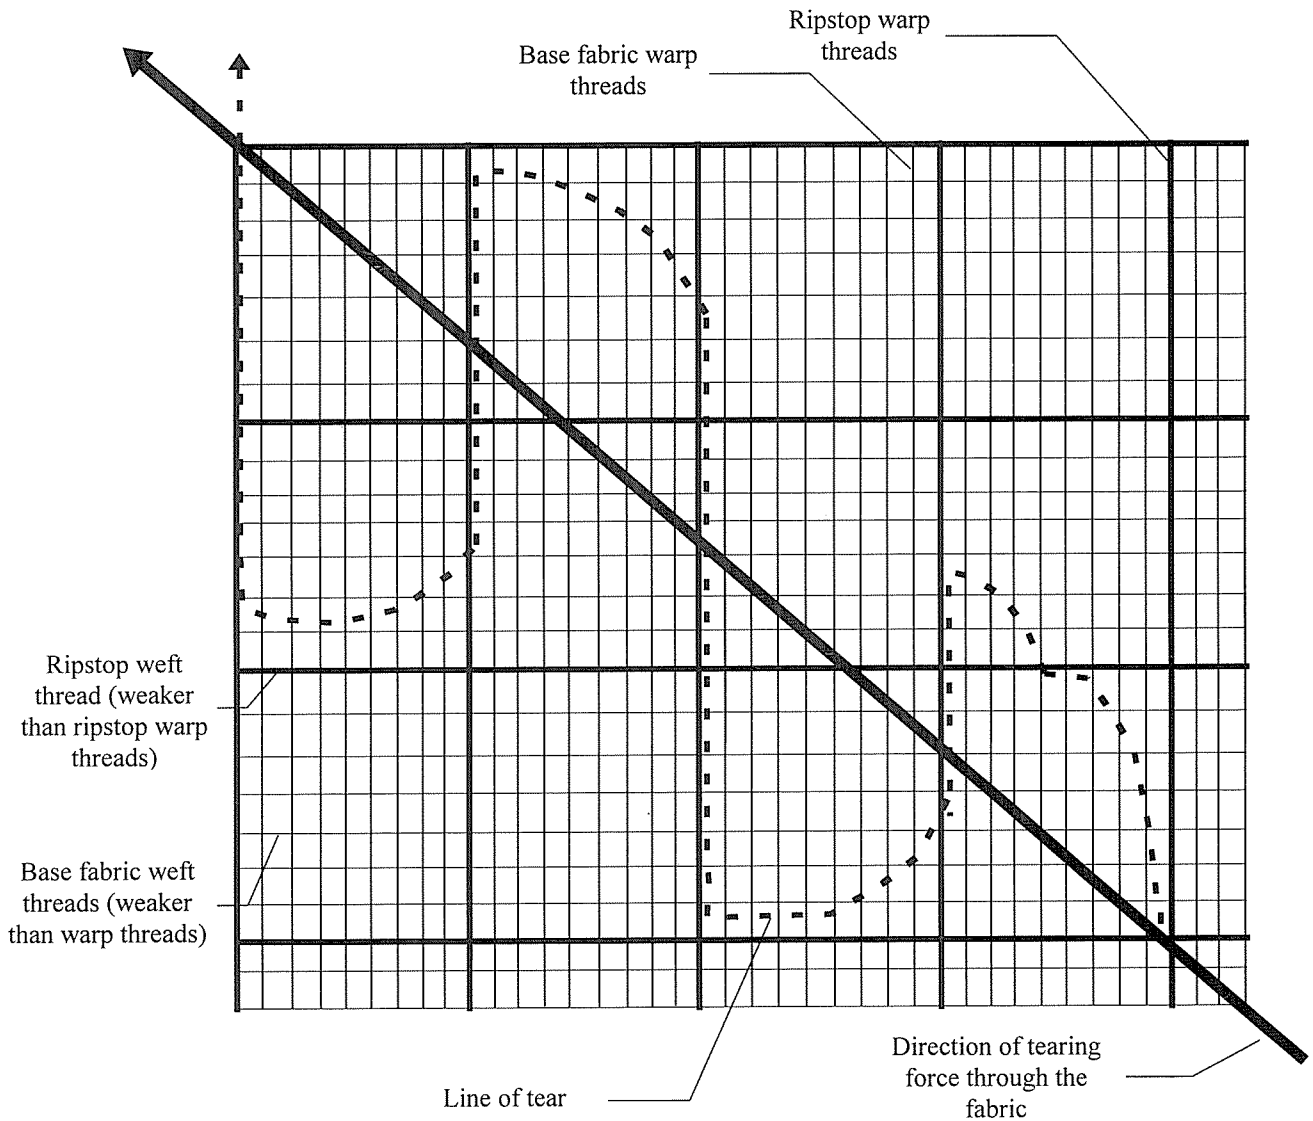
Figure 4
Exaggerated view of how a tear may progress through the base fabric

The dotted line represents an exaggerated representation of how the saw-tooth tear phenomenon occurs in a fabric that incorporates ripstop threads and has stronger warp threads. The tear will tend to follow the line of the stronger warp threads as the weaker weft threads give first. The warp threads start to break once the tear moves away from the natural line of force that is causing the tear.
