**Report 97-206**

**tug *York Syme***

**grounding**

**Maria Island, Hauraki Gulf**

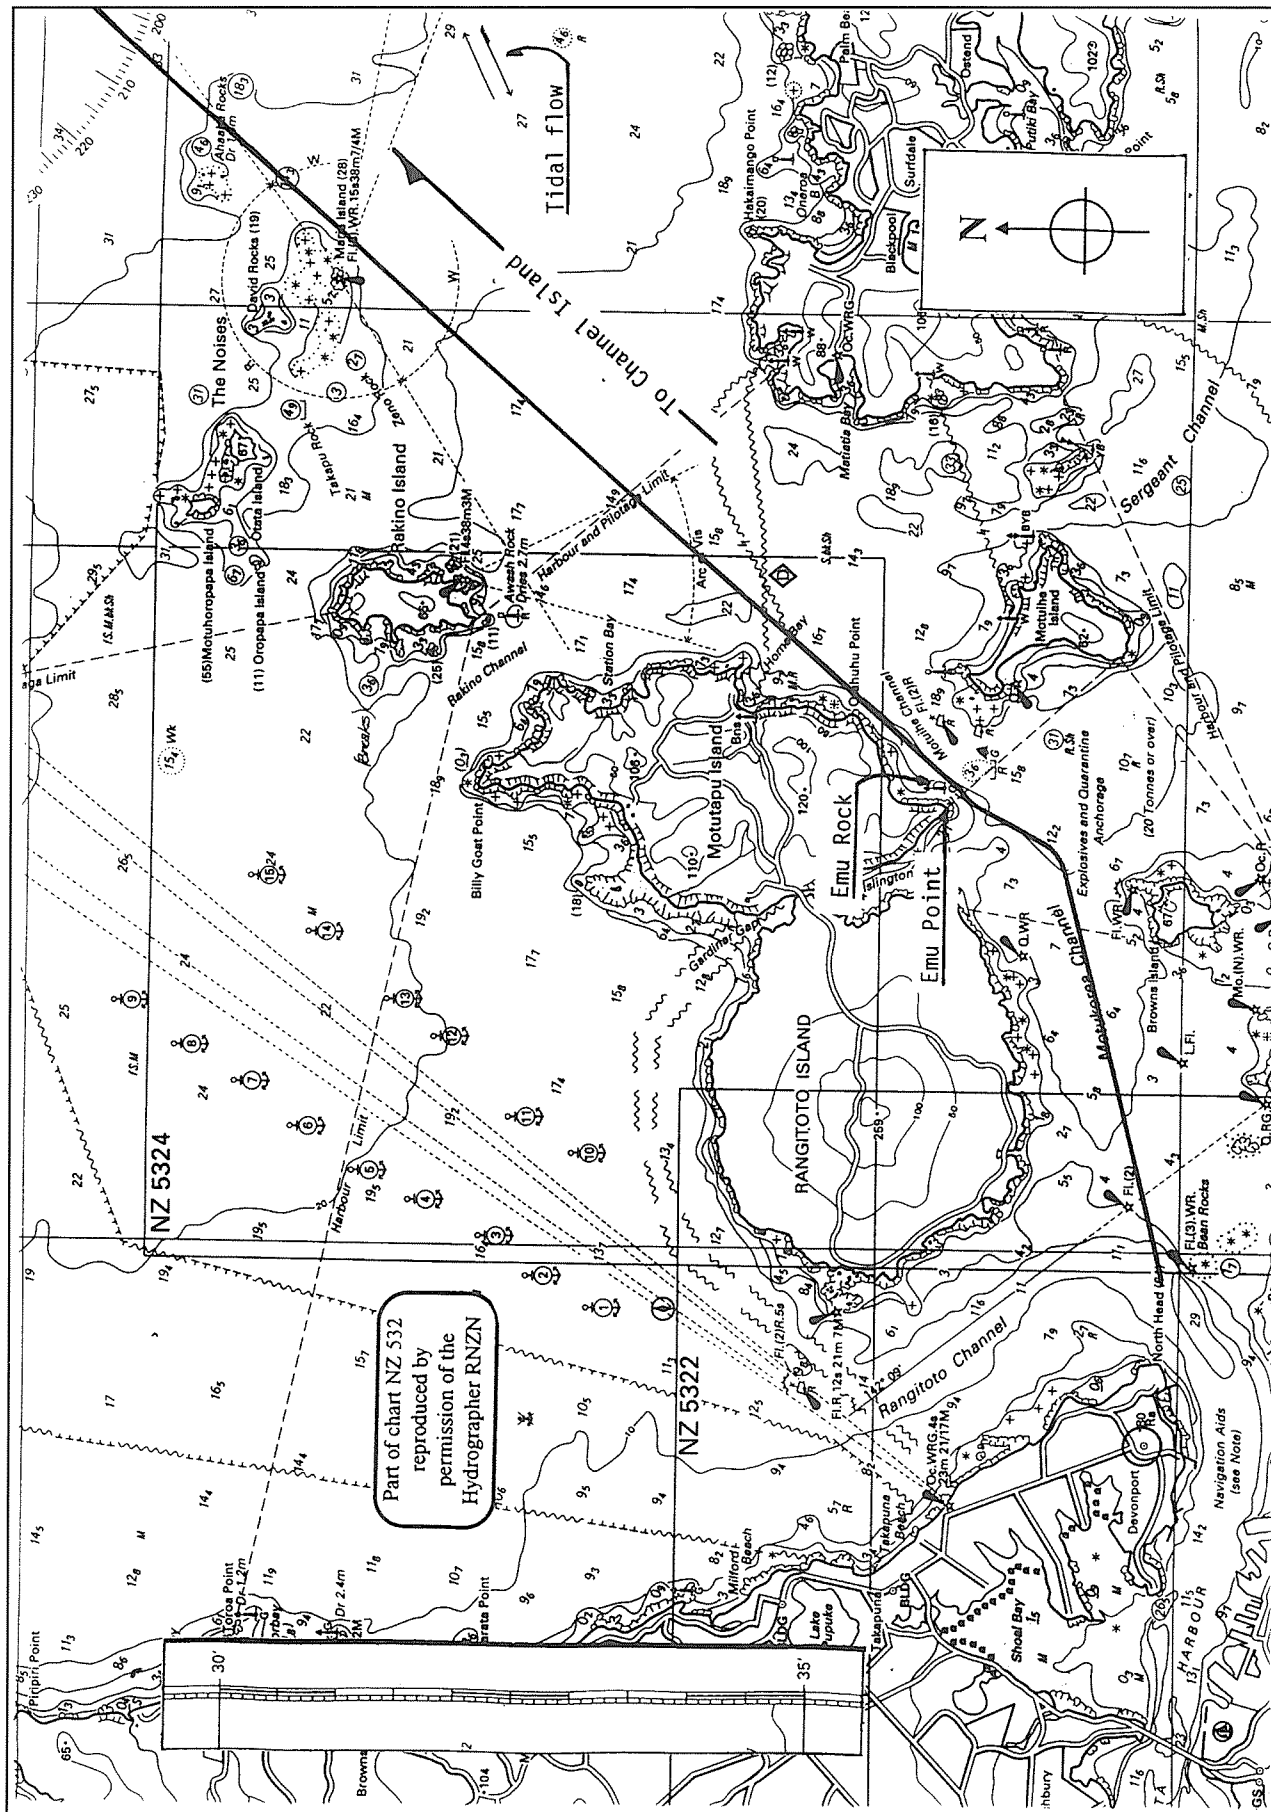
Figure 1  
Part of Chart NZ532 showing intended track of York Syme

1.1.2 The planned route (see Figure 1) from Auckland to the dumping ground was:

- 1.1.9 At about 2030 the *York Syme* passed Emu Rock, which was marked by an unlit green beacon. The skipper later stated that he saw the beacon and estimated it to be 100 to 200 m distant. At this time he was able to see the flashing white light on Maria Island and brought *York Syme* around to the course for Channel Island. On that course the passing distance off Maria Island should have been a quarter of a nautical mile (see Figures 1 and 2).

- 1.1.19 The skipper called Auckland Maritime Radio, advised them of the grounding and requested a tug to be sent out to tow both vessels clear of the reef. The message was a Pan Pan urgency call<sup>6</sup>. In this first call the skipper advised the grounding position as being on the Ahaaha Rocks (see Figures 1 and 2).

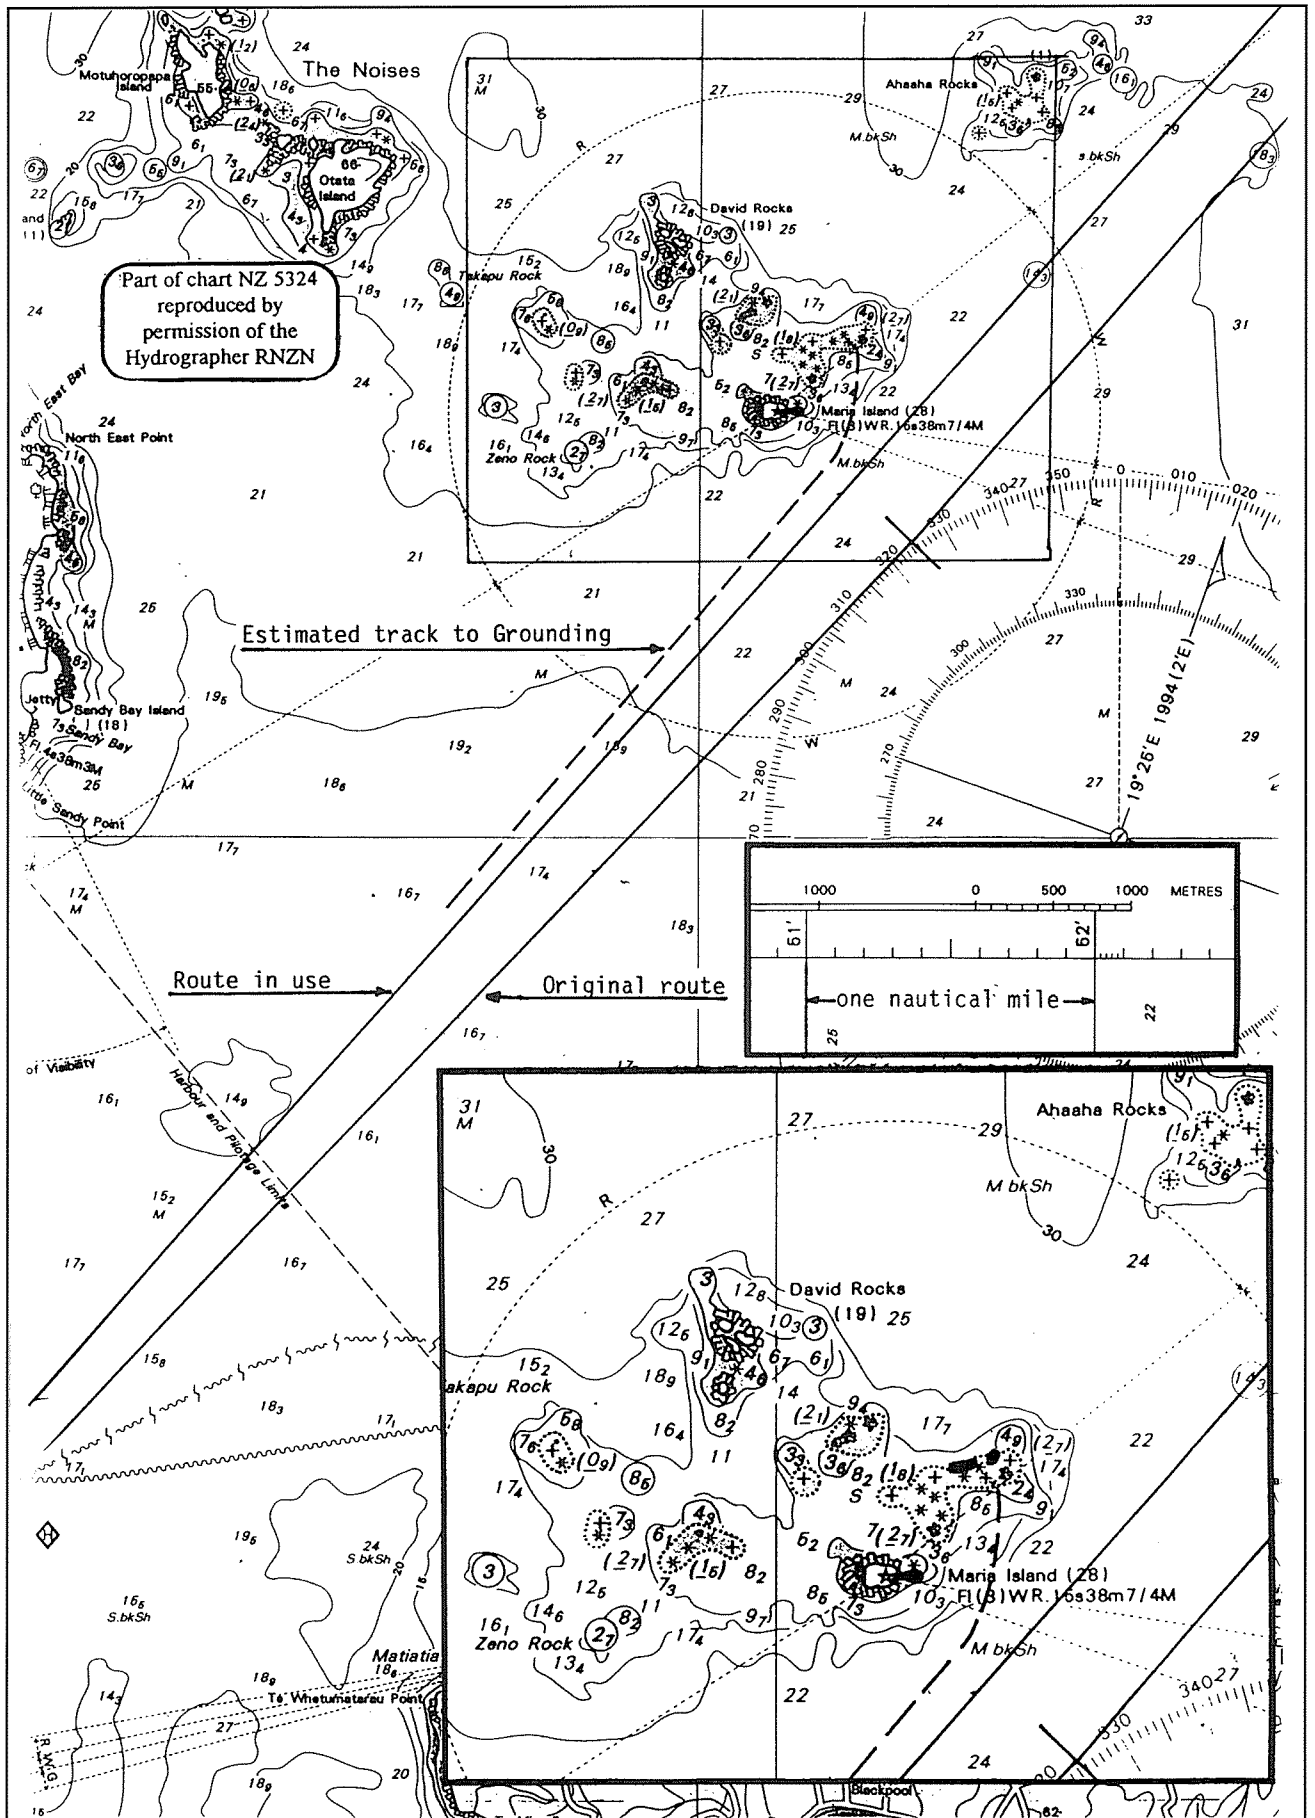
Figure 2  
Part of Chart NZ5324 showing original and simplified planned routes and the estimated track of *York Syme*.

1.1.3 The skipper of *York Syme* estimated he had made the passage to the dumping ground 400 to 500 times. The route had evolved over the three year period of the contract, initially involving a greater number of courses but had been simplified in use. (See Figure 2)

- 1.1.16 The *York Syme* struck a rock and drifted into the reef area. *H7* followed into the reef, passing down the port side of *York Syme*. As *H7* continued through the reef the towline fouled on rocks, became taut and pulled the stern of *York Syme* around. The *York Syme* and *H7* came to rest on the northern side of the reef with the towline fouled among the rocks, (see Figure 2).

- 2.4 The planned route from Auckland to the dumping ground that evolved over the period of the dredging contract reduced the original clearance off Maria Island from 0.6 nautical mile to only 0.25 nautical mile. Changing the passage from Emu Rock to Channel Island from two courses to only one course did not save any appreciable distance.
