Report 97-211

jet boat *K-Jet 3*

rolled on a shingle bar

Lower Shotover River, Queenstown

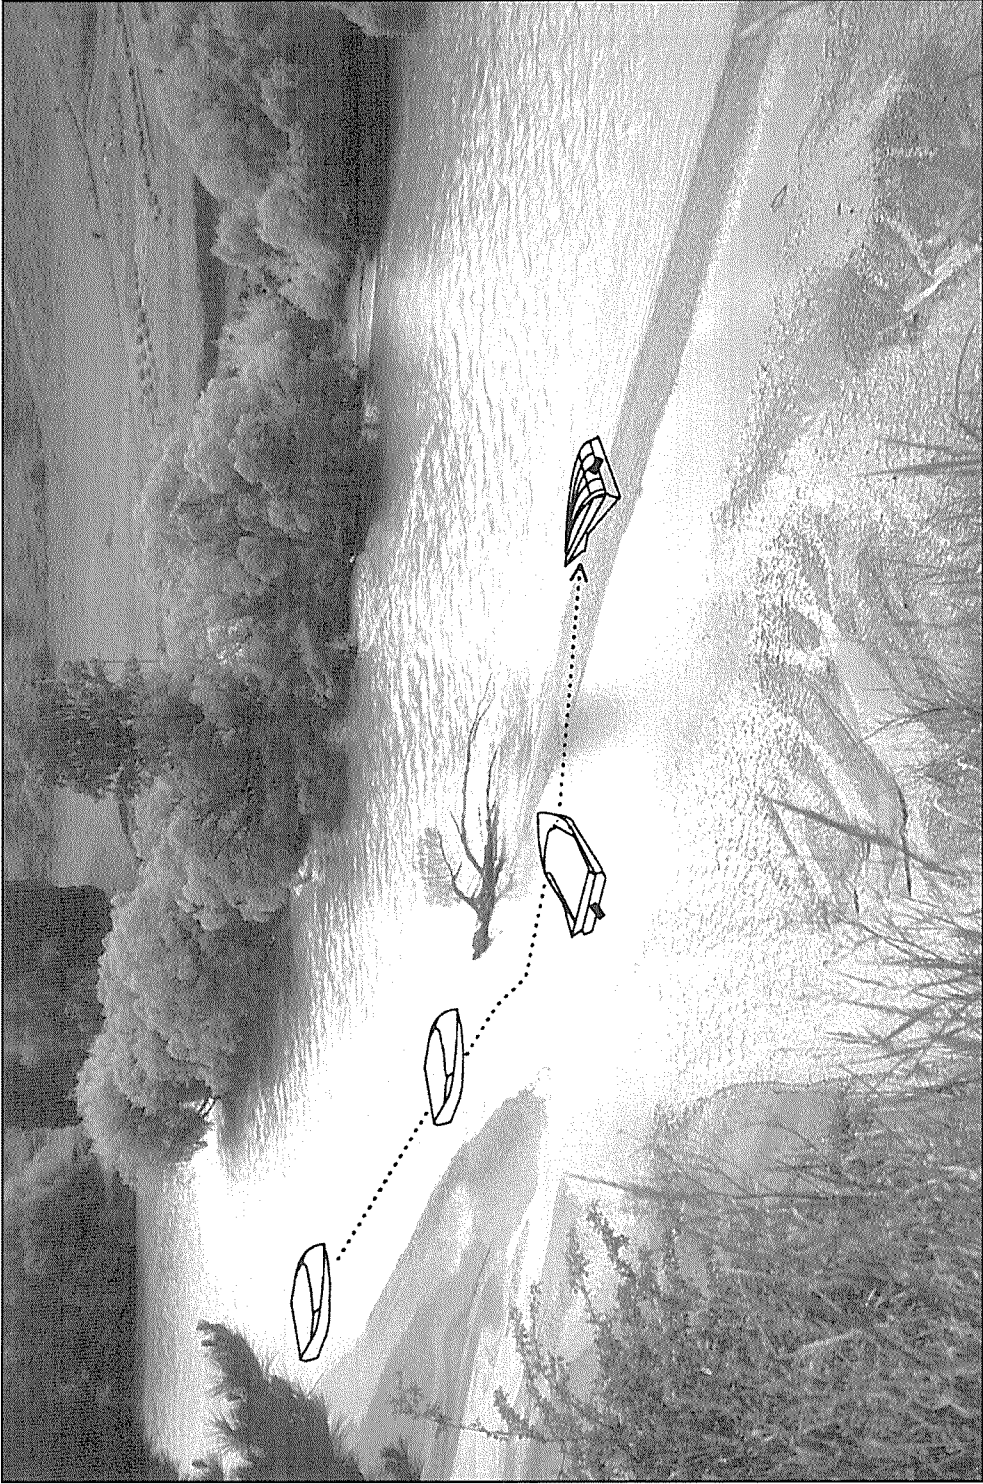
Figure 1
Approximate track of *K-Jet 3* to the right of the tree

- 1.1.5 At about 1530, *K-Jet 3* left Tuckers Beach heading back down the Shotover River to return to Queenstown. Just above the Shotover River road bridge, *K-Jet 3* came around a wide sweeping right hand bend in the river and was running parallel and close to the right hand side of the main channel. The driver lined the boat up heading for a large dead tree that had grounded on a shingle bar near the right hand side of the main river flow (see Figure 1).

- 1.1.6 To the right of the tree, the river fanned into a small tributary which became progressively shallower, ending in a shingle bank over which the river flow was just visible. *K-Jet 3* entered the small tributary at about 70 km/h and began a left turn close to the tree. As the boat drew level with the tree, the driver exclaimed, “Oh [***]” and some passengers observed the driver turn *K-Jet 3* to the right slightly before executing a hard left turn. The driver later recalled releasing the accelerator at that time.

- 1.1.7 As the boat entered the hard left turn, the foot of the bow struck a shingle bar behind the tree and the boat skidded sideways along the shingle bar for about 10 m, before rolling over to the right and coming to rest up side down, half in and out of the water.
