**Report 98-009**

**Cessna 177B Cardinal**

**ZK-DKL**

**impact with mountainous terrain**

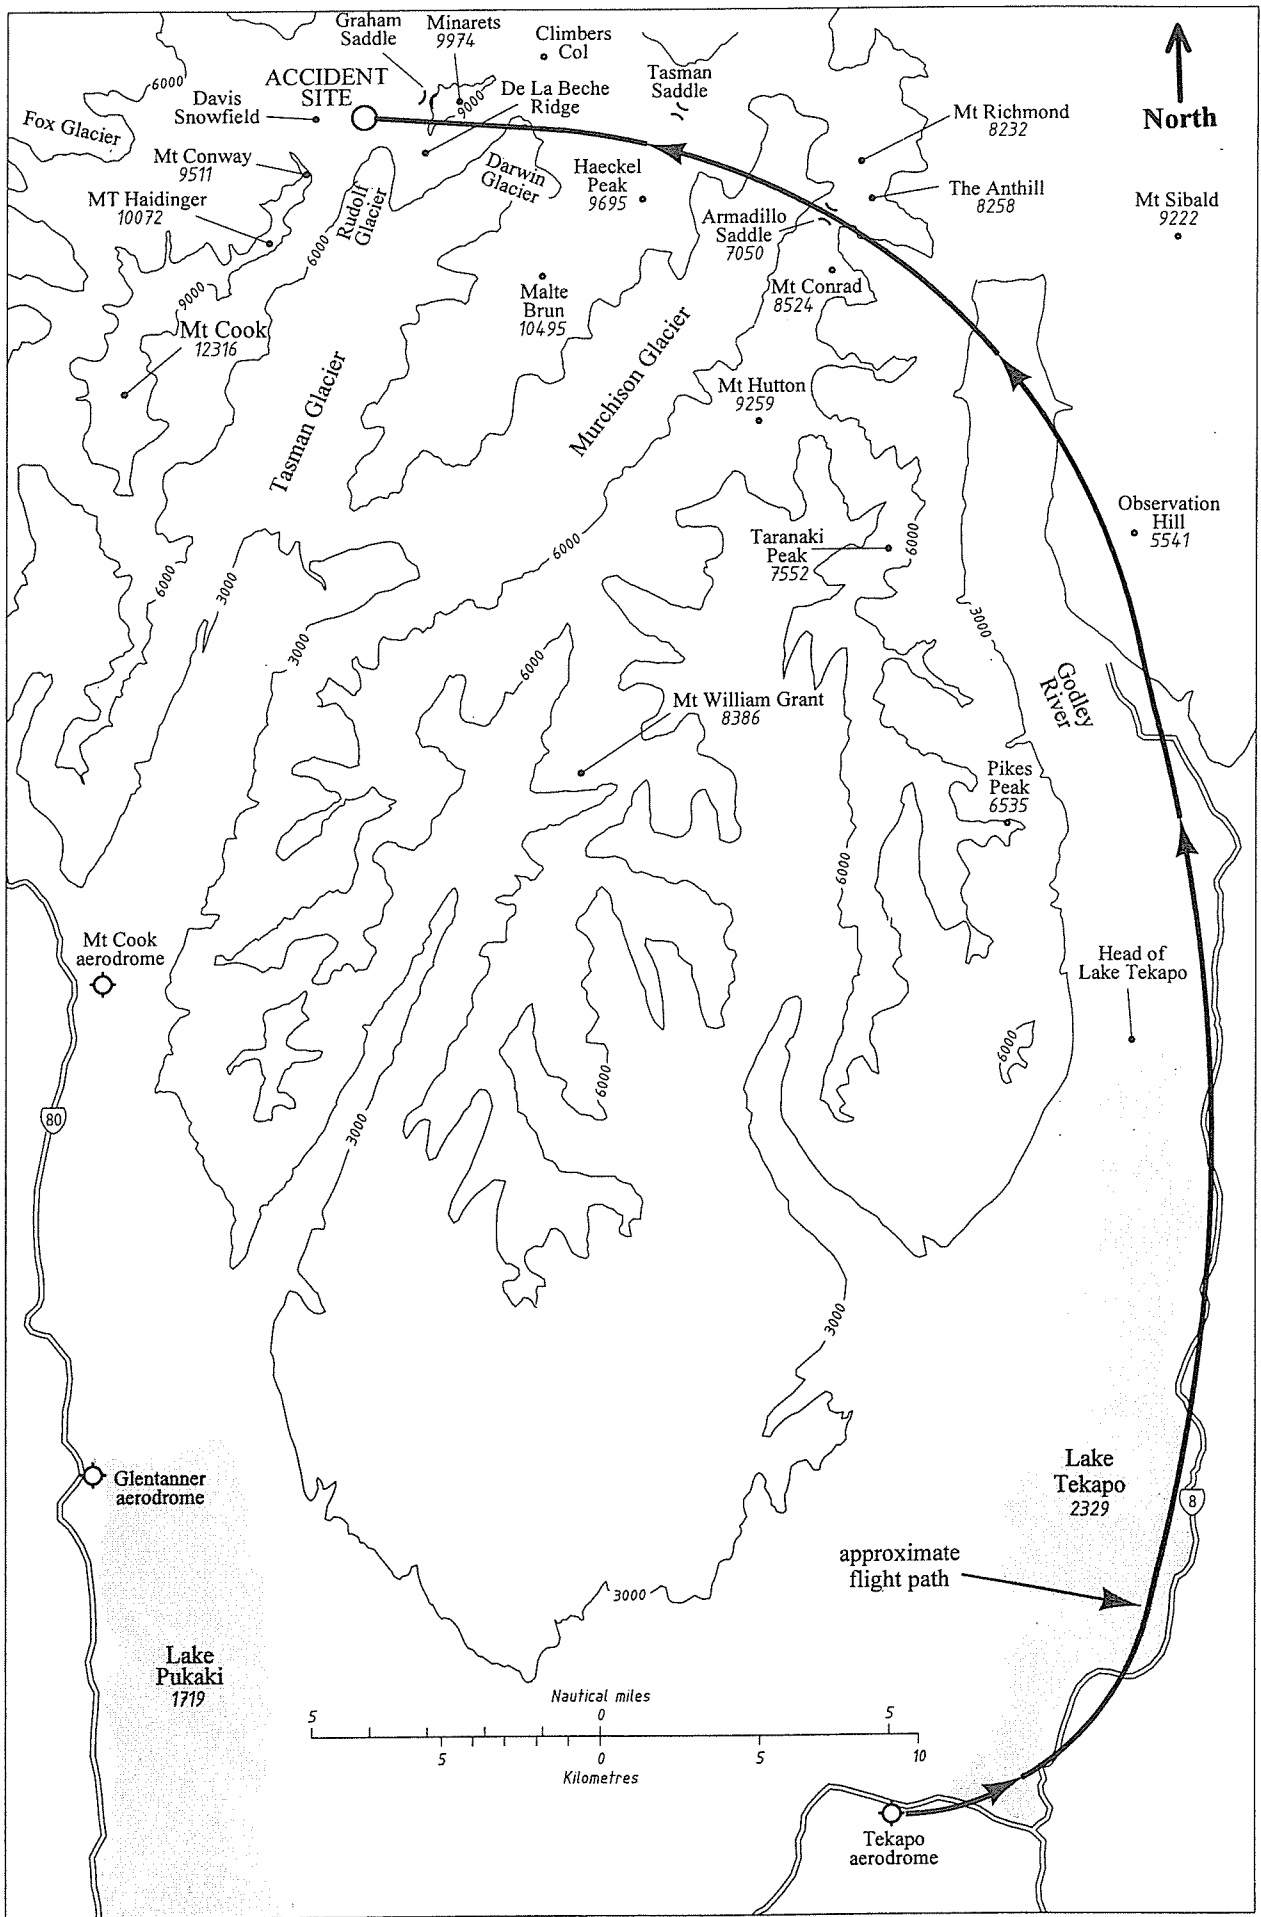
**Figure 1**  
**Approximate flight path of ZK-DKL**

- 1.1.2 The flight was planned to follow the standard route over the head of Lake Tekapo, the Godley River valley, Armadillo Saddle, Tasman Saddle, across the Main Divide near Climbers Col or Graham Saddle, circle around the western side of Mount Cook to Tasman Glacier, orbit and descend to land at Glentanner Aerodrome. (See figure 1.)
