Report 98-101

Train 721

heat buckle derailment

near Scargill

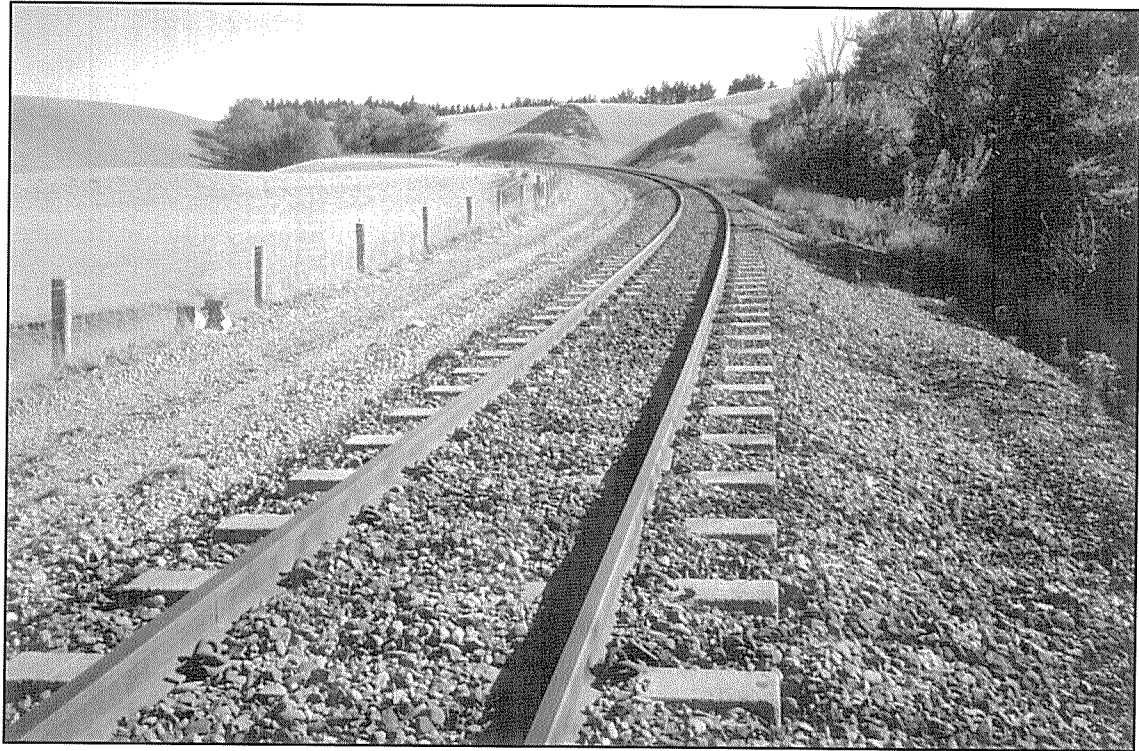
Figure 1
Ballast section adjacent to point of derailment

1.2.5 The track ballast used in the area of the derailment was clean crushed river gravel, well drained and with a minimum depth of 250 mm below the underside of the sleepers. The ballast section at the actual buckle site could not be established because of the track damage caused by the derailment. However there were areas of track immediately to the north of the derailment where the ballast section was inadequate, both at the top level of the sleeper and from the outside face at the sleeper. (See Figure 1.)

- 2.4.2 The depth of ballast below the bottom of sleeper on either side of the derailment site conformed with the depth requirements of Tranz Rail's Code and it is likely that similar depths existed through the derailment site itself. However, the shoulder ballast section immediately adjacent to the POD was deficient and it is likely this deficiency existed through the derailment site.

- 2.4.3 The deficient ballast shoulder section had developed as a result of a "pinnacle" track situation. The POD was on an embankment formation between cuttings, and to compensate for differential settlement over the years the track had been progressively lifted over the embankment with additional ballast added to achieve this. This caused gradual deterioration of the ballast shoulder profile and resulted in the deficient profile as shown in Figure 1.

- 3.3 It is highly likely that the shoulder ballast profile was significantly and visibly deficient, especially to the outside leg of the curve, at the POD.

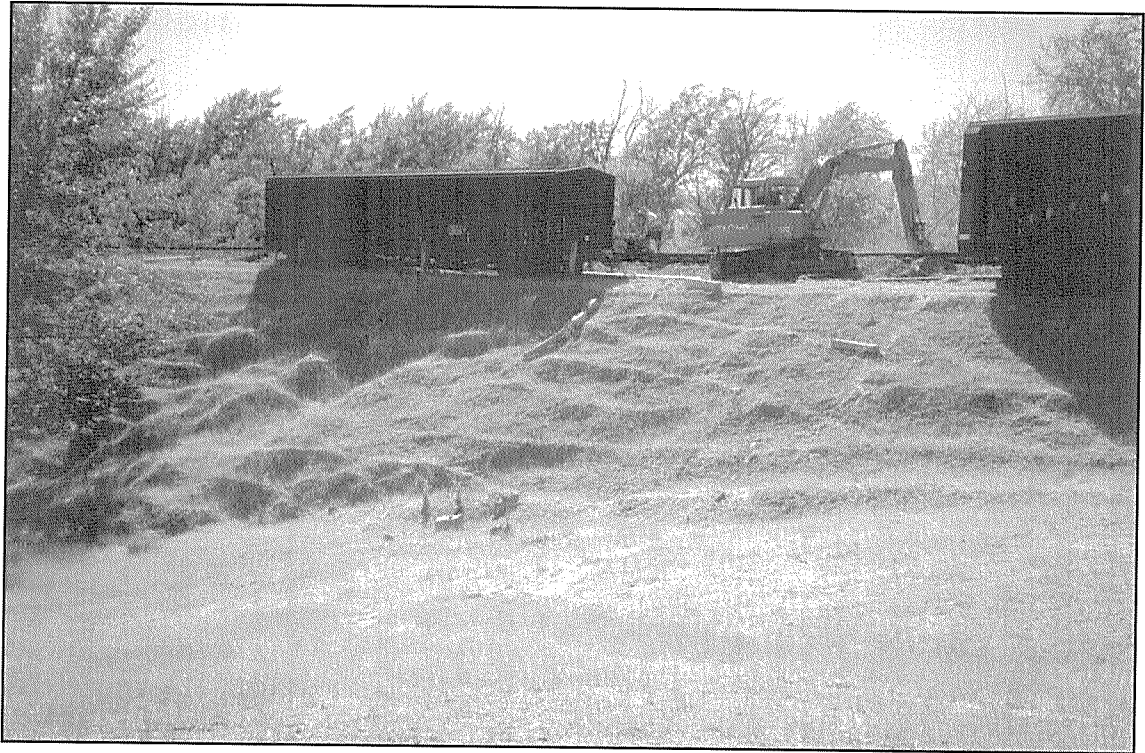
- 1.3.2 The derailment occurred near the centre of the 640 m radius right hand curve.
- 1.3.3 The railway alignment in the Scargill area follows a line of cuttings and fillings through undulating, rolling countryside. In the area of the track buckle, the alignment was built up on an embankment approximately 25 m deep between cuttings either side. (See Figure 3.)

Figure 3
General view of the embankment
