Report 98-105

Train 235

derailment

Rail Incident Report 98-105

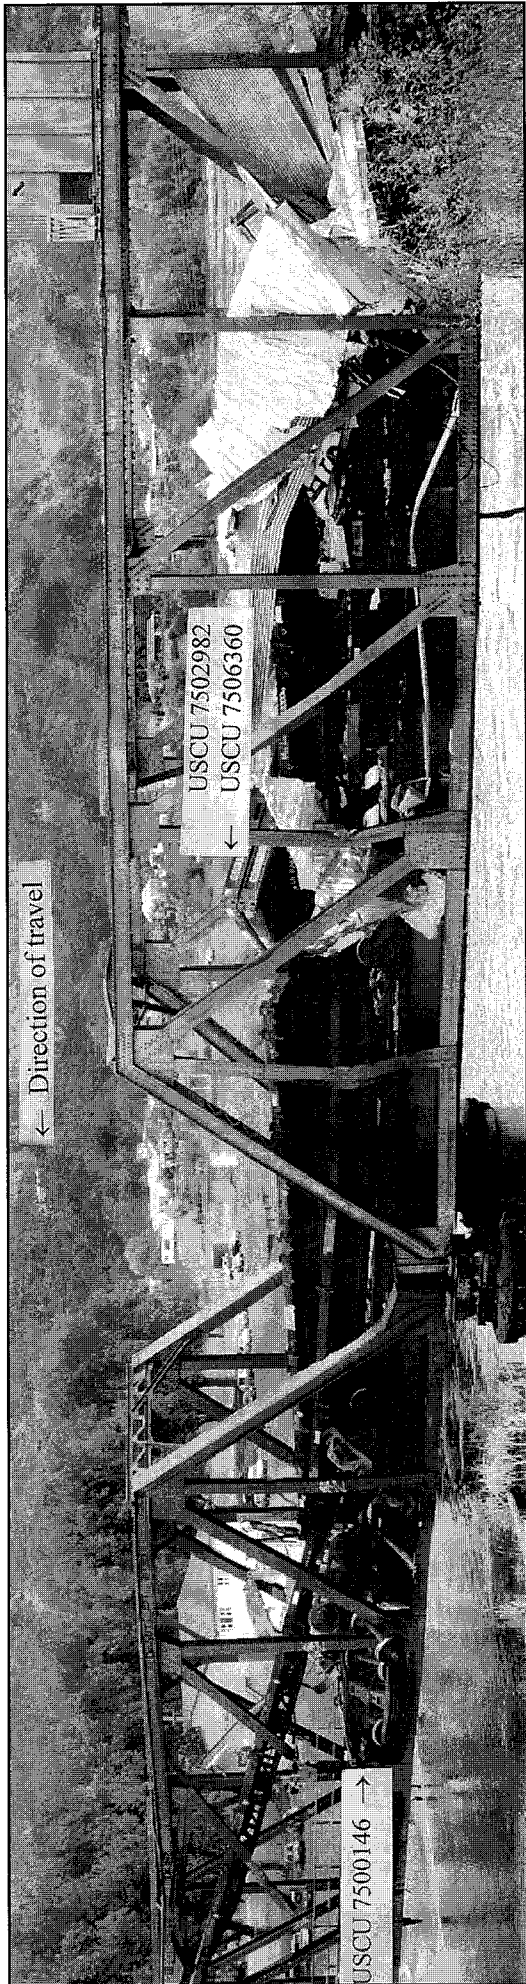
- 1.1.4 Shortly after the front of the train had crossed the bridge the LE noticed that the train had lost all air pressure and the train brakes had been automatically applied. The LE suspected a burst hose but when he walked down his train he found the train had parted, with the rear portion of the train derailed into the bridge structure at the northern entry to Bridge 267, (see Figures 1 and 2).

Figure 1
 General view of the derailment scene from the east

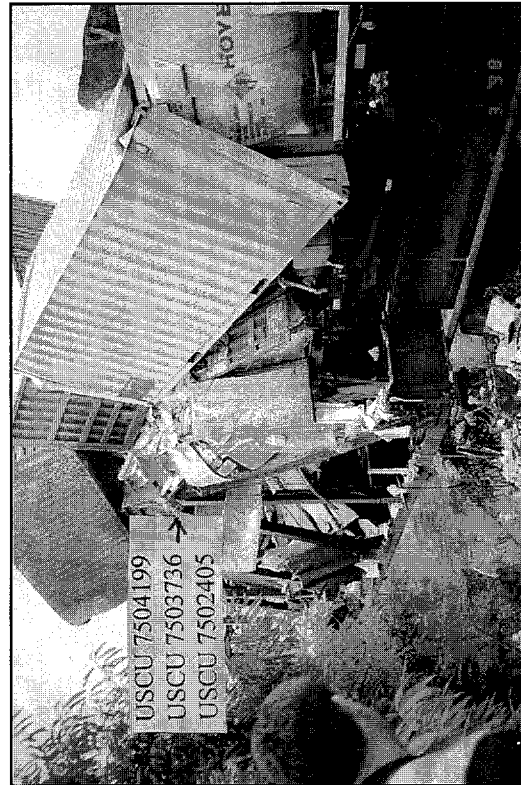
Figure 2
 General view looking south at the north entry to the bridge

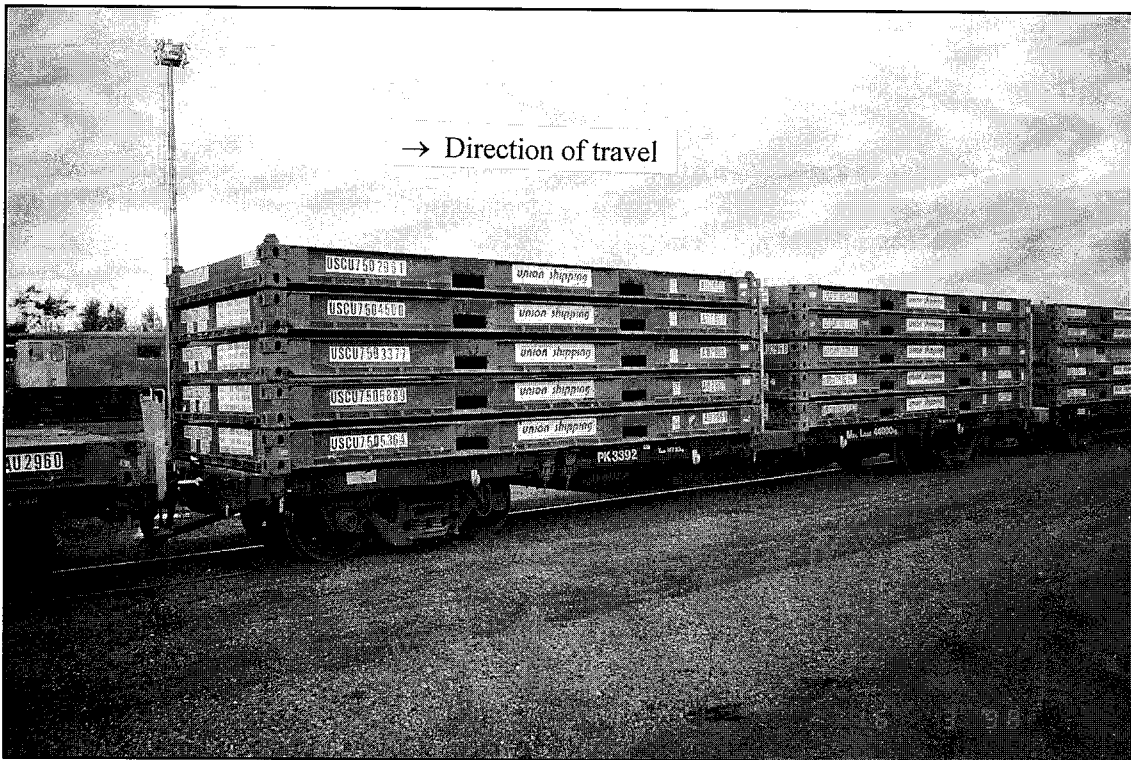
Figure 3
General view of the three stacks preceding the stack which collided.
PK3478 and the bottom of stack 4 at left

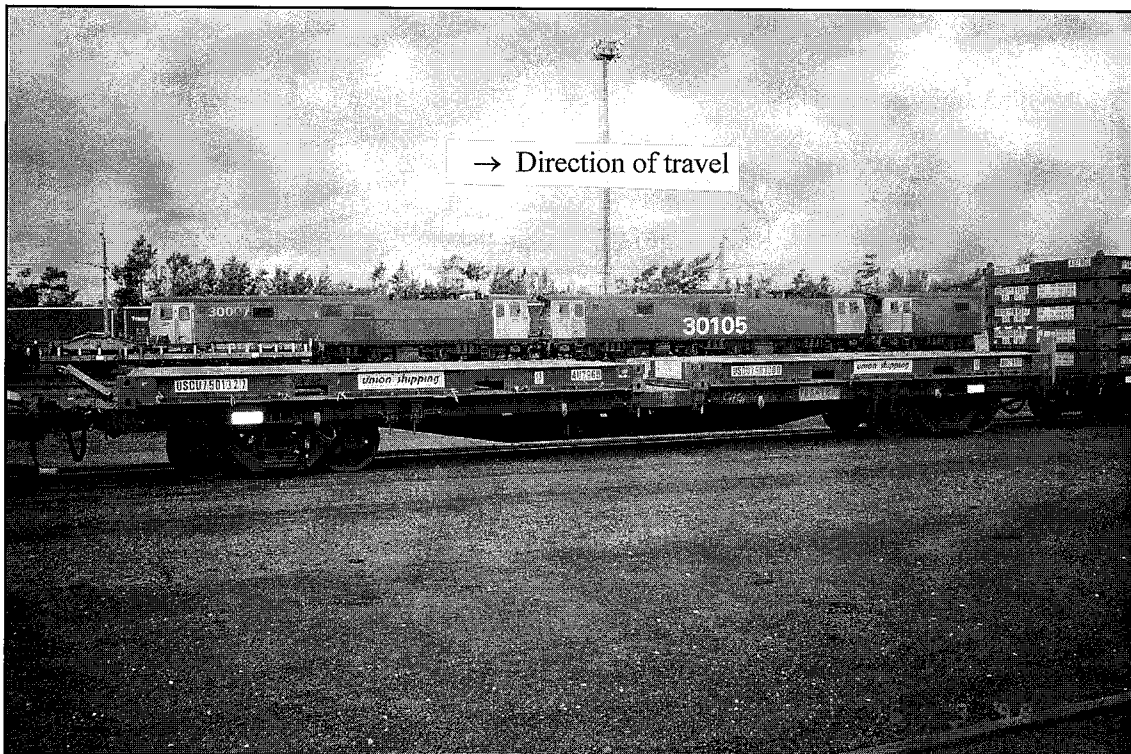
Figure 4
PK3478 showing the bottom bases in position following the incident.
Both stacks were five high prior to the collision, similar to PK3392 at right

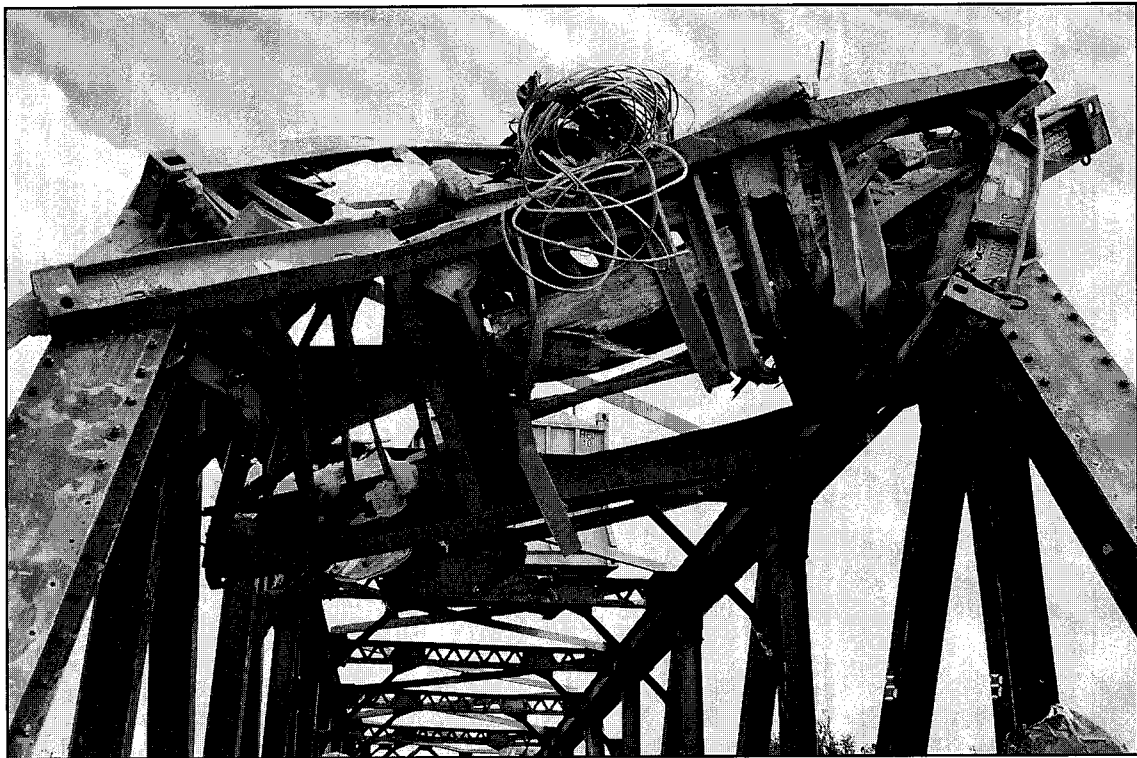
Figure 6
The two “Sea Container” bases wrapped around the top cross member at the entry to the first
through-truss span

- 2.1.1 Witness reports and the damage to the bridge and bases indicated that the initial impact which triggered the derailment was the collision of the second and third bases of the leading stack of bases on wagon PK3478 (stack 4) with the left side end girder as they entered the truss.

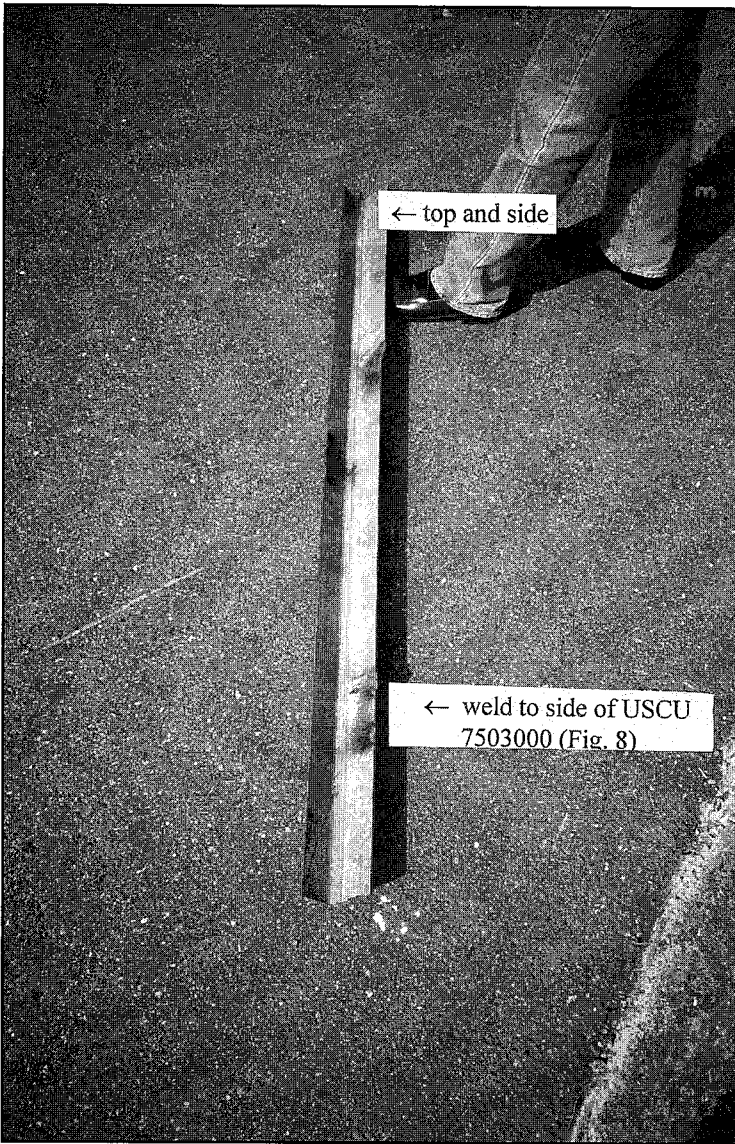
Figure 7
Length of steel angle found 2
km of the derailment site

- the 80 mm x 60 mm length of steel angle found on the track side north of the derailment site had been welded to the leading right side of stack 4
- the trailing left side of stack 4 had been welded although no corresponding length of steel angle was found
- the leading left side of stack 5 had been welded although no corresponding length of steel angle was found
- the trailing right side of stack 5 had been welded using a length of 80 mm x 60 mm steel angle (a remnant was attached)
- the total length of the welds on stacks 4 and 5 were approximately 540 mm and 850 mm respectively and the pattern varied on each stack.

1.3.5.3 The length of steel angle that was found by the track was laboratory inspected to determine the quality of the welds and the effective weld length. Examination of the portion of the fractured welds remaining on the recovered length of steel angle showed high porosity with an assessed average weld effectiveness of approximately 30%. The leg length of the welds indicated a relatively good fit had existed between the steel angle and the stacked bases on this corner compared with other welded corners. The recovered steel angle showed distortion in the vicinity of the weld to the middle base.

- 2.1.2 The remains of the welds on the length of steel angle found at 561.96 km NIMT matched the remains of the welds on the bases making up the leading stack on PK3478. In particular the match with the first base, which remained locked on the wagon, showed the steel angle found had originated from the right leading corner of the stack.

- 2.1.3 The distortion of the steel angle from the right leading corner was consistent with lateral movement of the bases at level 3 between a “Doric” base and a “Sea Container” base above it before weld failure. The distortion was similar to the longitudinal distortion present at stack 1 level 2 (see 1.3.5.1) where again a “Sea Container” base was on top of a “Doric” base.

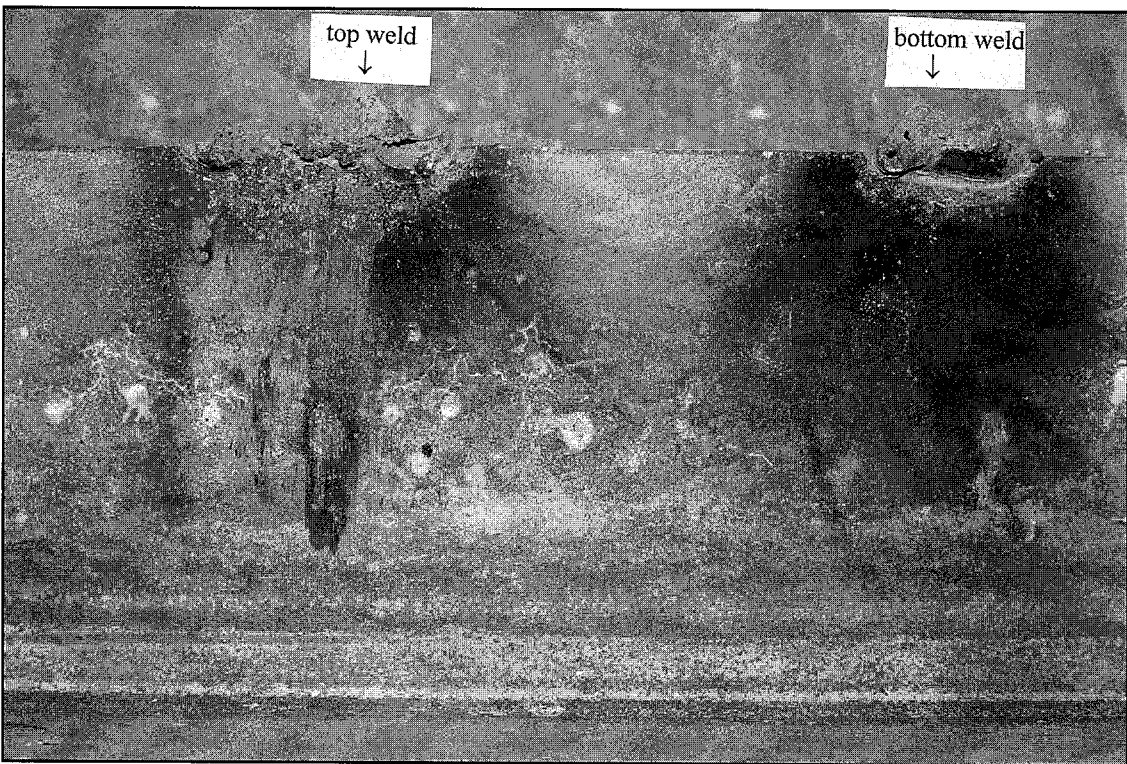
- 1.3.2.2 Inspection of the bases recovered from the bridge showed signs of welding on some corner castings, with USCU 7503736 having a broken portion of steel angle welded to it.
- 1.3.2.3 On Wednesday 18 March 1998 an undamaged length of steel angle (Figure 7 and Figure 8) was found approximately 2 km north of Bridge 267 at 561.96 km NIMT. The dimensions of the steel angle and the pattern of welding along its length indicated that it may have been used for restraining bases on wagon PK3478 on 14 March.
- 1.3.2.4 Some days after the incident a fractured piece of steel angle was found amongst the debris dumped following site clearance. Its size and weld patterns indicated that it may also have been used to restrain bases on wagon PK3478.

Figure 8
Close up of the welds which were to the side of USCS 7503000 (base 1)

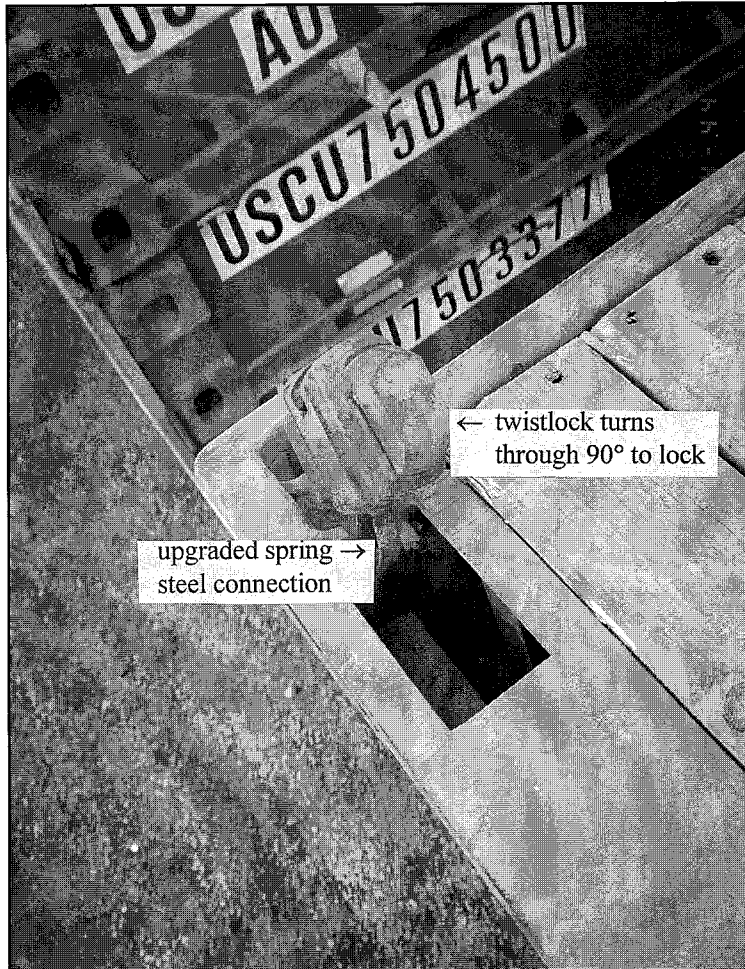
Figure 9
Retractable pivoted twistlock in the partly raised position.
(Note the upgraded spring steel connection detail to replace the defective casting detail typified in Figure 14.)

- 1.6.1 The USCU 750 series are 750 bases built for USNZ by Doric Engineering, Tasmania in 1993 which are referred to in this report as “Doric” bases.
- 1.6.2 USNZ advised that shortly after the contract had been completed it was found that the twistlock pin castings were suffering an unusually high rate of failure. This was found to be caused by a material quality problem, and following USNZ and Doric Engineering negotiations a refurbishment programme commenced in 1994 with the aim of replacing the castings with a spring steel connector (Figure 14 shows a typical casting failure and Figure 9 a refurbished base with spring steel connectors).

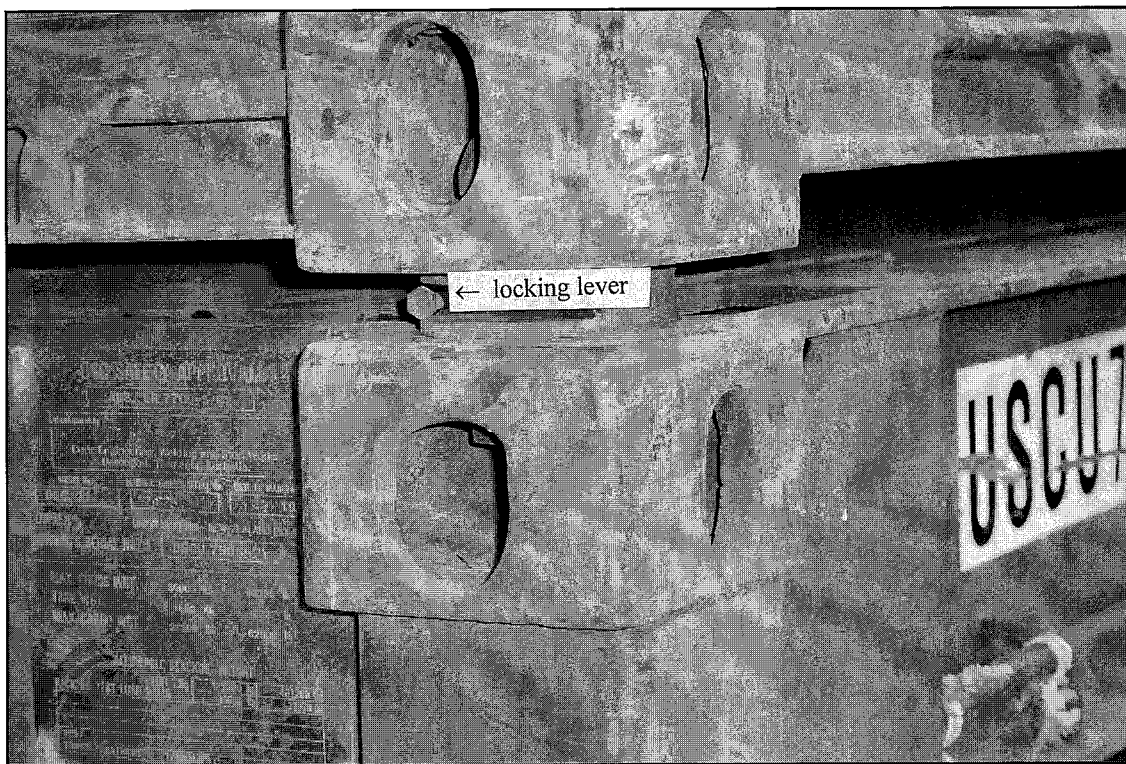
Figure 10
Twistlock locked in place

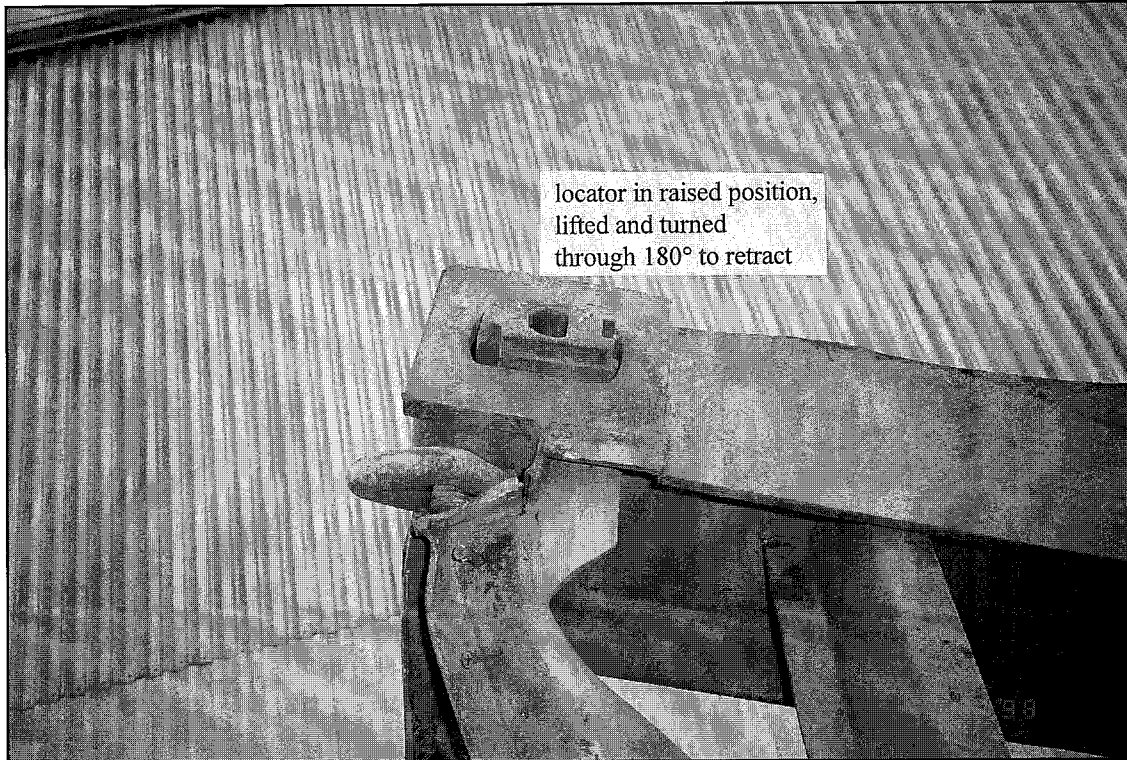
Figure 11

Retractable locator. Two locators on each base located at opposite corners

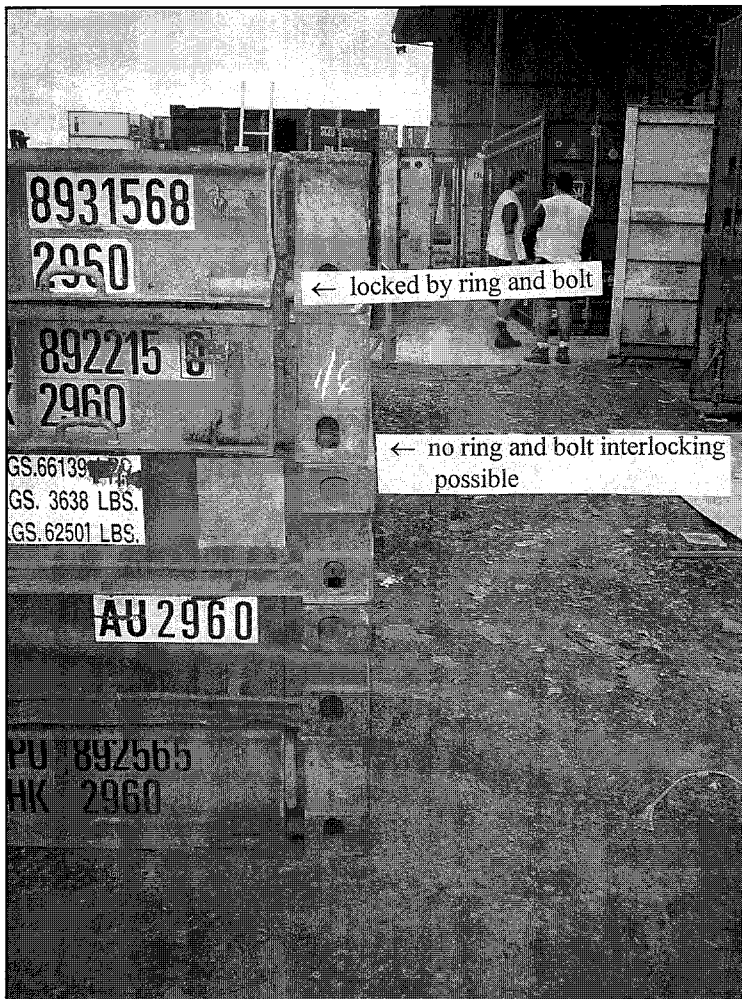
Figure 12
Method of locking
“Sea Container”
bases using a ring
and bolt at each
corner (these bases
were not involved
in the incident)

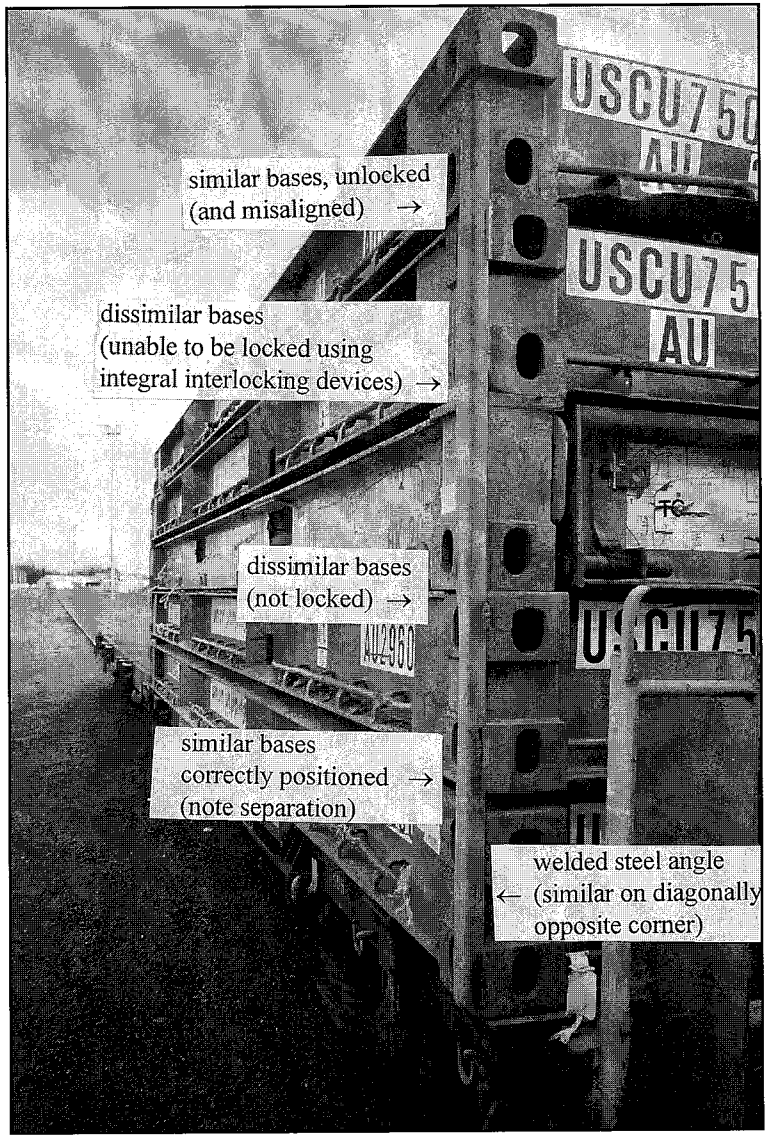
Figure 13
The trailing left corner of stack 1 on UK8509

- the shorter angle leg lengths (30 to 60 mm) did not overlap the holes in the corner castings and allowed a possible full length weld on the corner casting

- the gap between the lengths of angle and the bases varied from flush to 16 mm and welding had been carried out with gaps of up to 6 mm
- the paint on the bases had not been removed prior to welding, and the scorching and burning of the paint was evident by soot markings on the lengths of angle and scorch marks around the welds on the bases

- the burning paint had produced bubbles of gas which caused porosity in the welds
- the total length of the welds on stacks 1, 2 and 3 were approximately 1650 mm, 1150 mm and 1650 mm respectively and the pattern varied on each stack

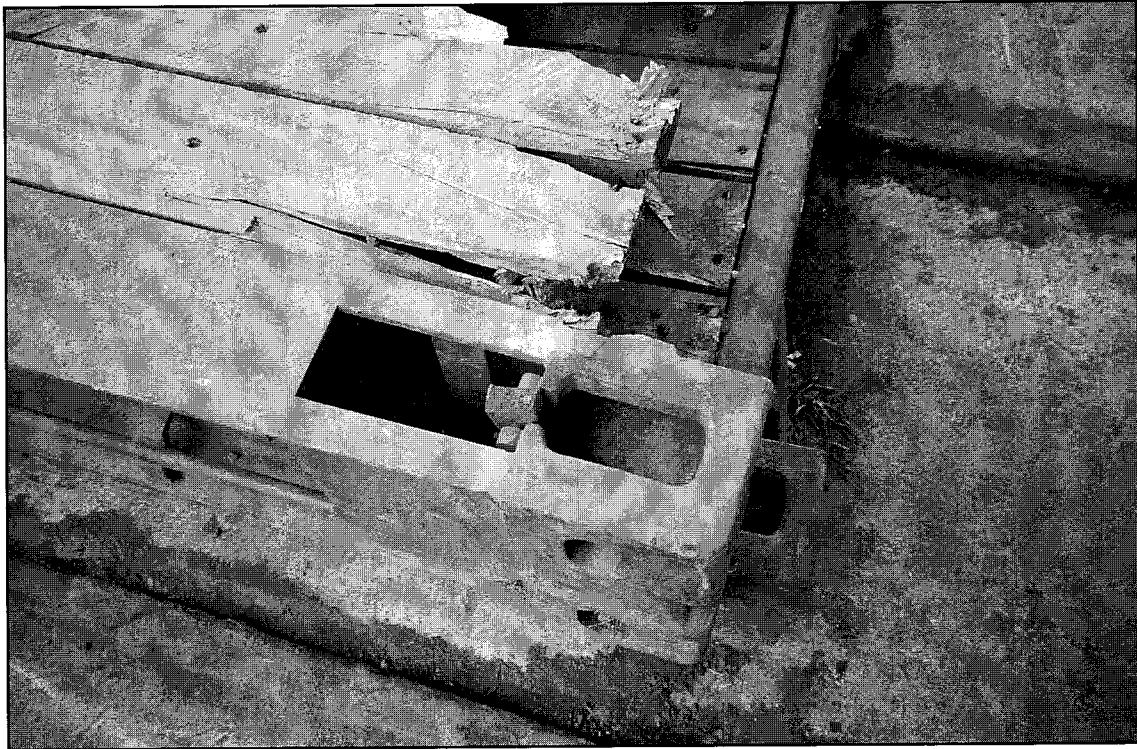
Figure 14
A typical “Doric” base twistlock casting failure (USCU 7502982)

- 2.2.6 Although the transport of bases in stacks was not a common traffic on rail or road such loads had been transported by both modes.
- 2.2.7 The "Doric" base twistlock history had resulted in approximately 50% of all twistlocks missing or broken based on the sample of 22 bases involved in the incident. It is likely that correct integral interlocking of stacked "Doric" bases had not been possible for some years.
