Report 98-201

general cargo vessel *T.A. Explorer*

grounding

19 January 1998

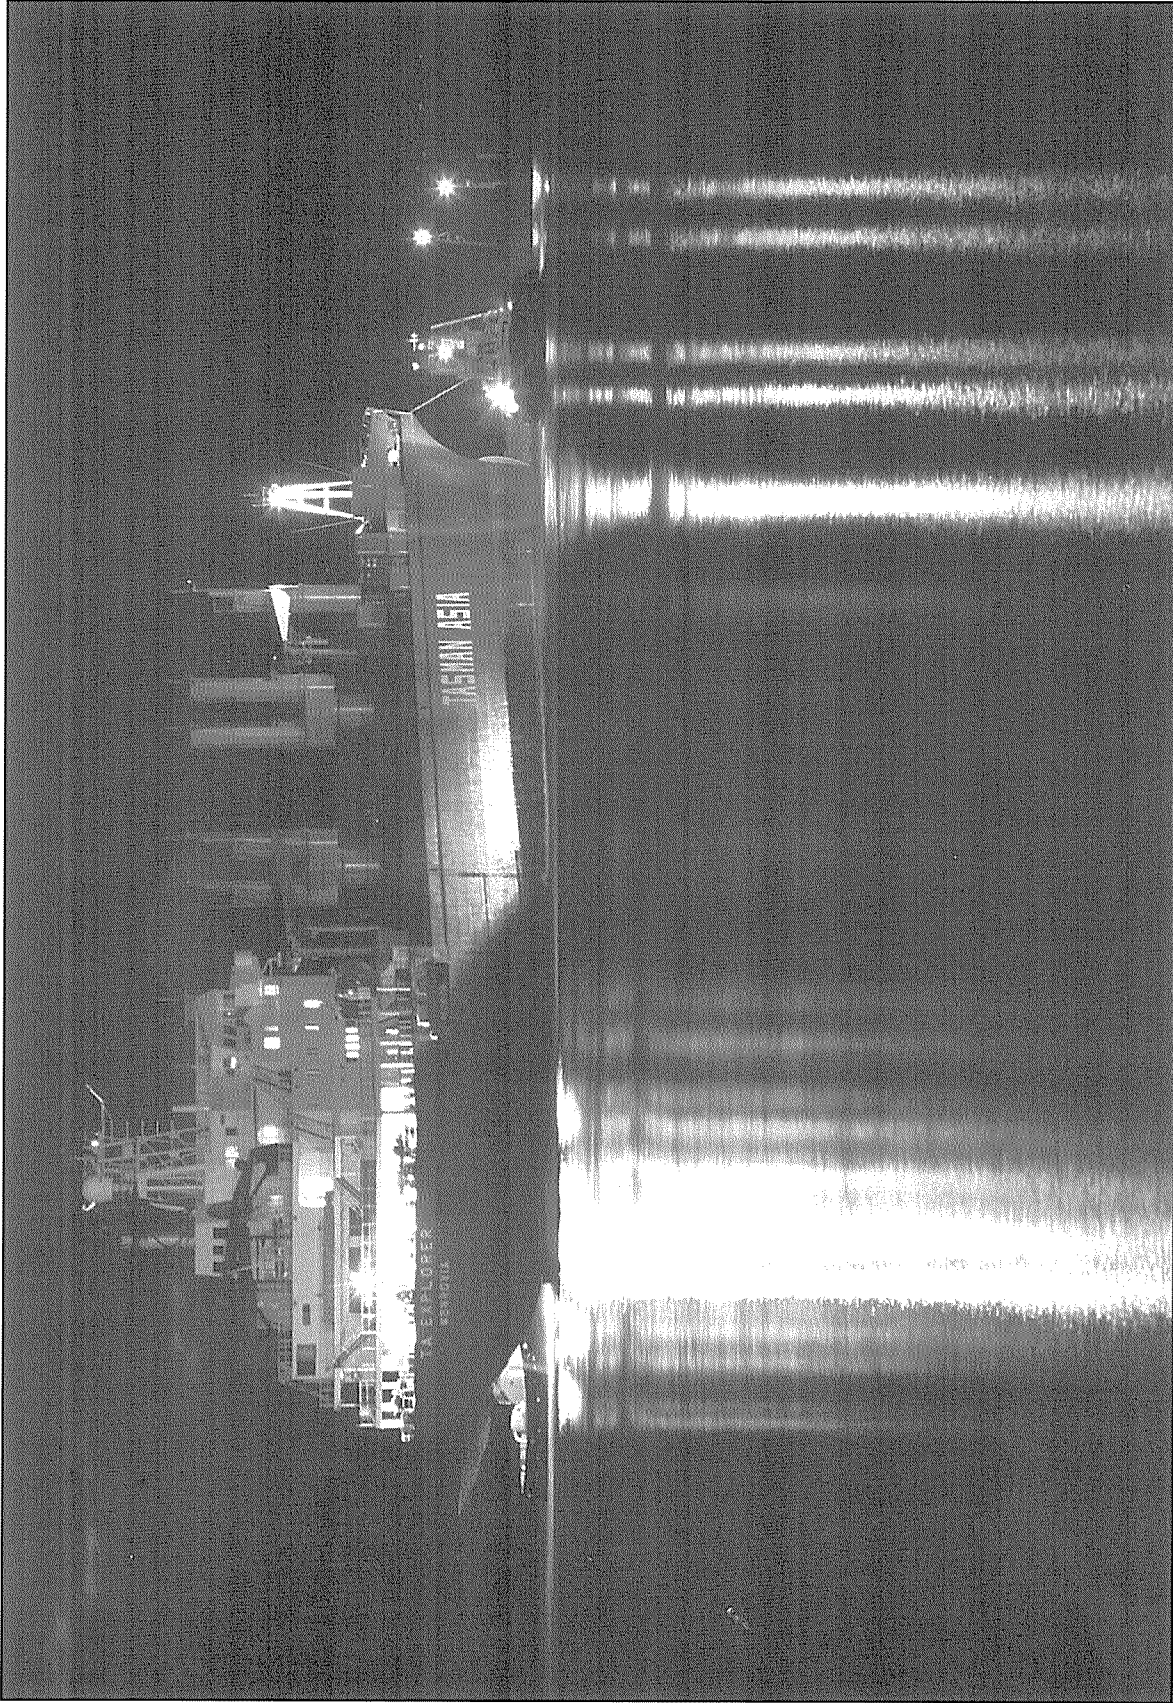
T.A. Explorer aground on Haulashore Island with the tugs *Huria Matenga* and *W.H. Parr* in attendance
(Photograph courtesy of Nelson Mail)

1.2.1 The only damage sustained by the *T.A. Explorer* was minor scraping of the paint under the bow.

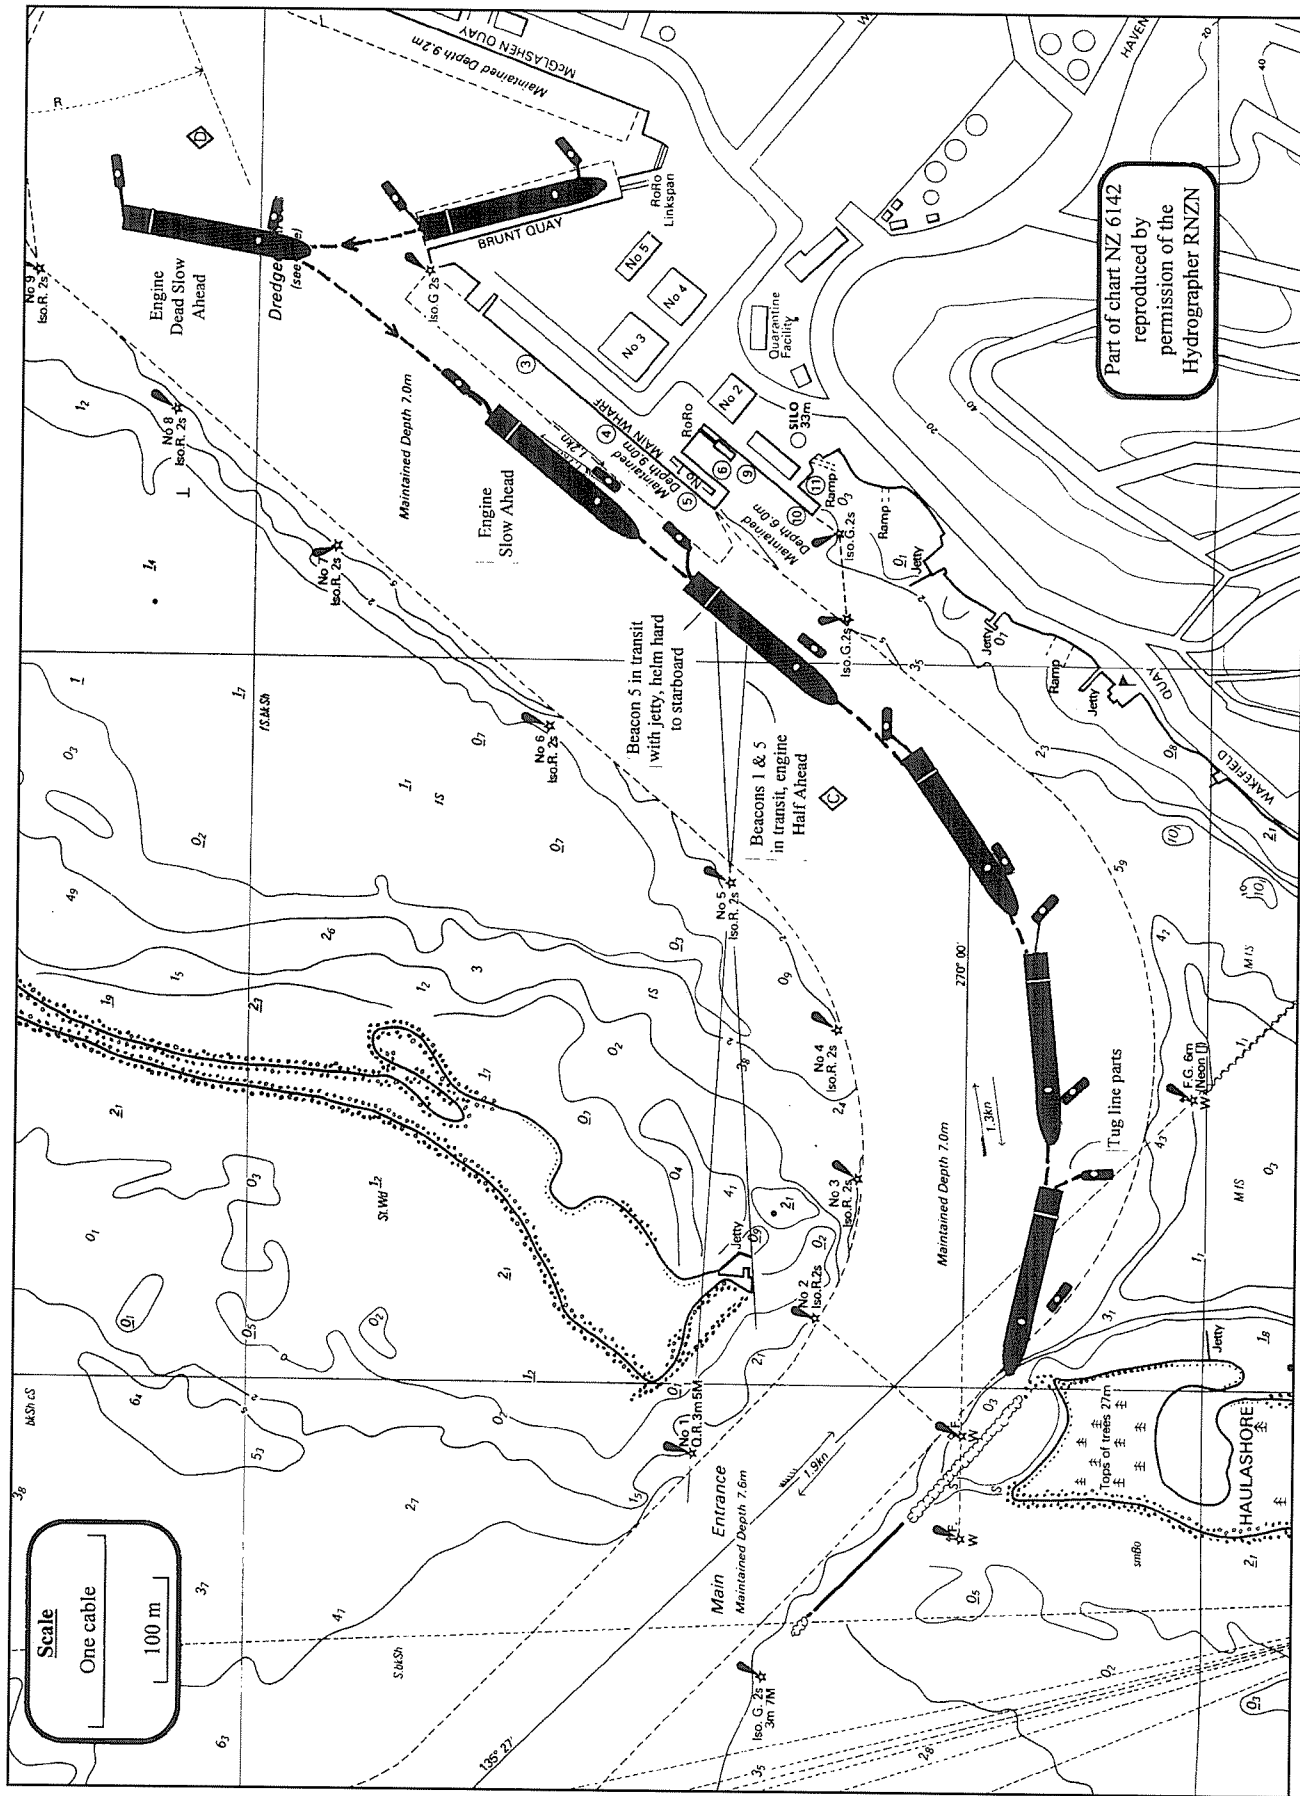
Figure 1
 Part of chart NZ 6142 showing key information. The ship and tug overlays are broadly to scale.

- 1.1.4 The main entrance channel for the port (see Figure 1) was dredged to maintain a minimum depth of 7.0 m at chart datum. The predicted height of tide at low water was 1.1 m above chart datum, which gave a predicted minimum available depth in the channel of 8.1 m at the time of sailing. The sailing draught of the *T.A. Explorer* was 3.8 m forward and 6.8 m aft, giving a predicted minimum under-keel clearance of 1.3 m.

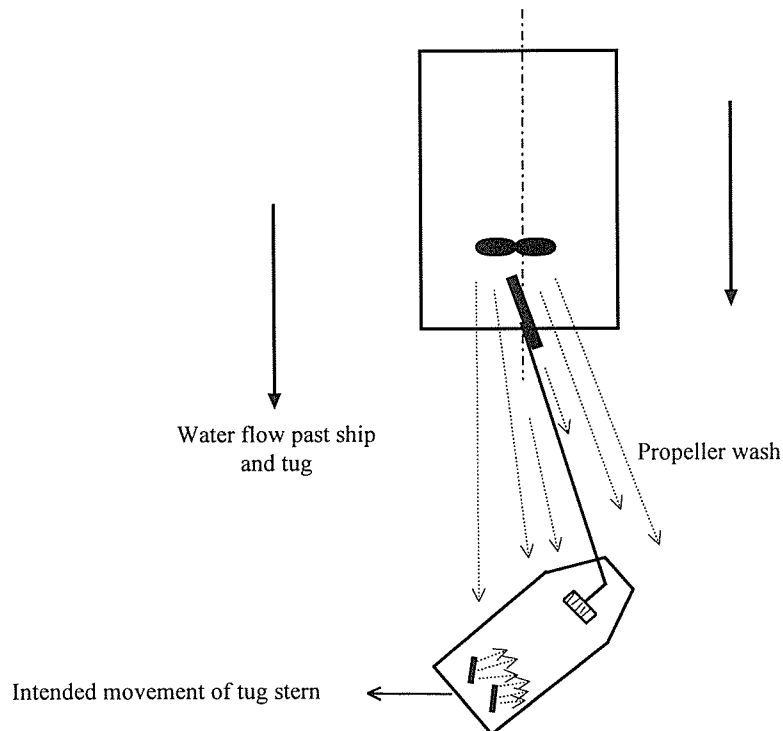
Figure 2
Diagram showing towing relationship between tug *Huria Matenga* and *T.A. Explorer* (Diagram not to scale)

1.1.24 As the skipper of the *Huria Matenga* made the adjustments to the Z-pellers, the tug was swept back into the propeller wash behind the ship. He angled the Z-pellers to pull the stern of the tug back out to port, which was partially achieved; however, the hydrodynamic forces on the tug created by the speed of the *T.A. Explorer* through the water, and by its propeller wash, kept the tug pinned in a position where the towline was slightly to starboard of the ship centreline (see Figure 2 below).

- 1.1.25 The skipper of the *Huria Matenga* began to adjust the angle and power setting of the Z-pellers in an attempt to drag the tug across to the port side of the ship; however, the propeller wash from the ship was sending aerated water into the Z-pellers causing them to cavitate. Additionally, the *Huria Matenga* was heeling over to port to the point where water was starting to wash over the deck on that side. In this situation, the skipper was not prepared to put full engine power into the manoeuvre.

- 3.7 While the skipper of the *Huria Matenga* endeavoured to comply with the pilot's instructions, the tug was swept into a position where it provided high retarding forces to the *T.A. Explorer*, but reduced its rate-of-turn. The reduction in rate-of-turn was enough to cause the *T.A. Explorer* to ground, but at minimal speed.

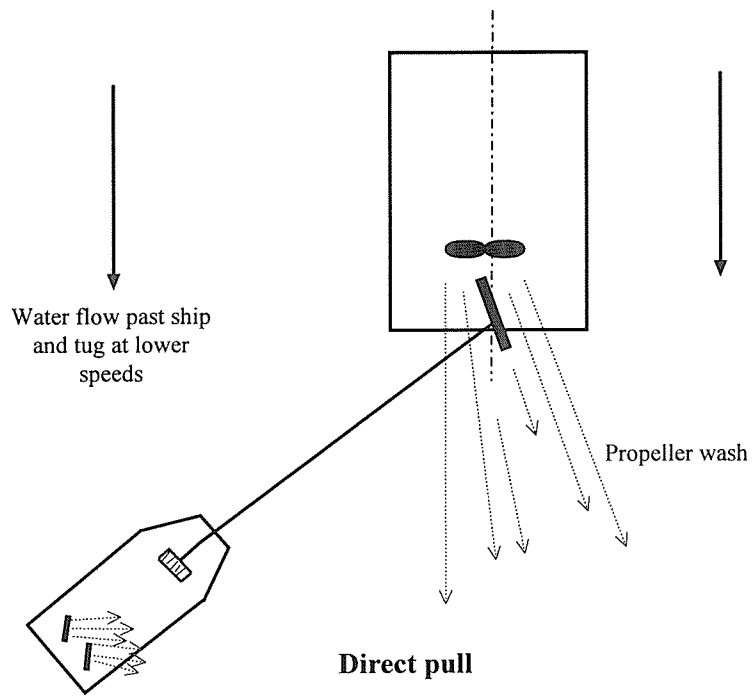
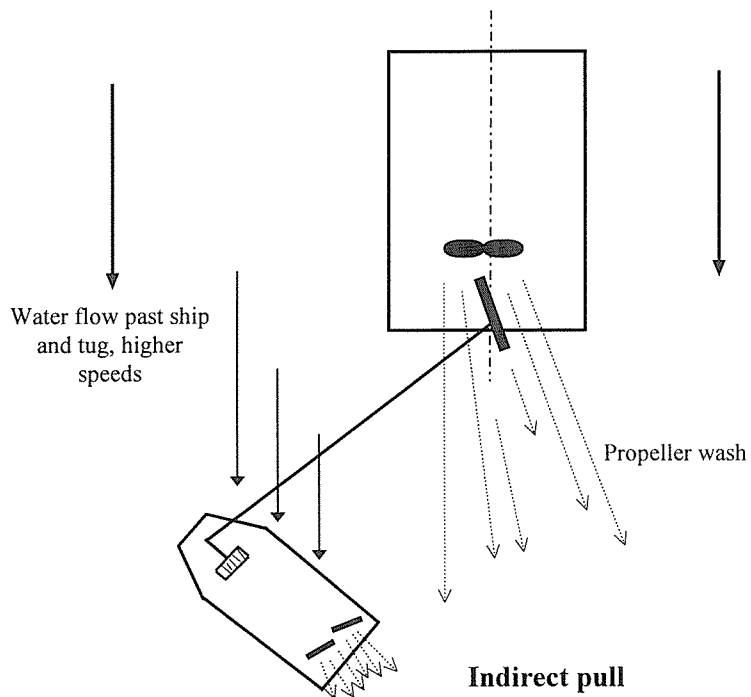
Figure 8
Diagrams illustrating the direct and indirect pull for a tug escorting on a line aft and assisting a starboard turn.

- 1.10.3 An exception to the rule is when a tug assists using an indirect pull, when hydrodynamic forces acting on the underwater profile of the tug are used to increase the pull on the tow line. A tug assisting using this method can apply forces on the tow line in excess of its bollard pull (see Figure 8).

- 2.6.1 While it is unlikely the parting of the towline from the *Huria Matenga* contributed to the grounding, if the *Huria Matenga* had applied an indirect pull to the stern of the *T.A. Explorer*, the towing forces imparted on the line would have been greater and the line may have parted earlier.
- 2.6.2 While it is not practicable to determine for how long each chaffed or fused strand had been broken, examination of the rope indicated that only a small portion of the strands failed as a result of direct contact with the Panama lead on the *T.A. Explorer*. A significant number of strands, therefore, must have been worn or fused before the *Huria Matenga* commenced the *T.A. Explorer* towage.
- 2.6.3 The condition of the tow line when it parted indicated that a more frequent and thorough inspection of tug towlines was required.
