Report 98-205

jet boat *Predator*

rock strike

23 March 1998

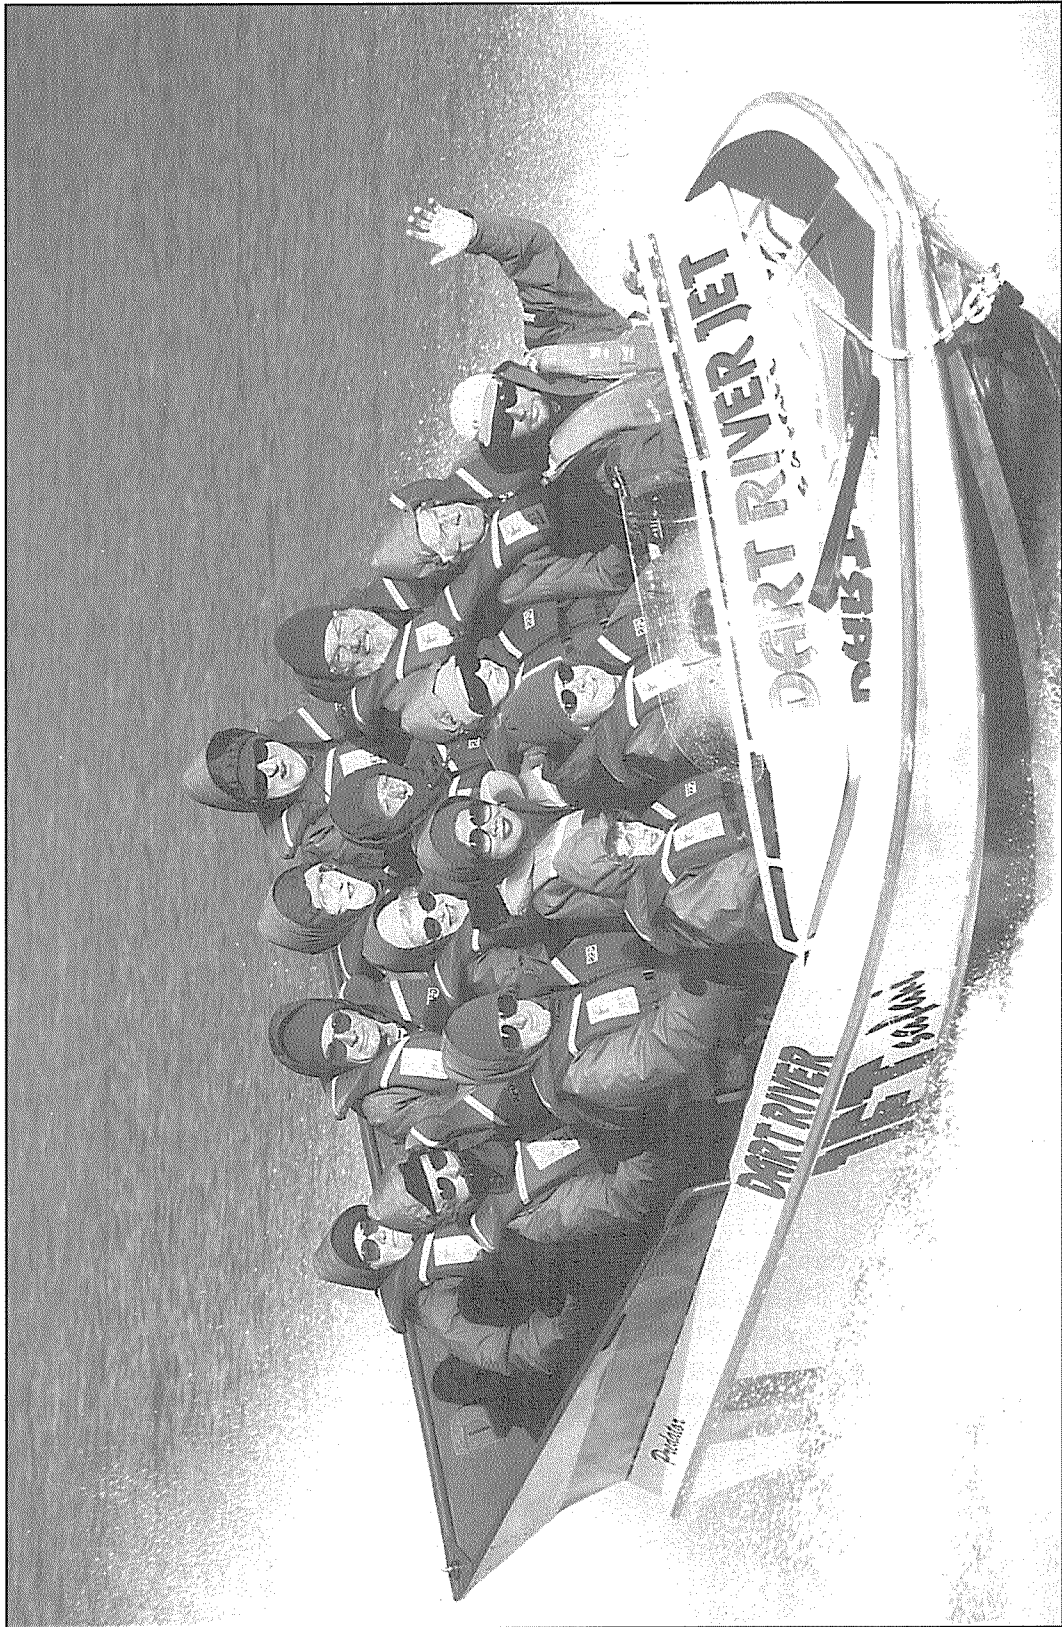
Predator

Type:	Pro Tour commercial jet boat
Class:	Passenger (under 6 m)
Limits:	Lake Wakatipu and Dart River
Allowable occupants:	15 (including driver)
Length:	5.70 m
Built:	In November 1995, in Glenorchy by Neil Rees, Dart River Jetboat Safari Limited
Construction:	Aluminium mono-hull
Propulsion:	One 8200 c.c. 328 kW Chevrolet 502 petrol engine driving a single stage Hamilton 212 jet unit
Normal operating speed:	Up to 60 km/h (35 km/h average for the safari)
Owner/operator:	Dart River Jet Safari Limited
Location:	Upper Dart River, Glenorchy Approximately 300 m up river from Surveyors Flat
Date and time:	Monday, 23 March 1998, at 1050 ¹
Persons on board:	Crew: 1 Passengers: 14
Injuries:	Crew: 1 (minor) Passengers: 2 (serious) 11 (minor)
Nature of damage:	Major distortion and impact damage at bow, moderate distortion of passenger seating, and minor scraping on hull.
Inspector-in-Charge:	Captain John Mockett

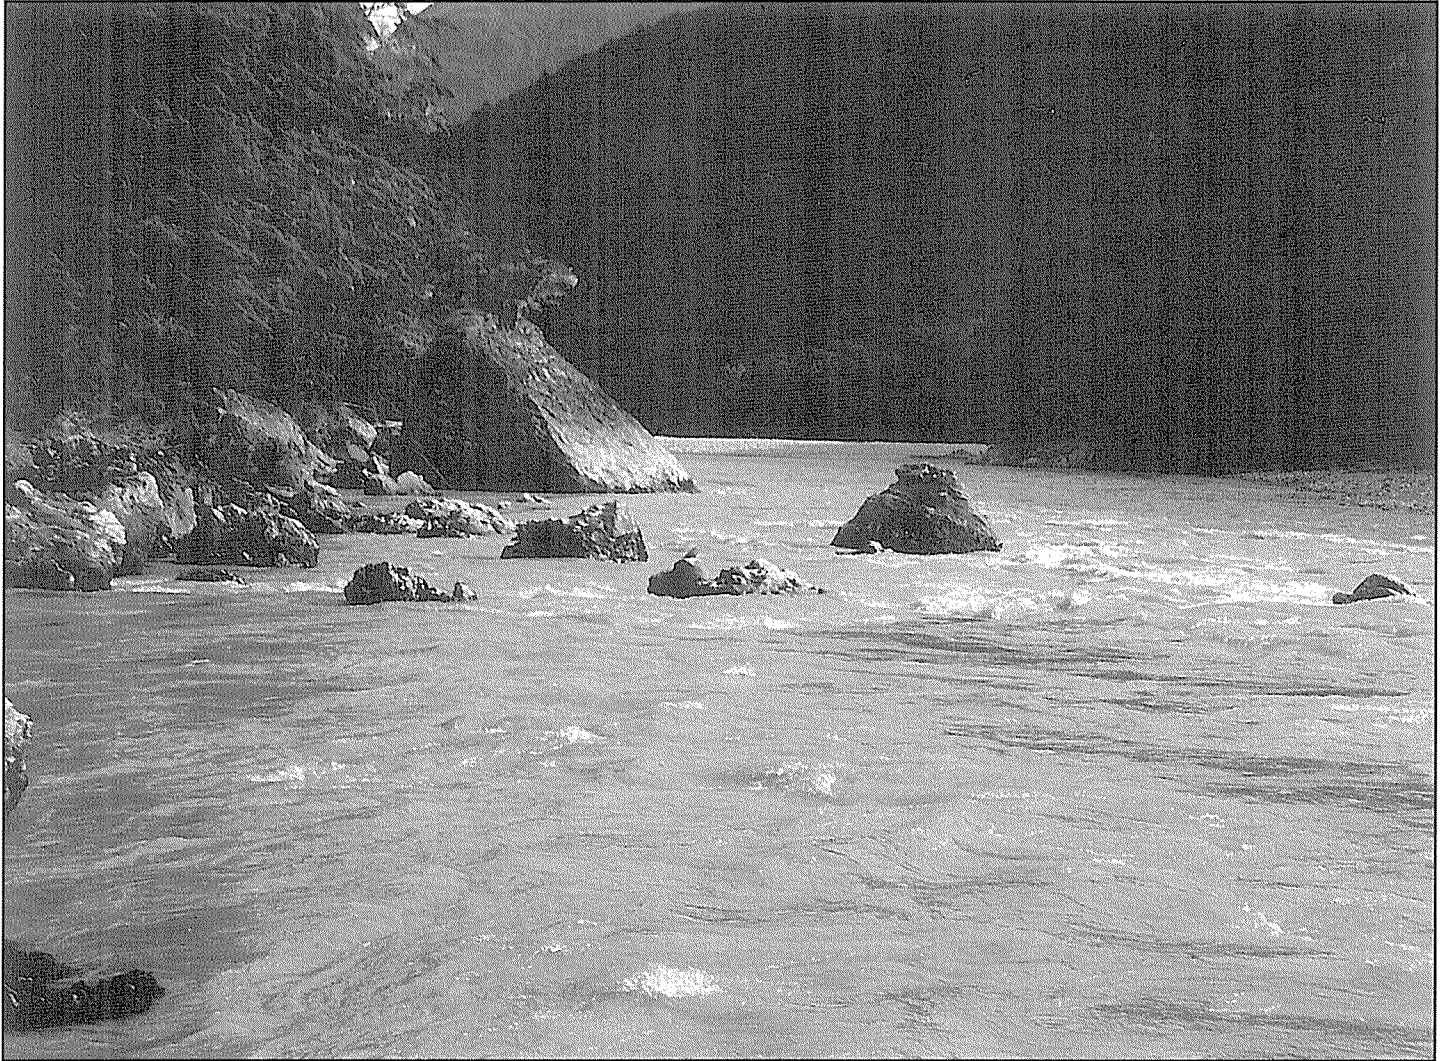
Figure 2
Accident site

- 1.1.10 About 300 m up river from Surveyors Flat, the driver had to negotiate a right hand bend in the river. The bend involved passages through a series of rocks, some of which were submerged (see Figure 2). The negotiating line had been established for safe passage at times of low river levels and thus avoided any rocks that might be submerged at other times (see Figure 3). The river level on the day of the accident was described by the drivers as “normal”.

- 1.1.13 Without engine power the driver lost directional control of *Predator*. As it decelerated the boat came off the plane and continued on the line in which it had been heading when power was lost. *Predator* was heading directly towards a large rock on the river bank (rock ‘B’ on Figure 3). Just before *Predator* struck the rock the driver called to his passengers to hold on tight .

- 1.1.14 The passengers were not restrained in their seats and the force of the impact threw them forward and one partially out of the boat. The handrails and the seat backs buckled as they absorbed the energy of the passengers’ forward momentum.

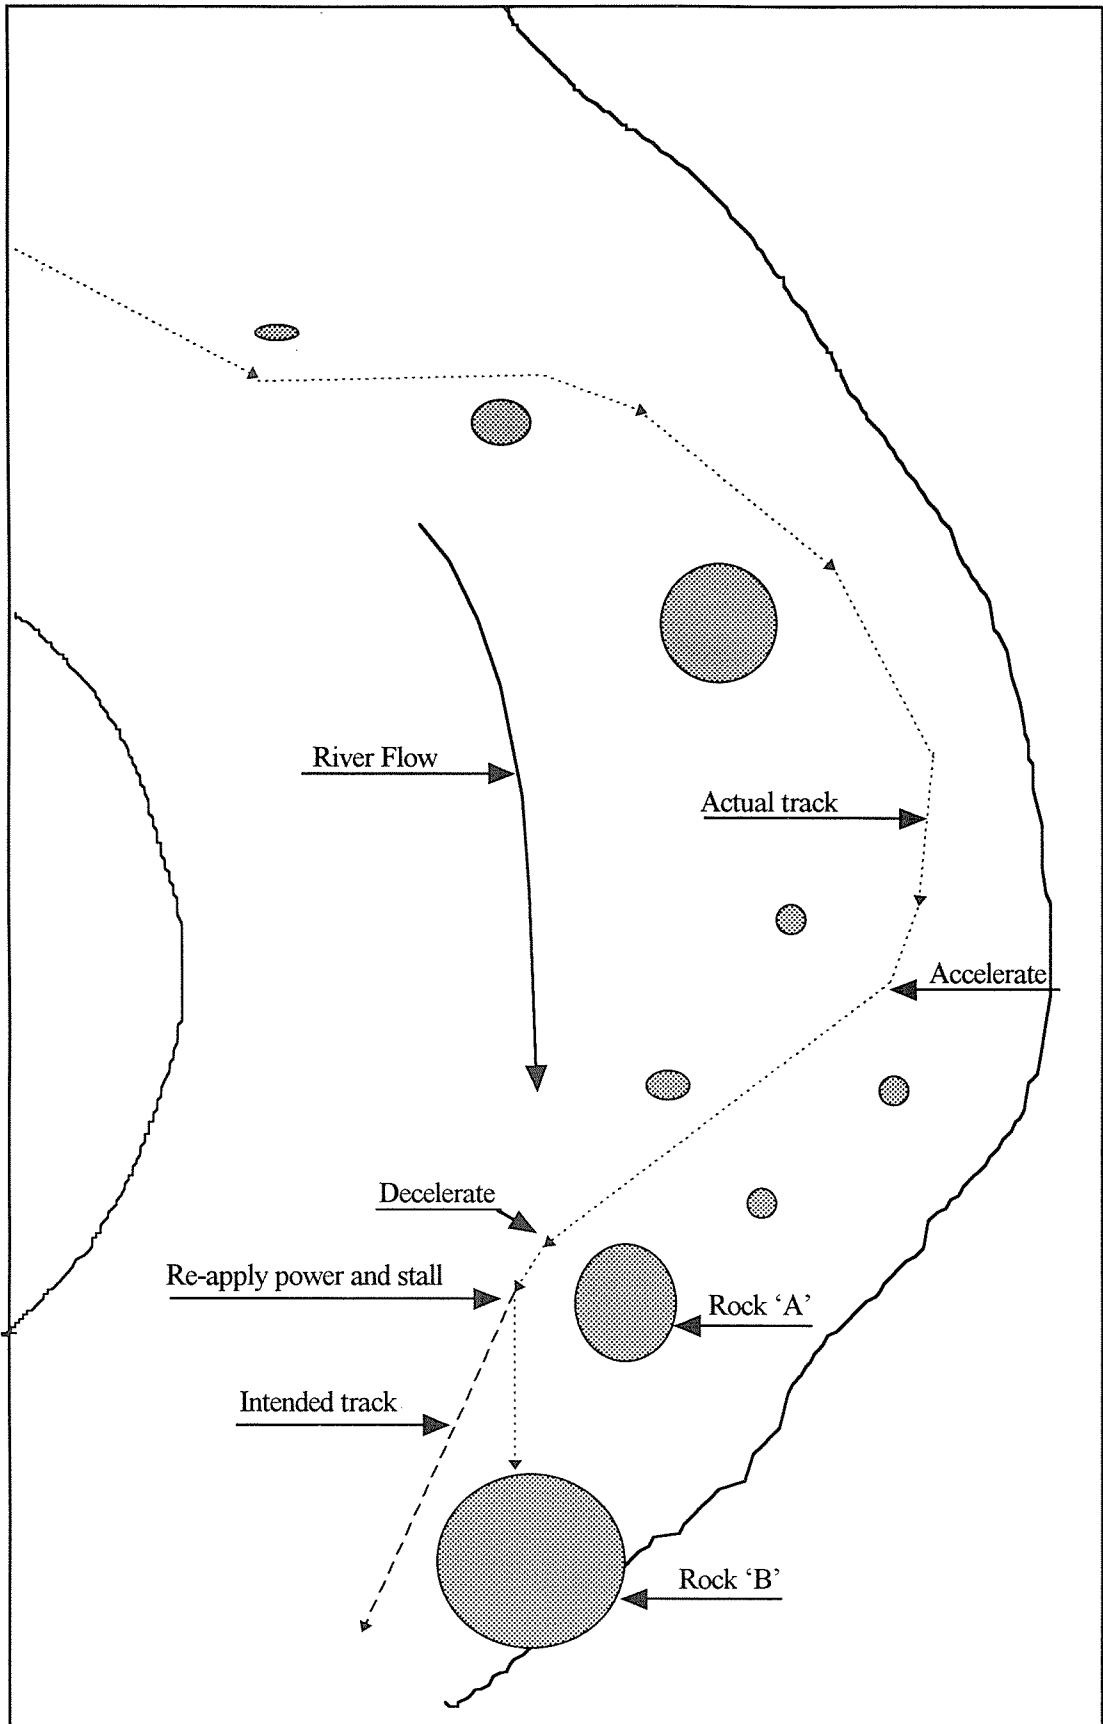
Figure 3
Negotiating line through right hand bend at accident site

- 1.1.11 The driver took *Predator* to the outer extremity of the bend and lined up with a straight passage between several rocks. The flow of the river crossed the passage line so the driver accelerated to about 60 km/h to maintain directional stability. (See Figure 3)

- 1.1.12 When he reached the end of this short straight run, the driver turned to the left to pass a rock (rock ‘A’ in Figure 3) and at the same time reduced power to give the required speed for the next manoeuvre. He realised that he had reduced the throttle more than required and re-applied throttle. At this point the engine stalled.

- 2.6 Having successfully negotiated the majority of the right hand bend of the river, the driver reduced power when turning left at the end of a high speed straight run. Reducing the throttle too much while in a tight left turn would have caused the boat to begin to come off the plane and the foot of the bow to dig in and turn the boat further to the left, which resulted in *Predator* pointing directly towards the large rock on the river bank.
