Report 98-206

Ro Ro cargo vessel, *Spirit of Vision*

grounding

30 April 1998

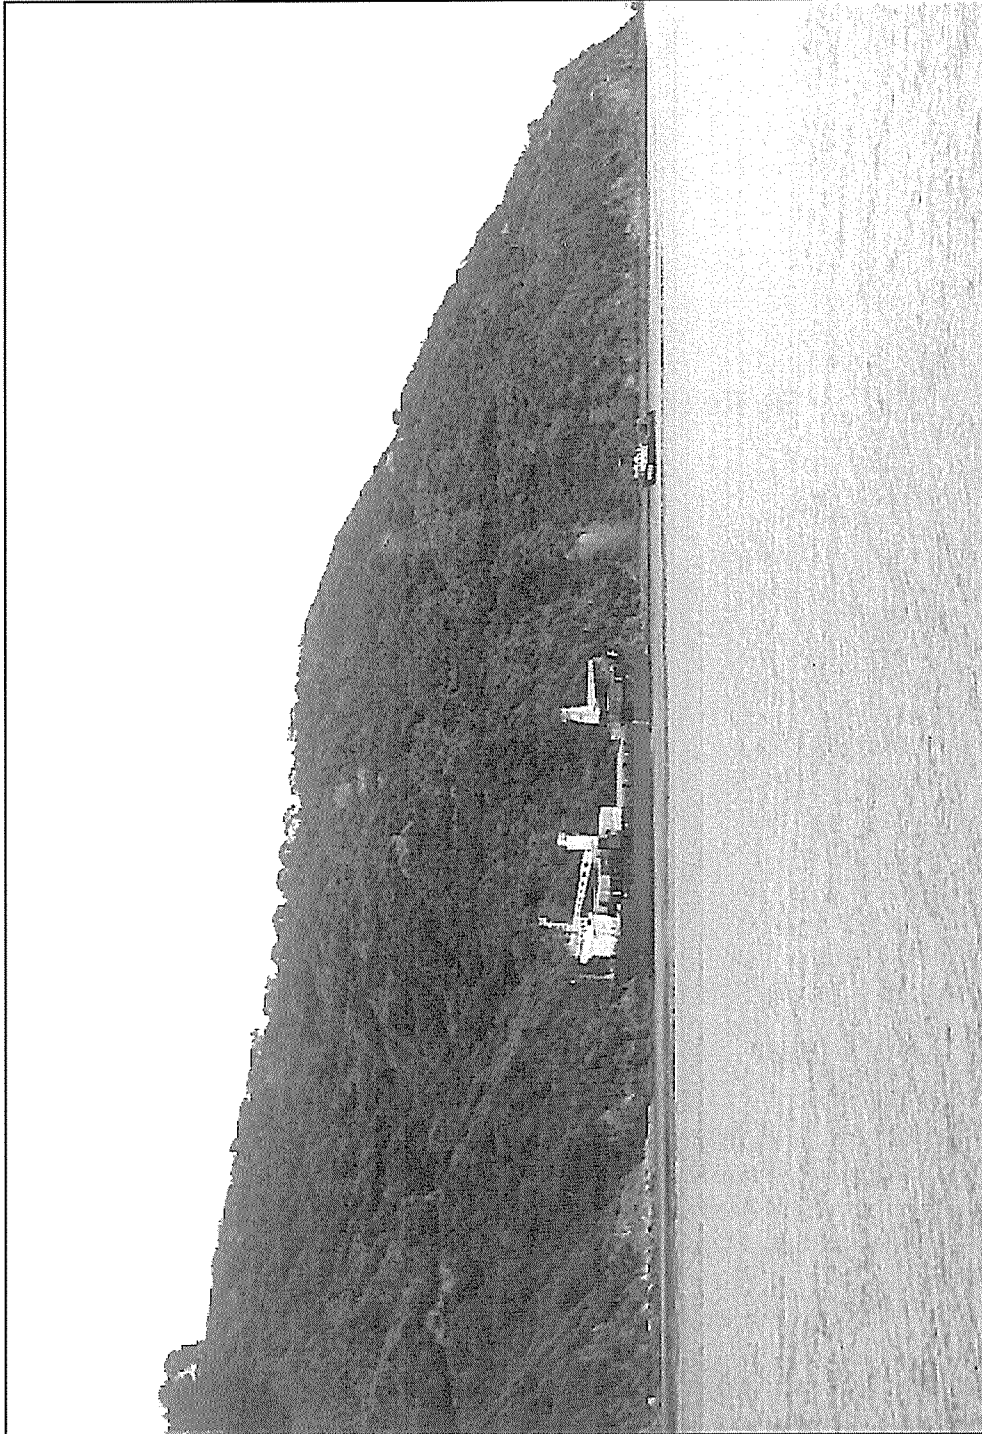
Figure 1
Spirit of Vision aground at French Pass

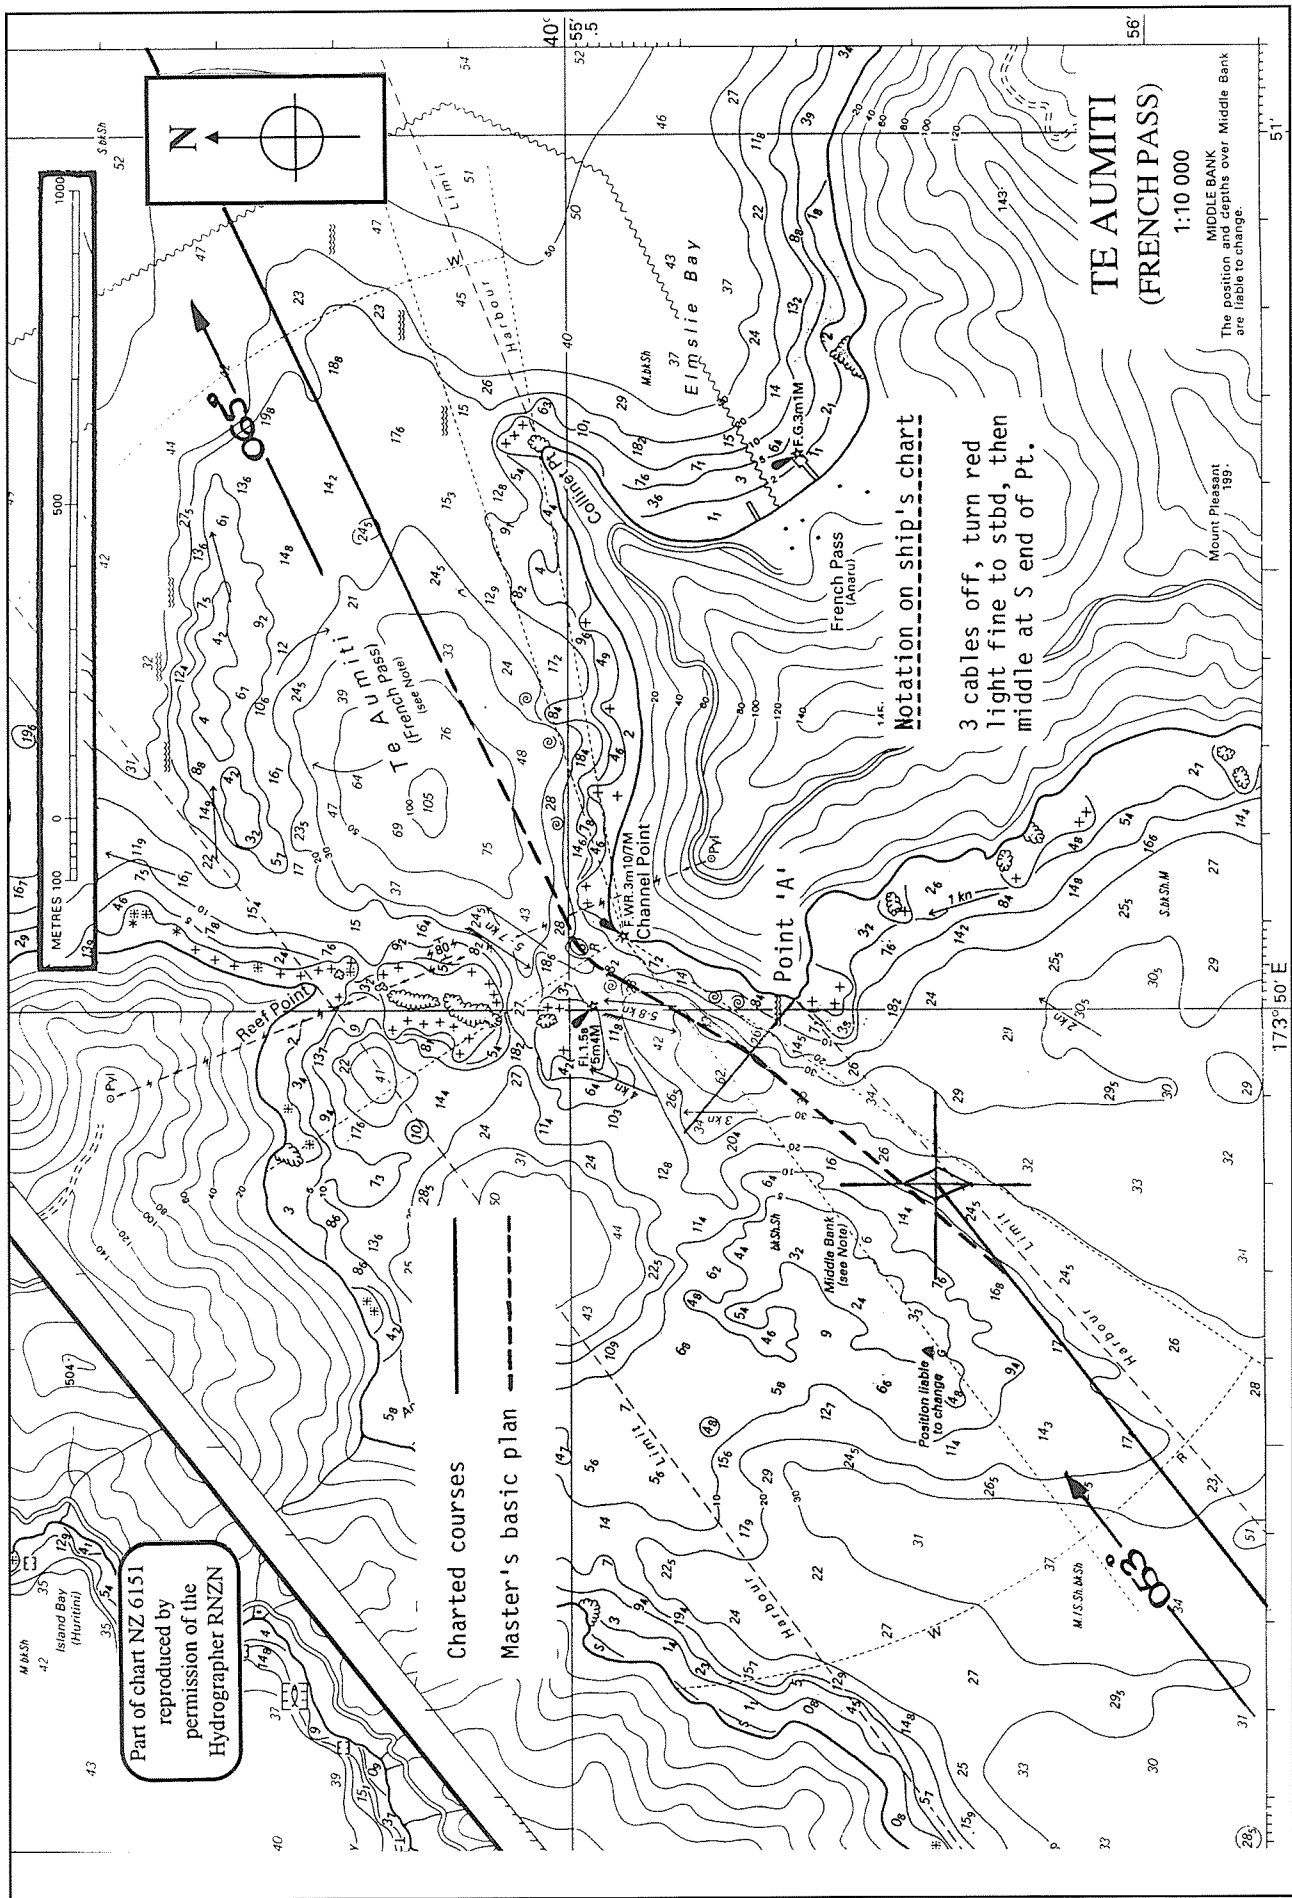
Figure 2
Section of chart NZ 6151 showing French Pass and the planned passage

- 1.1.7 The master took over the conduct of the vessel at about 0240 at which time the vessel was steering 053 degrees and making a speed of about 11.5 knots. The charted 053 degree course line terminated at a position two cables from the headland (hereafter known as Point 'A') to the south-south-east of Channel Point. Courses for the transit through French Pass were not charted. (See figure 2)

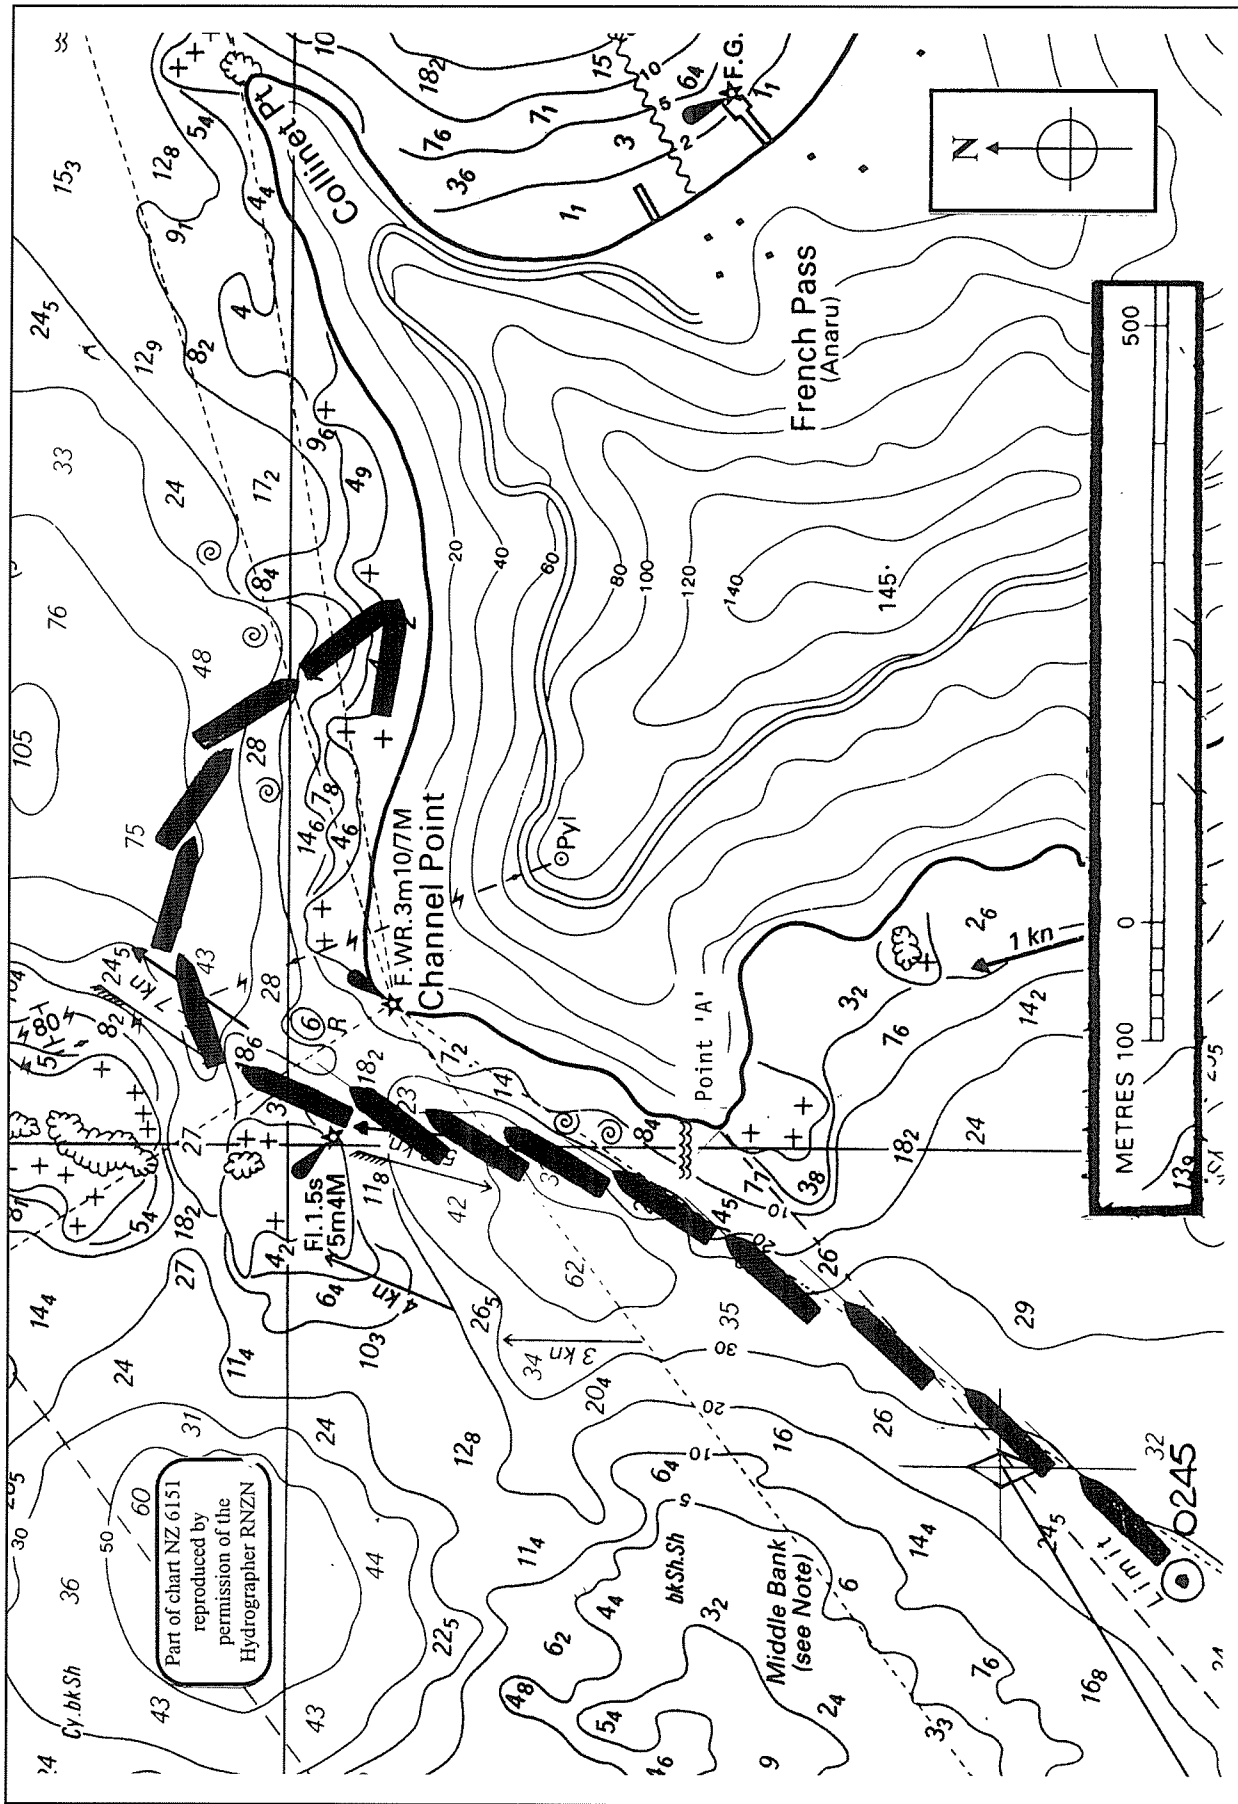
- 1.1.8 The master plotted the position of the vessel at 0245 and found that it was slightly south of the charted course and three cables distant from Point 'A'. He altered course to about 045 degrees which initially put Point 'A' right ahead. He expected a tidal stream which would set the vessel to the north-west until passing Point 'A'. (See figure 3)

Figure 3
 Section of chart NZ6151 showing estimated track of *Spirit of Vision*

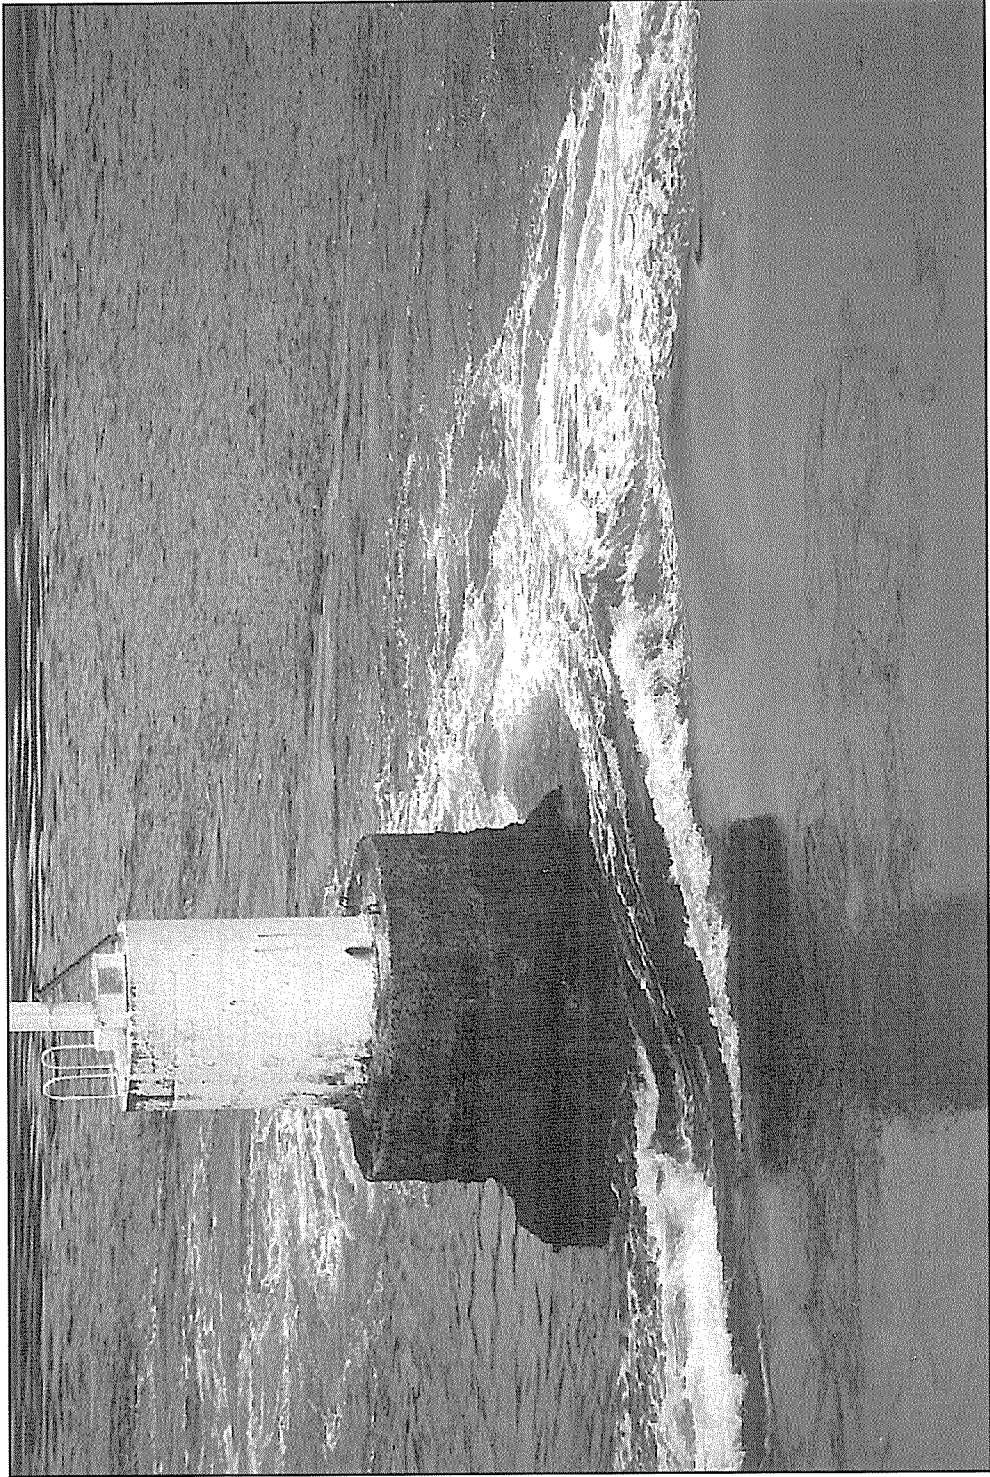
Figure 4
Tidal flow around narrows light beacon

- 1.6.6 The north-east tidal stream occurs during an ebb tide. When the stream begins, the height of tide allows it to flow through the whole width of the Pass. As the tide recedes, the reef to the north of the light beacon dries and the stream is restricted to the deep water of the navigable passage and one other deeper area resulting in a stronger flow.
