Report 98-212

Restricted-limit passenger catamaran *Scat Cat*

foundering

Lake Rotorua

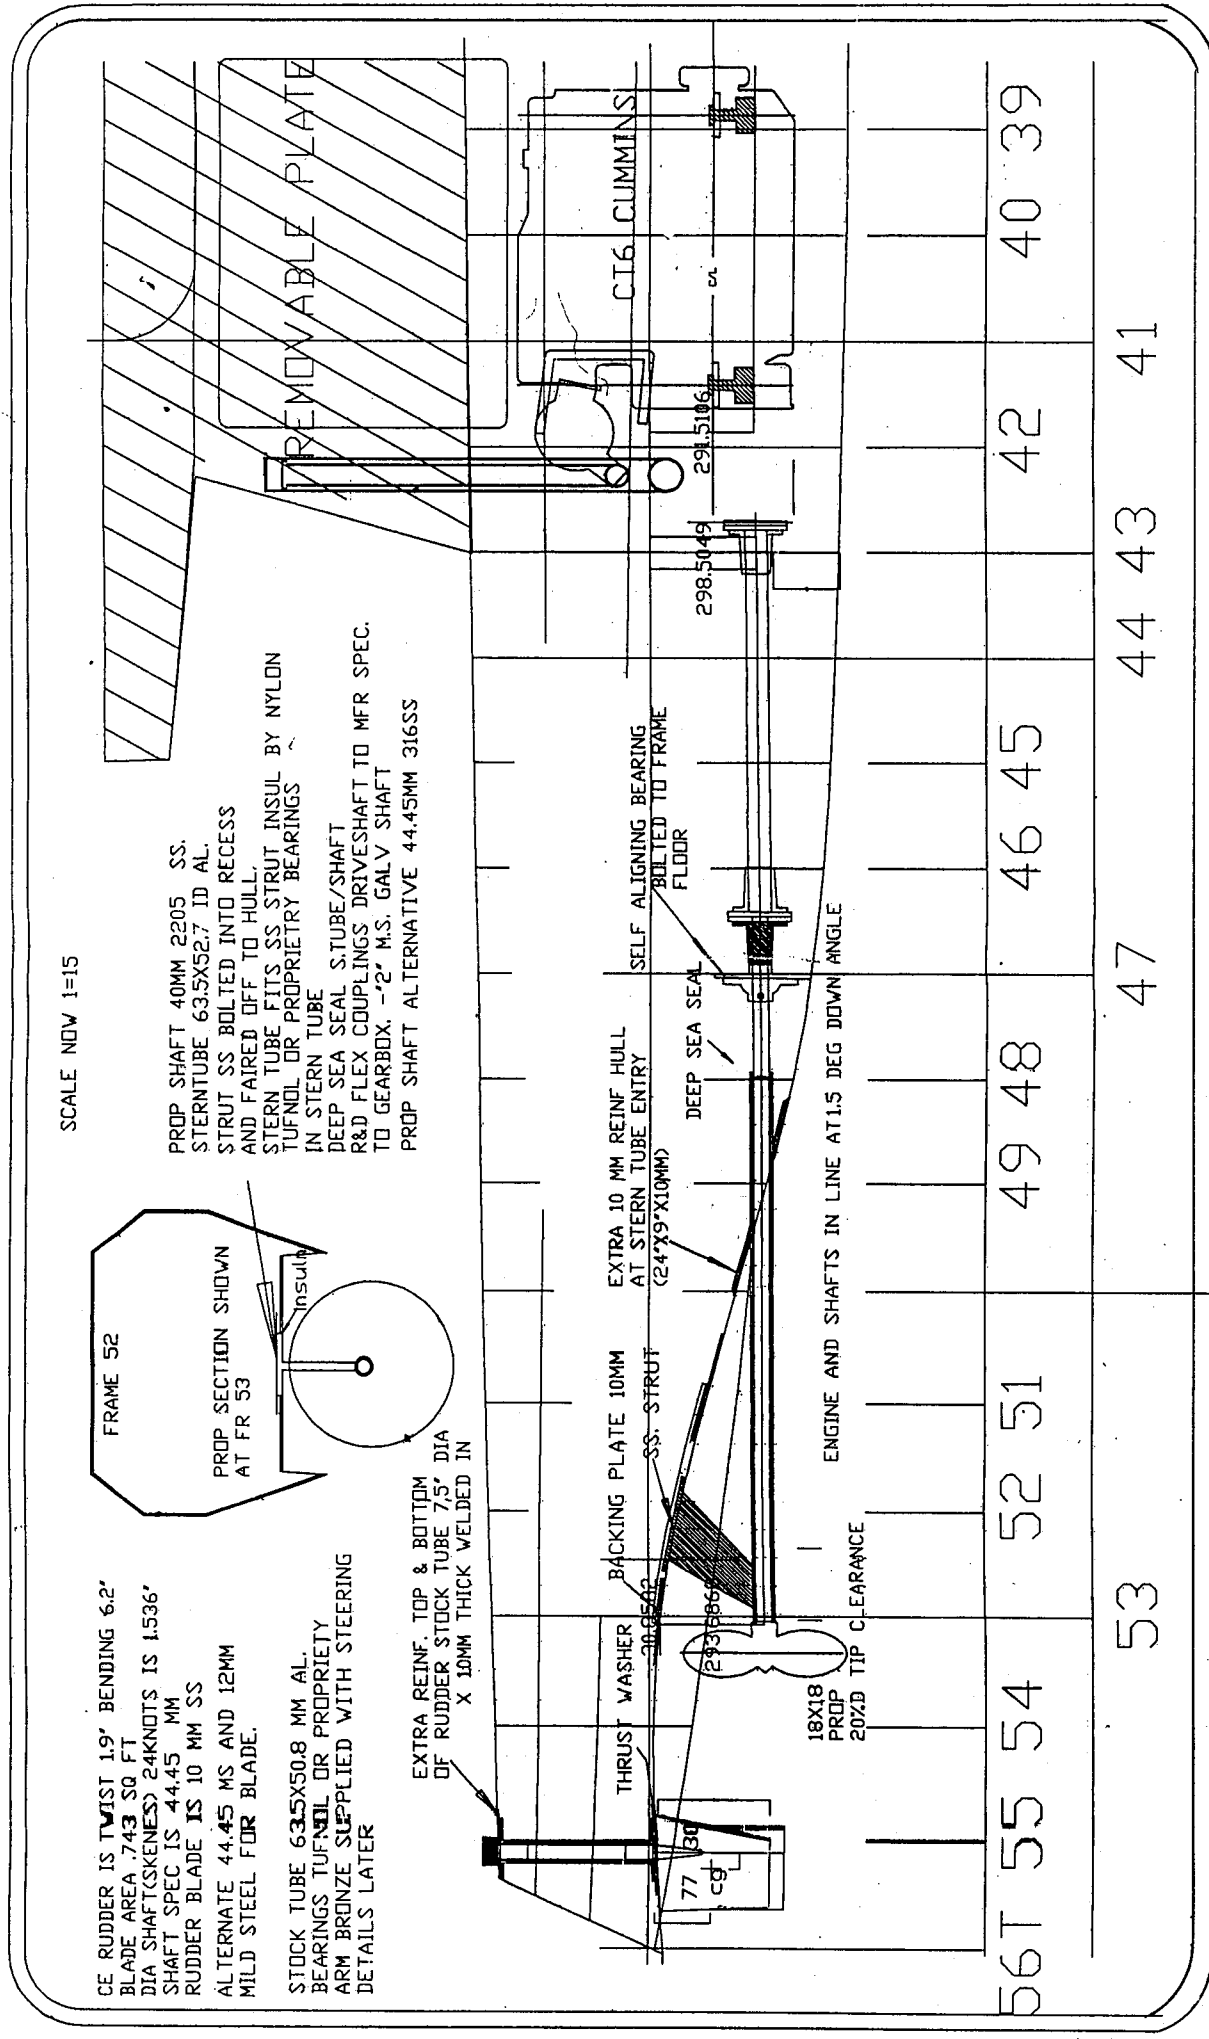
- 1.4.2 The propeller shafts were made from 44.5 mm diameter stainless steel bar. The shafts exited the pontoons through aluminium stern tubes. The stern tubes were of 65 mm outside diameter and 6 mm wall thickness giving an internal diameter of 53 mm. The propeller shafts, therefore, had a clearance of 4.25 mm within the tubes. The stern tubes projected about 250 mm outboard and 300 mm inboard of the pontoon entries. (See Figures 3 and 4).

- 1.5.3 The outboard section of the port stern tube had been partially torn from the pontoon hull creating a hole through the skin of the pontoon. The tube was worn from the inside to such an extent that the original wall thickness of 6 mm was reduced to zero on one edge of the section of tube remaining in place. (See Figures 3, 4, 6 and 8).

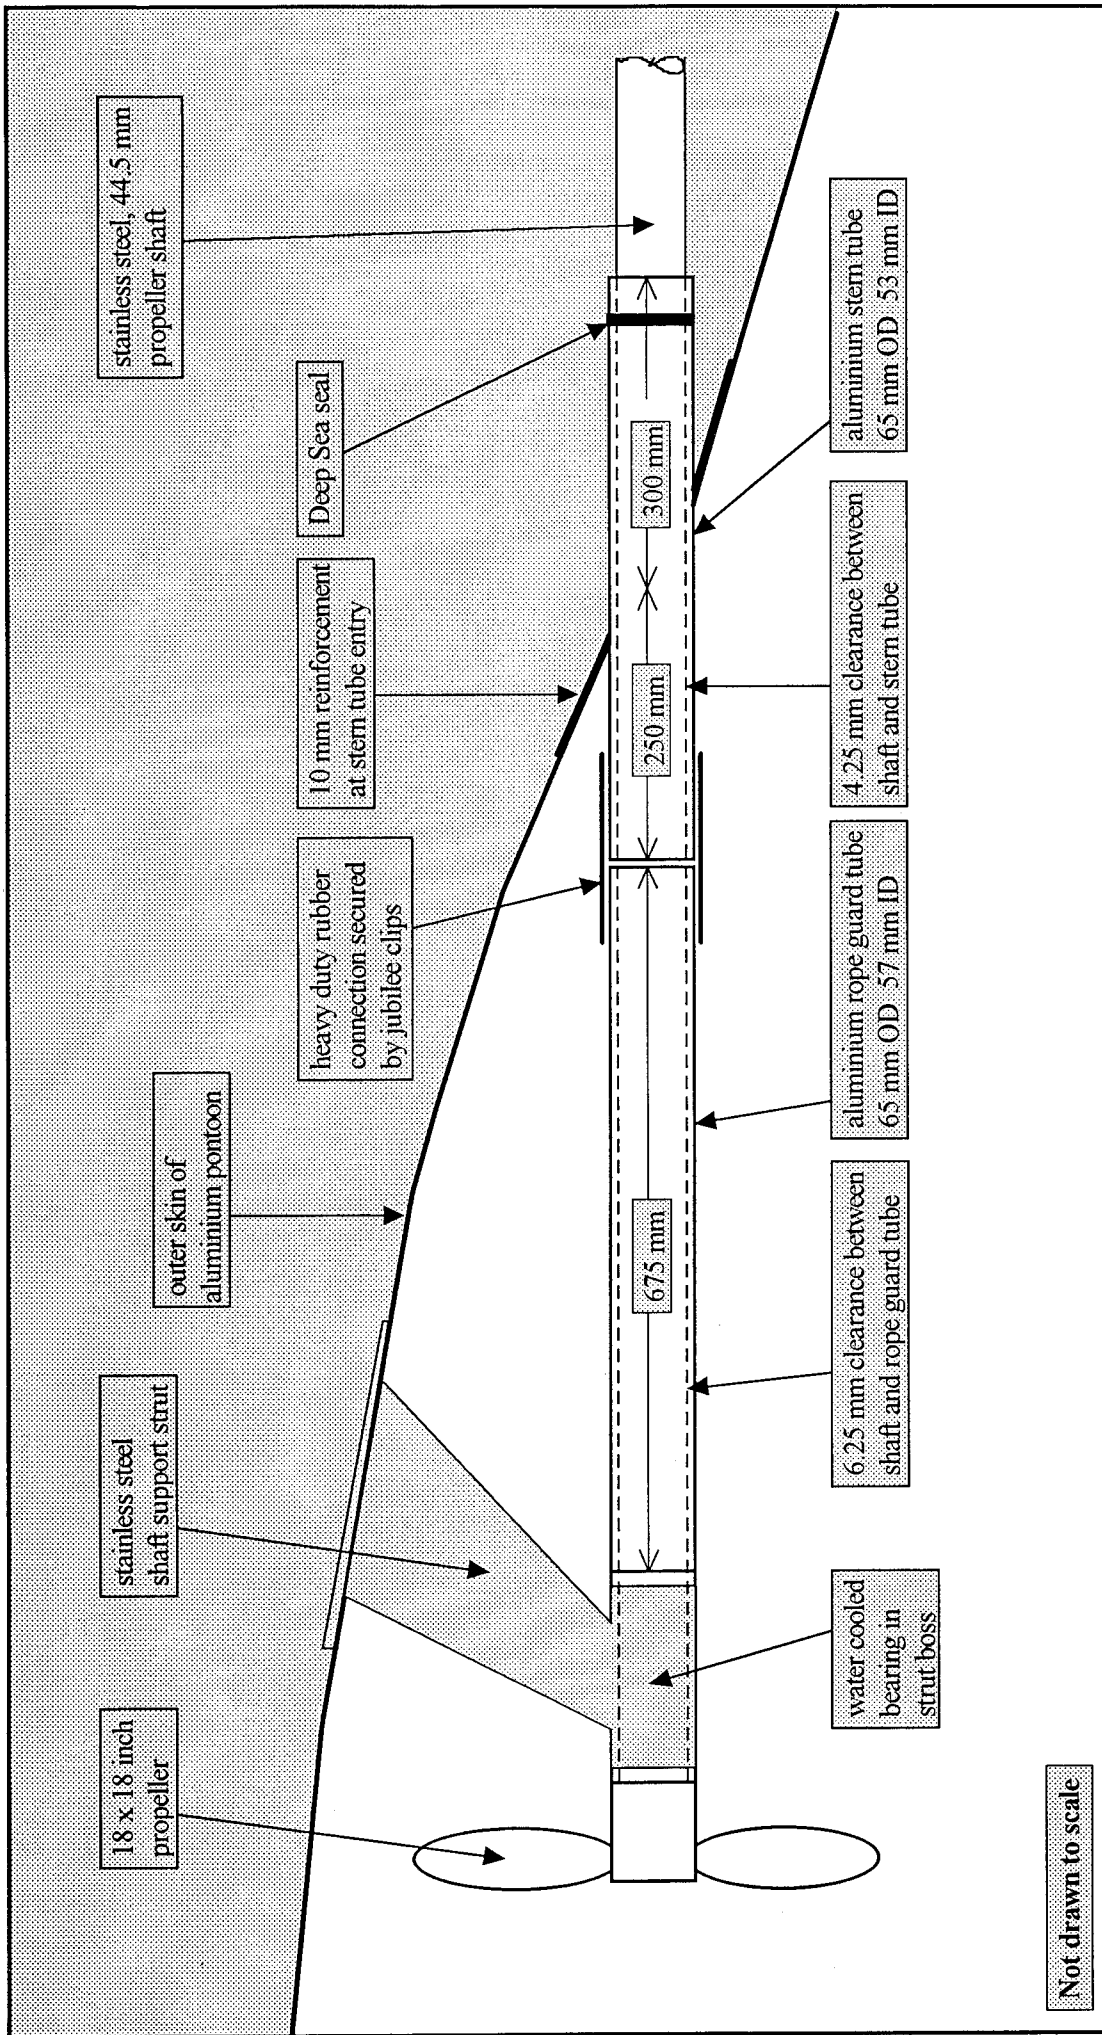
Figure 4
Line plan of *Scat Cat* showing detail of propeller shaft arrangement

- 1.5.2 The aluminium rope guard on the port side of the vessel was missing. To the outboard side of the port propeller shaft there was a section of the hull that had been damaged, possibly where the rope guard had contacted when it was torn free. (See Figure 4).

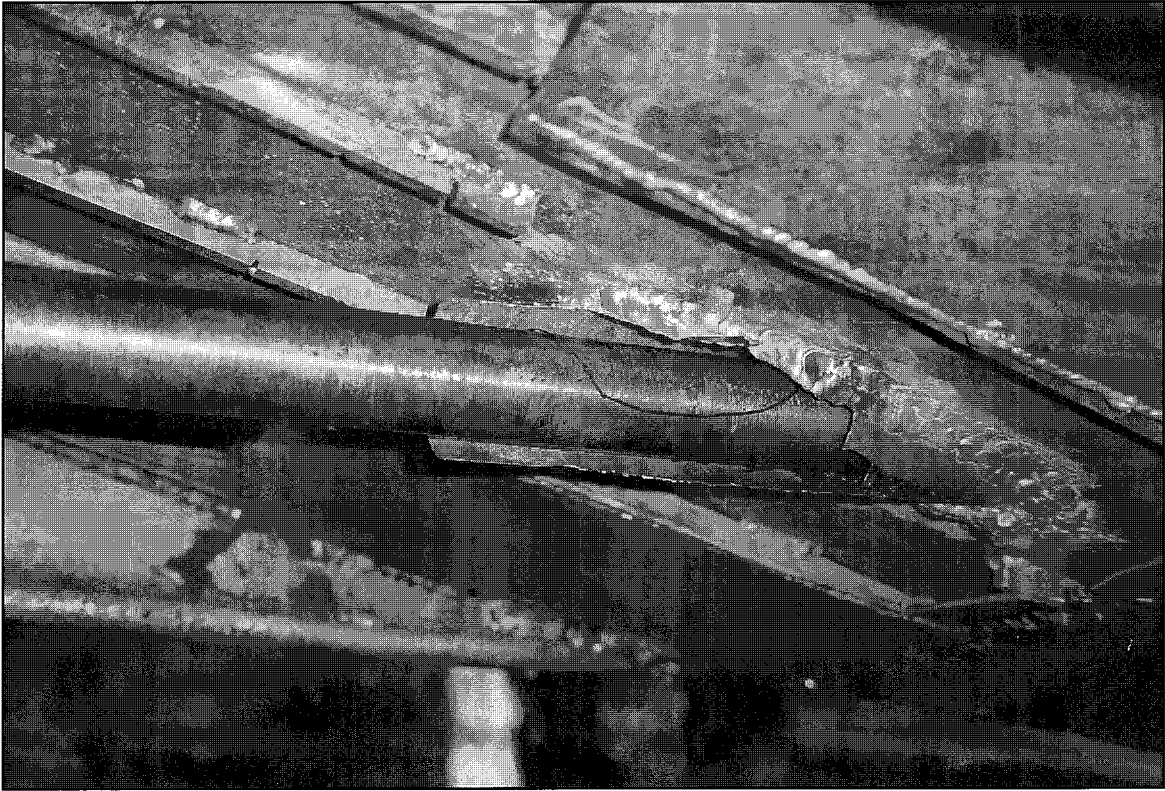
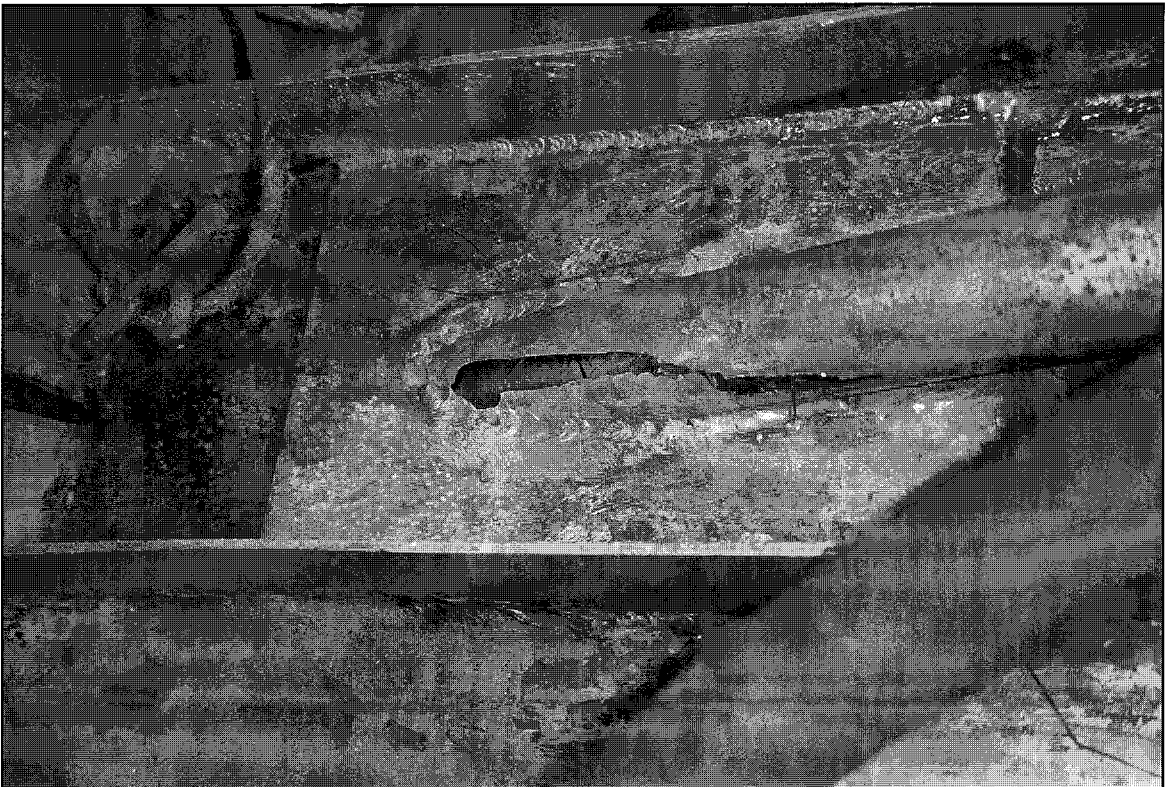
Figure 5
Views of damage to port stern tube entry

- 1.5.4 The inboard section of the port stern tube had worn from the inside of the tube to such an extent that it had worn a hole about 200 mm long and averaging about 15 mm wide on one side of the tube. No wear was apparent on the opposite side of the tube. (See Figures 5 and 8).

Hull penetration from the outboard side

Hull penetration from the inboard side

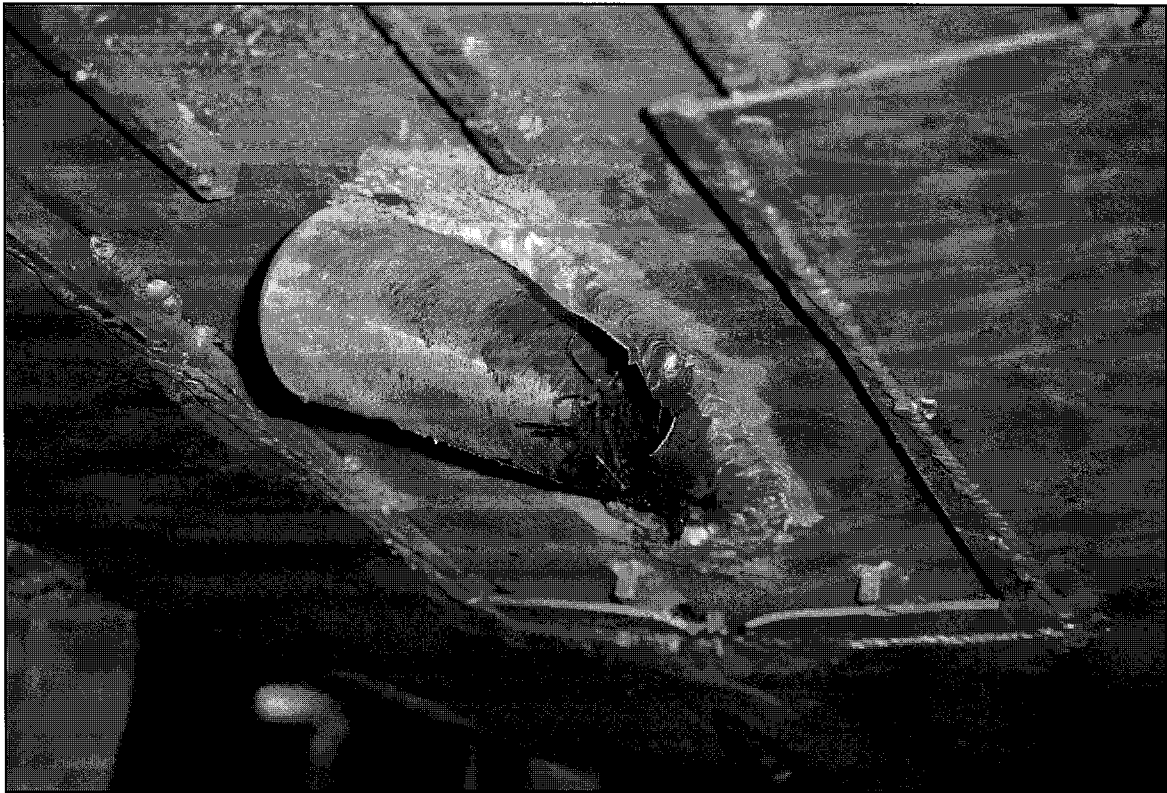
Figure 6
Damaged stern tube after removal of propeller shaft
Note exposed remains of old heat exchanger

- the original engine air intakes were welded shut and new air intakes fitted, extending from the engine trunking to the cabin top
- the cover plate that had been removed from the old heat exchanger on the port pontoon was replaced to give a smooth surface

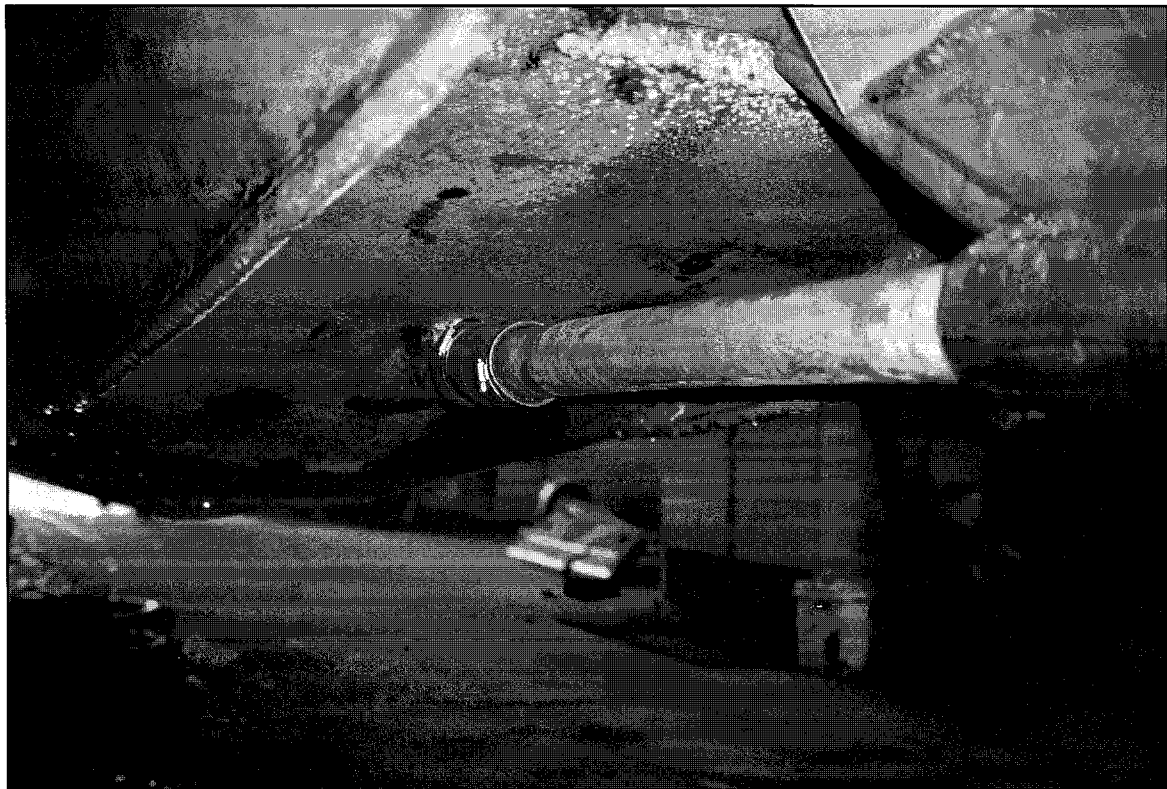
- 1.5.5 The starboard propeller shaft rope guard (see Figures 7 and 9) was removed and was found to be worn from the inside of the tube and on one side only. The original wall thickness of 4 mm was reduced to about 1 mm in the worn area. One side of the strut bearing, which was fitted into the rope guard tube, was completely worn away.

Figure 7
View of intact starboard propeller shaft arrangement

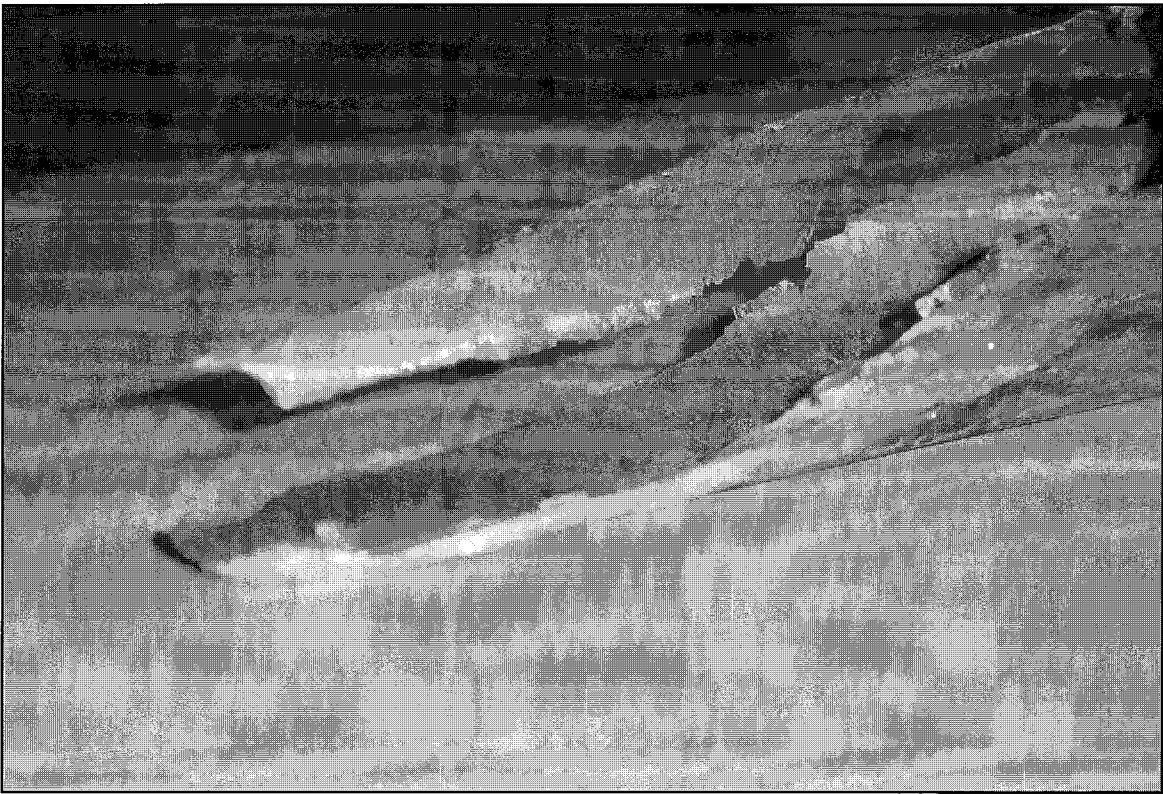
Inboard section. Note hole worn right through tube

Figure 8
Port stern tube sections after removal showing wear to inside of tube

- both propeller shafts were renewed in the same material
- both stern tube entries were renewed. The new tubes were stainless steel of 63.5 mm internal diameter, increasing the clearance with the propeller shafts to 9.525 mm, and fitted on stainless steel plates which were bolted through the hull

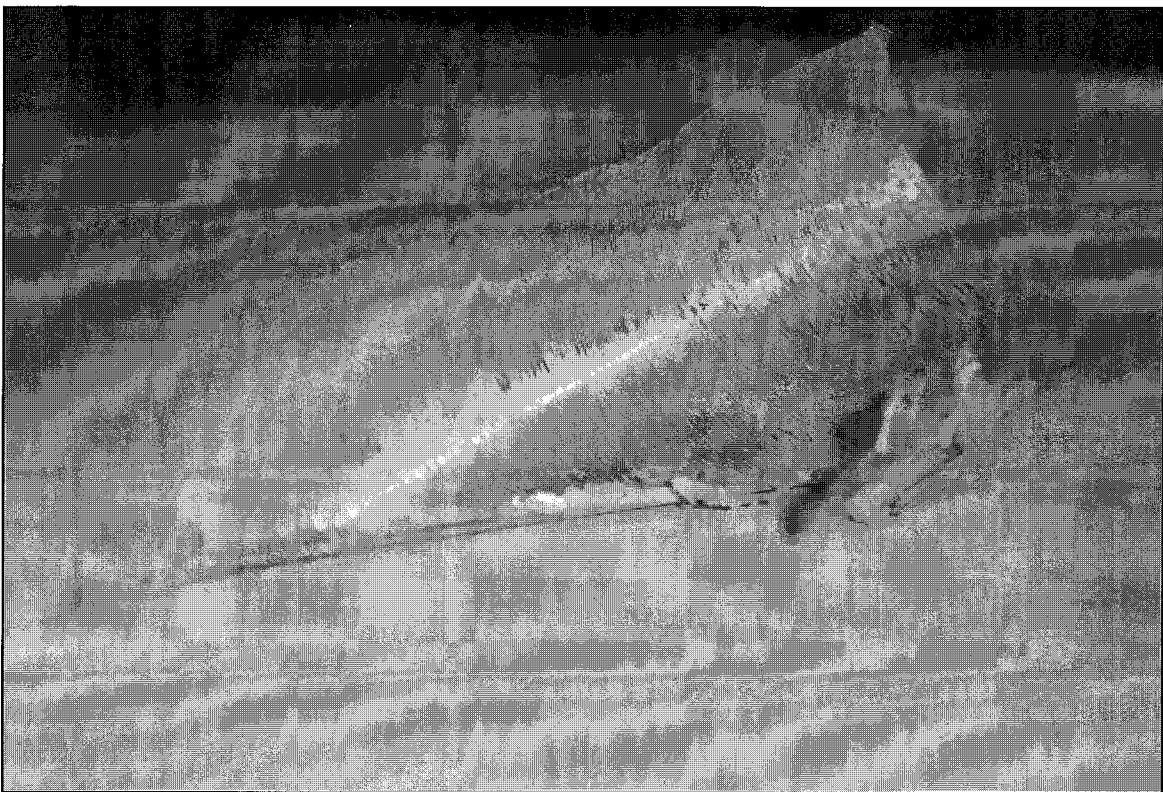
Outboard section. Note thinness of remaining aluminium

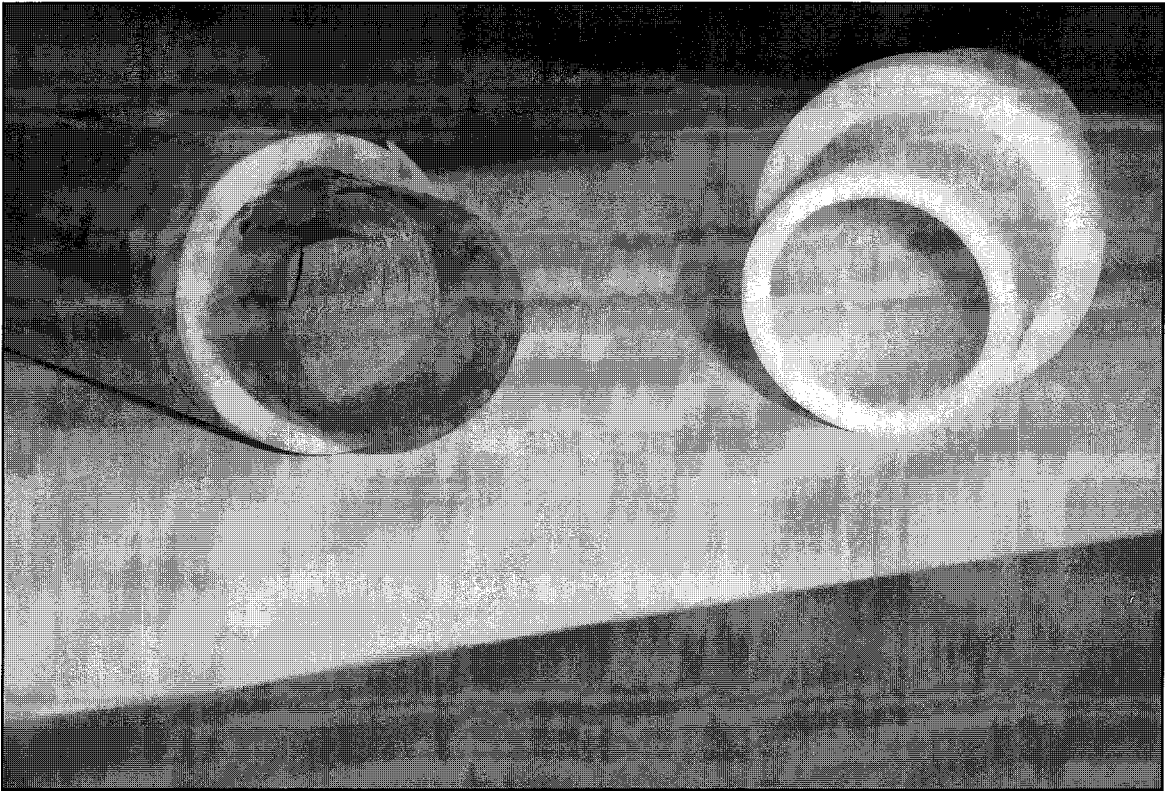
Aft end. Note complete wearing of one side of bearing. New bearing shown.

**Figure 9
Starboard rope guard showing one-sided wear to inside of tube.**

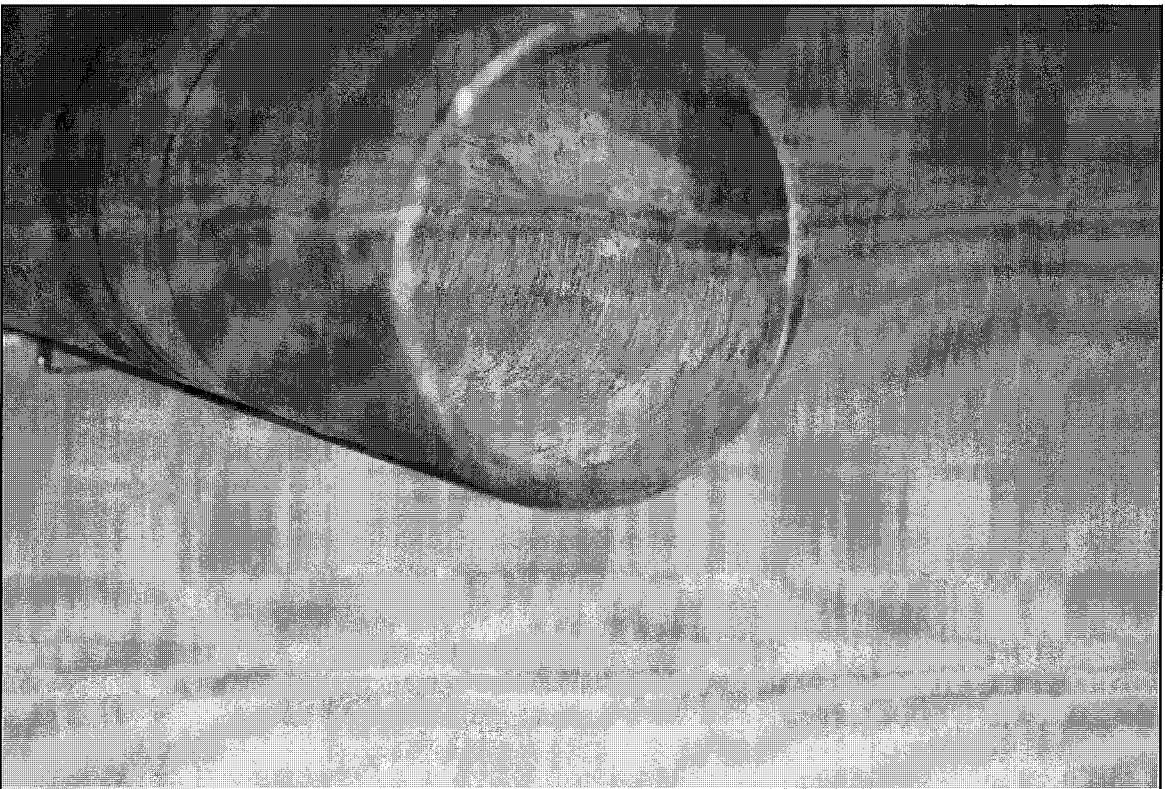
Forward end. Note thinness of tube in way of wear.
