Report 98-213

jet boat *Terminator*

rollover on to shingle bar

jet boat *Helijet 7*

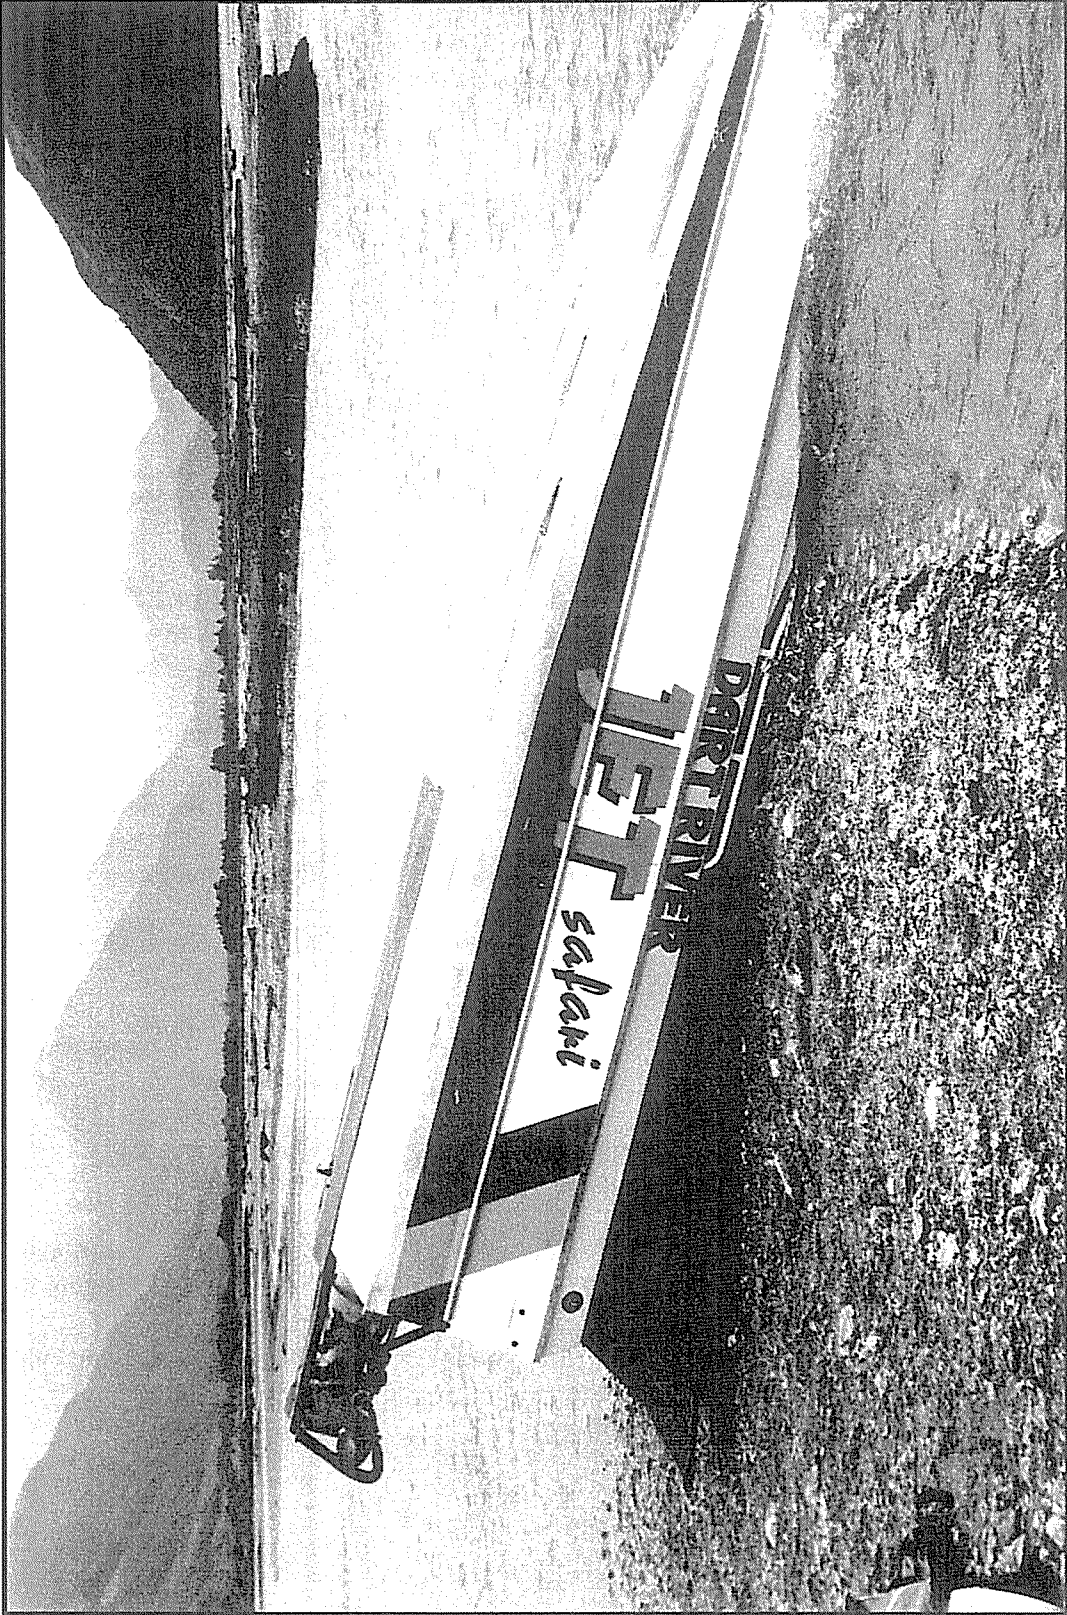
Figure 1
Terminator, shortly after the accident

- 1.2.1 The only damage to the boat was scratched paint and a fractured hand rail. The engine had stopped when the boat rolled over. It did not show any signs of fuel leakage from being upside down and there was no fire.
- 1.2.2 The day after the accident, the engine of *Terminator* was tested. After removing crankcase oil from the cylinders and replacing the spark plugs, the motor ran normally. The steering worked normally. There was no evidence of mechanical failure that might have contributed to the accident.

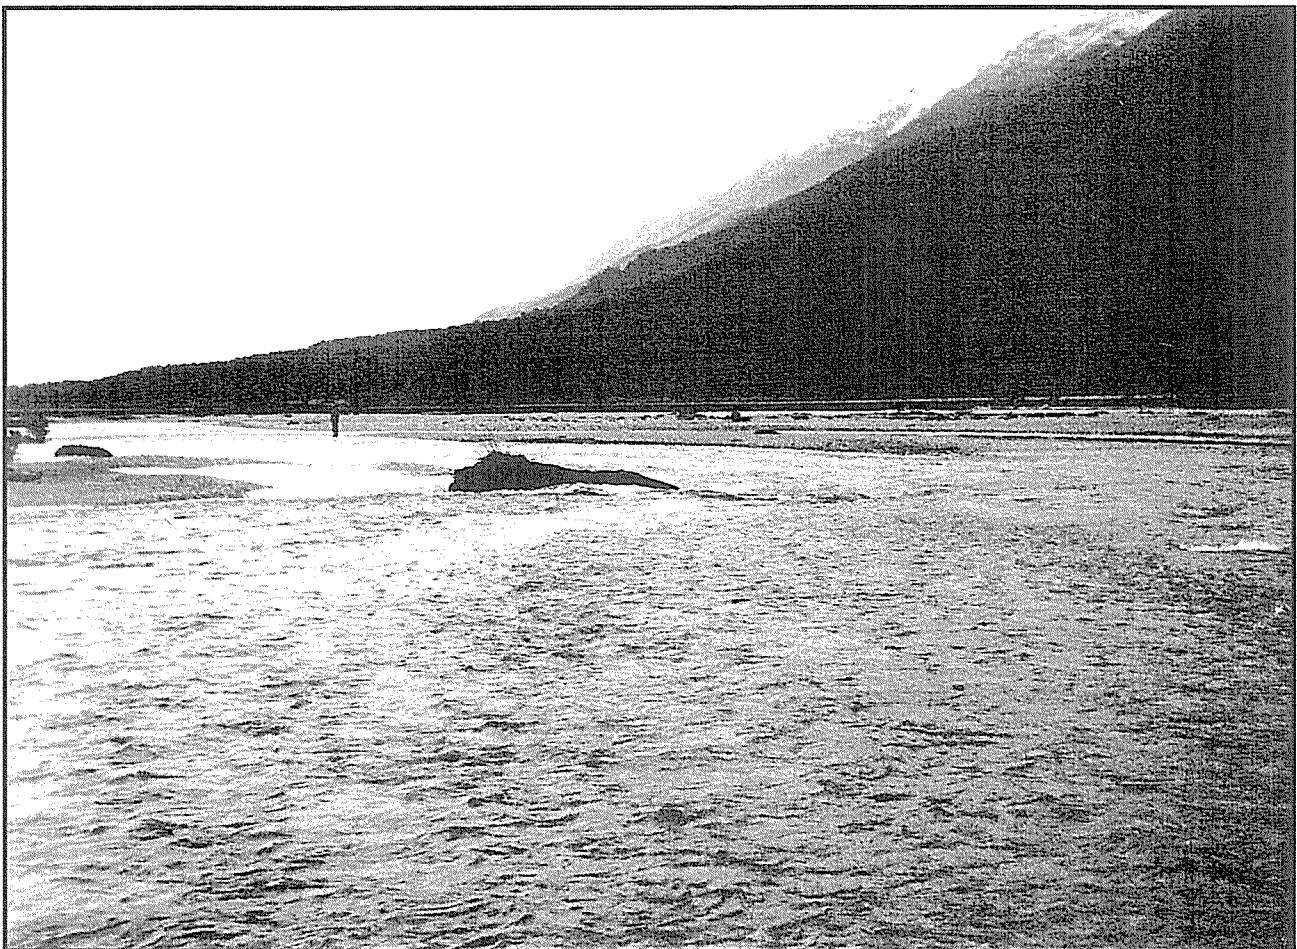
- 1.1.18 The channel that *Terminator* was following veered left as it converged with another channel; however, a clump of earth blocked part of the confluence of the two channels. The driver noted that the main water flow was to the right of the clump, so he began to line the boat up for that point, first flaring the stern of the boat out to the left to reduce boat speed to facilitate the hard left turn that would be required to avoid a shingle bank after passing the clump (see figure 3).

Figure 3
Driver's view of channel; note the clump and the obstruction close right of it, and the shingle bank behind.

- 1.1.19 As *Terminator* passed the clump, the left rear chine of the boat caught on an object extending out from the clump, just under the water surface, which caused the boat to become partially airborne and nose into the water in an induced slow left turn. The forward right chine then caught in the water and, despite the driver's attempt to keep it straight, the boat broached to the left, skimmed across the water sideways, struck the shingle bank and flipped upside down, coming to rest with its bow in the water.

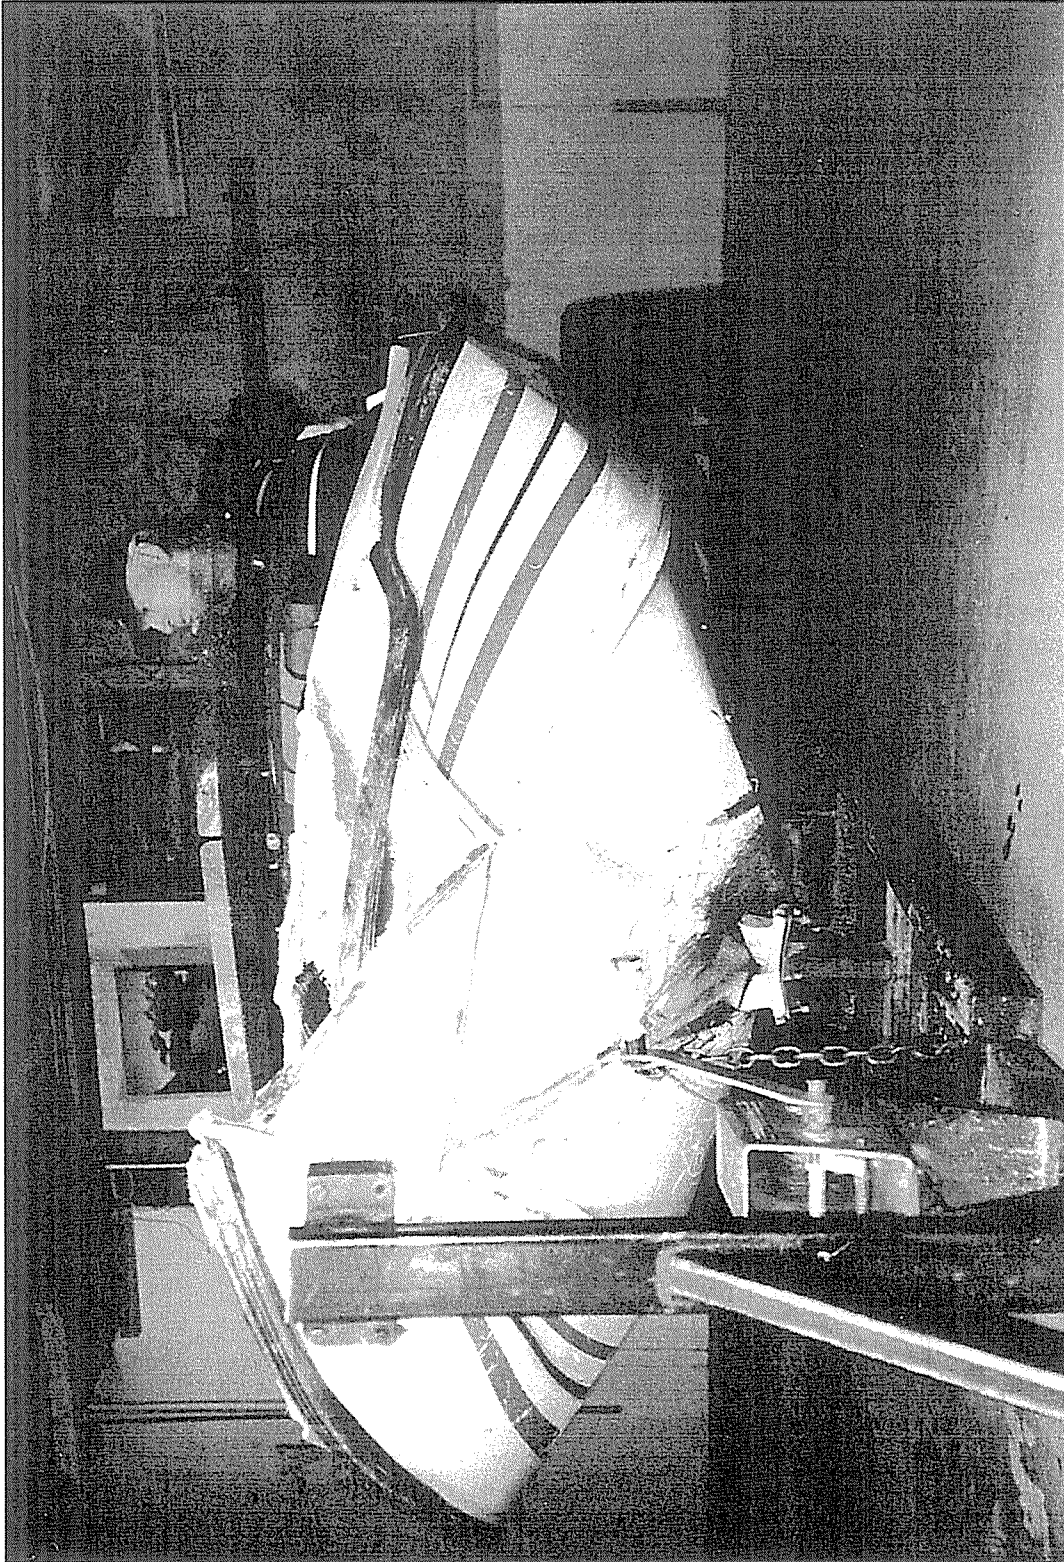
Figure 5
Damage to bow of Helijet 7

- 2.2.2 *Helijet 7* was extensively damaged in the collision. The aluminium bow was pushed back about 60 cm and bowed outwards. Part of the GRP foredeck shattered and had sprung from the hull. The front seat mount sheared from the floor frame and the back of the front seat was pushed forward by the impact from the rear seat passengers, sheering the steel channel frame from the seat frame.

- 2.2.5 Comparing the nature of the hull damage with the impact marks on the rock face, it was apparent that *Helijet 7* had struck the rock face with a bow-high attitude and with a bias on the left side, indicating that the boat might have been either starting to turn to the right, or had some residual side-slip to the left, when it struck the rock face.
- 2.2.6 A number of crash stop manoeuvres were made with *Helijet 7* (near full ahead to full reverse bucket). As expected with jet boats, the boat assumed a severe bow-down attitude as it came to a rapid stop.
- 2.2.7 When the crash stop manoeuvre was attempted without reducing the throttle, the test driver had to use both hands to apply sufficient reverse bucket to stop the boat effectively.

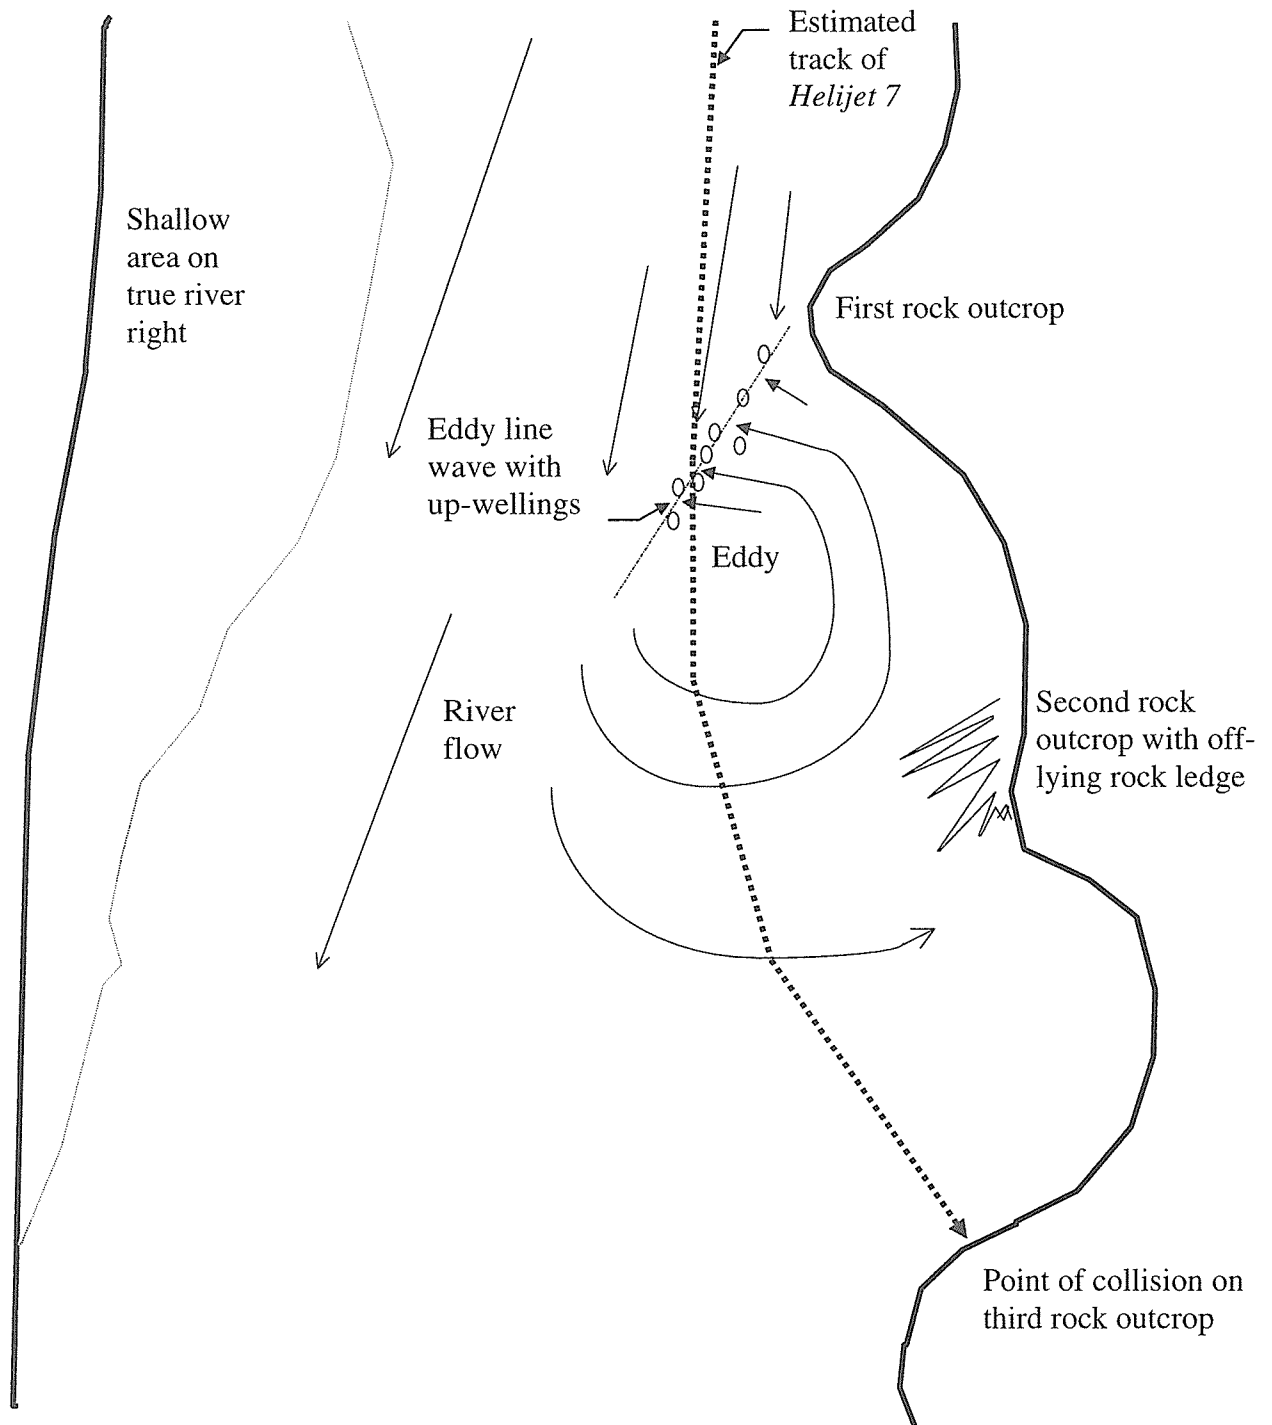
Figure 6
Schematic diagram of accident area (diagram not to scale)

- 2.1.6 The river flow formed an eddy behind the first outcrop, which created an eddy line⁶ and upwelling where the eddy re-entered the main flow. The driver steered *Helijet 7* near the first outcrop at a speed of about 70 km/h, passing about 2 metres off it, heading parallel to the river bank (see figure 6).

- 2.1.7 As the craft crossed the eddy line, the driver applied a small amount of right helm to begin a right turn that was necessary to keep the boat in the main channel. *Helijet 7* did not appear to the driver to respond, so he applied more right helm, still under near full engine power. *Helijet 7* still did not respond. The driver recalled releasing the throttle pedal and moved the helm to hard left and back to hard right lock before applying full throttle again in an attempt to move the boat right. Throughout this sequence the bow of *Helijet 7* veered to the left heading for the third outcrop.
