Report 98-214

fishing trawler *Dong Won 529*

grounding

Breaksea Islands, Stewart Island

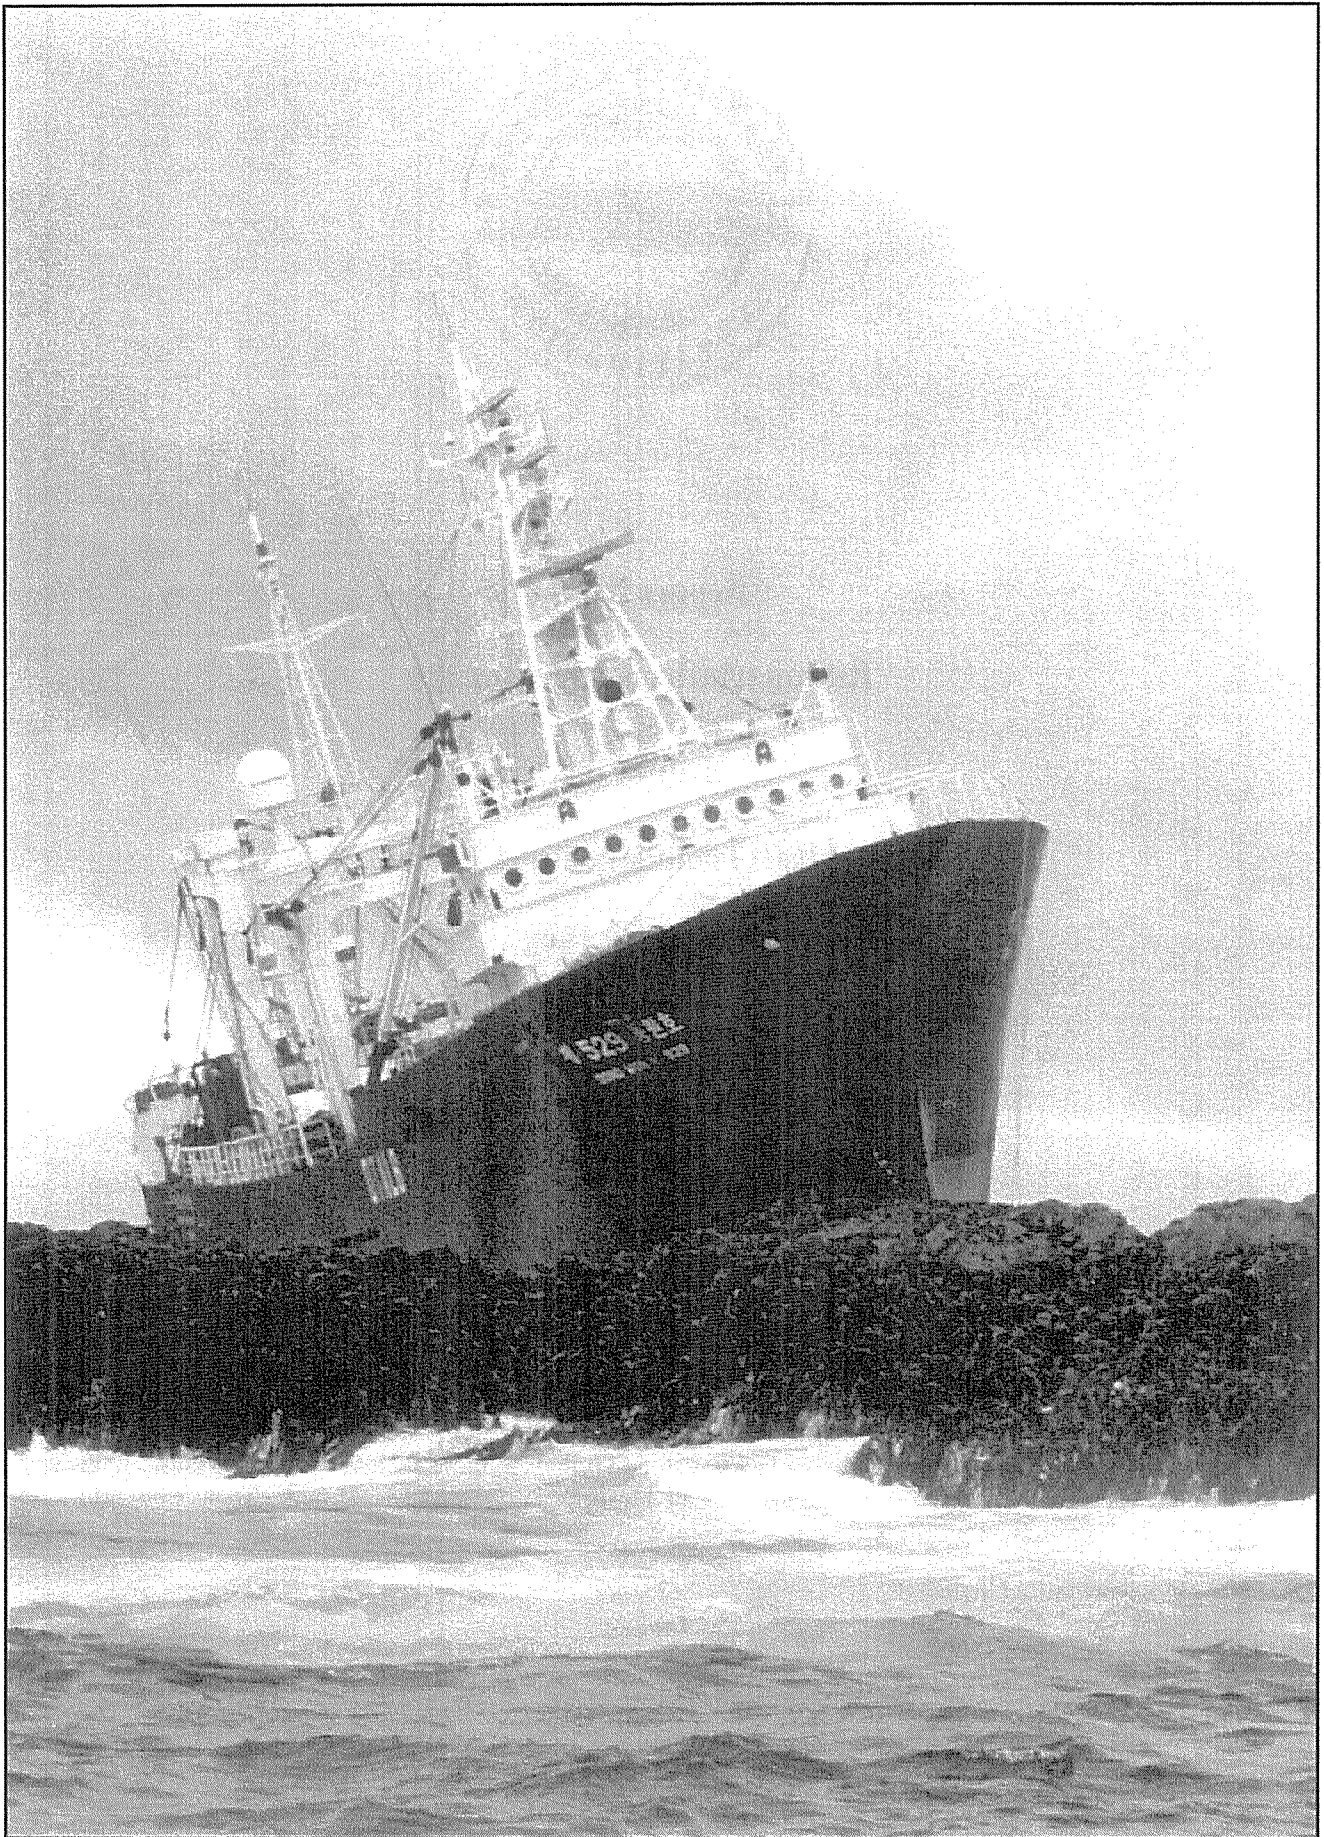
Dong Won 529 aground at Breaksea Islands
Photograph courtesy of Mike Squires, Stewart Island and NZ Professional Skipper magazine

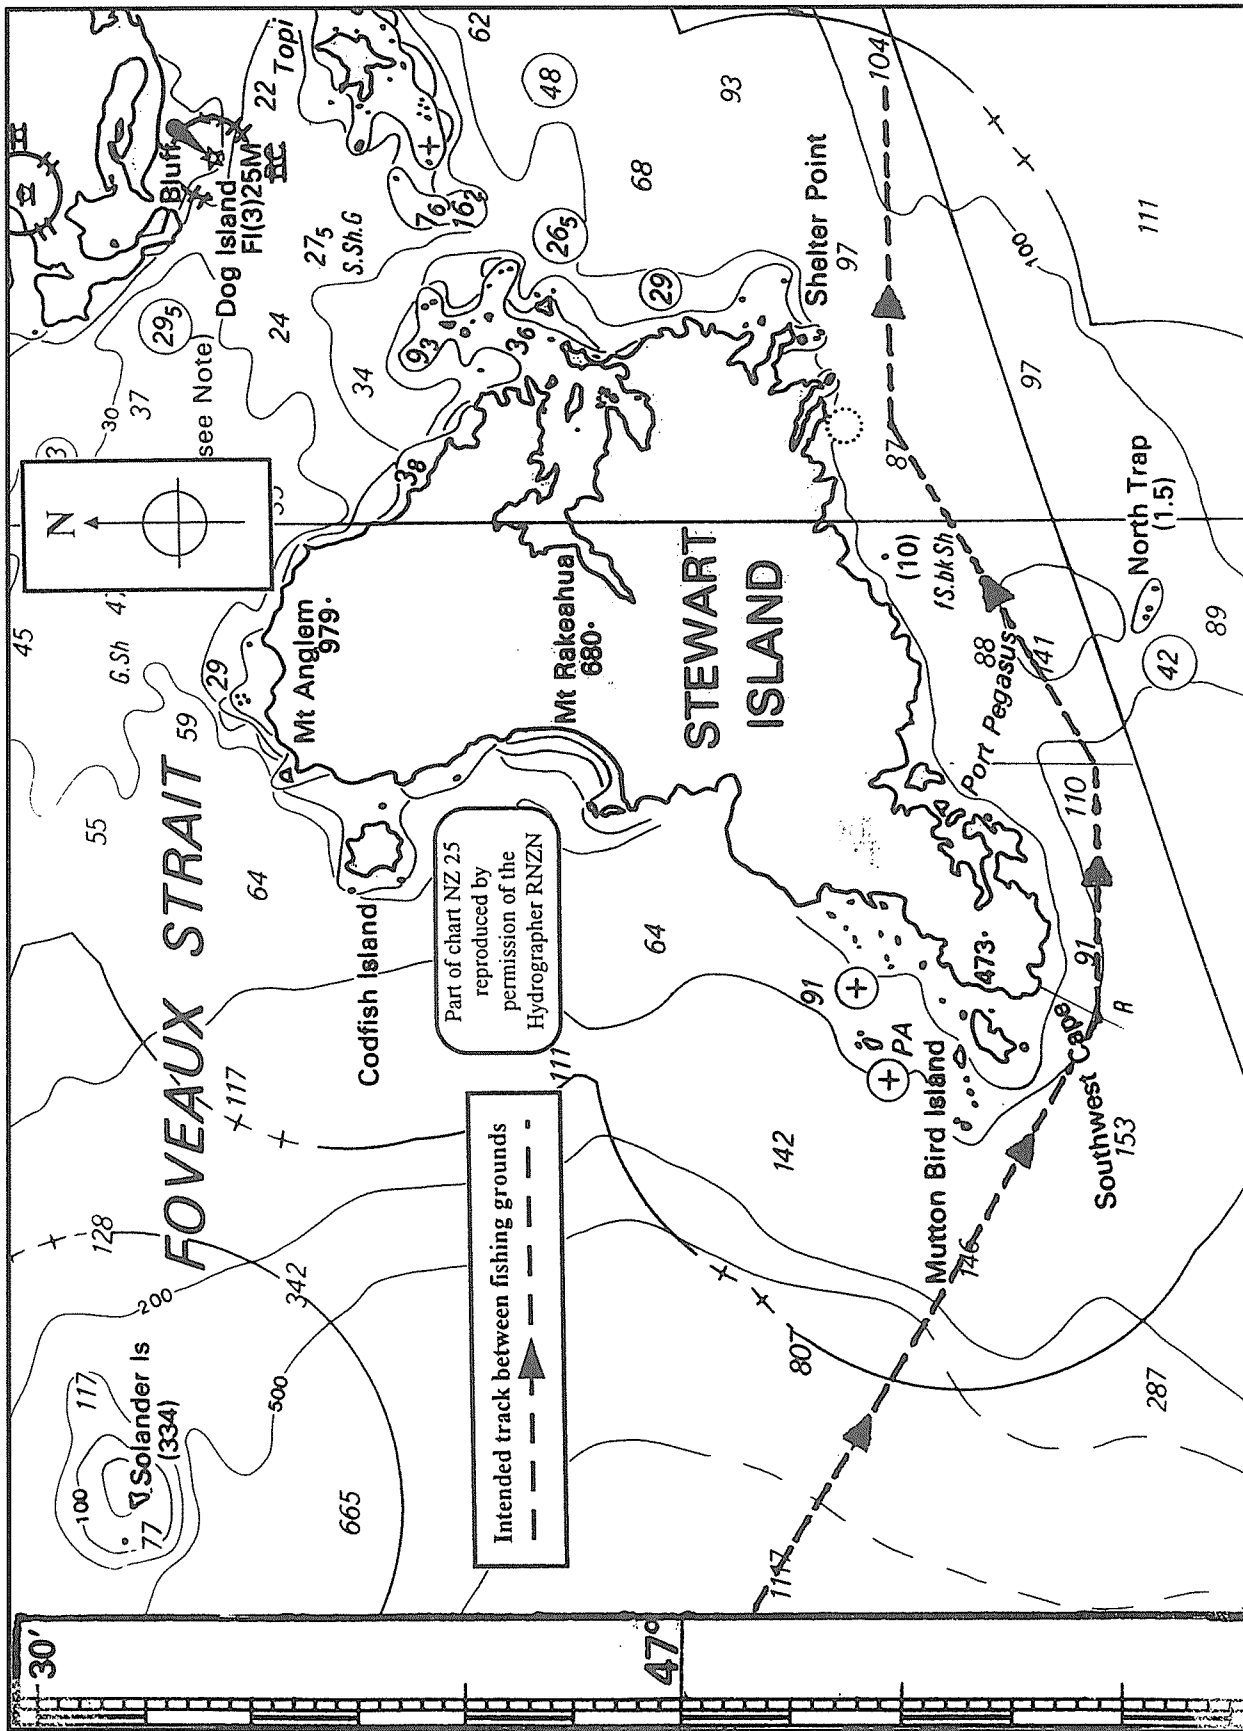
Figure 1
Part of chart NZ 25 showing intended track between fishing grounds.

- 1.1.3 The passage was planned to pass Southwest Cape, then head east for about 12 miles before paralleling the coast on a course of about 065 degrees until about three miles off the land in the vicinity of Breaksea Islands on the south east tip of Stewart Island. Once this point was reached the intention was to either proceed to the next fishing ground on a course of about 090 degrees or, if the weather was bad, to remain in the shelter of Stewart Island. (See Figure 1)

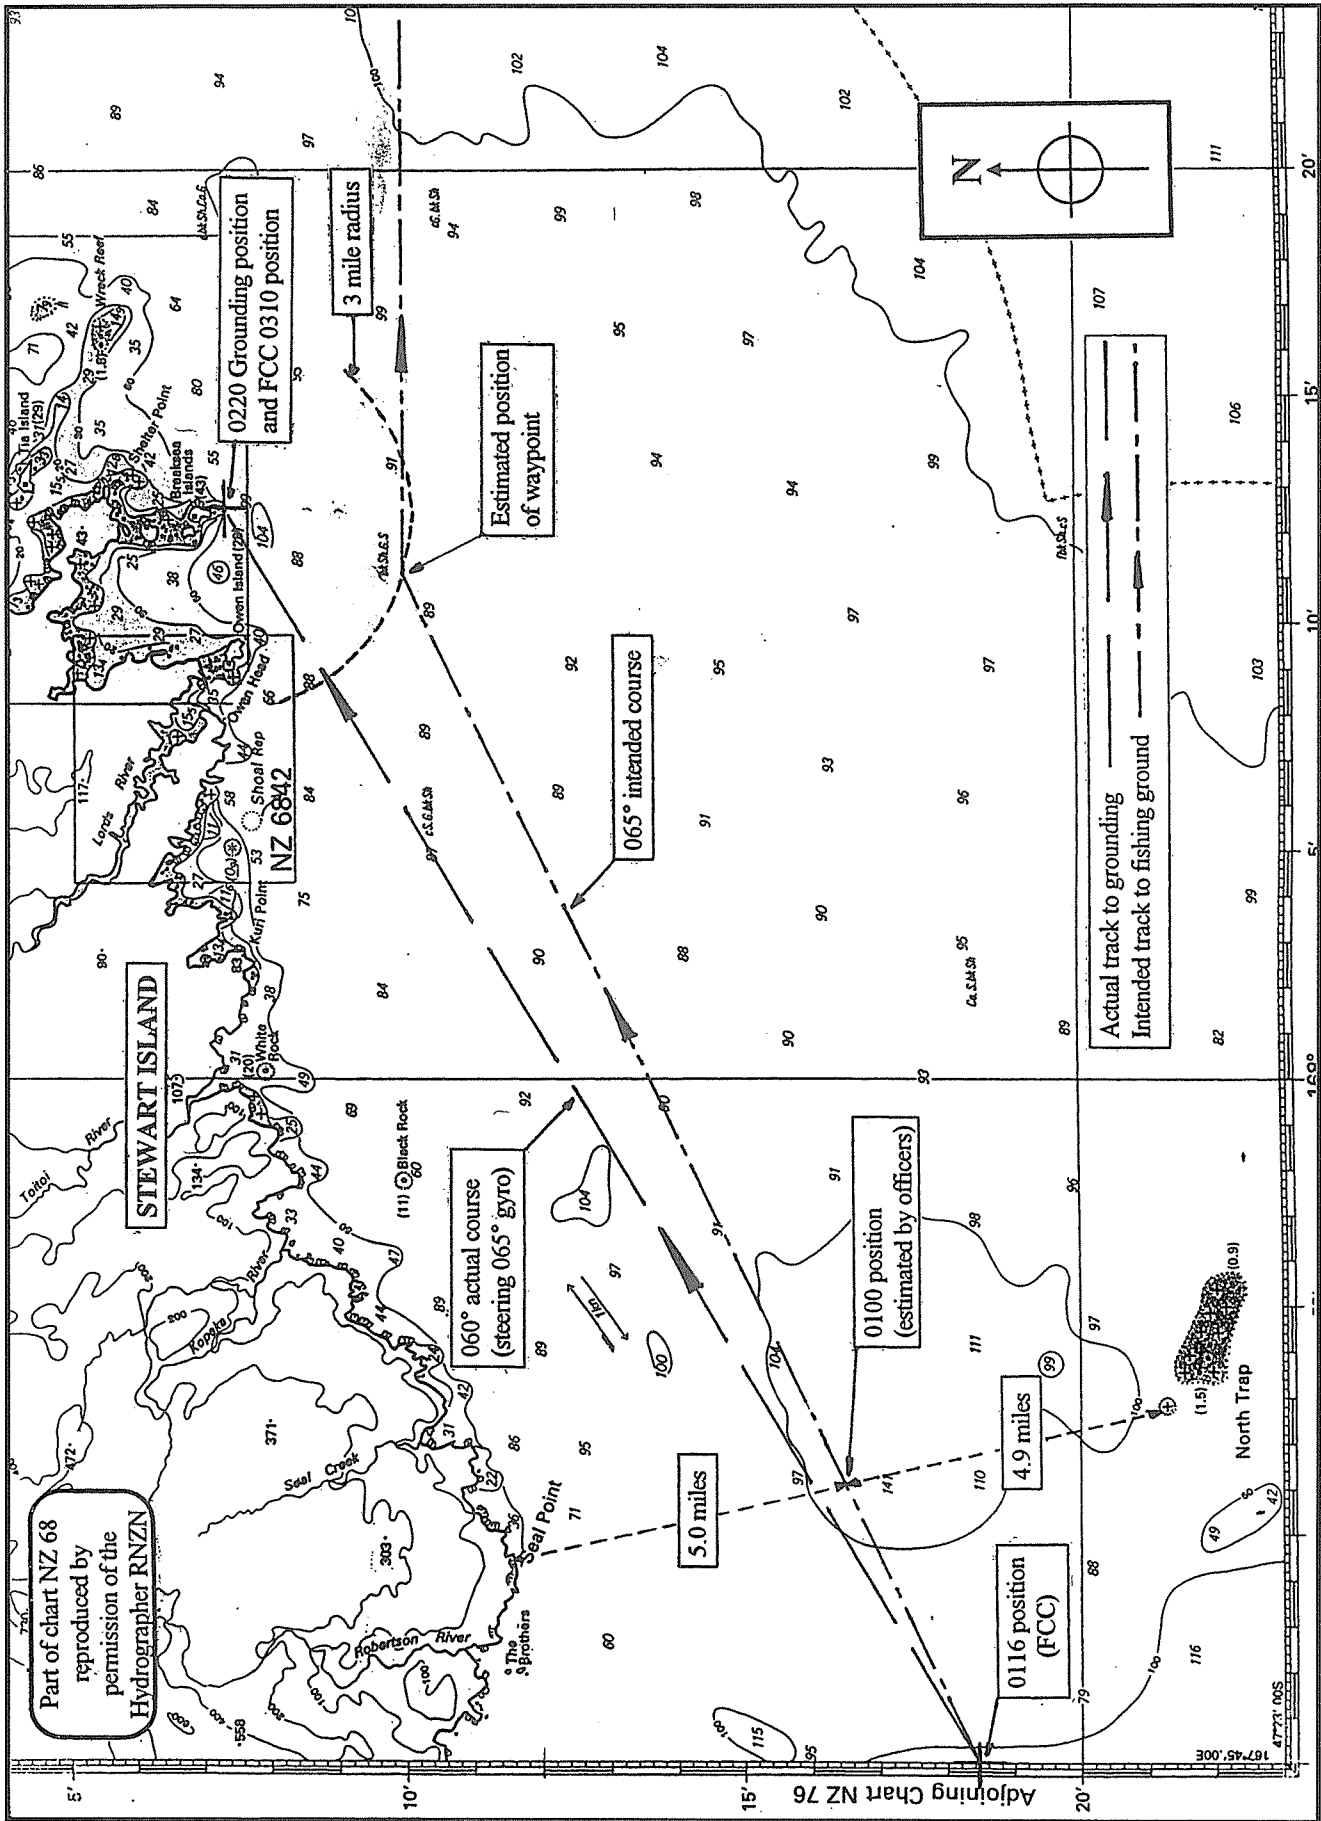
Figure 2
Part of chart NZ 68 showing planned and actual courses

- 1.1.4 *Dong Won 529* left the Solander fishing grounds and proceeded along the planned route. The master and first officer kept the navigation watch from 1900 to 0100 the next day. At the change of watch, when the chief officer and second officer took over, the vessel was already on the course of 065 degrees paralleling the coast. (See Figure 2)

- 1.1.5 The master instructed the oncoming officers that, when the vessel reached the next planned waypoint, a position described as 2½ to 3 miles off Breaksea Island (see Figure 2), the chief officer was to assess the weather and sea conditions, and turn towards the new fishing ground or reduce speed and stay within the lee of Stewart Island.

- 1.1.6 Prior to the change of navigational watch, the first officer observed the position of the vessel and indicated it to the chief officer and second officer, both of whom had arrived on the bridge 15 minutes before their duty time of 0100. The officers' recollections differed slightly with regard to the exact position of the vessel at 0100 on the morning of Tuesday, 6 October 1998 but they agreed that it was in the area about halfway between Seal Point and North Trap. (see Figure 2)

- 1.4.6 The line joining the 0116 position and the grounding position indicated a course made good of 060 degrees. The officers stated that the vessel had been steering 065 degrees by the gyro compass. They stated that there was an error on the compass such that it read higher than true. The recollections of the size of the error varied but the consensus was that it was about 5 degrees.

- 1.4.7 None of the officers could recall the exact position of the vessel at the 0100 change of watch on 6 October, but all indicated that it was in the area about halfway between North Trap and Seal Point. This estimated position coincided with the line joining the 0116 ALC position and the grounding, but the timing did not.

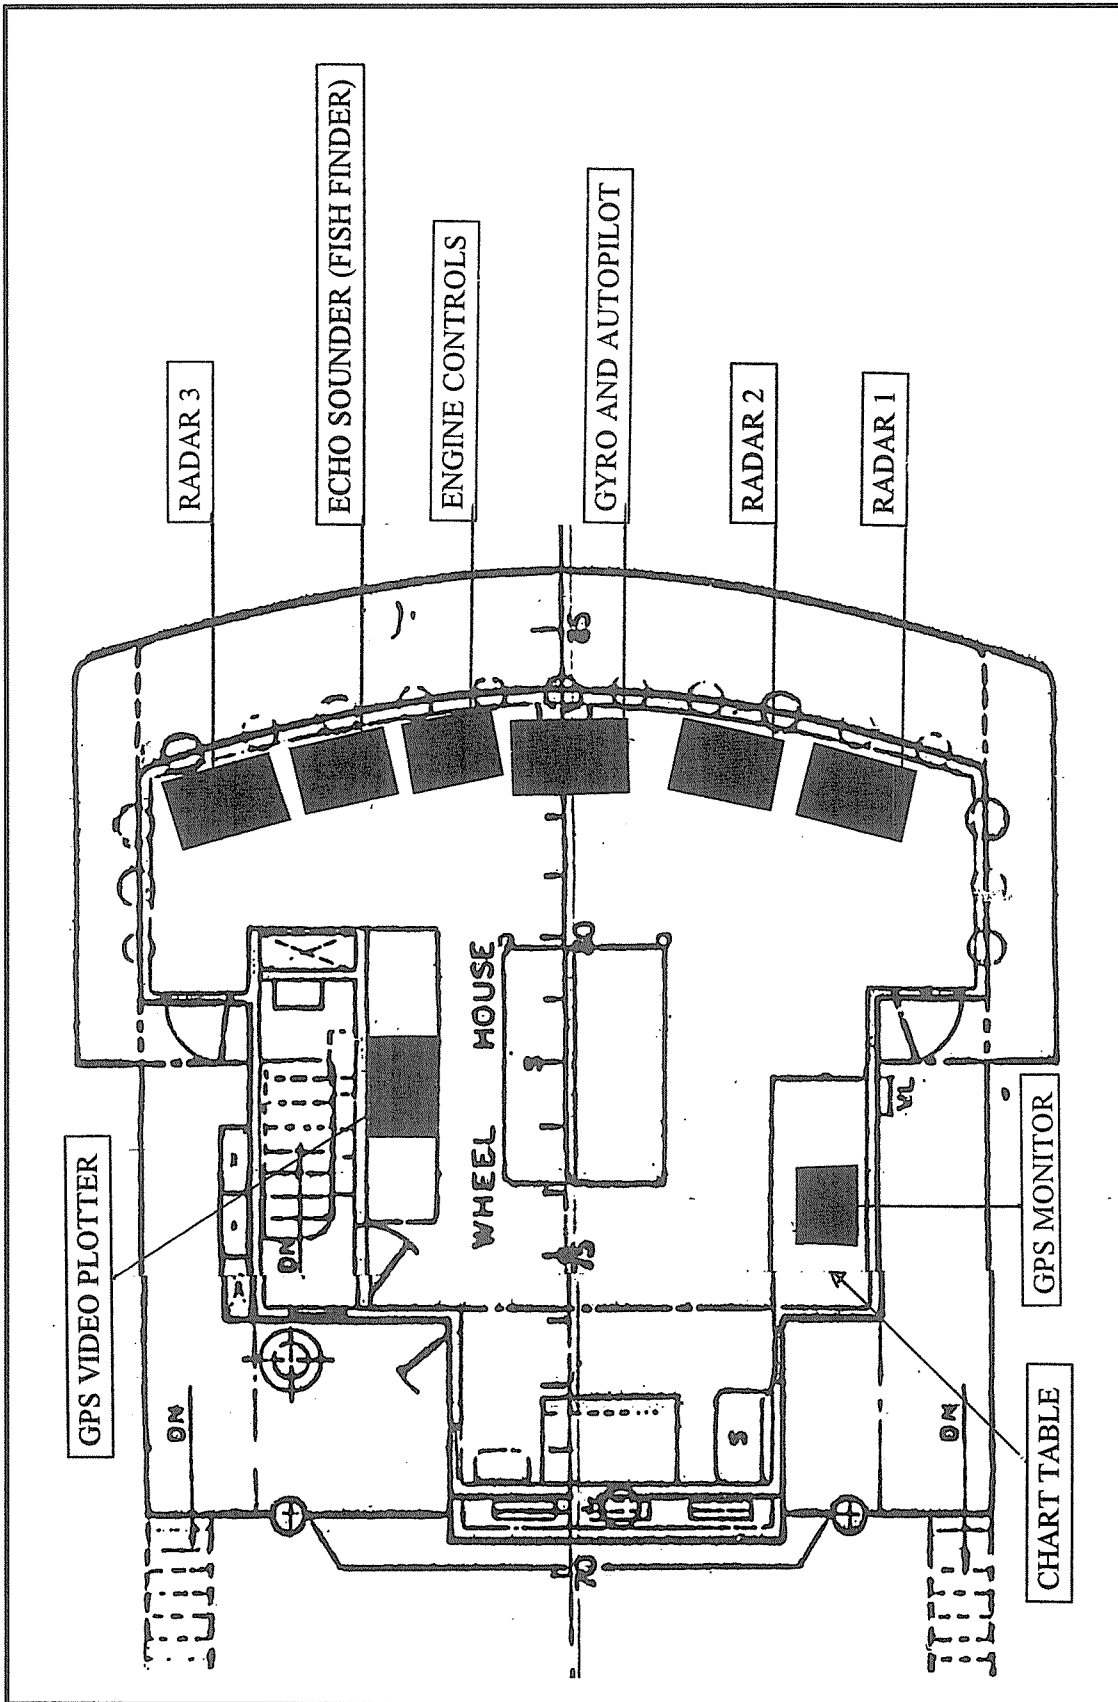
Figure 3
Plan of bridge showing approximate positions of navigational equipment

- 1.1.12 From his position at the chart table, the only navigational aid immediately available to the second officer was a Global Positioning System (GPS) display. The GPS display at the chart table did not have a video plotter incorporated. (See Figure 3)

- 1.1.13 There were two radars and a GPS video plotter operating elsewhere in the wheelhouse, but to view them the second officer would have had to leave the chart table area where he was working and move to the appropriate area of the wheelhouse.
