Report 98-216

Coastguard rigid inflatable rescue craft *Rescue 1*

failure of buoyancy pontoons

8 December 1998

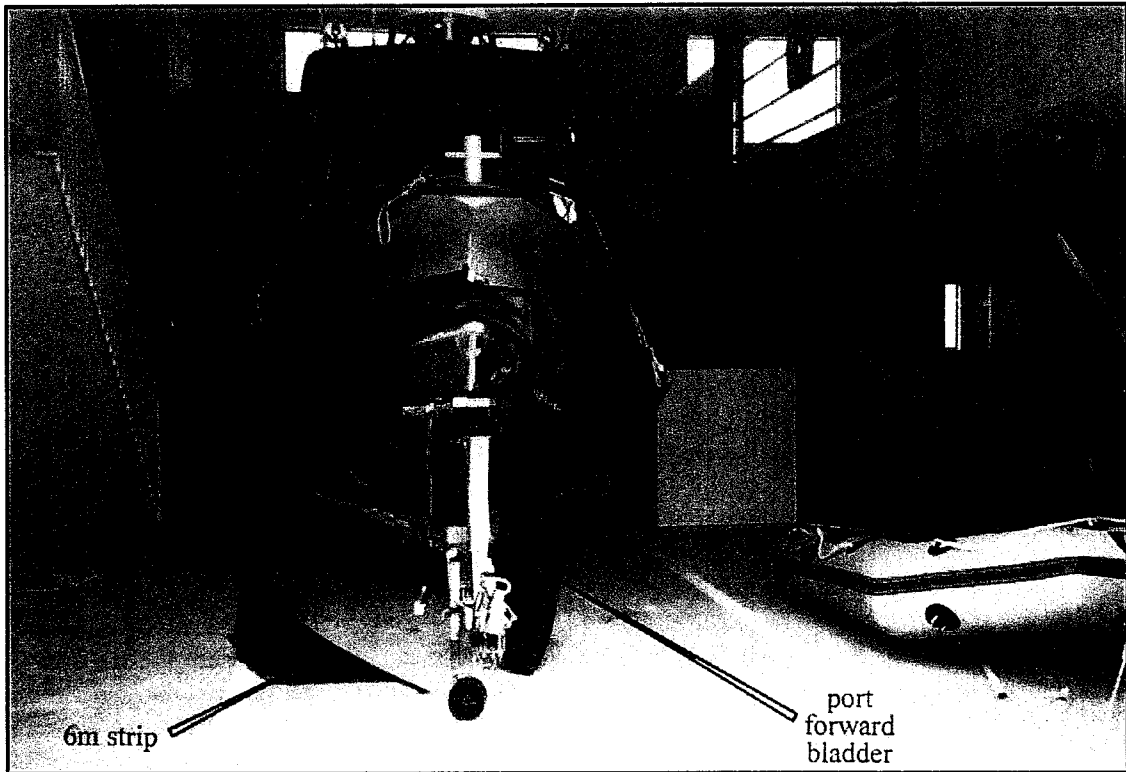
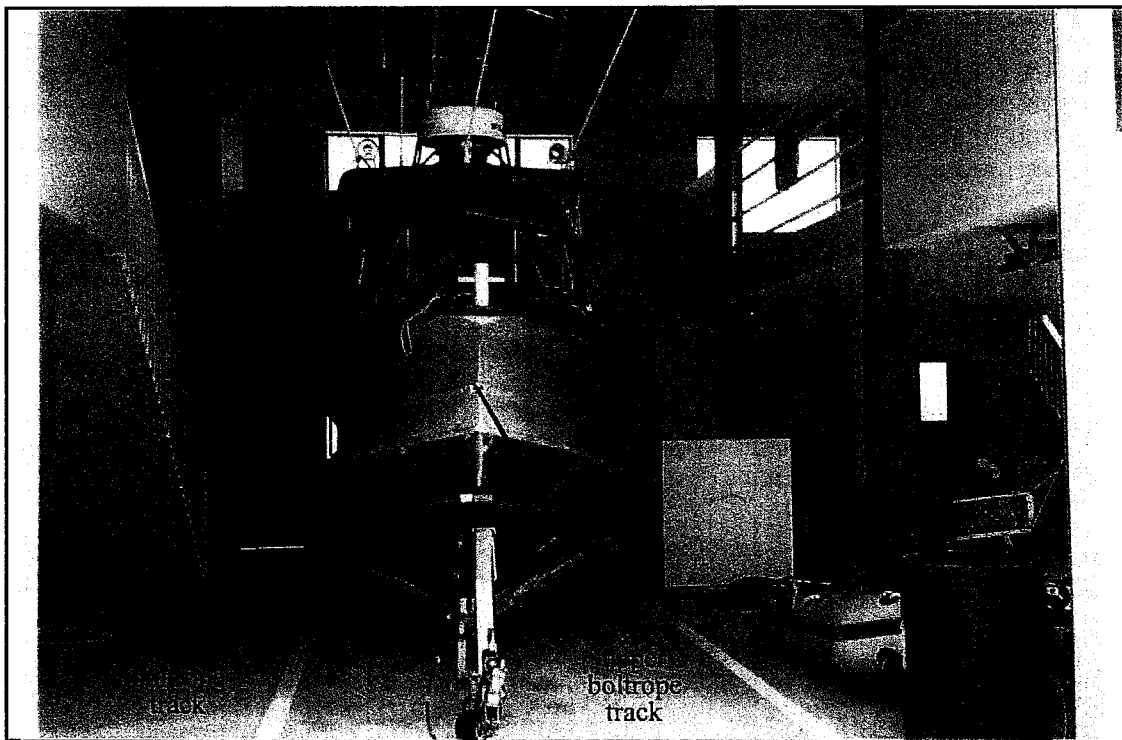
Figure 2
Rescue 1 at coastguard headquarters

- 1.1.12 On inspection, the crew of *Rescue 1* discovered that the outer covers of the pontoons had torn free from the bow. The starboard side had split down the full length of the vessel releasing the two bladders. On the port side, the forward bladder had deflated but remained attached to the hull. The lower starboard boltrope had slid out of its track and a 6 metre strip of the torn cover was trailing in the water behind the vessel, (see Figure 2).

Damaged pontoon attached

Pontoons removed

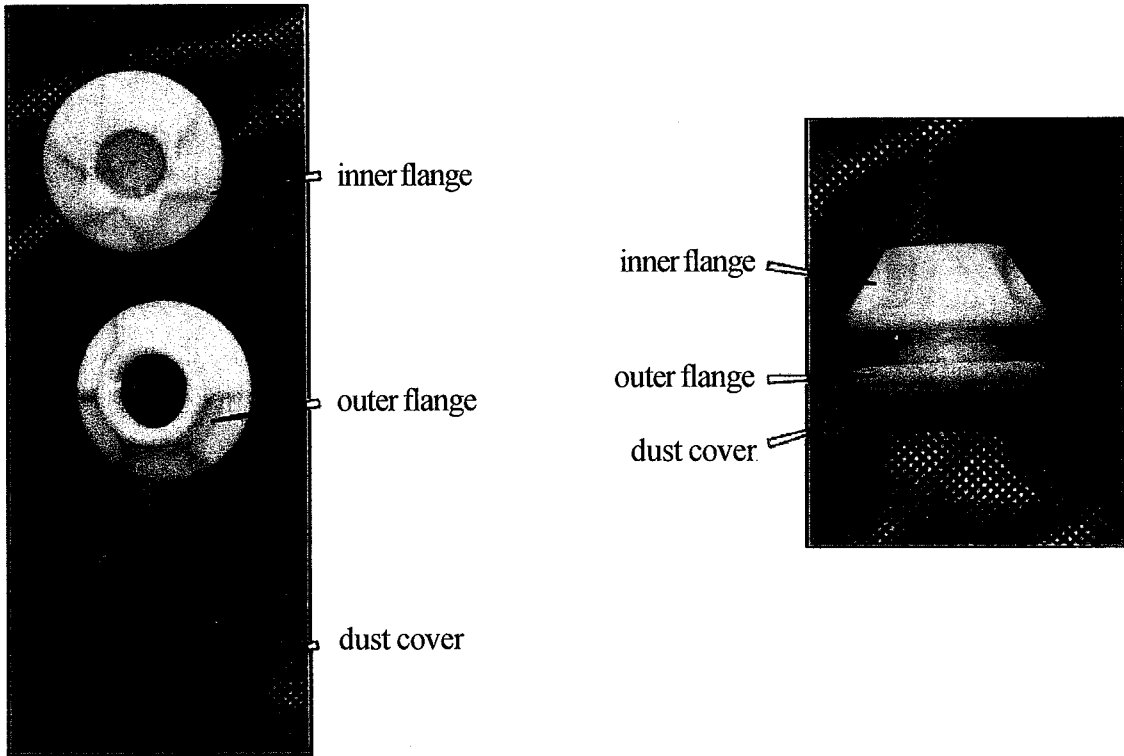
Figure 3
Pressure relief valve

- 1.3.4 On 30 March 1998, the outer covers were removed and pressure relief valves fitted to the bladders by members of the coastguard using instructions provided by Naiad, who also supplied the valves. The fitting involved gluing a reinforced patch with a precut hole on to the bladder and cutting a similar size hole in the bladder. The inner flange of the valve was then inserted through the hole and the outer flange was screwed on to form a seal between the two flanges and the rubber. A dust cover was then fitted, (see Figure 3).

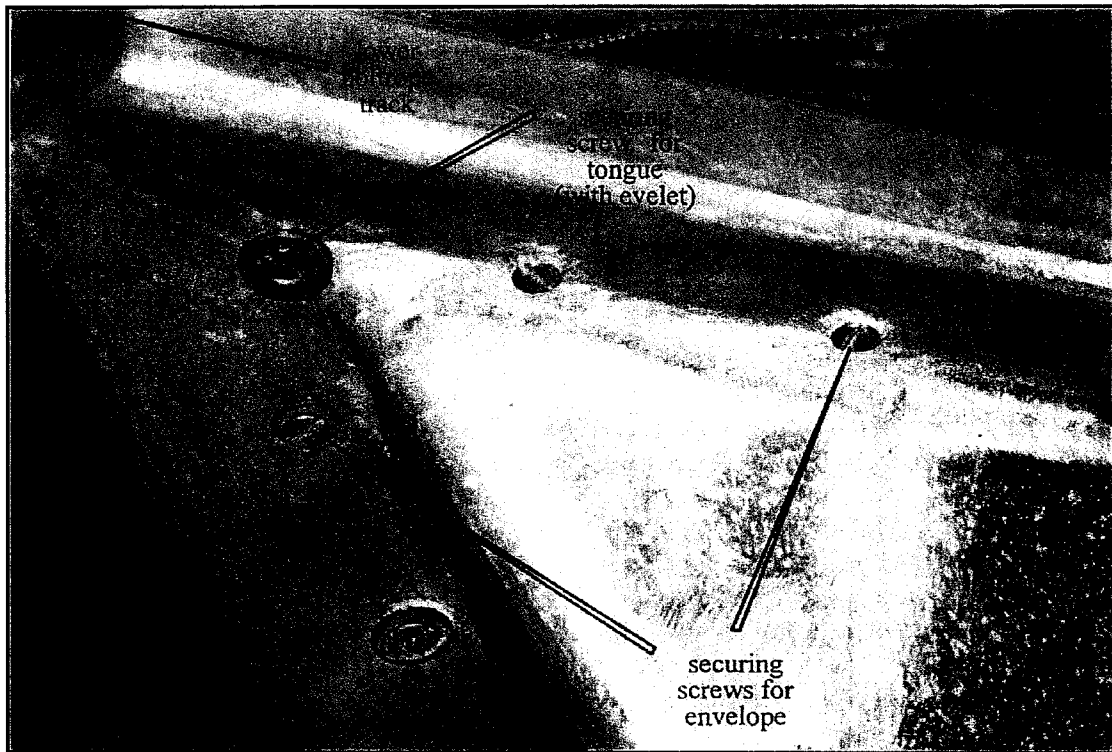
- 1.4.2 At the bow, the tongue had torn off its securing screw leaving the eyelet still attached by the screw to the bow. The tear in the tongue was from port to starboard. The 4 eyelets securing the envelope had pulled out without tearing the fabric and all the eyelets except the starboard aft one were missing; all the screws were still in place, (see Figures 6 and 7).

Figure 6
Securing arrangement at bow

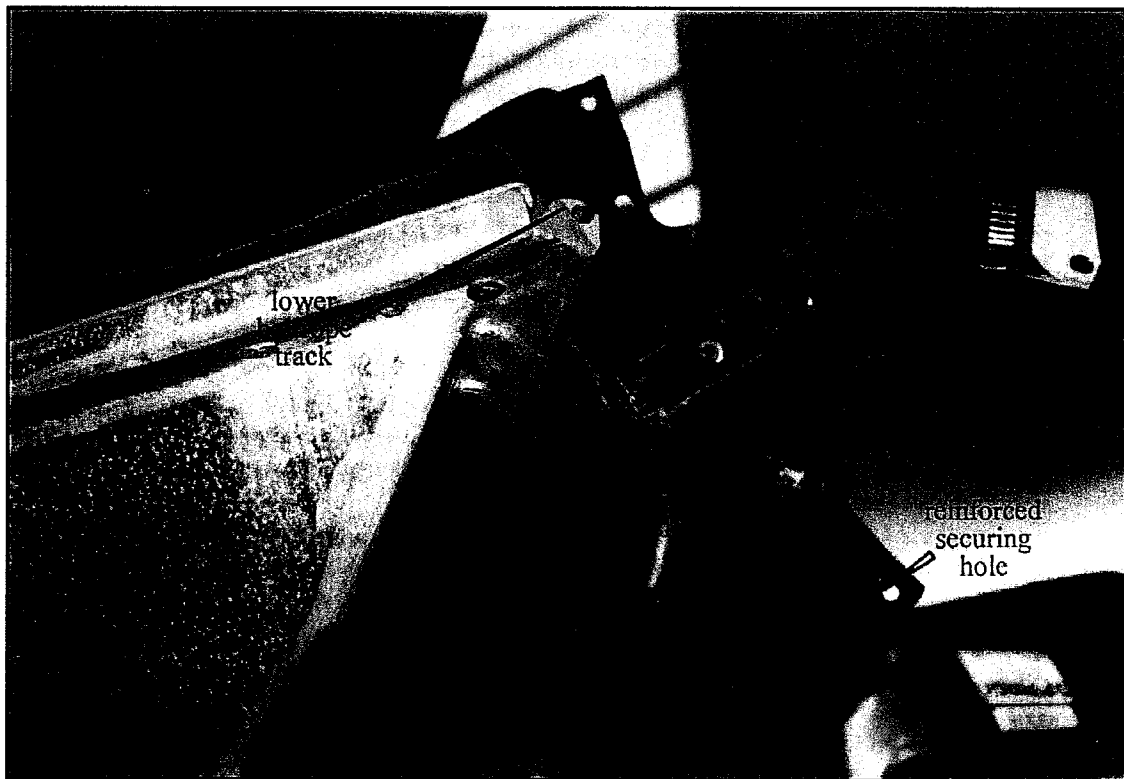
Figure 7
Torn tongue and envelope

- 2.18 With the holding power of the boltrope gone, and the failure underway, there was little to prevent the tear progressing through the rest of the outer covers. The eyelets in the tongue and envelope had little holding effect as there were no washers between them and the securing screws.

- If the envelope is to be attached, it should be fitted with sufficient tolerance to allow movement of the pontoon, without the glued seams or securing screws of the envelope taking any strain off the boltropes. This tolerance should also allow for a situation where the pontoon becomes partially deflated. (013/99)
- When securing the tongue and/or envelope to the bow, a washer or other load bearing device, of a size compatible with each eyelet and screw head, should be fitted between the eyelet and the screw head to reduce the possibility of the eyelet failing. (014/99)

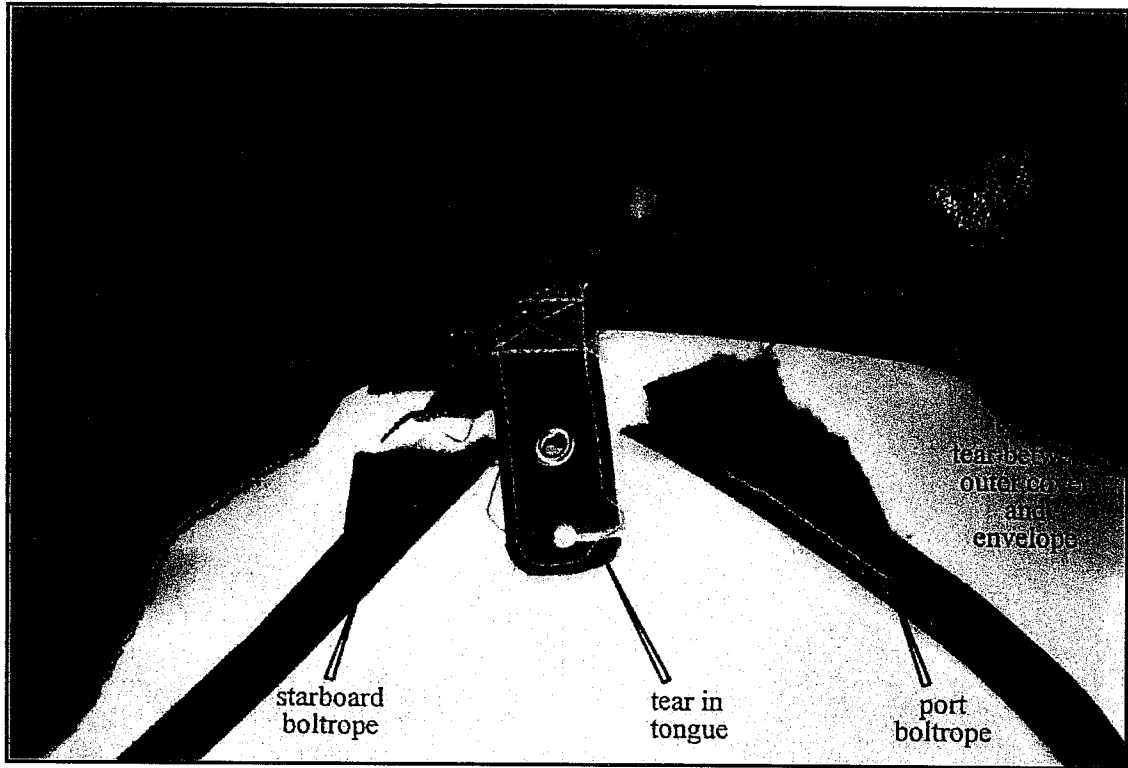
- 1.4.3 Where the envelope was glued to the outer covers, the PVC spread coat had pulled away from the base fabric for about 70 mm on each side. There was also a tear in the envelope from the middle of the U for about 130 mm toward the bow, (see Figure 8).

Figure 8
Tears at glued seams, envelope and lower boltropes

- 2.15 When the bow buried in a wave the force was mostly absorbed by the envelope. The weakest part of the envelope, the repaired eyelet on the port side, failed first followed by the glued seam between the envelope and the outer cover on the port side.

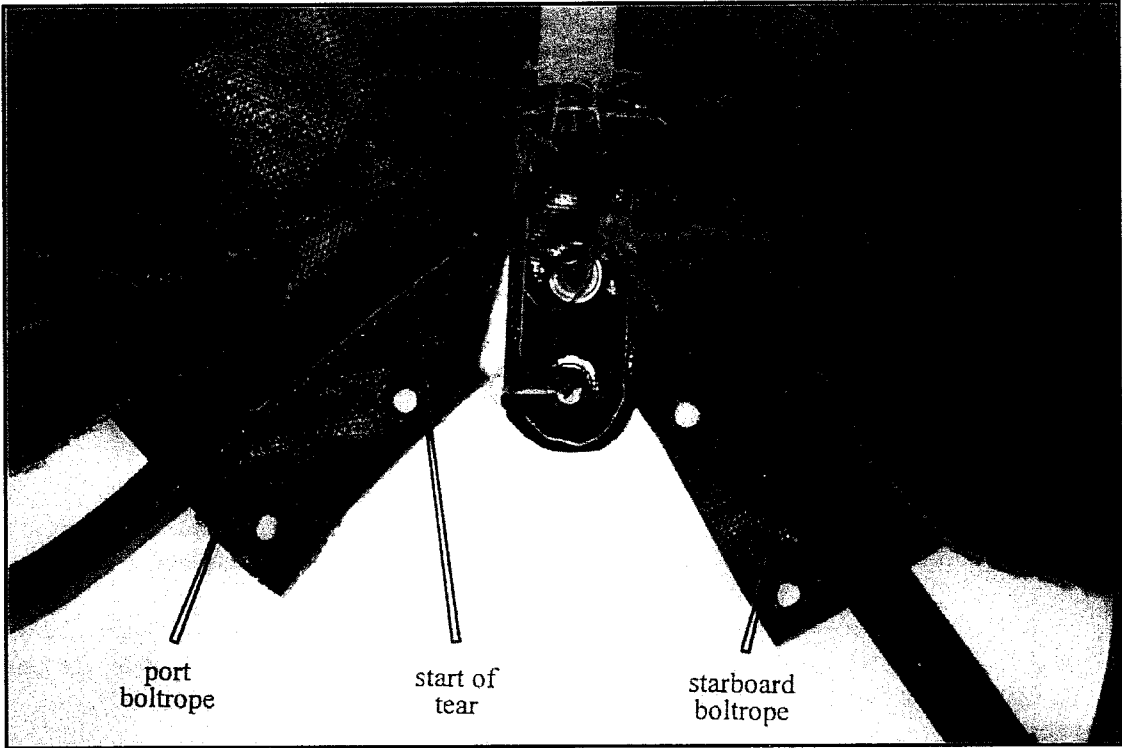
- 2.12 Because the outer cover fabric does not stretch significantly, it took only a small loss of air before the pontoons lost their tightness and sagged. Partially deflated pontoons cause greater stresses to be placed on the lower boltropes and securing arrangement, as the supporting effect of the upper section of the aluminium pontoon recess is lost.

Figure 11
Tears to port and starboard lower boltropes

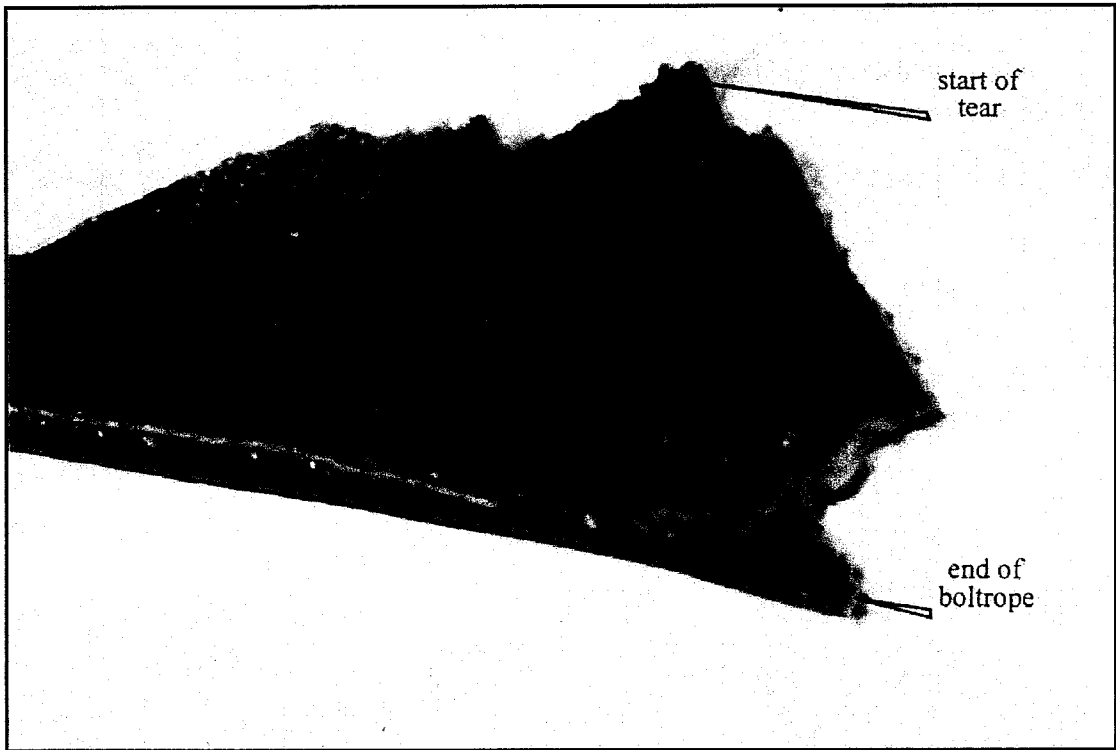
- 2.19 On the port side of the outer covers the tear stopped 800 mm from the bow. This may have been due in part to the pontoons being partially deflated before *Rescue 1* buried its bow in to the wave. At some time during the failure sequence, the pressure relief valve released from the port forward bladder due to its incorrect fitting, this caused complete deflation of that bladder. This probably prevented the tear tracking the whole length of the outer cover on the port side.

Figure 12
End of port boltrope showing start of tear
