Report 98-218

fishing vessel *Meridian 1*

grounding

15 December 1998

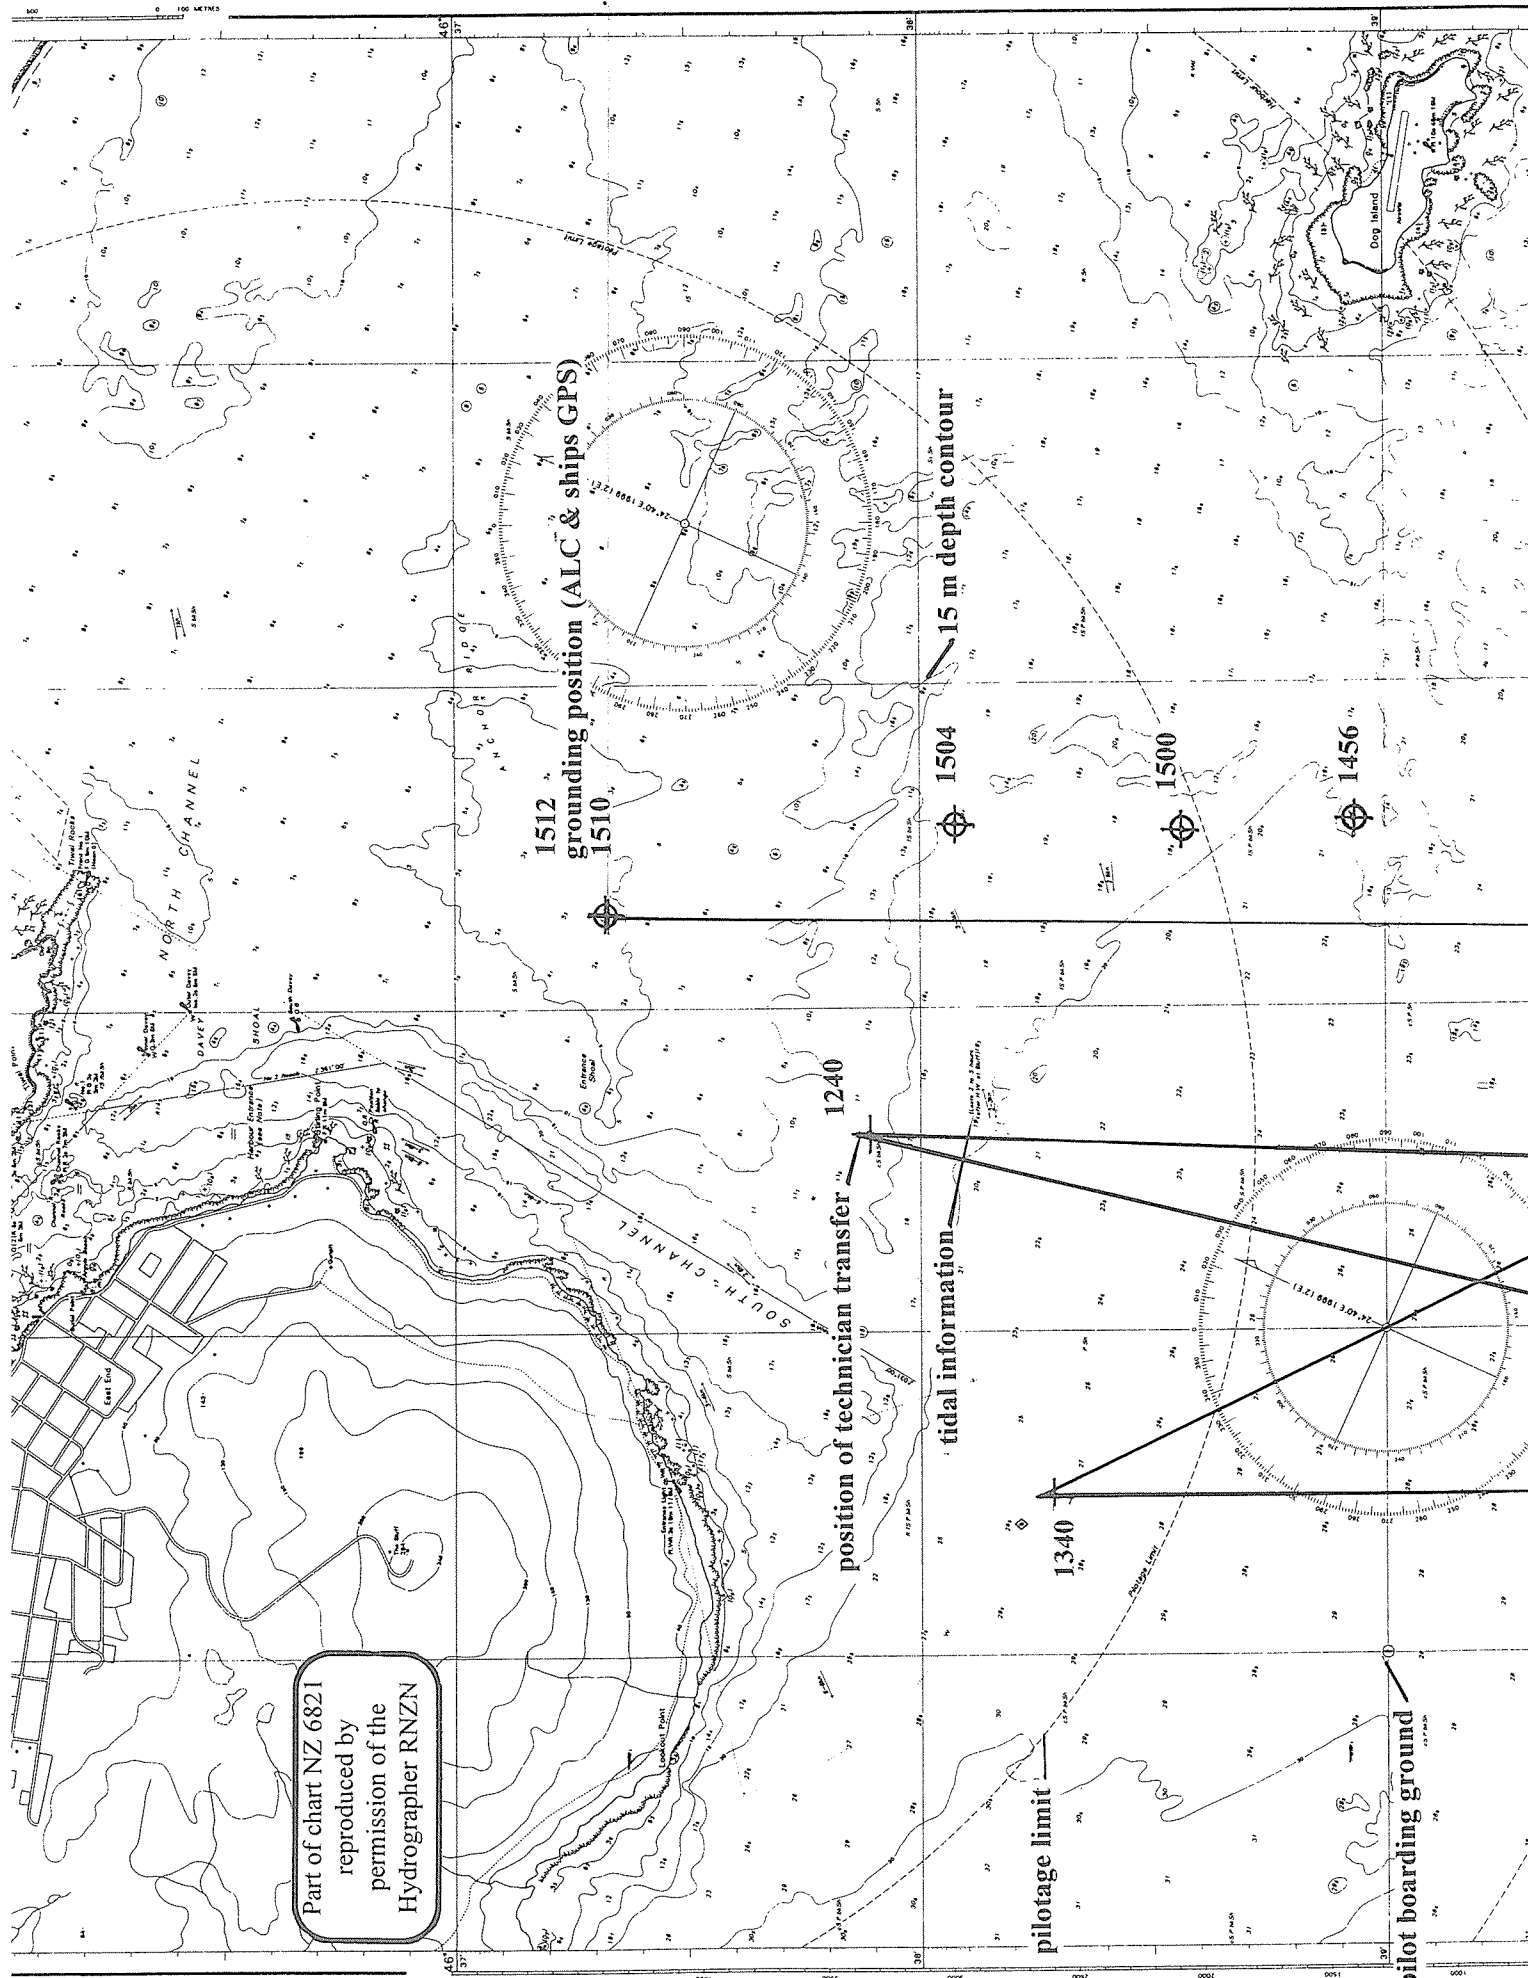
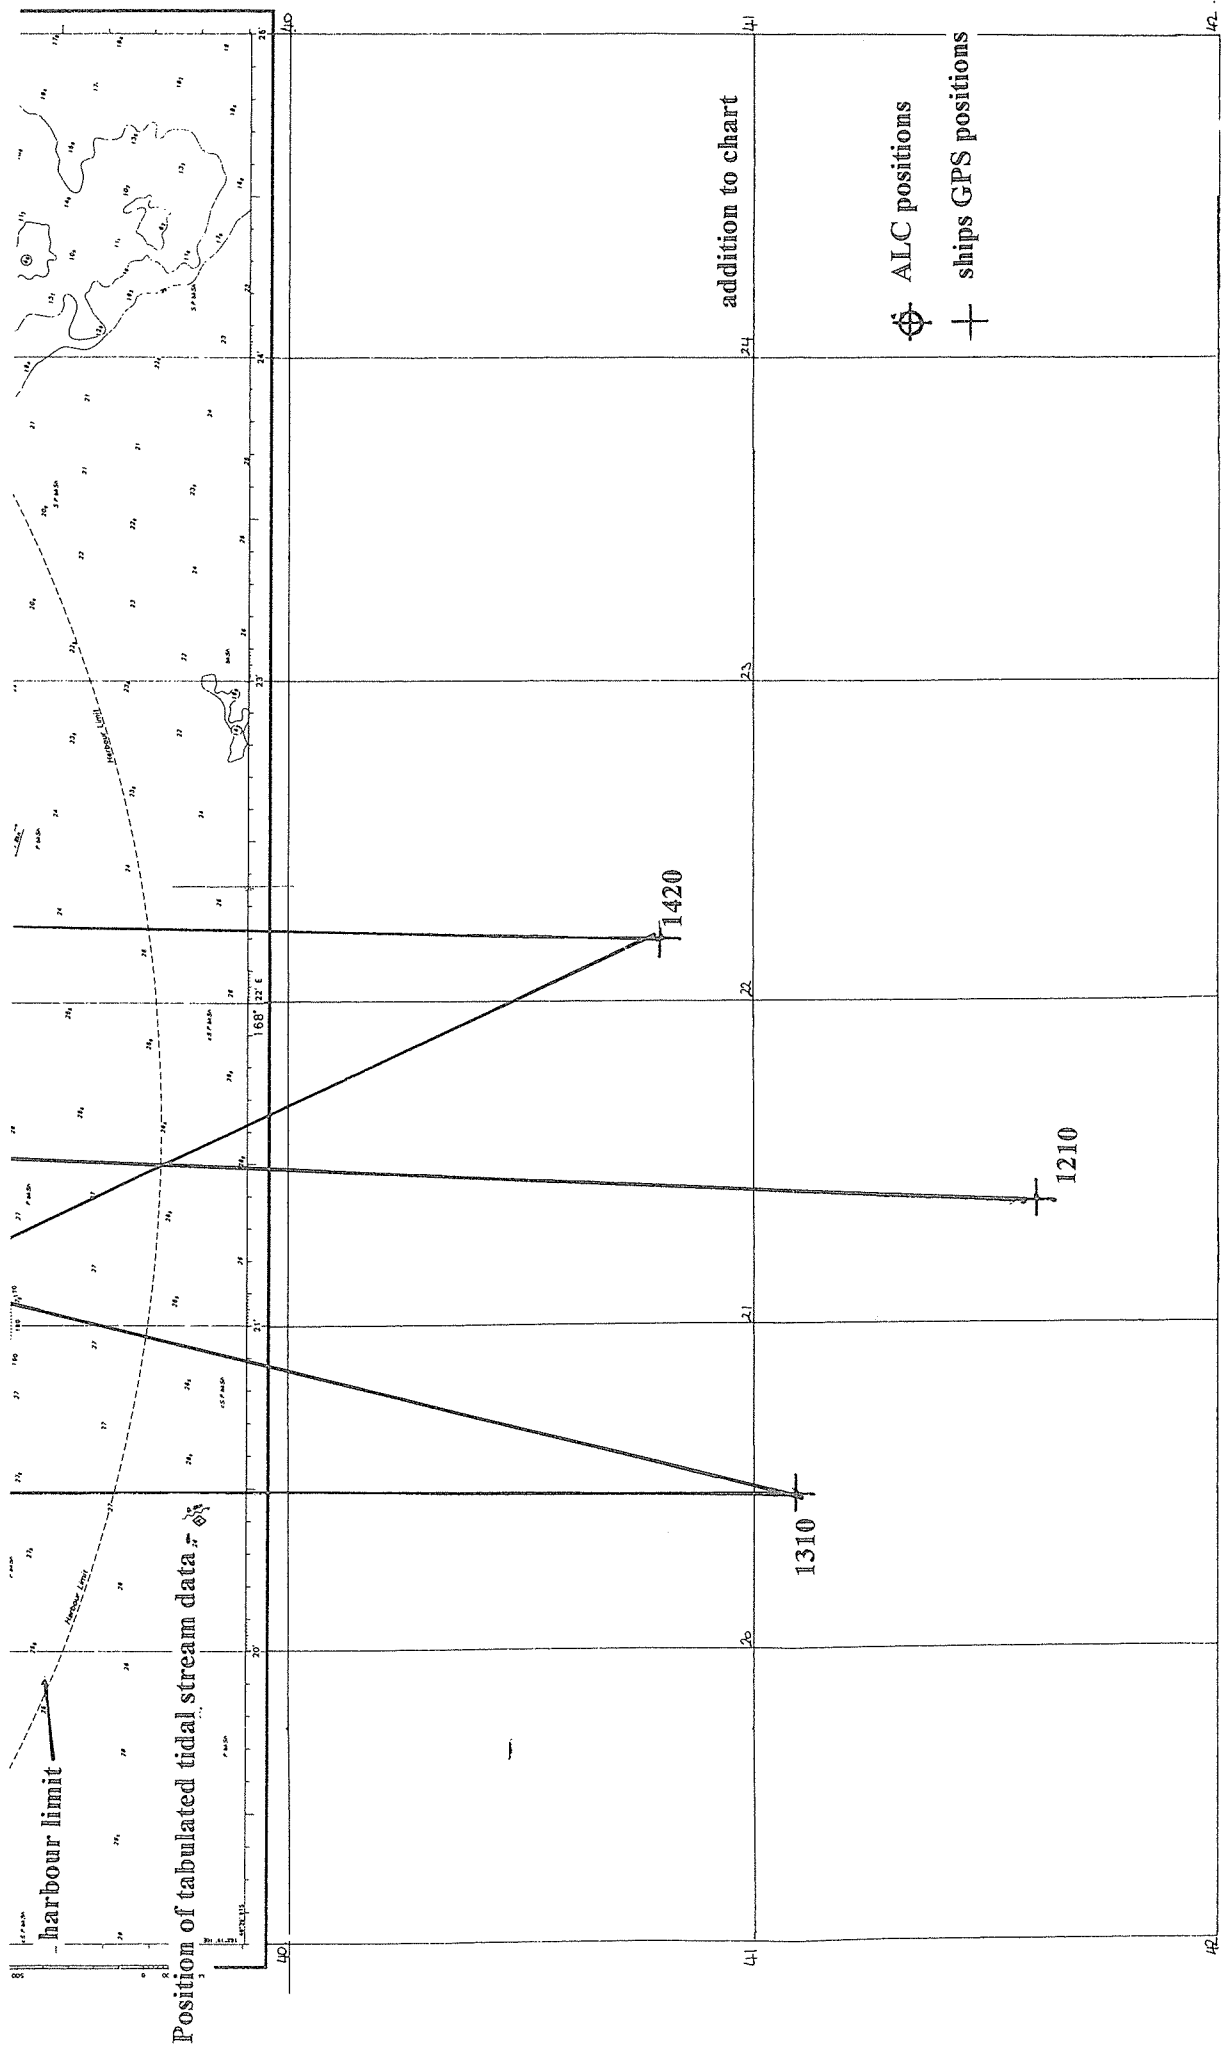
Figure 1
 Part of chart NZ 6821, showing the plain paper addition and key information
 (scaled down to 40% of original size)

- 1.1.6 The duty pilot advised *Meridian 1* that the pilot launch would first transfer a pilot to the inbound bulk carrier *Kite Arrow* at about 1230 then proceed to *Meridian 1* to transfer the technician. Meanwhile, he instructed *Meridian 1* not to proceed further north than the pilotage limit and to preferably stay outside the harbour limit. These limits were marked on chart NZ 6821 at a radius of 2 and 3 miles respectively, from Stirling Point light, (see Figure 1).

- 1.1.10 At about 1220, after transferring a pilot to the *Kite Arrow*, the pilot launch skipper called *Meridian 1* on VHF radio and instructed the master to proceed north of the pilotage limit to rendezvous and transfer the technician. The transfer took place at 1240 in a position about one mile north of the pilotage limit and to the east of the South Channel leads, (see Figure 1).

1512
grounding position (ALC & ships GPS)
1510

1240
position of technician transfer

1504
15 m depth contour

1340
pilottage limit

1456
pilot boarding ground

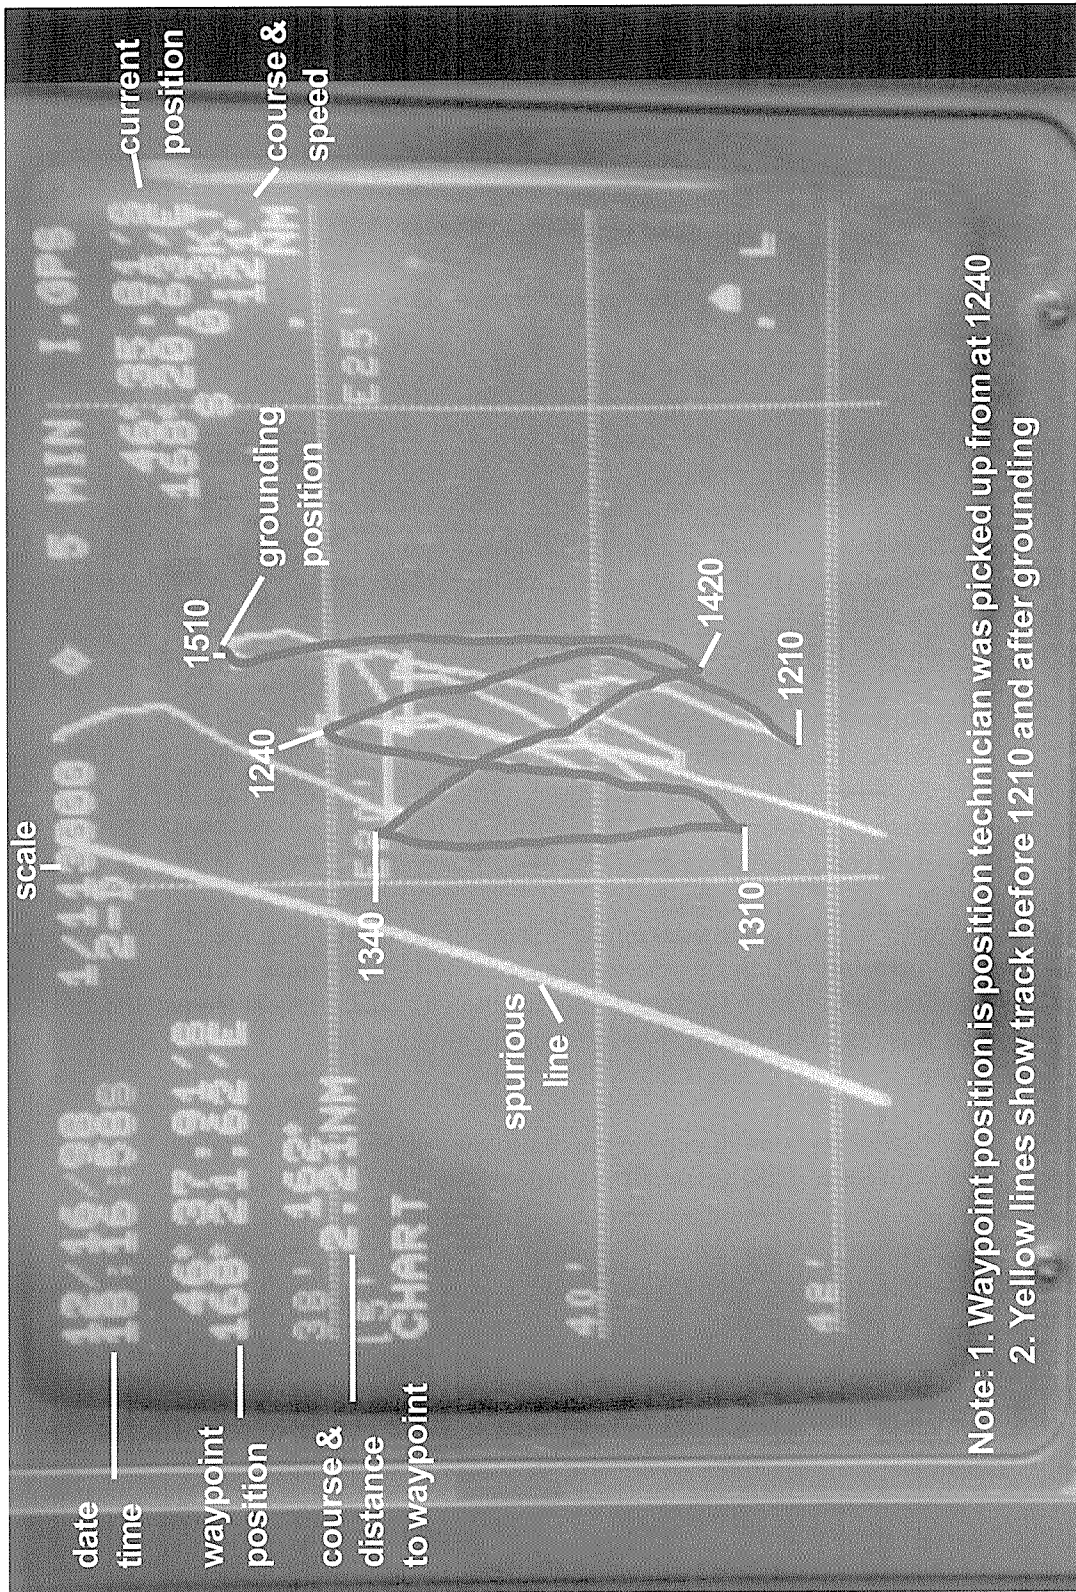
Figure 2
 Photograph of GP 1250 GPS plotter screen showing track of Meridian 1 between 1210 and grounding position

- 1.3.10 The track of the vessel, as shown on the screen of the GPS plotter in use during this period, broadly coincided with the courses and distances recorded in the deck log book and with those plotted on the chart. The positions derived from the ALC during tests conducted by the technician also broadly coincided with those positions, (see Figure 2).
