Report 98-219

cargo vessel *Gao Cheng*

near grounding and collision between 2 tugs and a beacon

28 December 1998

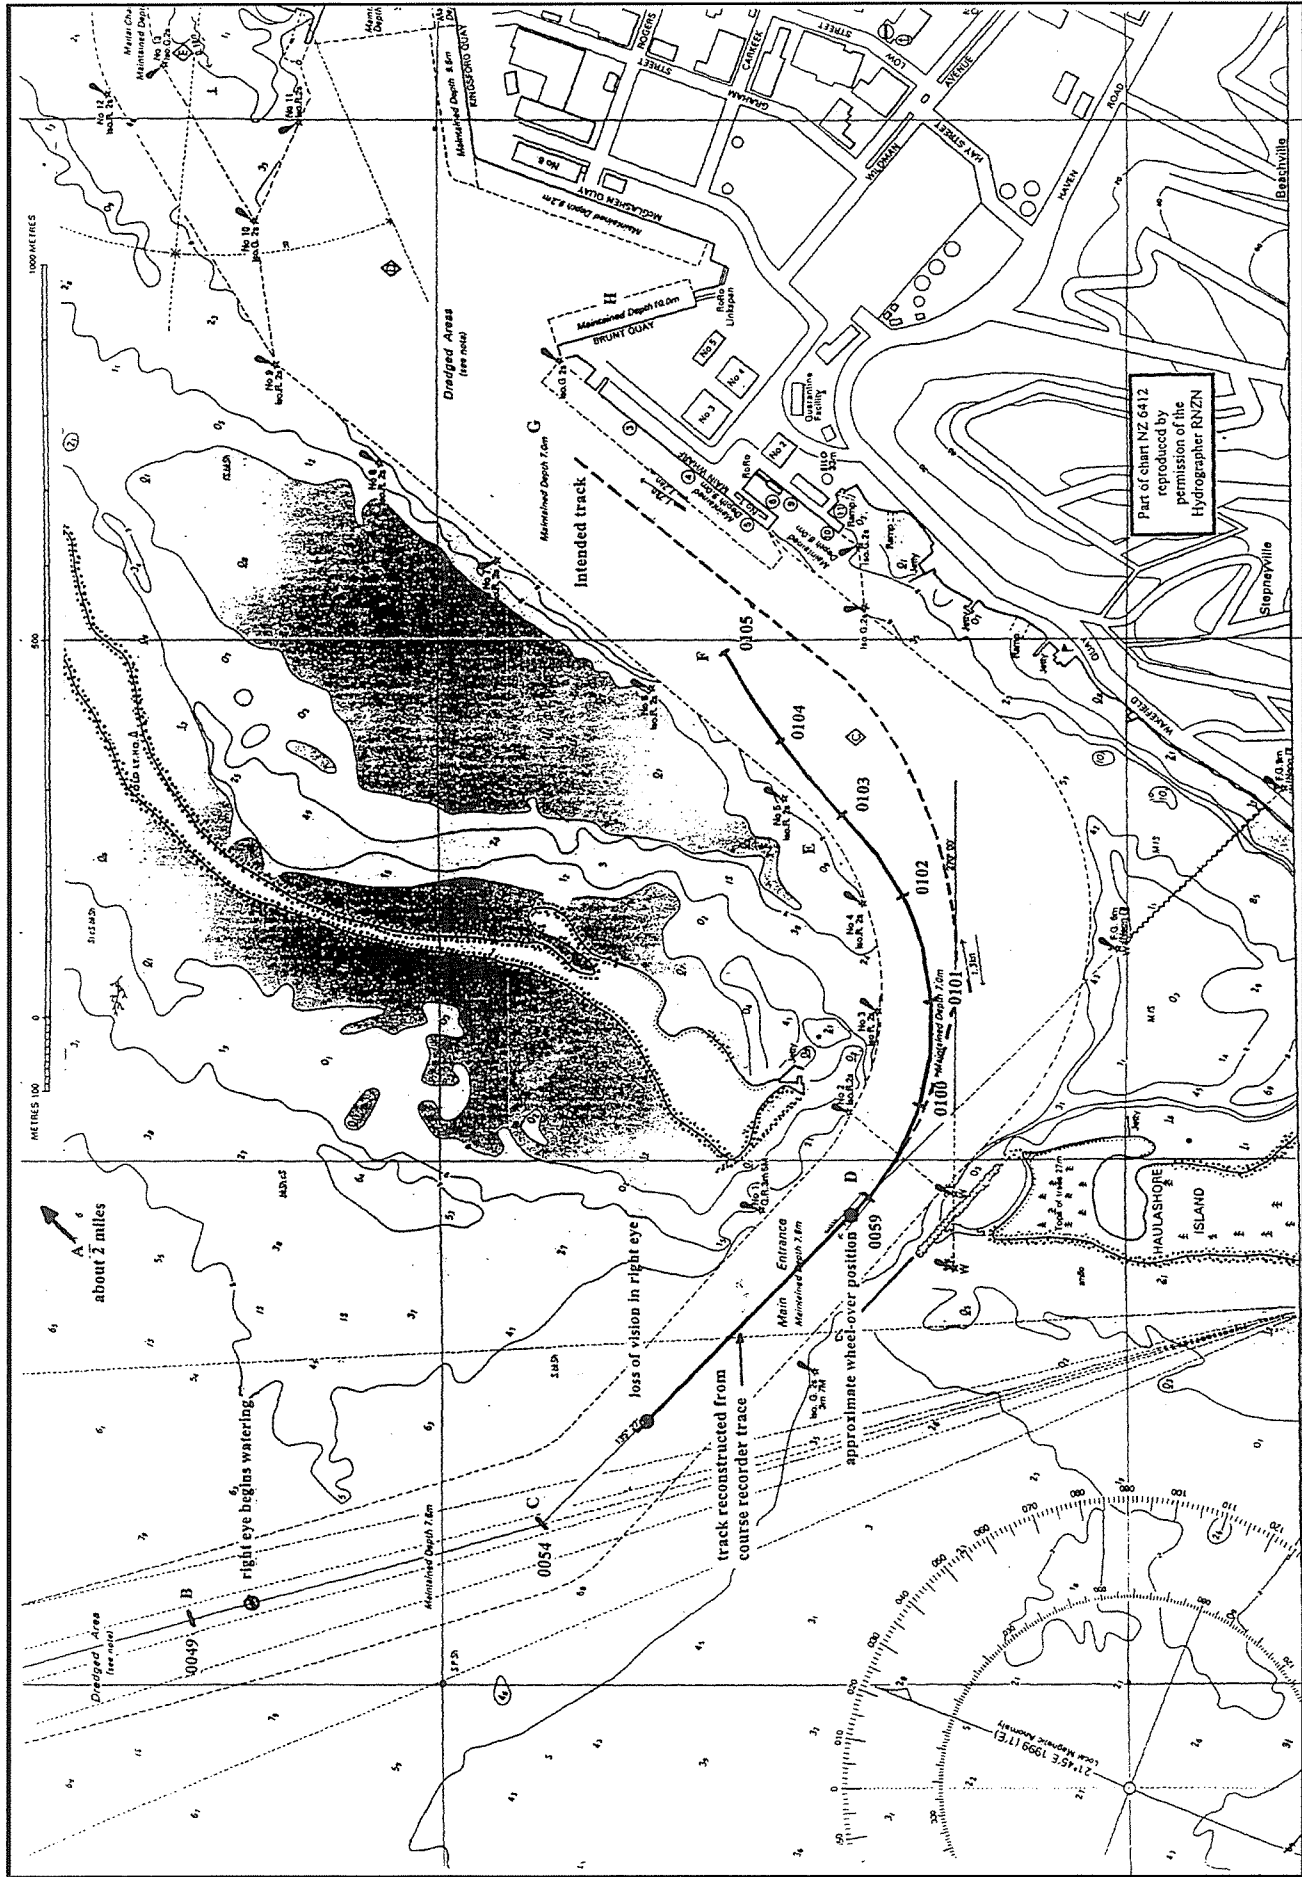
Figure 1
Part of Chart NZ 6412 showing relevant information

- 1.1.12 The pilot later stated that when the *Gao Cheng* was about 400 metres from the turn onto the inner leading lights his right eye began to water profusely. He was not overly concerned as he had experienced this problem on previous occasions. He continued with the pilotage and turned the vessel onto the inner leading lights, steady on a course of 135 degrees true.
(See Figure 1.)

- 2.1.8 The positions marked on both Figures 1 and 4 represent the following (times and courses have been corrected for the errors mentioned above).

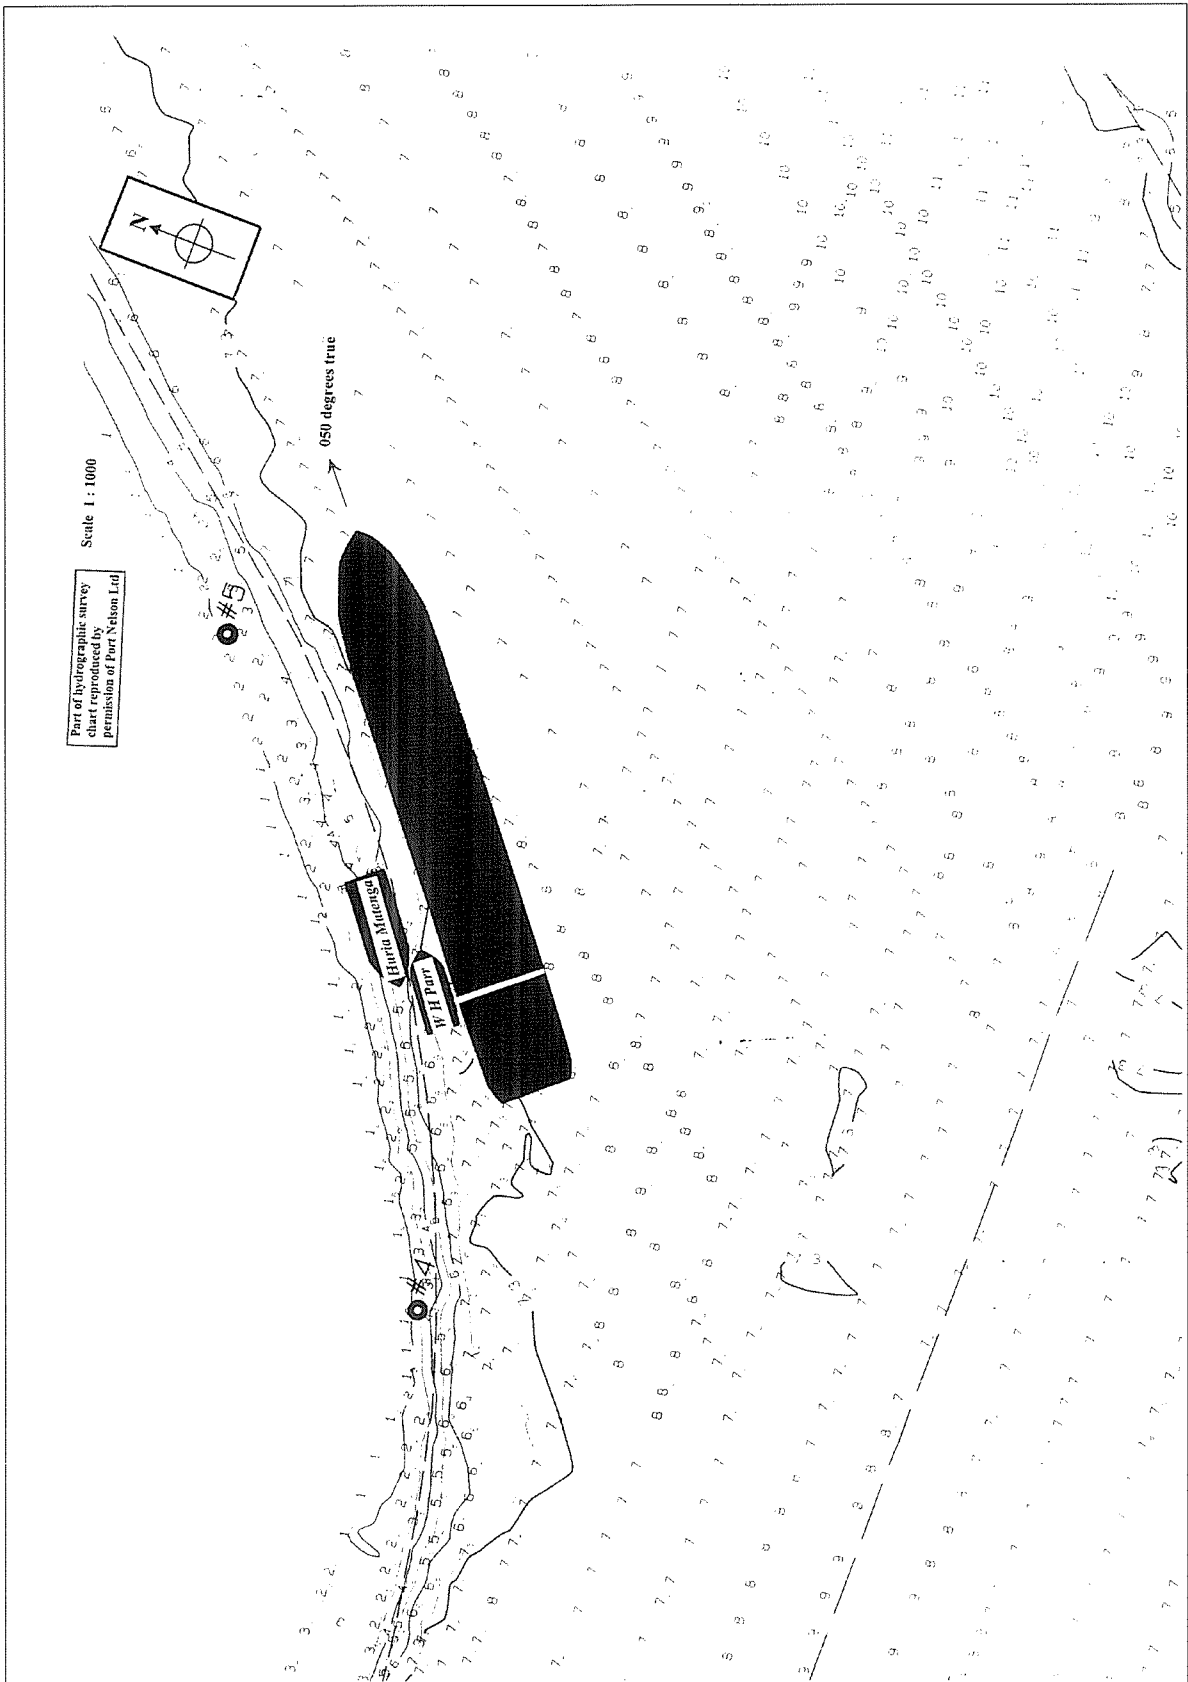
Figure 2
Chartlet showing position of vessels at time of incident

- 1.1.21 When the *Huria Matenga* was about three quarters through the turn its stern swung outside the channel midway between numbers 4 and 5 beacons and grounded. The skipper assumed that only the skeg of the tug had touched bottom, as the drive units appeared to be still functioning normally.

- 1.1.22 The skipper of the *Huria Matenga* decided not to attempt to refloat his tug immediately because the *Gao Cheng* was approaching at 4 knots, and if the tug had come free it could have got in the path of the ship. Instead, he swung the bow of the tug to starboard, to lie parallel with the channel giving the *Gao Cheng* and *W H Parr* as much room as possible in which to pass. He then de-clutched the engines (see Figure 2).

- 1.1.28 At about 0100 the *W H Parr* collided with the *Huria Matenga*, and the *Huria Matenga* was pushed sideways for about 100 m and over the top of number 5 spar light beacon. The skipper of the *Huria Matenga* again de-clutched the engines.

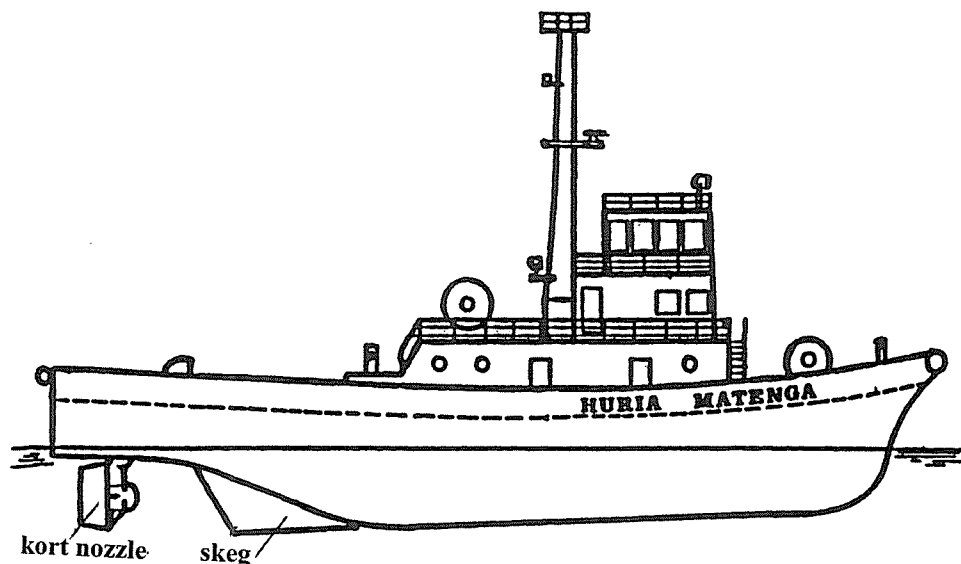
Figure 3
Huria Matenga

- 1.2.1 After the incident all vessels were checked for damage. The *Gao Cheng* had minor scraping and loss of paint on the port side aft. Both tugs had minor denting to the bulwarks and slight damage to the tyre fendering.
- 1.2.2 The *Huria Matenga* was inspected by divers the next day but the only underwater damage found was loss of paint on the skeg. (See Figure 3.)
- 1.2.3 Number 5 navigational beacon was sheered off below the waterline.

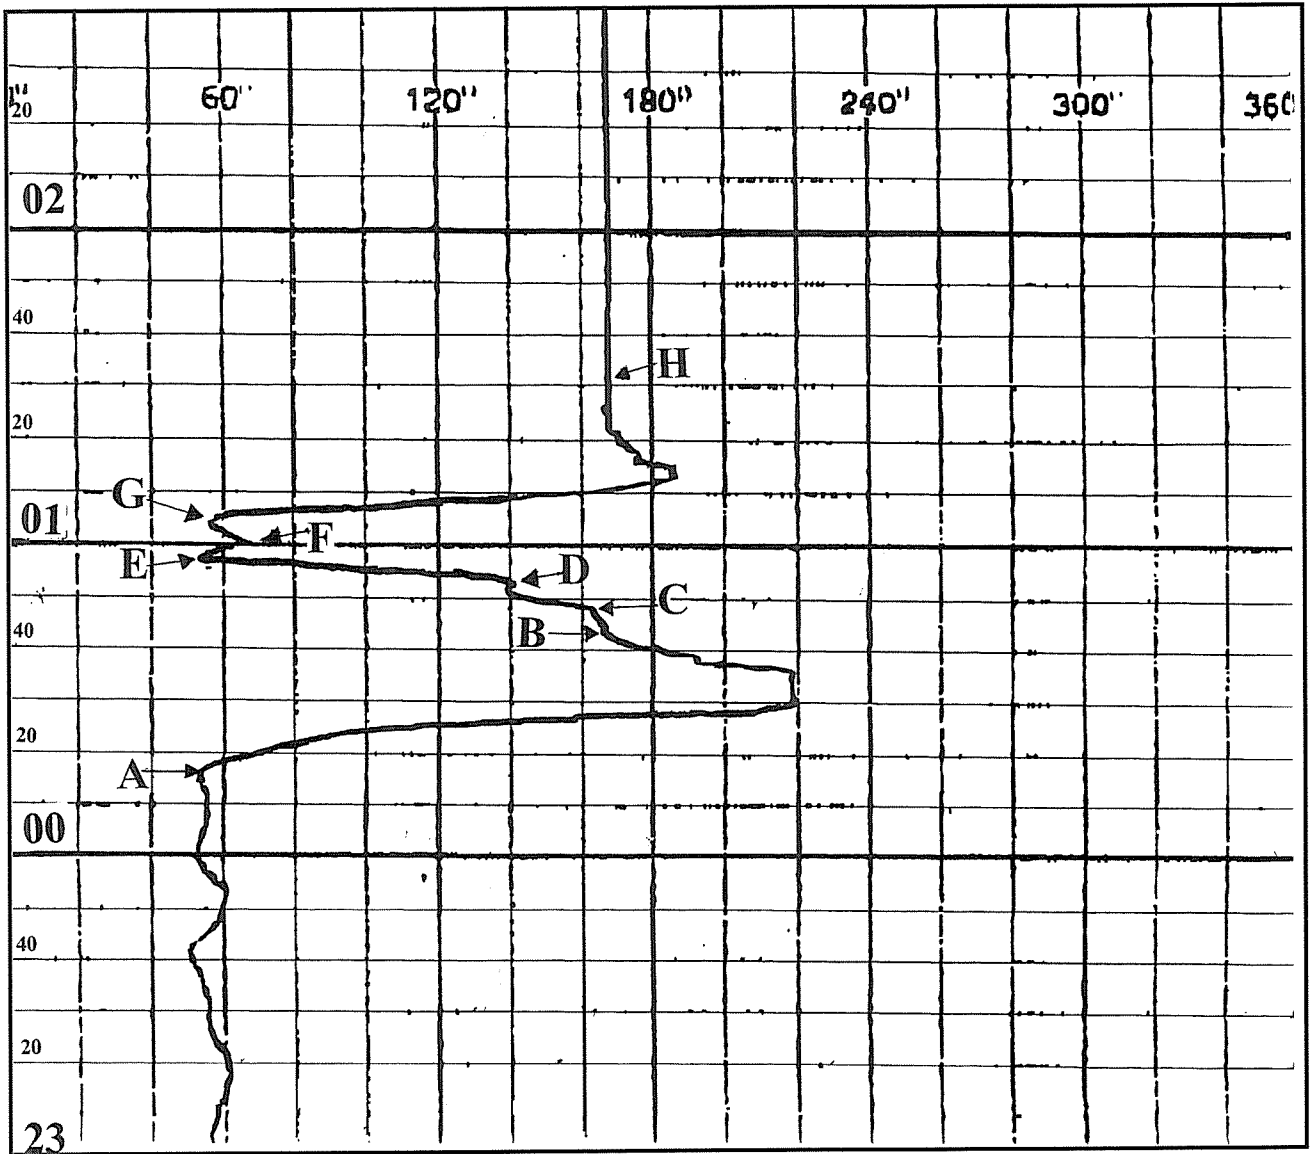
Figure 4
Course recorder trace (times refer to NZDT)

- 2.1.6 When the anchor was aweigh at 0022, the pilot ordered half ahead on the engines and commenced a turn to starboard. This equates to position A on the trace, timed at 0017. From this, it appeared that the trace was set up 5 minutes slow of NZDT.

- 2.1.7 Brunt Quay lies in a direction of 344/164 degrees true. When the *Gao Cheng* was alongside Brunt Quay the course recorder trace read 168 degrees true. It was therefore assumed that the trace was set up reading 4 degrees high.
