Report 99-004

Cessna 206

ZK-EKJ

impact with mountainous terrain

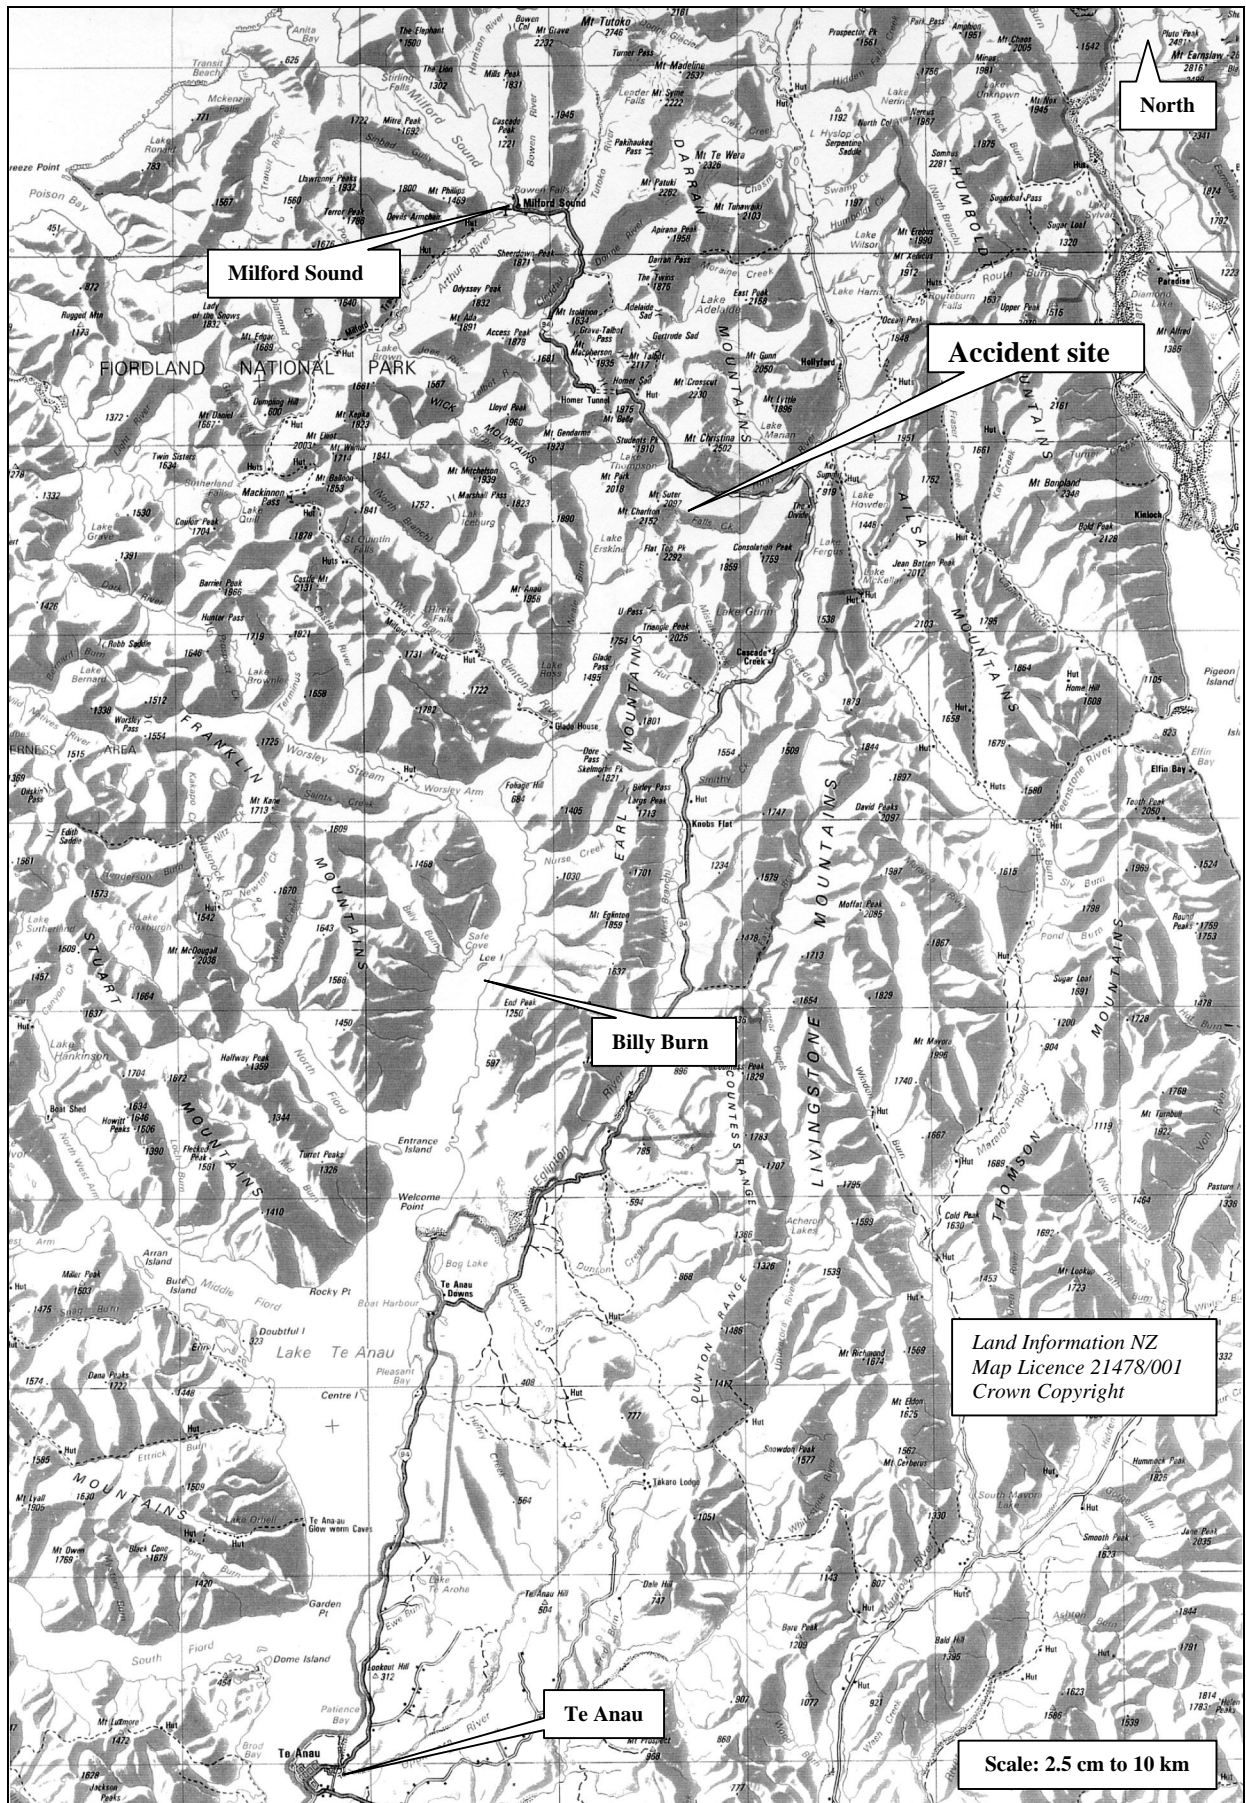
Figure 1
General area and accident site chart

- 1.1.7 From Billy Burn the direct route at about 6000 feet amsl was along the Neale Burn valley on the western side of the Earl Mountain Range to near Lake Erskine. (See figure 1.) The pilot of another aircraft who was in the area at about the same time crossed the Earl Mountains south of Lake Erskine. He reported that there was some cloud along the tops of the Earl Mountains and that the visibility was good. He said there was some turbulence and downdraughts in the area, especially below about 8000 feet amsl.

- 1.1.10 The accident occurred on 18 April 1999 at about 1538 hours. The accident site was on the south face of a craggy vertical mountain ridge, 600 metres east of Mount Suter, 17 km south of Milford Sound, at an elevation of approximately 6340 feet amsl, in Fiordland National Park. Latitude: 44° 49.6' south, Longitude: 168° 01.5' east.
