**Report 99-006**

**Hughes 269C**

**ZK-HYE**

**wire strike**

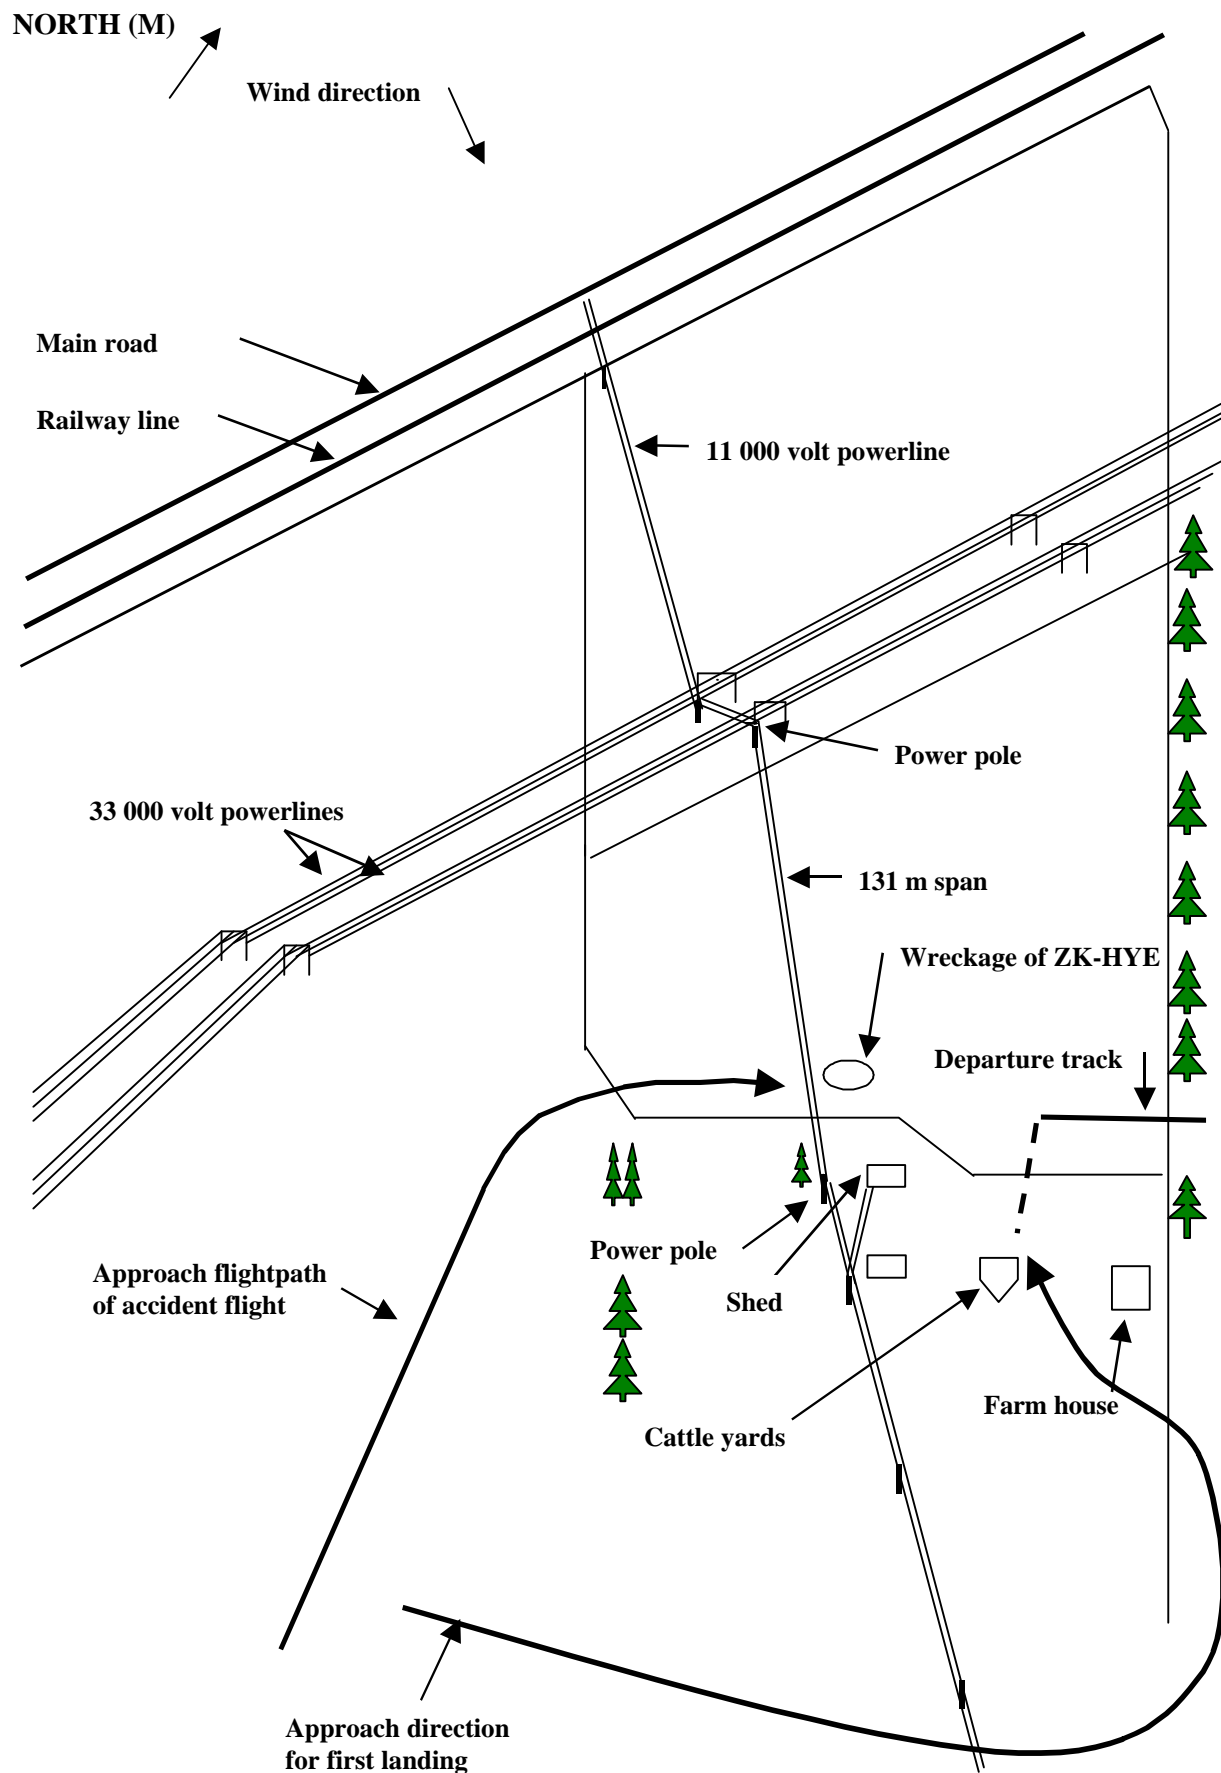
**Figure 1**  
**Accident Site**  
 (Not to Scale)

- 2.10 The flightpath taken by the pilot when he approached the paddock from the south, meant that the power pole on the eastern end of the 131 m span was obscured by the trees near the implement shed. The pole at the western end of the span was some distance away and would have blended in with the poles supporting the 33 000 volt power lines in the next paddock.

- 2.12 The eastern pole of the 131 m span would have become visible as ZK-HYE moved abeam of the shrouding tree, about 25 m before the wires. However, the pilot's view of the pole may have continued to be obscured by the passengers seated to his right. Because the pilot was not able to clearly see either pole he was deprived of a reminder of the presence of the wires across his view.
