Report 99-103

middle ferry shunt and siding shunt

collision

Wellington ferry terminal

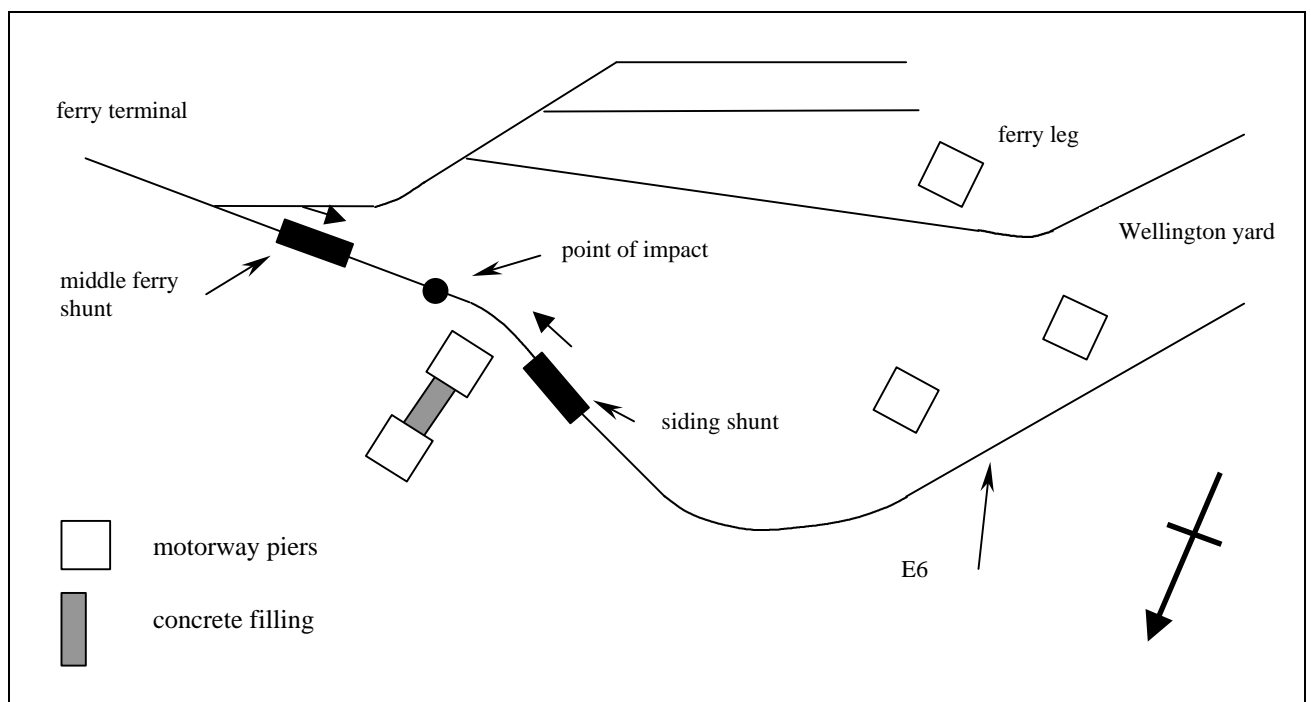
Figure 1
Site plan of the collision area (not to scale)

- 1.5.1 The ferry leg road and road E6 ran parallel except where they parted to negotiate the motorway piers.
- 1.5.2 The curvature of road E6 and the restrictive effect of the recently filled columns under the motorway bridge restricted the available line of sight to 40 m approaching the point of collision.

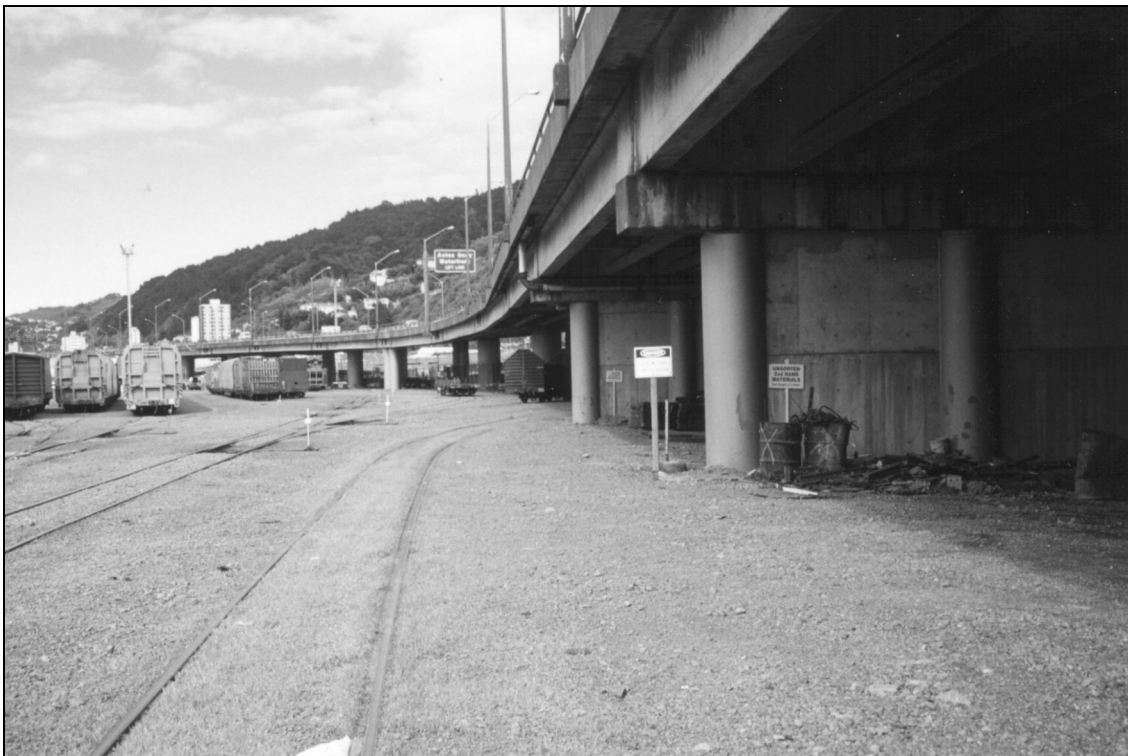
Figure 2
The view from the middle ferry shunt 40 m before the point of impact

- 1.2.10 Once the handbrake was in the correct position the senior shunter climbed on to it, and then instructed his LE to go “down the yard”.
- 1.2.11 The senior shunter was facing the direction of travel as the wagon was propelled. He estimated his shunt had only moved about 45 m when he noticed the siding shunt locomotive appear from behind the motorway pier, some 40 m ahead.

- 2.7 The maximum permitted speed of 25 km/h was not appropriate for road E6 due to the restricted line of sight in the vicinity of the motorway piers. With both trains travelling at 15 km/h, even if both shunters had seen the opposing shunt as soon as it came into view, and reacted immediately, making allowances for normal human reaction times there would still have been a collision, although less severe. For each shunt to stop when travelling at 15 km/h required at least 25 m from sighting an obstruction allowing for normal reaction time. In the event the middle ferry shunt responded immediately but still had little braking time. The siding shunt did not respond until the last moment due to the shunter having been looking to his right at where the TXO was standing, and therefore there was no effective braking.

- 2.8 If road E6 is to continue to be used as access between Wellington yard and the ferry terminal a speed restriction is considered desirable and a safety recommendation has been made in this regard.

Tranz Rail has erected signs that say “Extreme Care – Restricted Visibility”. We believe a warning of the hazard is more appropriate than a maximum speed to an RCO who is controlling a movement from a moving vehicle.
