**Report 99-108**  
**north yard shunt and No. 1 shunt**  
**collision**  
**Middleton yard, near Christchurch**  
**18 May 1999**

# Rail Incident Report 99-108

<b>Train type and number:</b>	north yard shunt No. 1 shunt
<b>Date and time:</b>	18 May 1999, approximately 1215 hours
<b>Location:</b>	Middleton yard, near Christchurch
<b>Type of occurrence:</b>	collision
<b>Persons on board:</b>	crew:           north yard shunt:    2 No. 1 shunt:           1
<b>Injuries:</b>	nil
<b>Damage:</b>	minor
<b>Operator:</b>	Tranz Rail Limited (Tranz Rail)
<b>Investigator-in-Charge:</b>	R E Howe

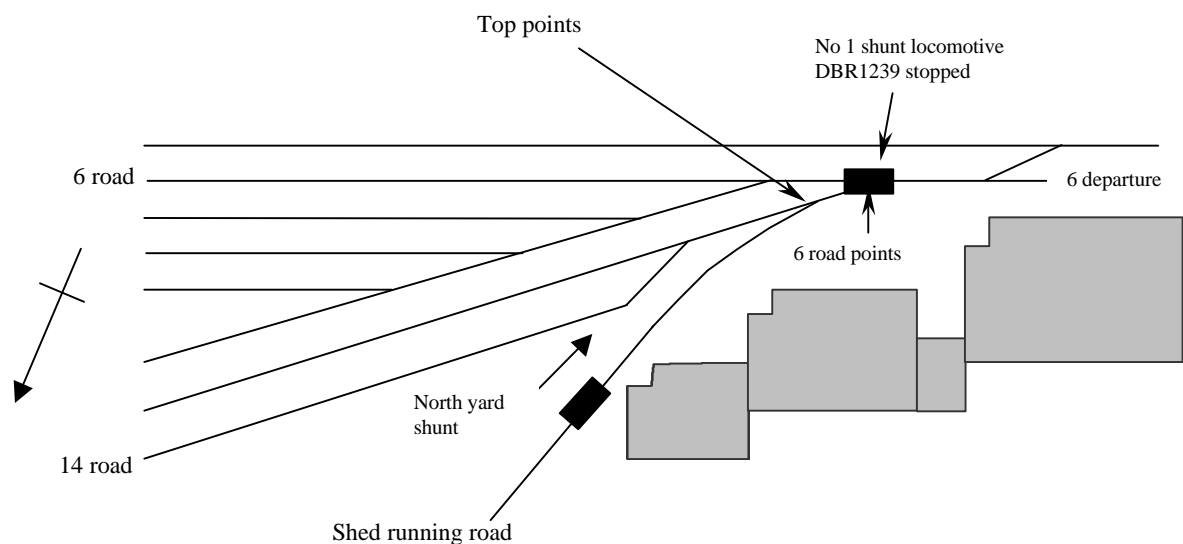
**Figure 1**  
**Locality plan (not to scale)**

- 1.1.4 LE2 left the office and changed over with the incoming LE1 on the locomotive once it had come to a stop.
- 1.1.5 At about the same time (1215 hours), the north yard shunt was approaching the top points, which was the turnout to 14 road in the freight terminal. The RCO was unaware that DBR1239 was standing across 6 road points over which his shunt had to run to gain access to 14 road.

- 2.4 No. 6 points was the next turnout beyond the top points and by standing where it was DBR1239 effectively occupied the headroom required by the north yard shunt once it cleared the top points turnout.

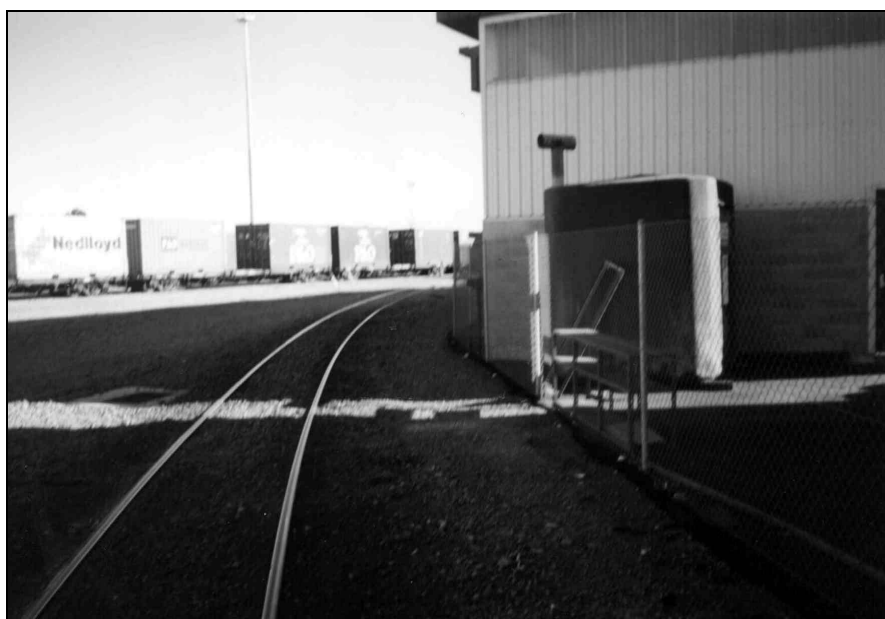
**Figure 2**

- 1.2.1 No. 6 road was a straight through road, which continued beyond 6 road points to become 6 departure.
- 1.2.2 The shed running road connected the freight terminal shelter roads to the yard. The exit from the freight terminal was around a right-hand curve where visibility was restricted by adjacent buildings. Figure 2 shows the view from the position where DBR1239 first became visible to the RCO on the inside of the curve.

**The view from where No. 1 shunt locomotive was first visible to the RCO of the north yard shunt**

- 1.3.3 As the shed running road curved to the right in the direction of travel the position taken up by the RCO on the inside of the curve ensured that he had line of sight as the shunt rounded the curve towards the top points. The maximum permitted speed for the movement was 25 km/h, although there was a requirement for speed to be controlled such that the movement could be stopped in the clear distance ahead.

- 2.8 The position taken up by the RCO on the front of the first wagon behind the locomotive met Tranz Rail's requirements. However, a combination of this position, the shunt speed and the view available meant the RCO was unable to stop the shunt before a collision occurred.

- 3.6 The OC not having an ASP radio with him when he went to pilot No. 1 shunt did not, under the circumstances, contribute to the collision.
- 3.7 The position taken up by the RCO meant that the line of sight on the shed running road approaching the curve into the Middleton yard was marginal for the maximum permissible speed of 25 km/h.

**7. There are restricted view lines when travelling from the Freight Centre back to the Marshalling yard due to buildings in the area.** Because of these restricted view lines all precautions must be taken to ensure that the shunt consist can stop within the view line ahead.  
The Service Co-Ordinators [previously OCs] before permitting any movements within this area MUST come to a clear understanding with the Rail Operator as to what movements are going to take place, and during this time under no circumstances are wagons or locomotives to stop foul of any roads.
