## **Report 99-114**

**Train 225**

**derailment**

**near Levin**

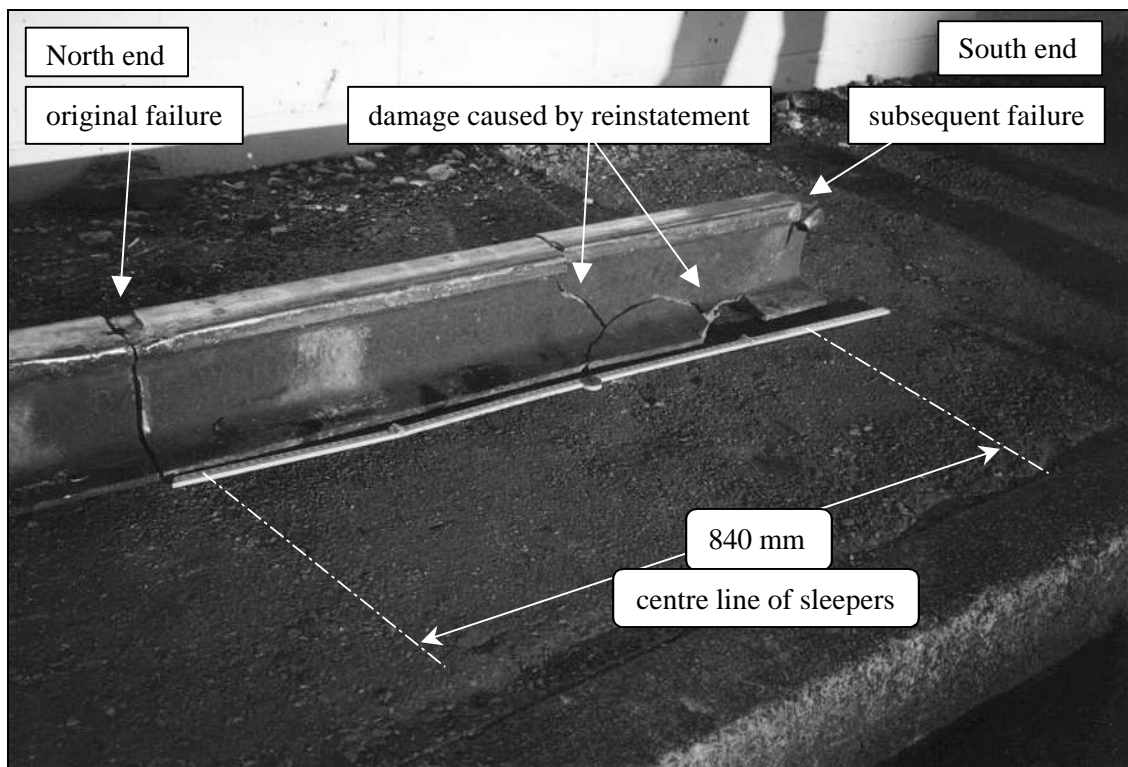
**Figure 1**  
**The length of broken-out rail section**

- 1.3.1 Figure 1 shows the general appearance of the broken rail reconstructed as found. The head of the rail at the original failure showed evidence of having been fractured for some time while the break in the web and foot of the rail was fresh. The fracture in the rail evident between the 2 failures occurred while trains were being piloted over the break after the ganger had reinserted the broken section of rail.
- 1.3.2 Figure 2 shows an end view of the rail section at the original failure. A 7 mm deep segment of the rail head had broken out adjacent to the fault on the south side revealing a horizontal layered surface. There was a 10 mm loss in depth in the rail head resulting in lateral metal flow either side of the rail giving a 7 mm lip on the outside of the rail and 3 mm on the gauge side. The latter metal flow was limited to 3 mm by wear from rail traffic.

- 1.5.1 The rail in the track had been ultrasonically tested on 13 October 1997, some 20 months prior to the incident, by a contracted Australian ultrasonic testing car. On the flaw detection report for that date a fault was recorded at 93.700 km NIMT on the left, outer rail and listed as a “Transverse Defect at Engine Burn”<sup>2</sup> (see Appendix 1). The run was made with kilometrage. The fault was not sized or given a priority ranking and was not therefore referred to track staff for action. White paint marks either side of the fault were applied to the web of the rail at the time which coincided with the position of the original failure. Figure 1 shows these white paint marks either side of the original failure.

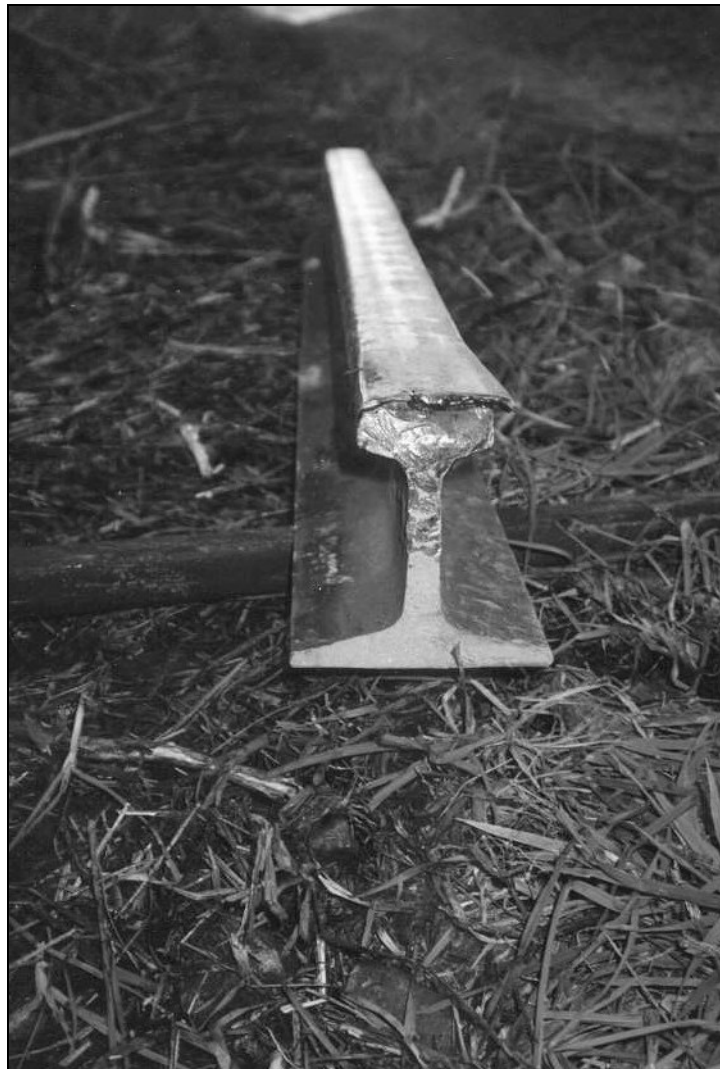
**Figure 2**  
**End view of the original failure face (north side of break)**

- 2.1.4 The 10 mm dip at the point of the initial rail failure had developed progressively over a considerable period as evidenced by the rolled lips on the rail head sides (see Figure 2). The dip had created a “hammering” effect on the track structure with the passage of rail traffic. There was evidence on the underside of the rail adjacent to the initial failure that there had been relative vertical movement between the rail and the sleeper at this point. It is likely that the plastic gauge plates between the Pandrol fastening and the foot of the rail were dislodged, exacerbating this movement. A combination of the rail dip and the loose fastenings would have created vertical movement of the sleeper under load without necessarily showing as an exceedance on the EM80 trace. The condition of the 2 sleepers at the break and the lack of evidence to support derailment damage at this point indicated the concrete sleepers may have failed prior to the rail failure.

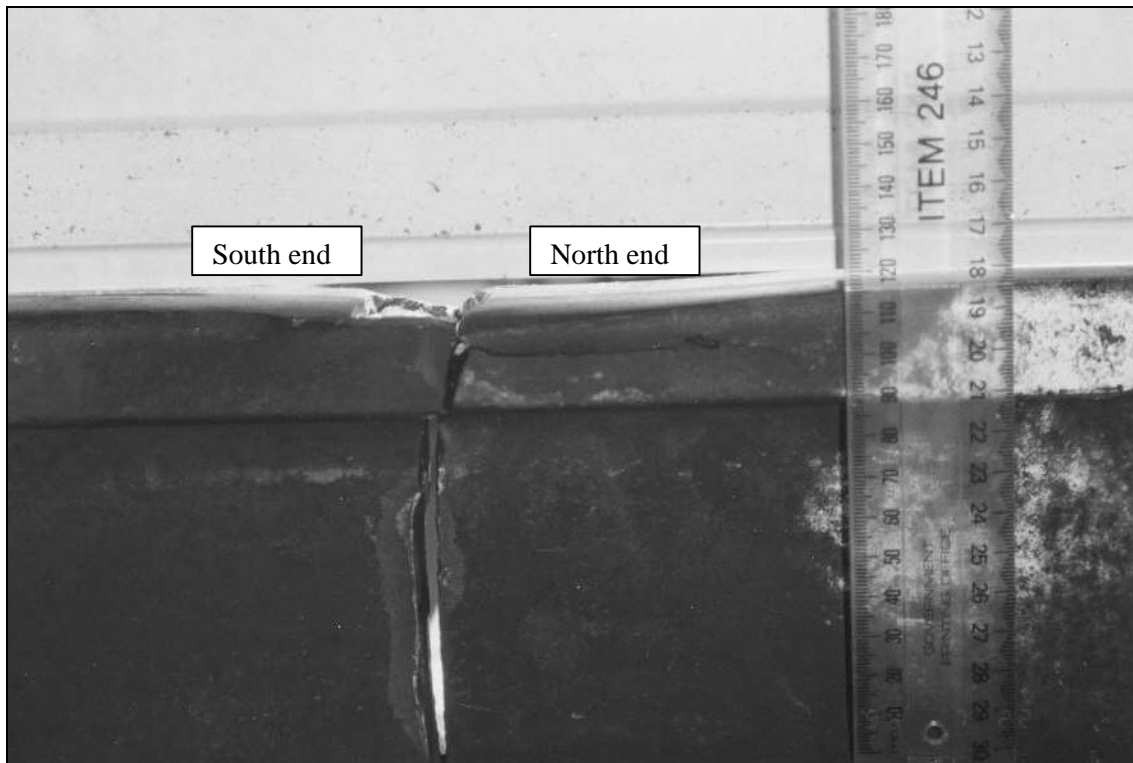
**Figure 3**  
**The extent of rail head flow**

- 1.3.3 Figure 3 shows the extent of the loss of depth, the metal flow at the initial failure point, and the metal break-out at the south end.
- 1.3.4 The subsequent failure at the south end (see Figure 1) showed no obvious steel defects. The heavily end-battered head section on the south side of the rail failure was typical of damage caused by the wheels of loaded wagons jumping the gap and impacting on the exposed rail end during the passage of trains after the failure.
- 1.3.5 Two concrete sleepers were supporting the broken section of rail, one immediately to the south of the original failure and the other under the subsequent failure. Figure 1 shows the positions of the sleepers in relation to the rail breaks. The standard spacing for concrete sleepers for curved track down to 400 m radius was 700 mm. The actual spacing was approximately 840 mm.
