Report 99-116

Train 3149 and an empty runaway diesel multiple unit

near collision

Papakura

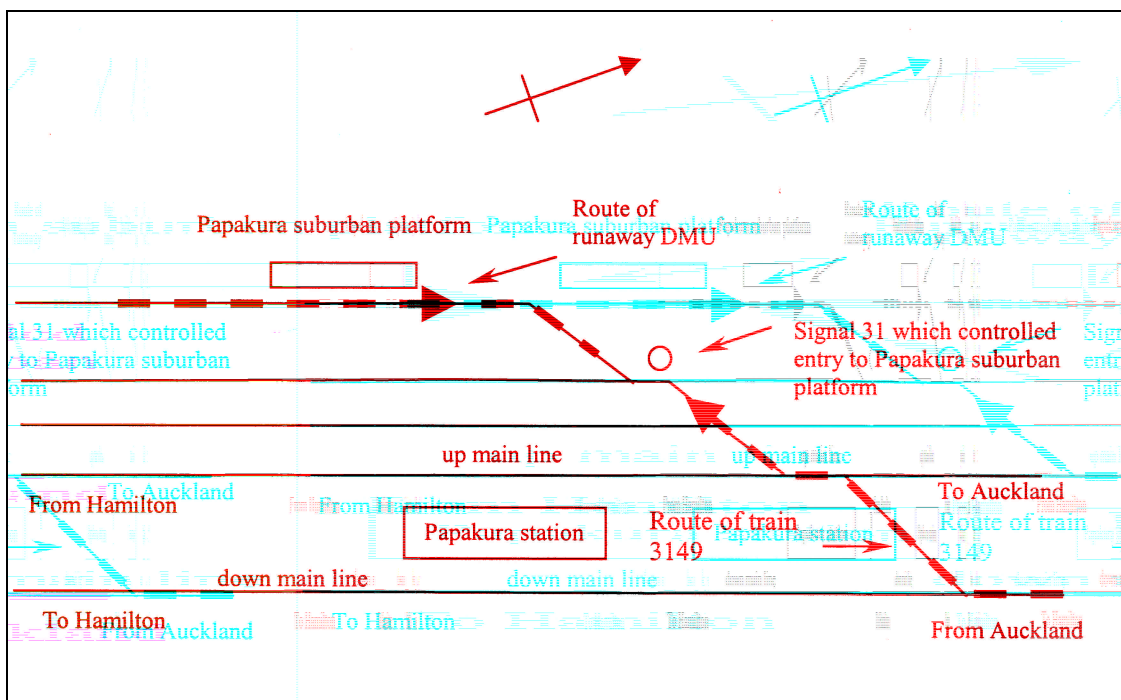
- 1.2 Site details**
- 1.2.1 The suburban platform at Papakura was situated on the west side of the yard, separated from the main station building by 3 railway tracks (see Figure 1).

Figure 1
Diagram of the north end of Papakura showing the movements of the DMUs involved
 (not to scale)

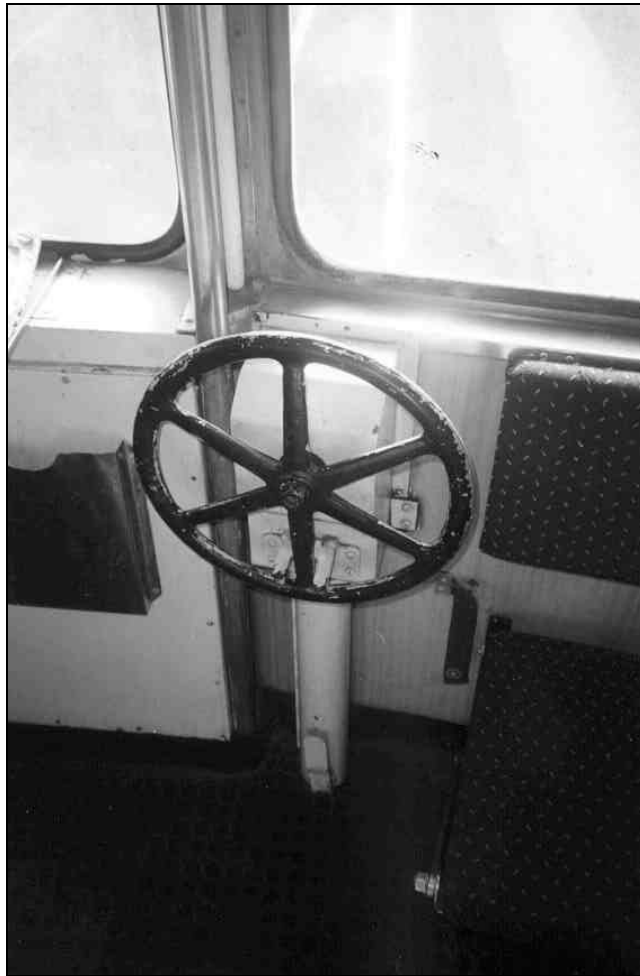
- 1.3.5 A handbrake wheel was provided on the front wall of the driving cab at each end of the DMU set. The handbrake at each end was designed to be held in position with restraining clips once the handbrakes were applied to avoid the brake wheel releasing. The ADK handbrake worked on 2 of the 8 car wheels and, although fitted with a restraining clip, was not fitted with a lock (see Figure 2). The ADB handbrake worked on all of the 8 wheels on that car. The importance of this brake was recognised by a restraining clip intended to be locked in position with a square key lock (see Figure 3).

Figure 2
A typical handbrake with restraining clip at the bottom, but with no locking facility, as used on ADKs

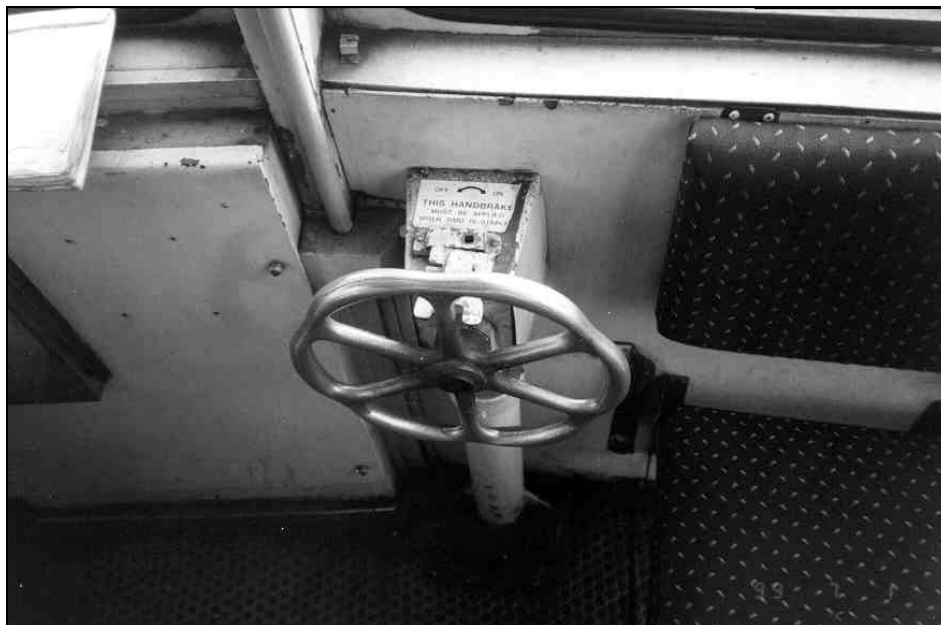
Figure 3
The handbrake in an ADB car showing clip in place and square key lock

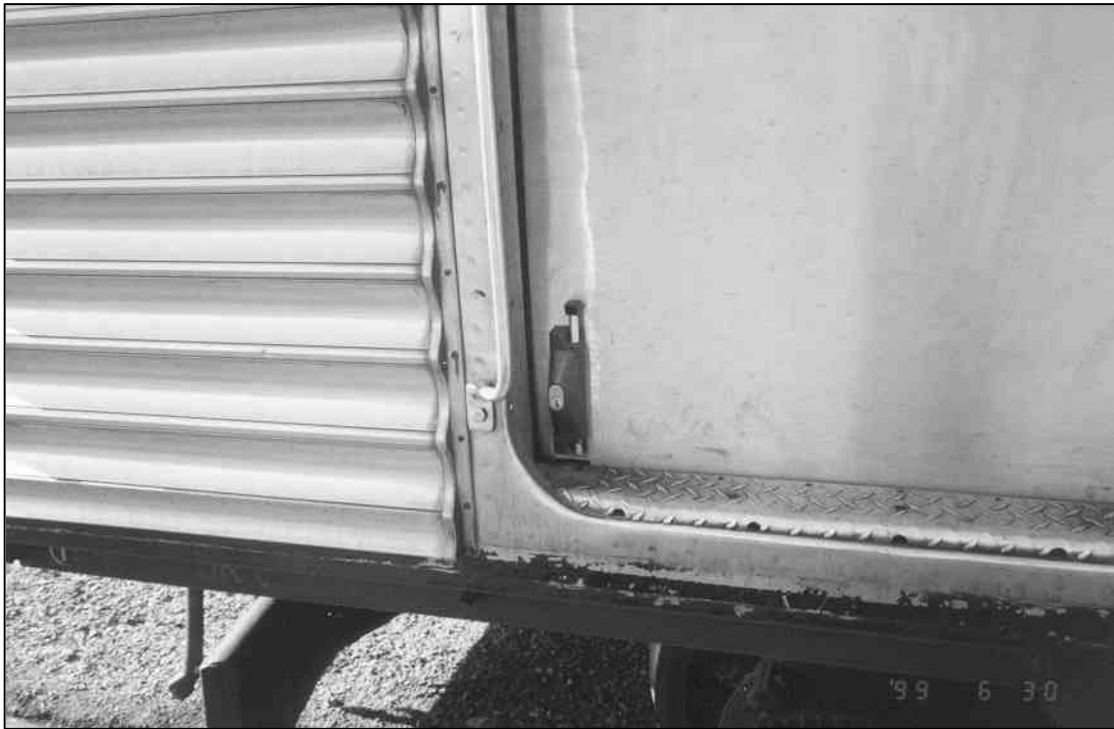
- 1.5.3 External doors to the driving cab were secured by either a lockable outside bolt which dropped into a hole in the step (see Figure 4) or drop bolts on the inside of the door which fitted into holes in the interior floor.

- 1.5.4 Comments from LEs indicated that the locking of external doors and internal doors when stabling DMUs was not a common practice. Most LEs claimed to have given up trying to follow this instruction because of the condition of a number of the key locks on the internal doors and the number of broken or unworkable locks on the outside bolts of external doors and damaged or non-fitting drop bolts on the inside.

Figure 4
A lockable outside bolt on a driving cab external door

- 4.1 Tranz Rail has repaired all external locks and installed new internal locks to all ADK and ADB driving cabs. Periodic inspection is undertaken by the operations manager to ensure driving cabs are secured in accordance with Section 4, clause 8.1.2 of the Rail Operating Code.

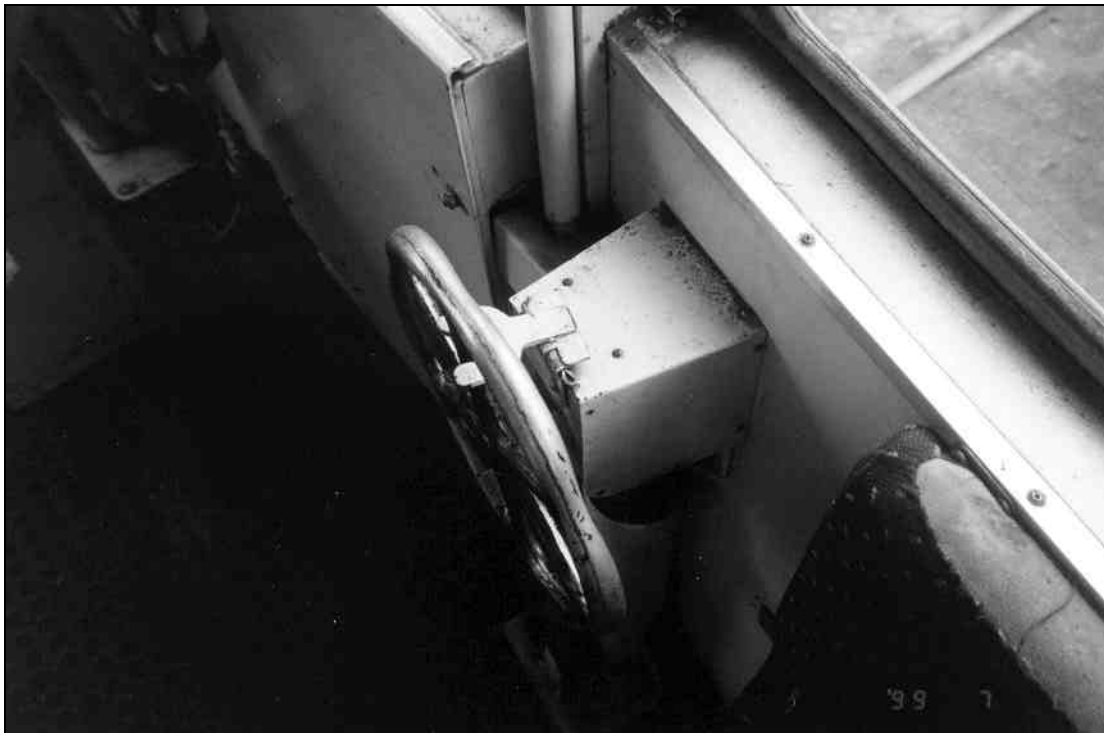
- of the 6 handbrakes only 3 had been applied and none was locked
- the 2 handbrake wheels that had restraining clips with square key locks available could not be locked (Figure 5 shows one of these)
- of the 6 external lockable doors only one was locked and one could not be locked
- of the 6 internal tower bolts only one was bolted and 2 could not be bolted.

1.6.3 Not all ADBs carried the appropriate signage and not all top restraining clips were present. Of those that were, some square key locks were inoperative. Figure 5 shows an example of non-compliance.

Figure 5
A handbrake with restraining clip at the top, but with no locking facility

- 5.1 On 30 May 2000 it was recommended to the Managing Director of Tranz Rail Limited that he:
 - 5.1.1 clarify the requirements for the application and securing of handbrakes on ADB and ADK cars, and ensure they are appropriately signposted. (028/00)
- 5.2 On 3 July 2000 the Managing Director of Tranz Rail Limited responded as follows:
 - 5.2.1 Requirements for the application and securing of handbrakes on ADB and ADK cars will be clarified. As noted in the report at 1.3.6 it is not mandatory to lock handbrake wheels as there is a requirement to lock cab doors when units are left unattended, and no change from this position is thought necessary. Existing signage is worded to ensure that the ADB handbrake is applied (as noted in the report at 2.3.1). We intend adopting a single sign to instruct that the handbrakes in both cars are to be applied when the DMU is stabled.
