Report 99-120

**express freight Train 474
and
express freight Train 227**

collision

24 August 1999

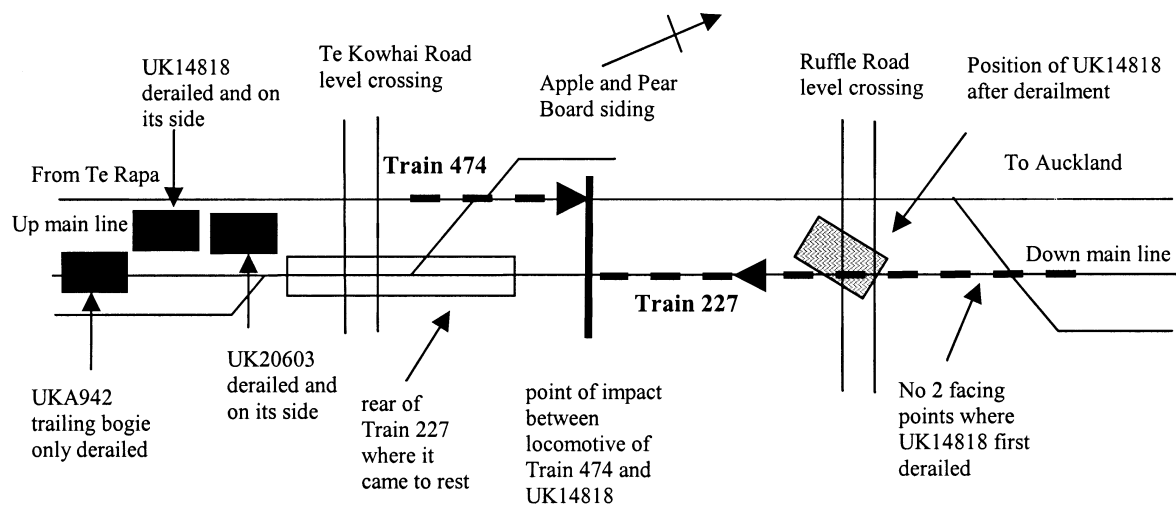
Figure 1
Site layout – not to scale

- 1.1.4 Realising that a collision was inevitable the LE applied the train brake before turning his face away from the locomotive cab window. As the container passed it struck the side of the locomotive cab and window. The LE was still in his seat and was showered with glass, but uninjured. Figure 1 shows the site layout.

- 1.1.14 On going back to check his train the LE found 3 wagons derailed in the vicinity of the Te Rapa public siding turnout. Two had tipped on their sides between the down and up main lines while the third had derailed trailing bogie only, and was still upright. The train had parted with the back portion of the train stopped across Te Kowhai Road level crossing.

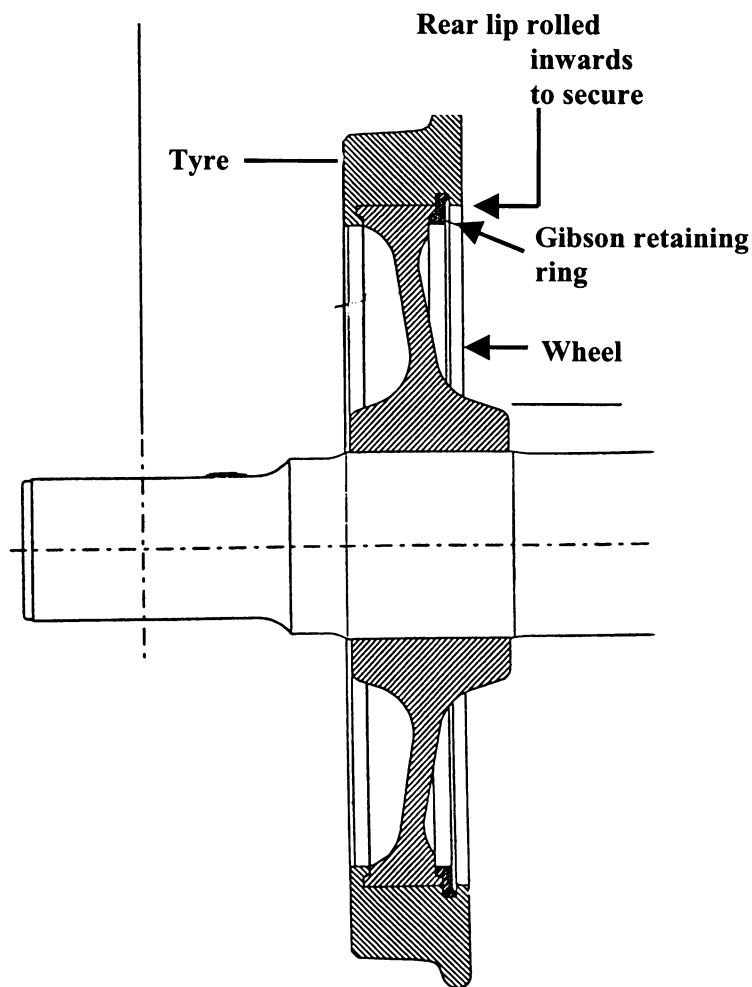
Figure 2
Diagram showing tyred wheel assembly

- 1.7.2 The method of fitting and retaining tyres involved shrink-fitting at a high temperature. As the temperature cooled a shrink-fit on the wheel resulted and the tyre lip was then rolled until the Gibson retaining ring was tightly gripped. Figure 2 shows the tyred wheel assembly.

- 1.7.3 Tyre loosening on the wheel centre was not unknown. The purpose of the Gibson retaining ring was to restrain any such loose tyres for a short period. If a tyre had become overheated, perhaps due to heavy brake action, and thus lost its shrink-fit on the wheel, the outer lip of the tyre and the Gibson retaining ring were intended to retain the tyre in place until it cooled and regained its shrink-fit.

- 1.7.4 If this overheating continued, for example through dragging brakes, the tyre could start to revolve and wear away the interface fit so that when the tyre cooled down it could still be loose on the wheel. This would accentuate the wear between the original interface fit surfaces and also gradually erode the Gibson retaining ring.

- 1.7.5 If the Gibson retaining ring failed, there would be nothing to stop the tyre from moving to the outside of the wheel.

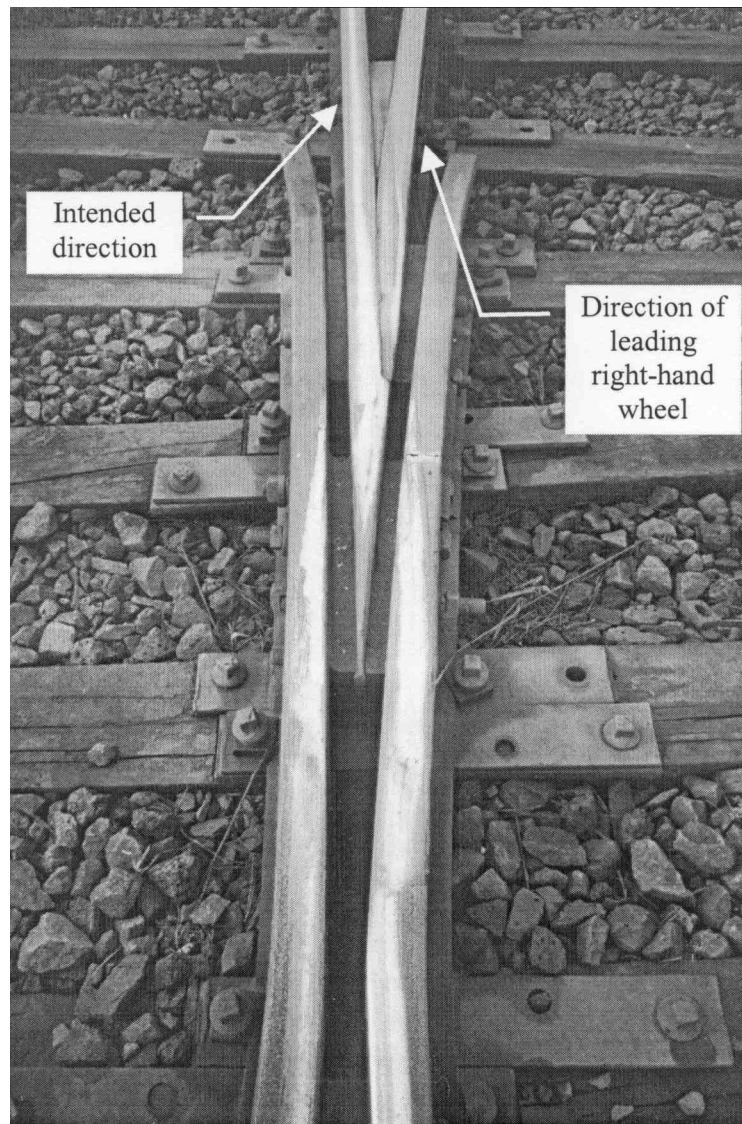
Figure 3
No 2 facing turnout at Horotiu

- 2.1.4 As the wagon traversed No 2 turnout immediately south of Horotiu, the rail discontinuity at the frog⁴ and displacement of the wheel flange was sufficient to cause the loose tyre to take a diverging route from the rest of the train (refer Figure 3), pulling the wheel at the opposite end of the axle in the same direction until both wheels were derailed. The first flange marks on the sleepers beyond No 2 turnout were 1170 mm apart, confirming that the tyre had moved away from the wheel.

- 3.1 Trains 227 and 474 were being operated normally prior to the incident.
- 3.2 The LEs were appropriately certified for the duties being carried out.
- 3.3 The derailment was caused by a loose tyre on the right-hand wheel on the leading axle of the trailing bogie of UK14818 moving laterally on the wheel, resulting in the wheel taking the wrong road at No 2 facing turnout immediately south of Horotiu.
