Report 99-201

bulk woodchip vessel *Prince of Tokyo*

grounding

Port Otago harbour entrance

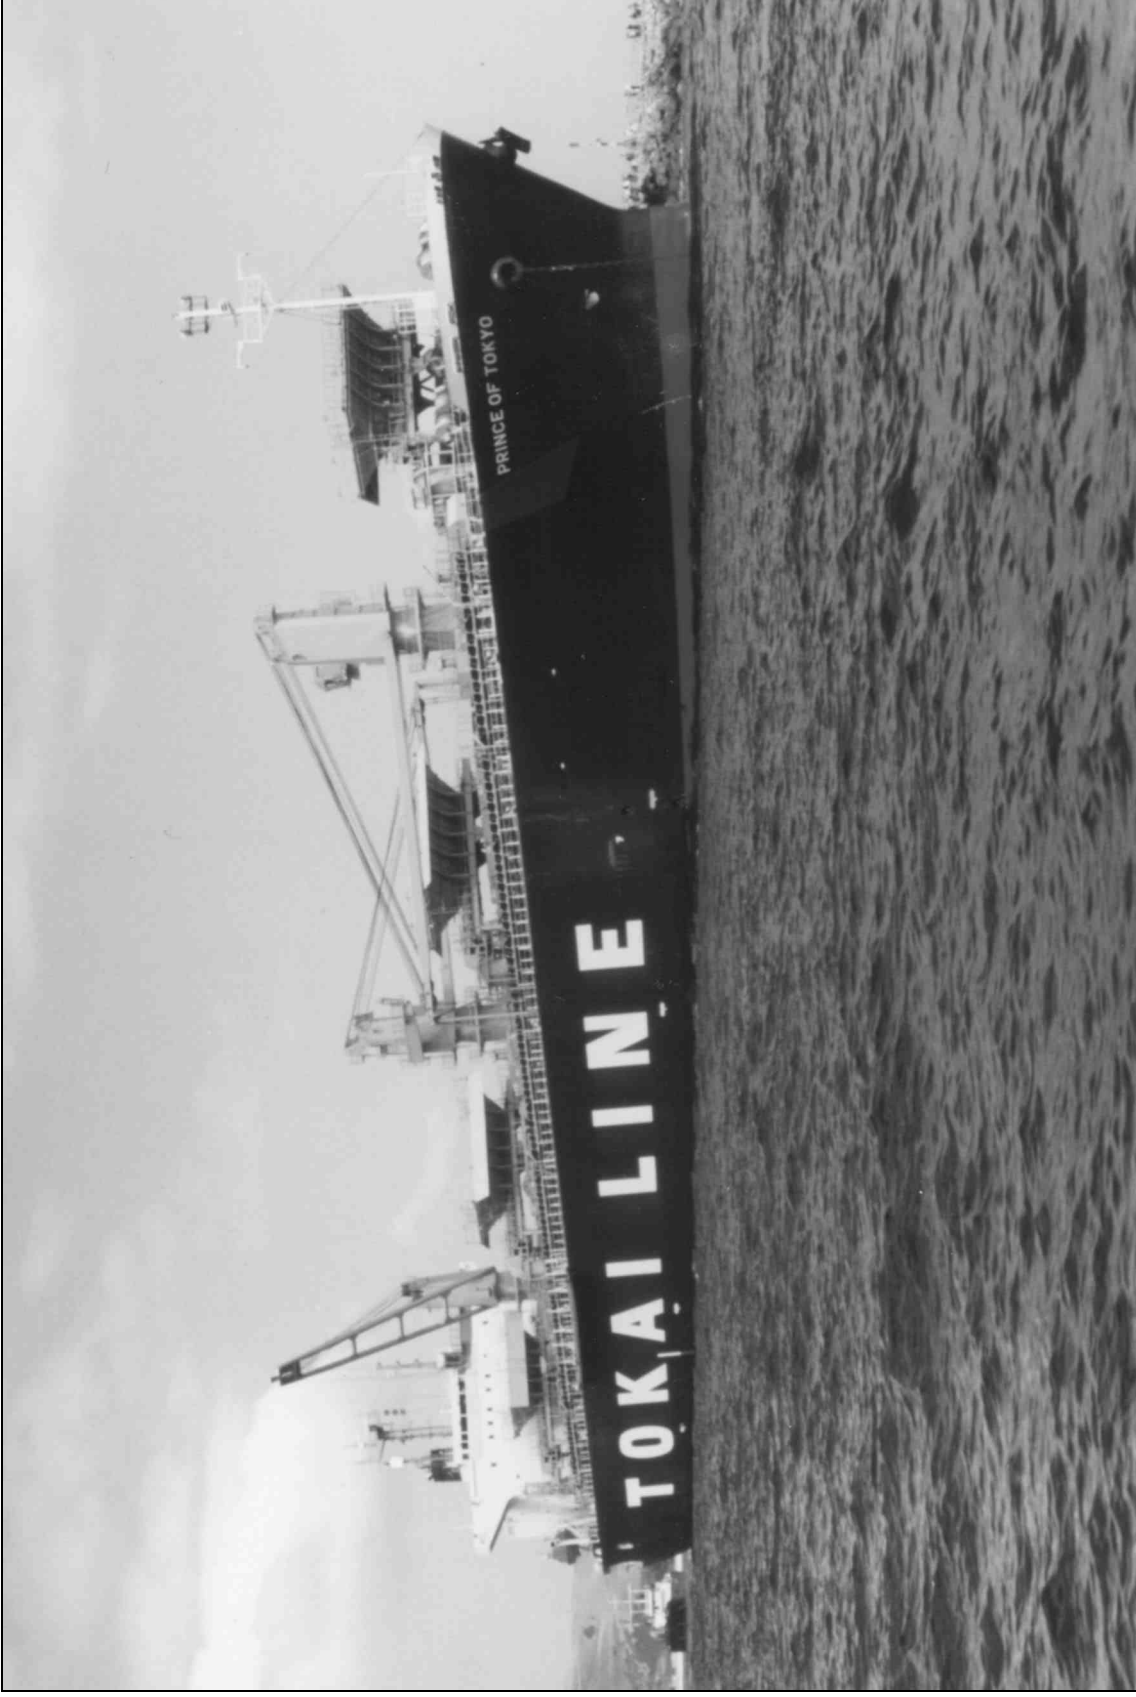
Prince of Tokyo, aground on the western mole at the entrance to Port Otago harbour

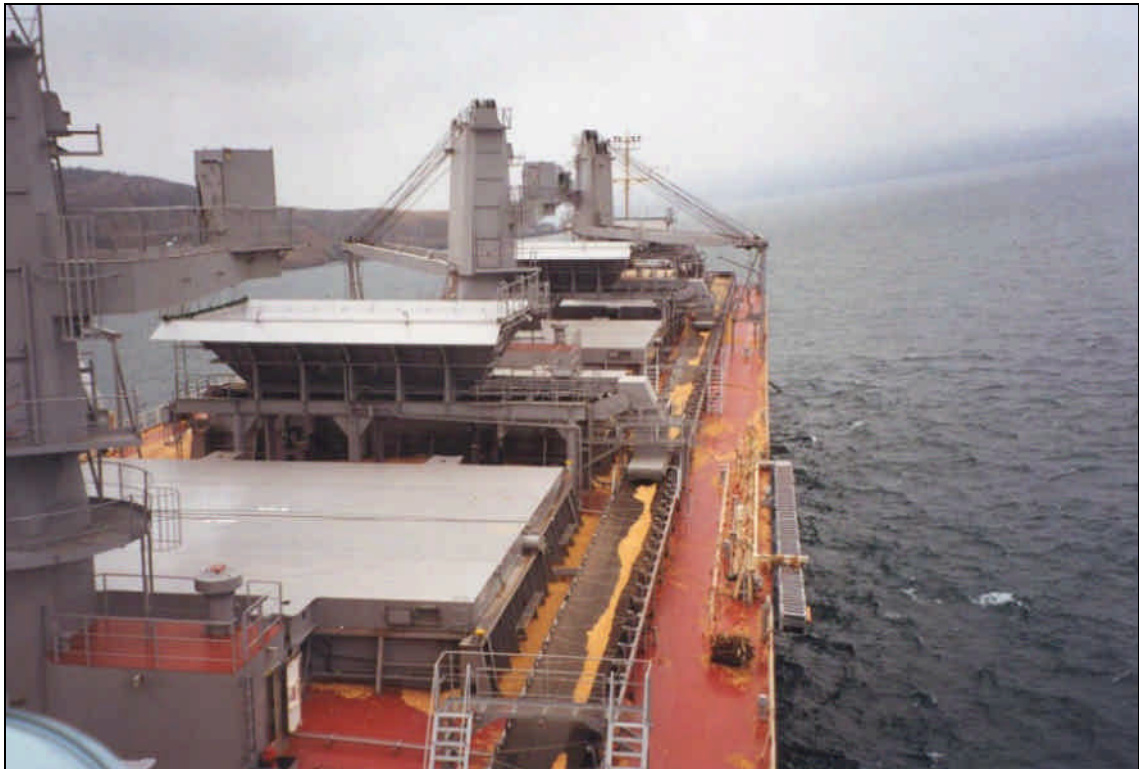
Figure 2
View of gangway from starboard bridge wing

- 1.1.20 The chief pilot could see from the wheelhouse that the gangway was hanging vertically. He was not sure if anyone had fallen overboard so proceeded out to the bridge wing to see for himself what had happened, leaving the helm on port 10 degrees. (See Figures 2 and 3.)

- 1.2.5 There was no pollution as a result of the grounding.
- 1.2.6 The broken wire on the starboard gangway was inspected after the accident. It was found to be squashed and stranded, consistent with being jammed between the sheave and the cheek plate of one of the permanently fitted blocks. The exact position the wire was in when it parted could not be established. The wire was relatively new and showed no other signs of damage. The test certificate was dated 6 January 1999.

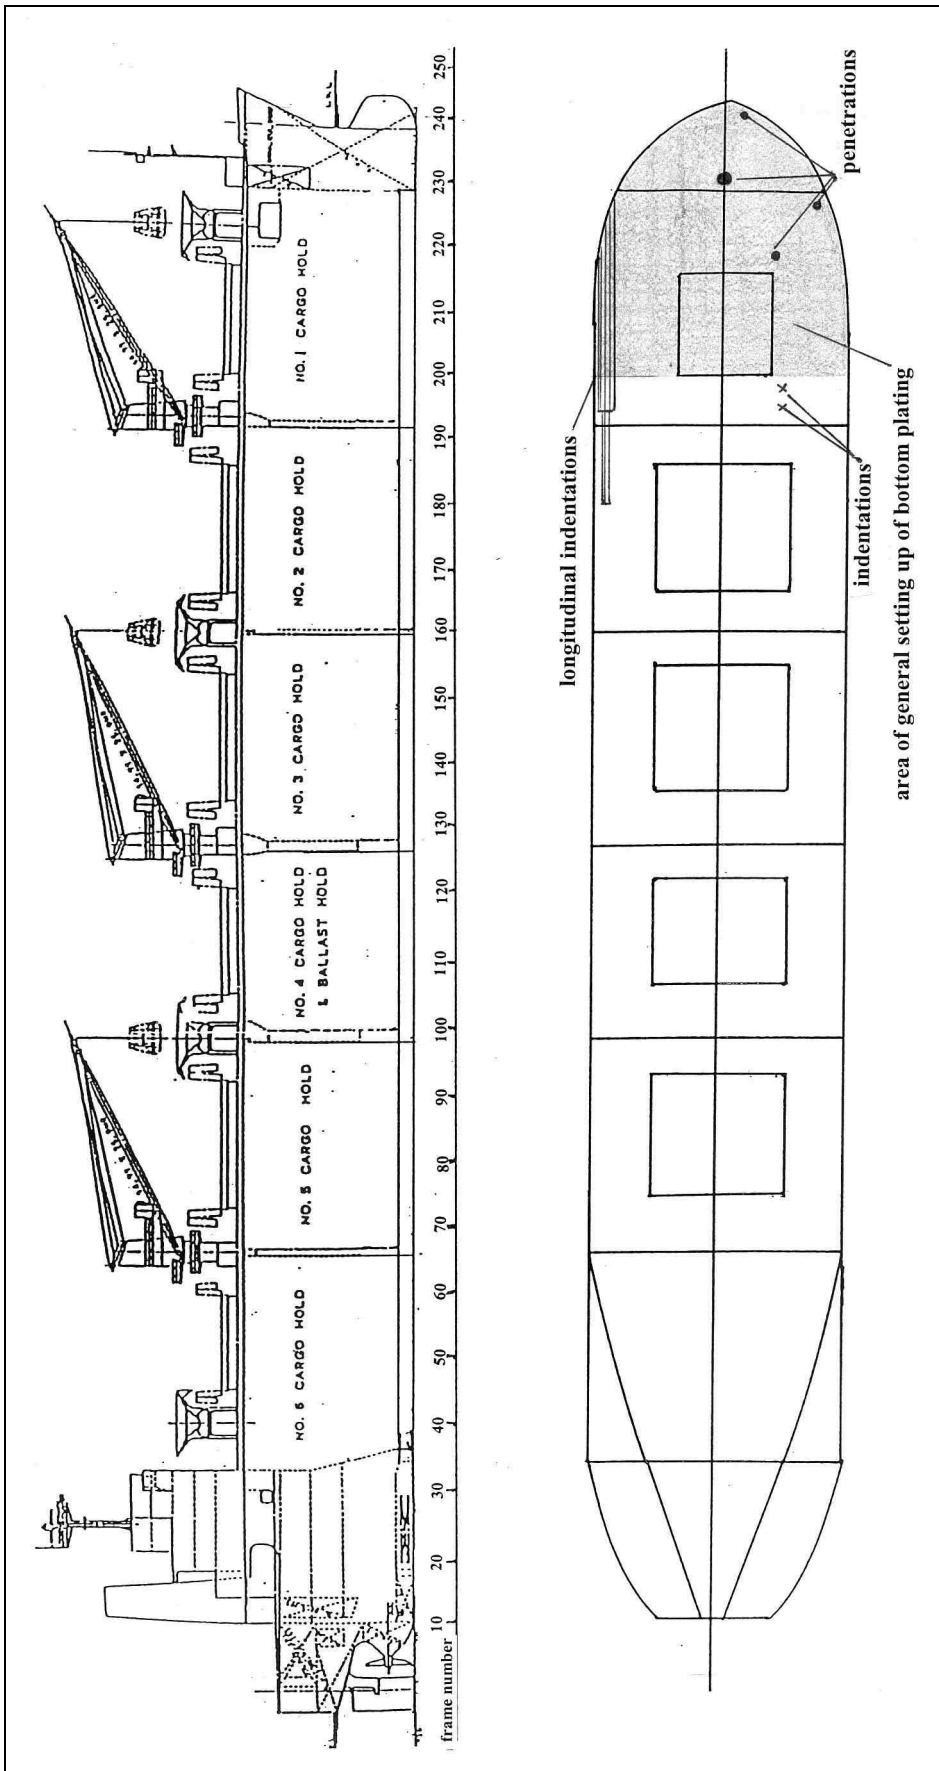
Figure 4
Diagram showing areas of damage

- 1.2.1 A preliminary damage report was made by the salvors on 15 February 1999, after the initial inspections by divers. It found that the *Prince of Tokyo* had grounded from the forefoot, back to about the middle of number 2 hold, on a bottom consisting of rock, gravel, rubble and large cast concrete tetrahedrons.

- 1.2.2 The tank soundings after the grounding indicated that the fore peak and number one starboard double bottom tank were taking water.
- 1.2.3 From about frame 200 forward the damage was extensive, with general setting up and indenting of the plating to a depth of up to 100 mm, extending right across the flat bottom between the frames and longitudinals.

- 1.2.4 There were 4 places, all on the starboard side of the centreline, where the shell plating was penetrated; 3 of these were small splits running longitudinally, the other was a larger hole. (See Figure 4.)

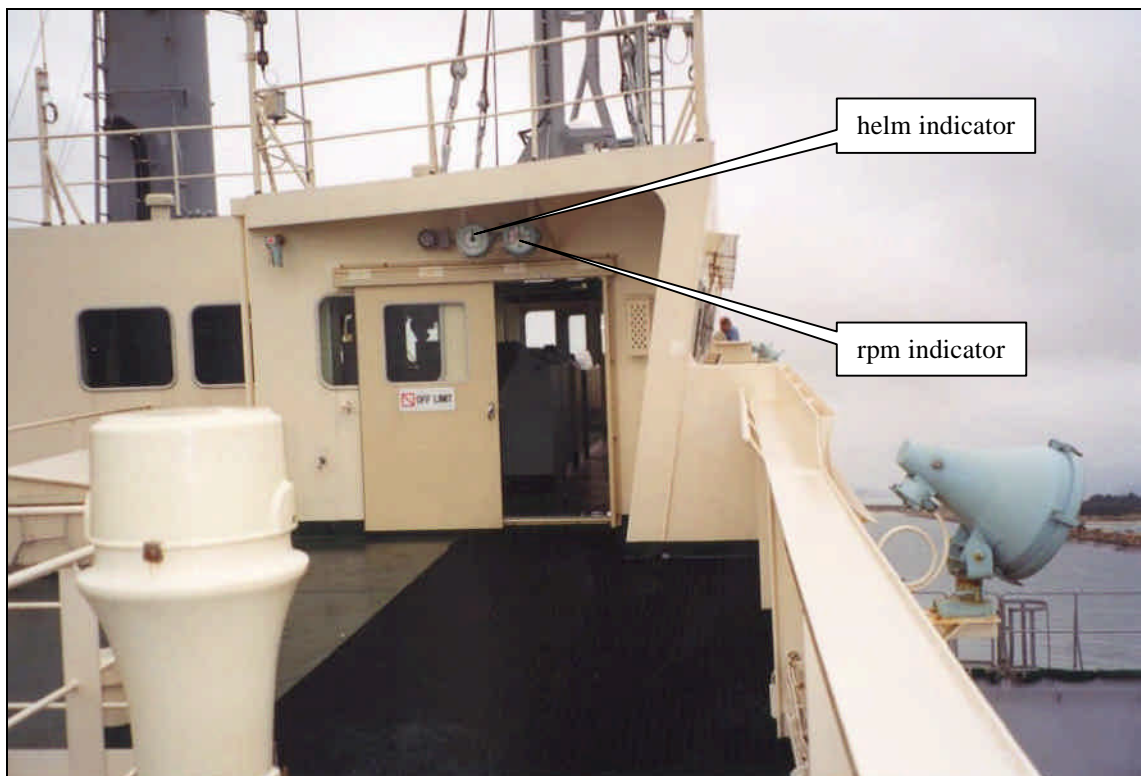
Figure 6
Starboard bridge wing

- 1.3.9 Above each wheelhouse door, facing out to the bridge wings was a helm indicator and an engine revolution counter. On each bridge wing was a gyrocompass repeater. (See Figure 6.)
