Report 99-205

ro-ro cargo vessel *Union Rotoiti*

machinery failure, loss of and damage to cargo

23 April 1999

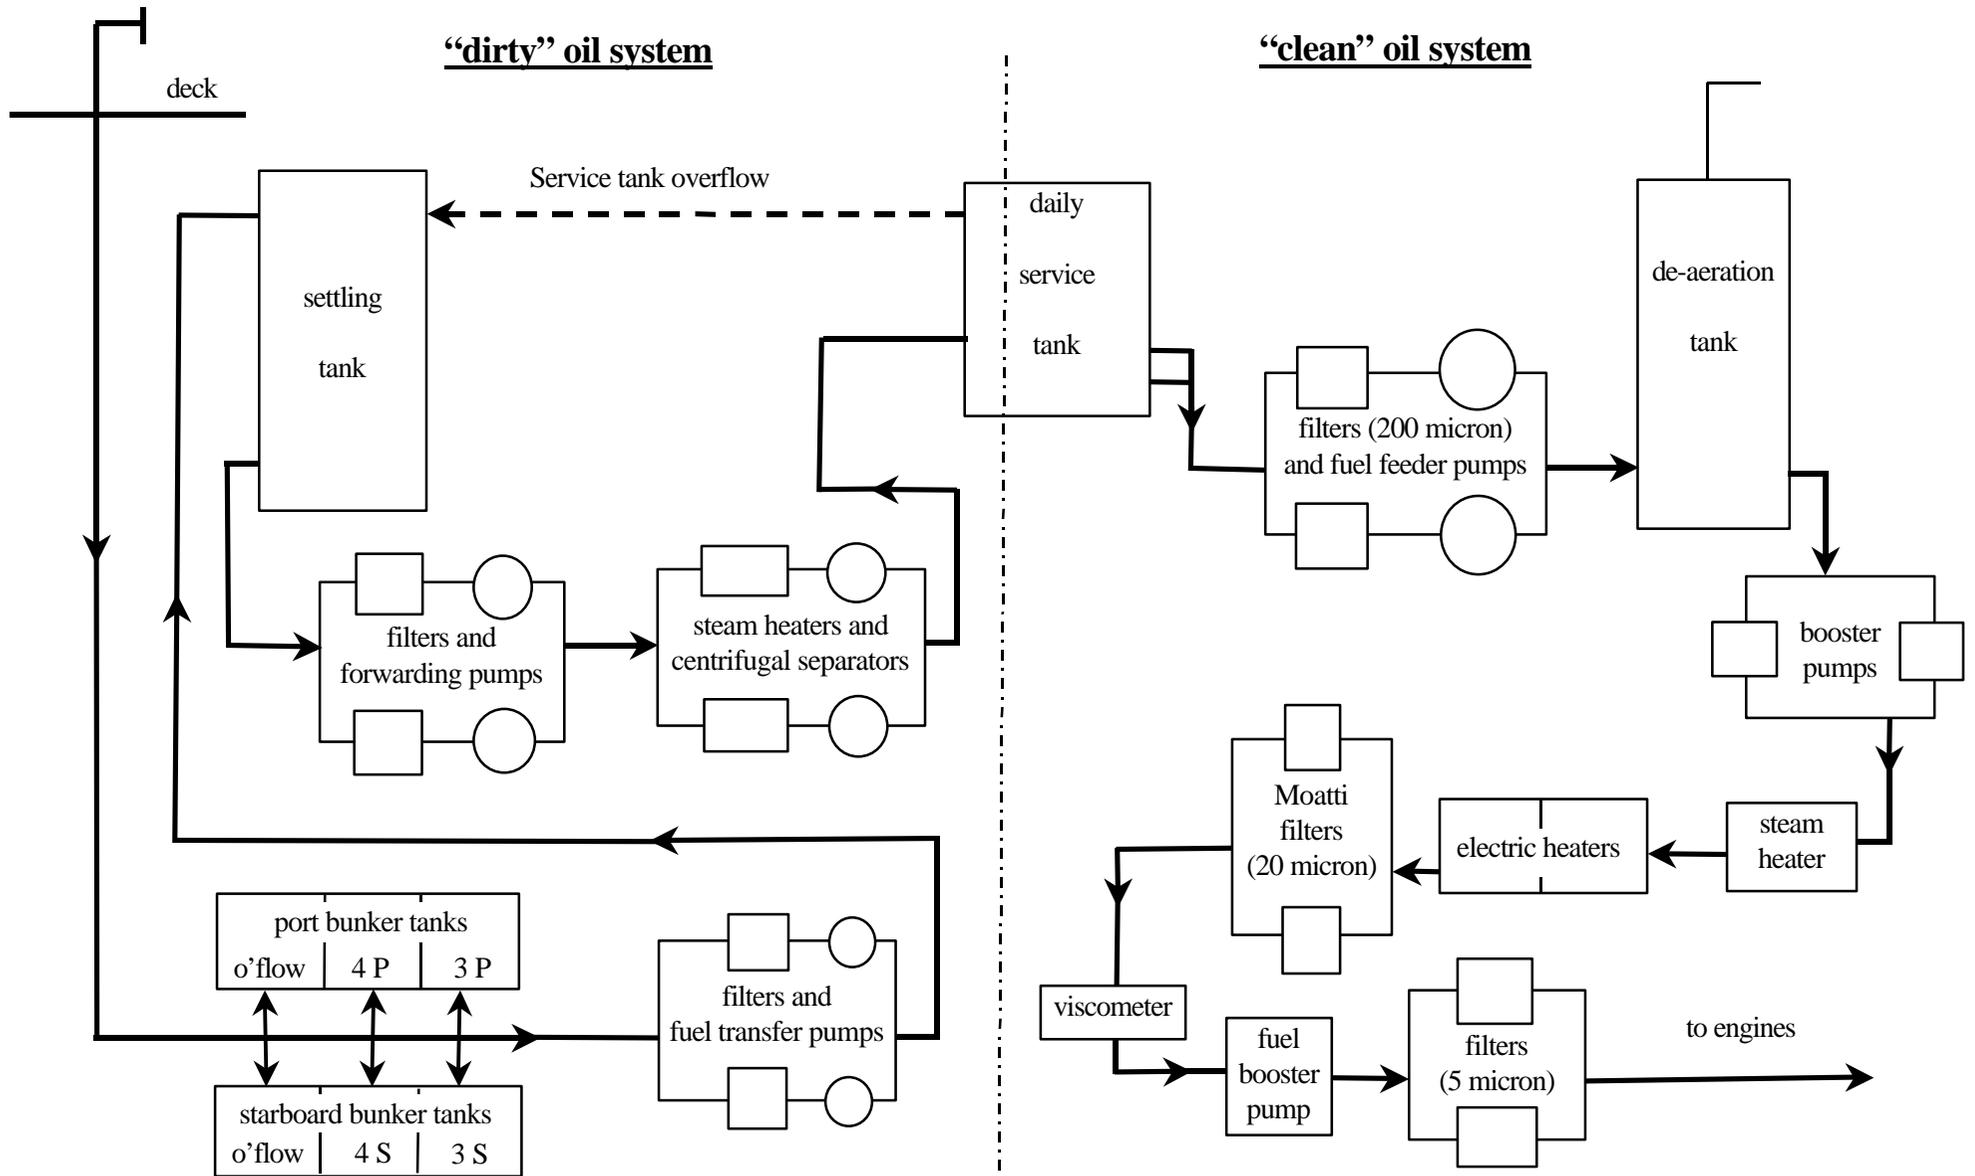
Figure 4
Schematic diagram of *Union Rotoiti* fuel system

- 1.4.2 The fuel system can be considered in 2 sections; the “dirty” and “clean” systems (see Figure 4). Fuel oil was taken through a connection on deck to the storage tanks, which were numbers 3 and 4 port and starboard tanks and the port and starboard overflow tanks. From these tanks fuel was transferred to a settling tank. From there it passed through filters and was purified by centrifugal separators, which removed any water and unburnable sludge. The purified oil was then stored in the daily service tank.

- 1.4.4 The daily service tank originally contained gas oil for the turbines and had been coated internally with an epoxy paint. Since the re-engineing in 1986, gas oil was replaced by heavy fuel oil and although epoxy coating was not required for tanks using heavy oil, neither was it considered detrimental and was thus not removed.

- 2.2.6 The internal coating of the service tank was blistering and flaking off around the area of the normal upper level of stored purified fuel. That area would be covered with fuel as the tank was filled and uncovered as the fuel was used, producing a variation in the temperature of the internal surface of the tank in that area. The temperature fluctuation was probably part of the cause of the detachment of the coating.

- 2.2.9 The motion of the vessel as it approached the depression probably agitated the flakes of coating accumulated in the bottom of the tank. Initially the disturbance would have caused only smaller pieces of debris to be drawn into the suction filters of the feed pumps, and could explain why the first blockage was not sufficient to significantly reduce the fuel pressure at the engines.

- 2.2.10 As the weather deteriorated and the motion of the vessel increased, so too would the degree of disturbance within the service tank. Greater amounts and larger pieces of debris would have been drawn into the filters causing a more extensive blockage which quickly reduced the fuel pressure at the engines to an extent that they starved of fuel and stopped.

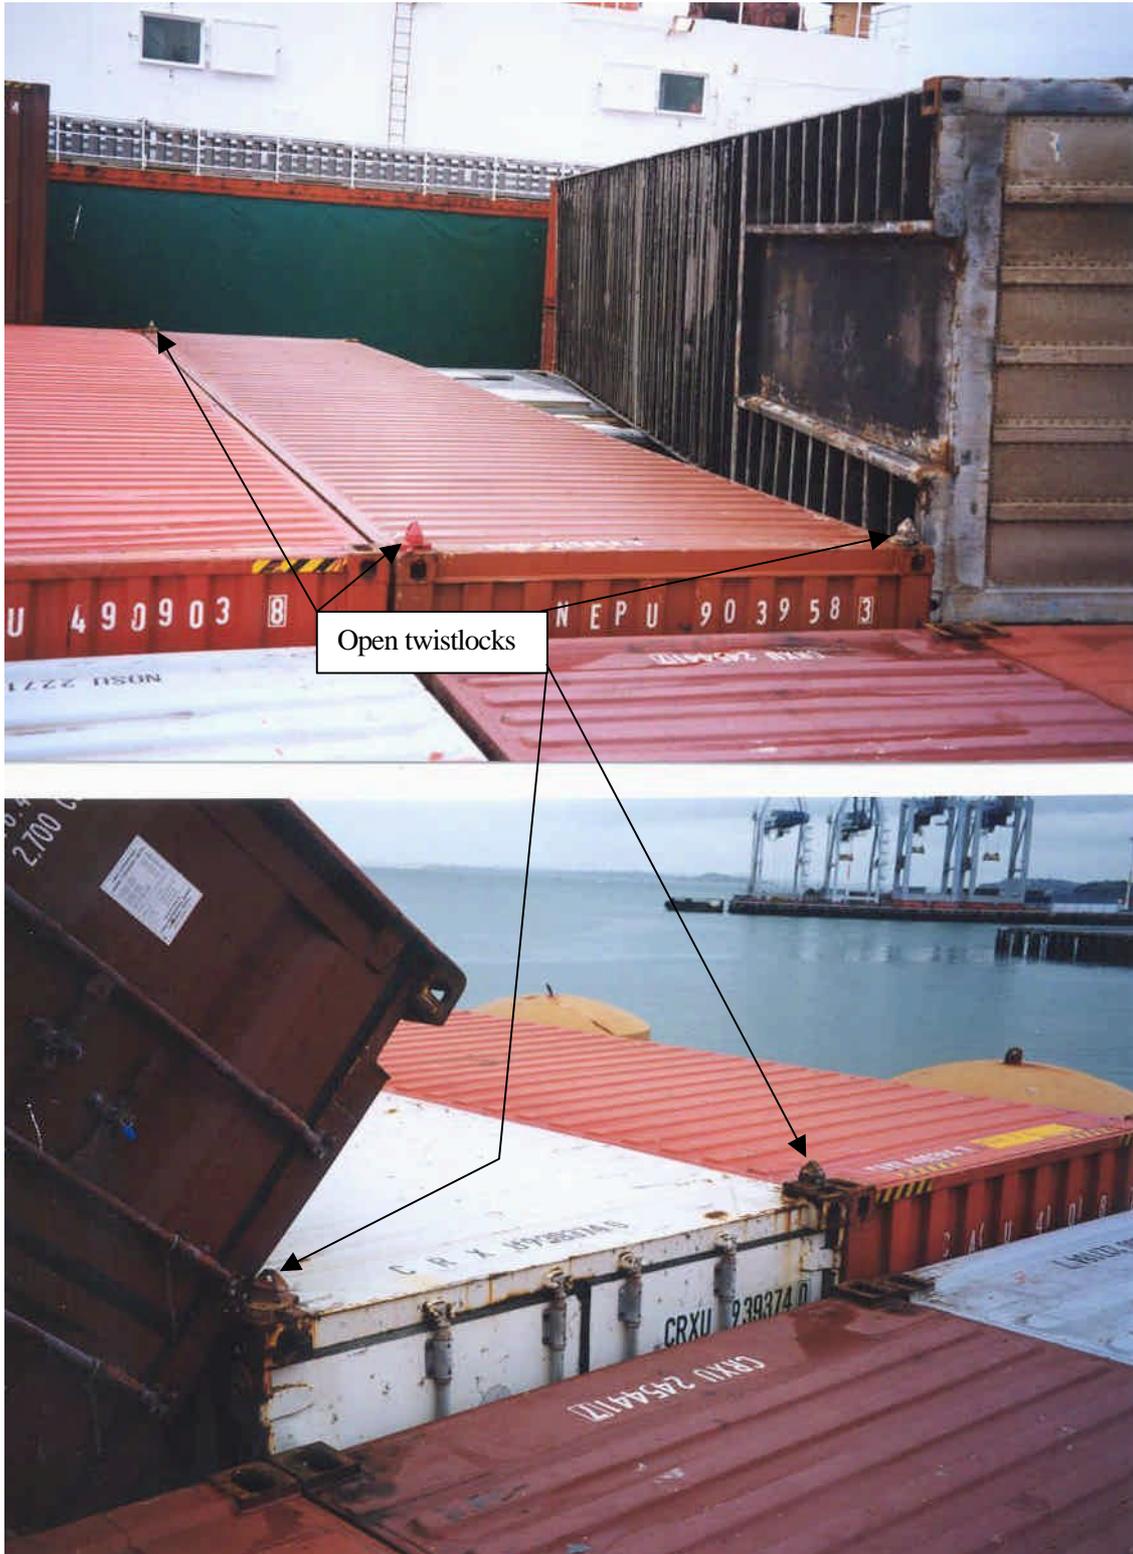
Figure 9
Photographs showing toppled containers on upper deck (note open twistlocks)

- 2.4.6 In instances where some second height containers had toppled, twistlocks that had been between the tiers remained in place but were in the unlocked positions. Had those containers been torn free of locked twistlocks, the result would have been severe damage to the corner castings of the containers and to the twistlocks. The absence of such damage indicated that the twistlocks had not been locked.

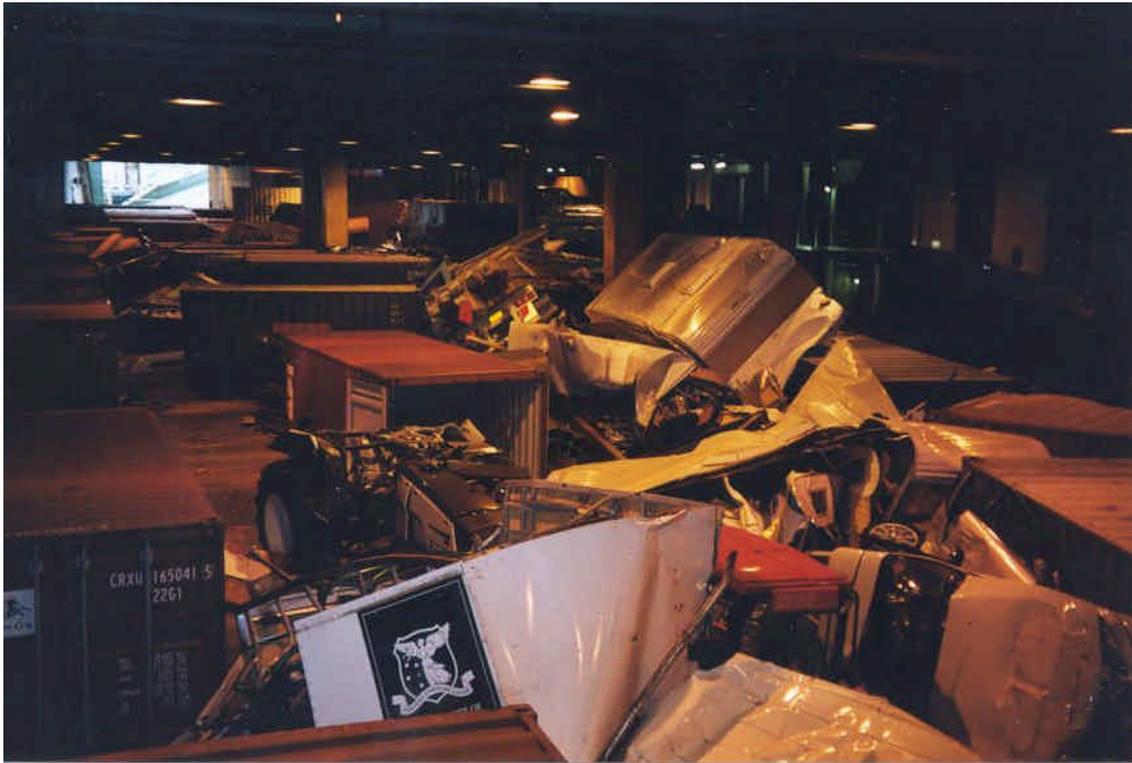
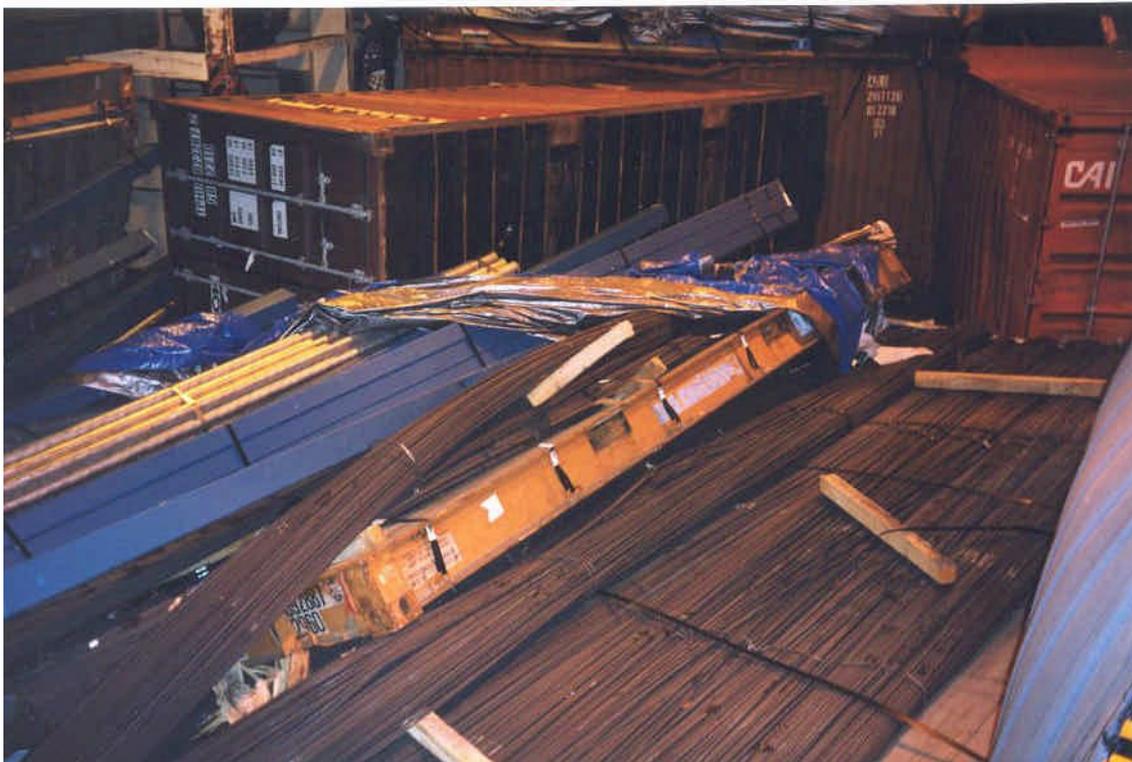
- 1.8.11 Cars, camper vans and other vehicles stowed in the centre of the main vehicle deck were virtually destroyed in the crush of moving heavier units. In some instances the contents of containers broke their lashings within the container and the cargo burst out of the side. (See Figure 10.)

Figure 10
Photographs of cargo damage in the main vehicle deck

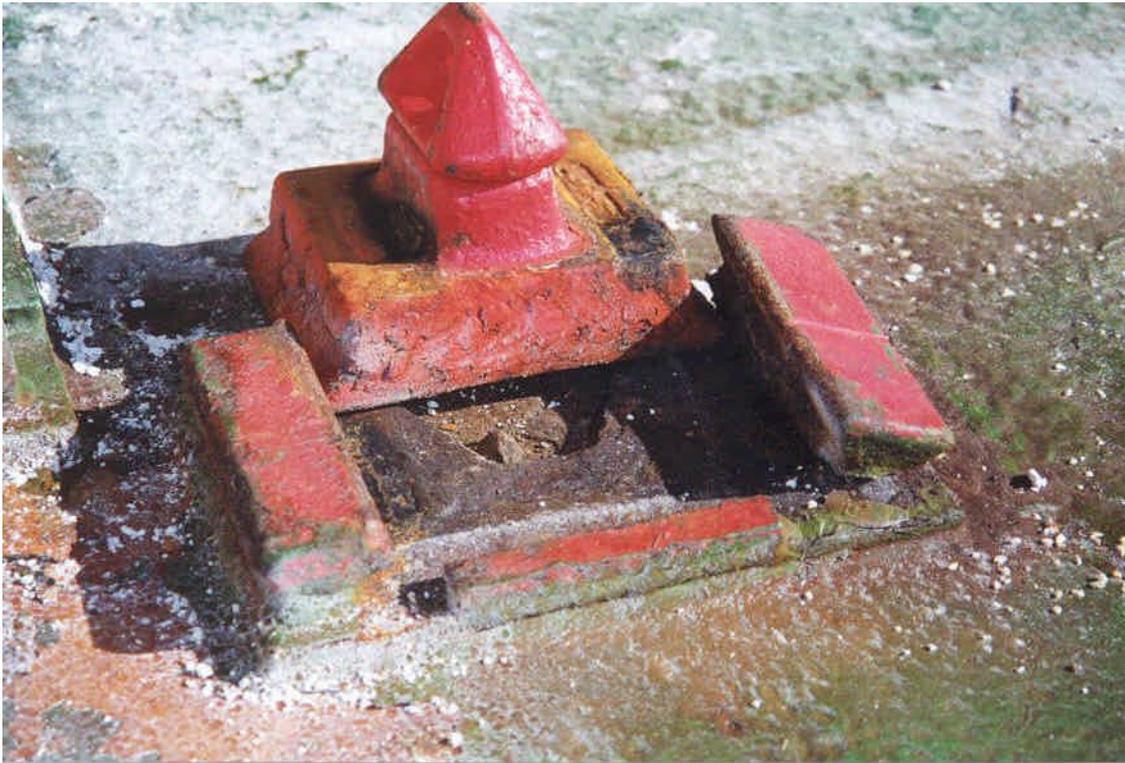
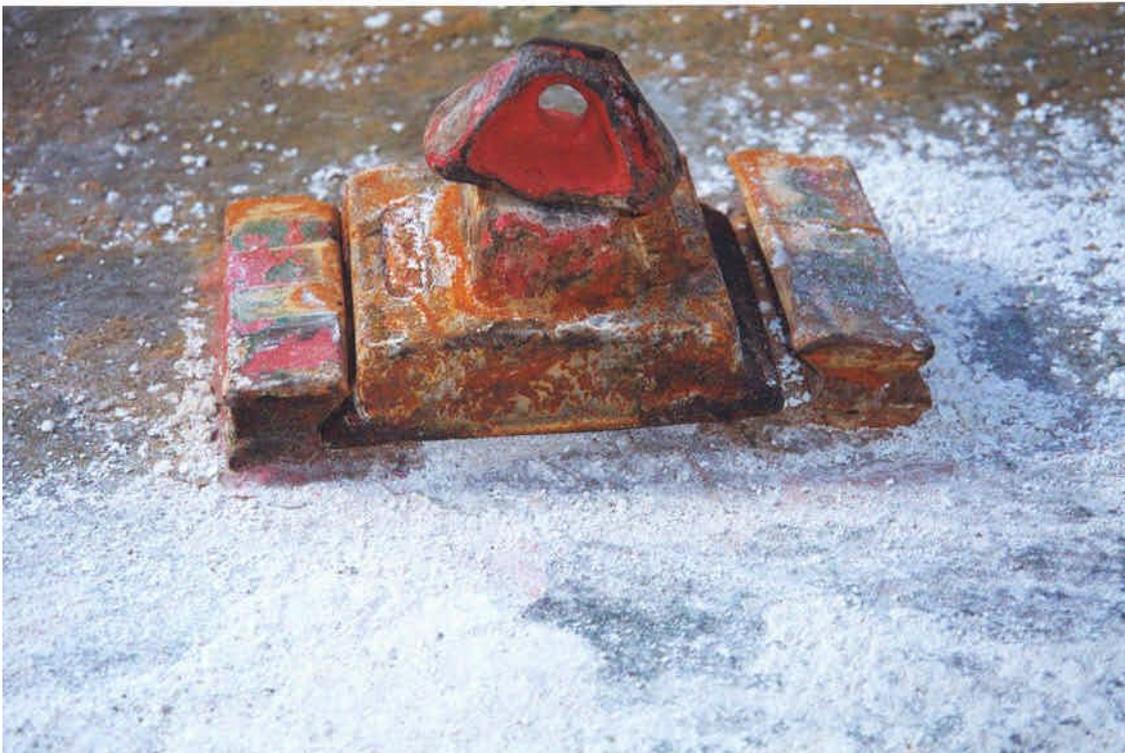
Figure 11
Photographs of worn deck sockets and twistlocks

- 2.4.4 The inspection of the upper deck when *Union Rotoiti* arrived in Auckland revealed that many of the deck sockets were corroded, worn or otherwise damaged to an extent that when twistlocks were slid into them, a snug fit was not possible. In some cases the twistlock could be lifted vertically out of the deck socket by hand, so effectively the bottom container would not have been secured to the deck.

- 2.4.5 In various positions through the stow, containers had pulled away from the deck sockets with their twistlocks still locked to their bottom corner castings. Either the sockets, the twistlock edges, or both were worn such that little holding capacity remained.

- 3.12 Many of the deck sockets were worn or damaged to an extent that they failed to secure the containers in the manner intended when subjected to the excessive rolling.
