Report 99-206

passenger charter yacht *City of Dunedin*

grounding and fire

8 May 1999

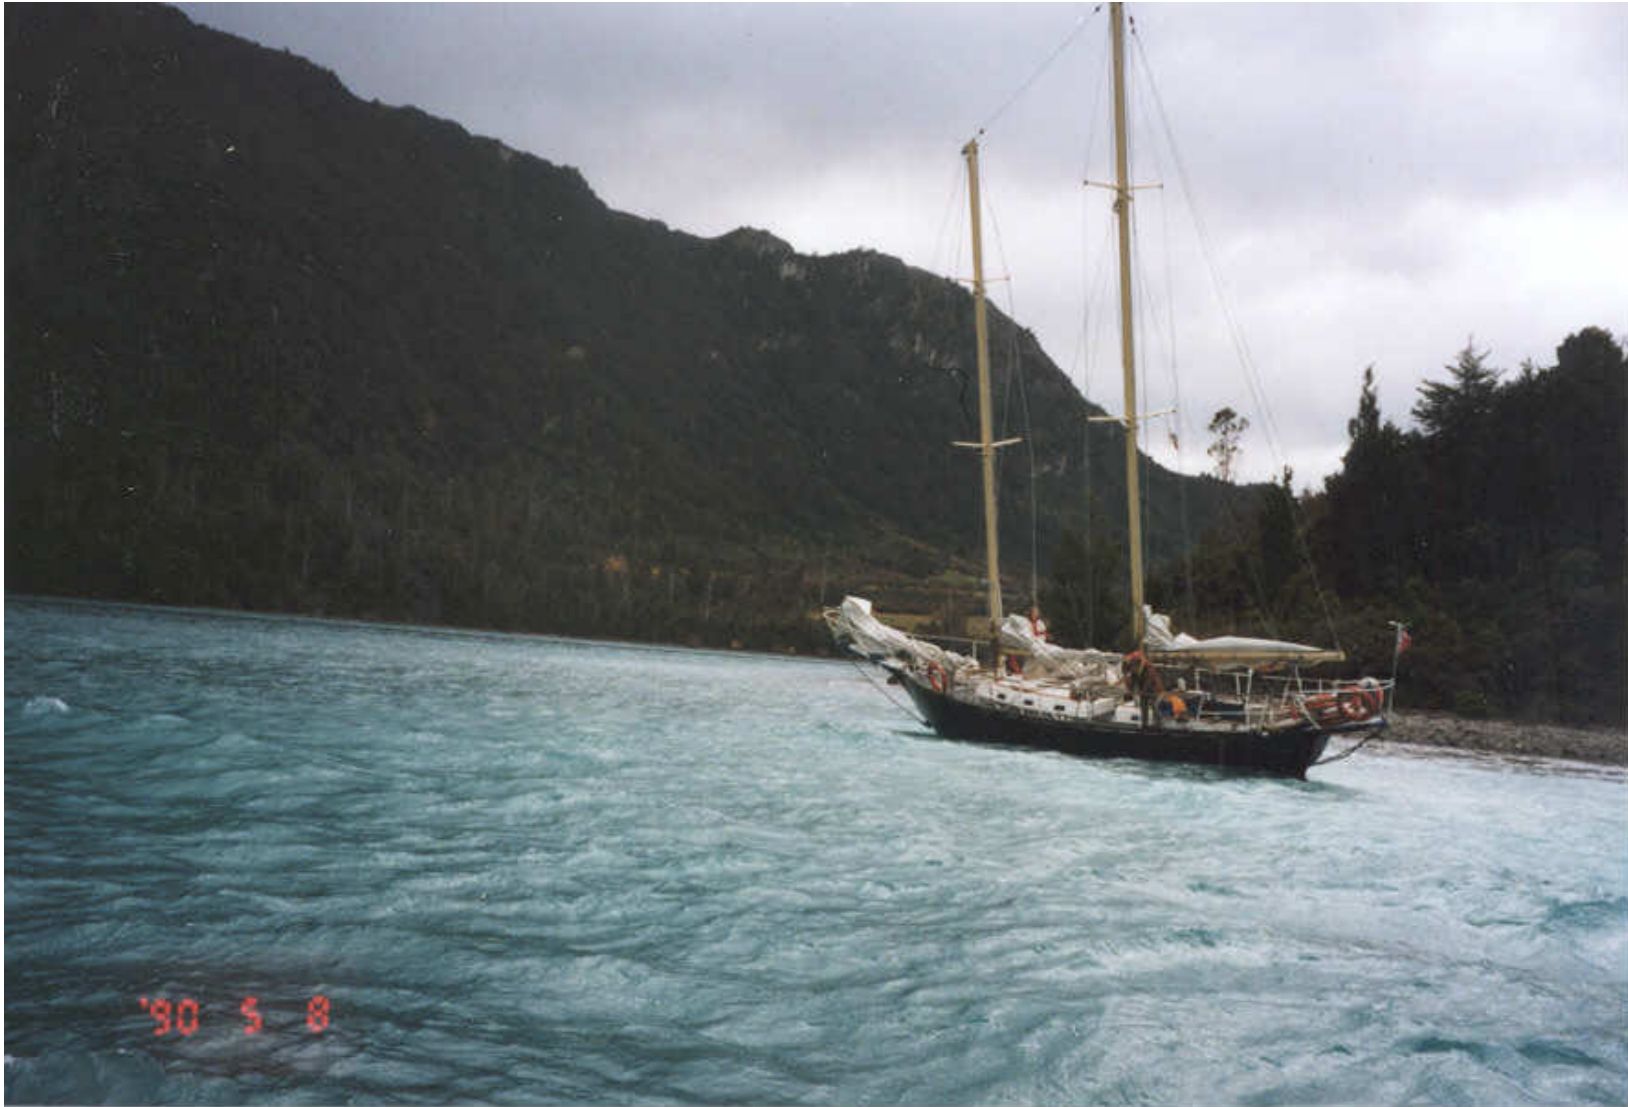
City of Dunedin aground in Bobs Cove

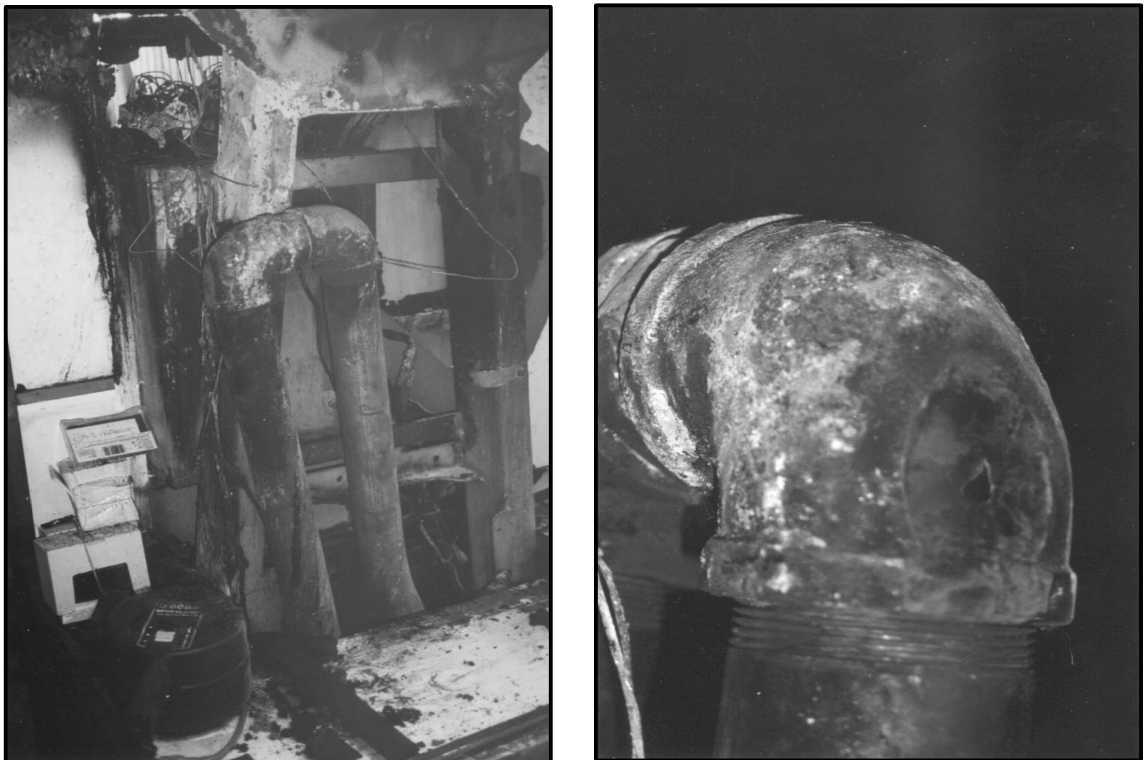
Figure 5
Photographs showing displaced exhaust and worn area of pipe

- 1.2.2 The high-rise section of the exhaust was found to be distorted. Originally the pipe was centrally located within the mast support structure. After the fire it was found to be distorted to starboard and forward of the mast support. With some effort the pipe could be pushed back between the legs of the mast support but in this position it rested hard against the inside of the starboard leg (see Figures 5 and 6).

- 1.2.3 The surface of the mast support where the exhaust pipe had been resting hard against it was worn smooth. The area of the exhaust pipe that had been chaffing on the mast support was the outside of a 65 mm right angle elbow joining the transverse and down sections of the pipe. The rounded elbow had been worn flat by the contact with the mast support (see Figures 5 and 6).

- 1.2.4 The worn area was so thin that pin holes were evident. When the centre of the area was touched lightly with the blade of a knife, the centre of the worn area fell away producing a hole about 10 mm in diameter.
- 1.2.5 The wooden enclosure of the exhaust high-rise and mast support was constructed of marine plywood overlaid with a tongue-and-grooved fascia. The marine plywood was extensively burnt and showed a distinctive burn pattern. There was a circular area on the starboard side where the plywood was completely burnt away, indicating that the fire had been seated there (see Figure 7).

- 2.2.6 The exhaust high-rise pipe had been rubbing against the mast support for some time; long enough for the side of the right-angled elbow joint to have worn flat and for pinholes to develop allowing exhaust gases to escape from the worn area. The worn area was enclosed in a wooden structure and would not have been visible without removal of the cover.

- 2.2.7 The wear was caused by vibration of the exhaust pipe against the mast support when the engine was running. The pipe was held against the mast support under tension. When the yacht grounded, the jolt was enough to spring the exhaust pipe free of the restraining mast support. Once free, the worn area was very close to the plywood surface of the enclosure. Without the flat surface of the mast support covering the worn area, the exhaust gases would have escaped more readily through the pinholes in the metal.

- 4.1 After the accident the exhaust high-rise was renewed using stainless steel and bracketed into position to eliminate movement.

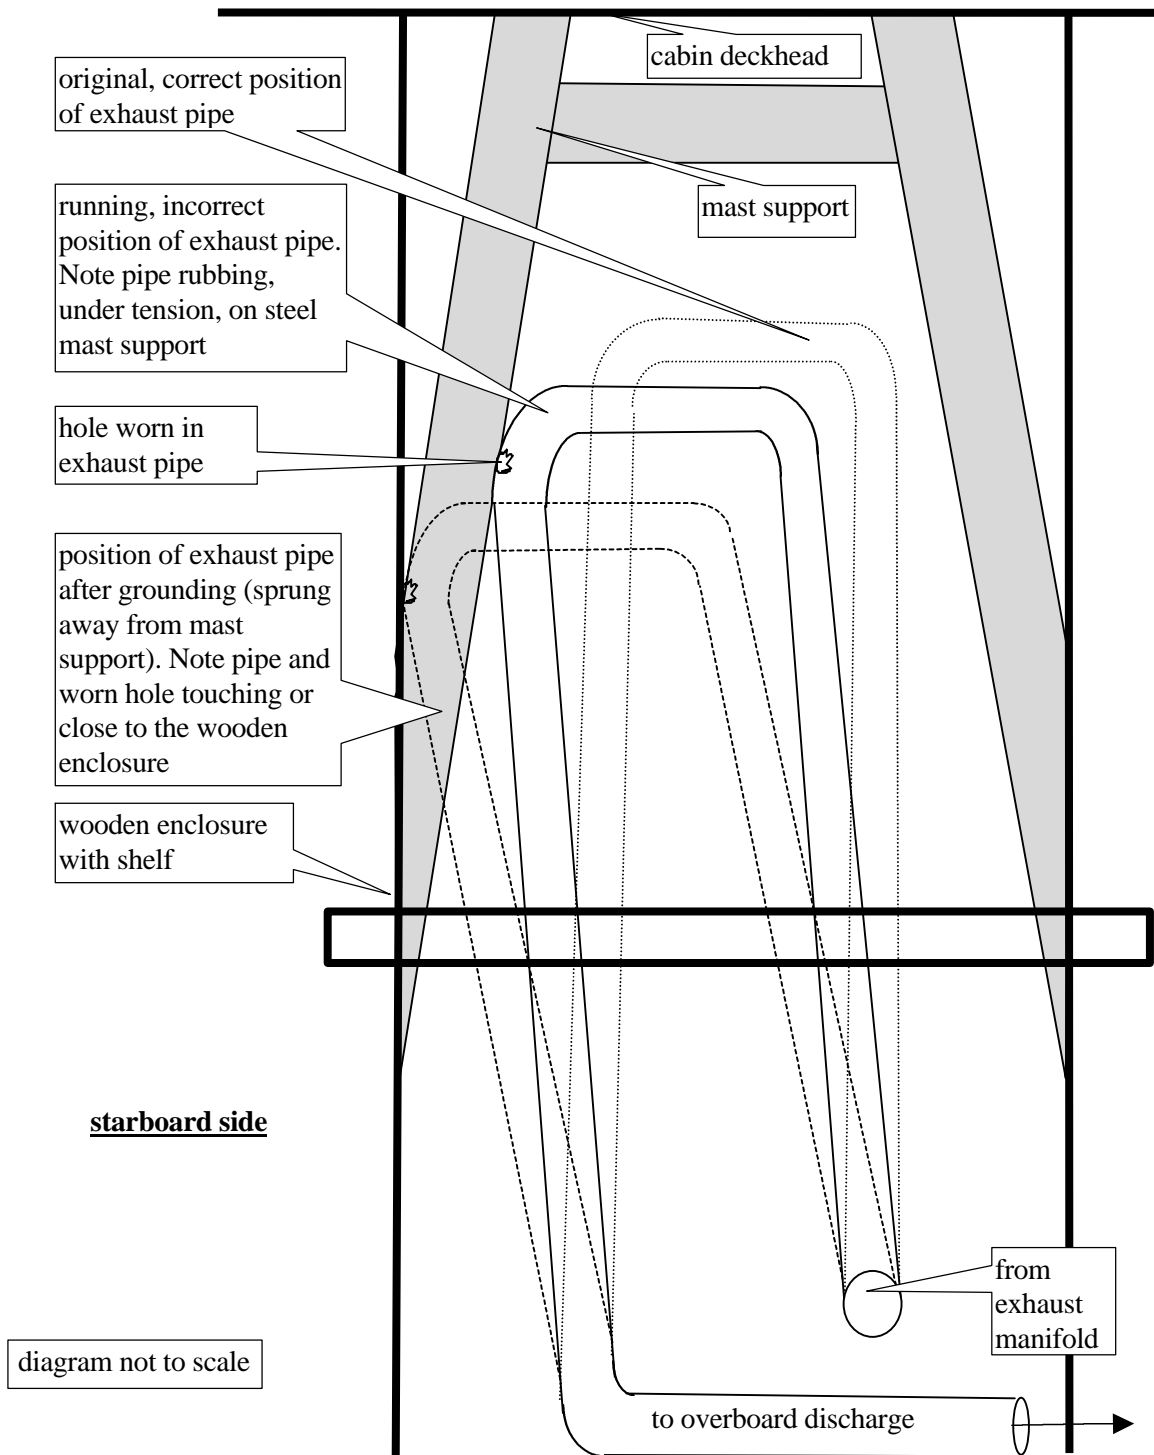
Figure 6

Front elevation showing exhaust pipe positions; designed original, as running and after grounding. Hole worn in exhaust pipe indicated to show the positions where formed and after grounding

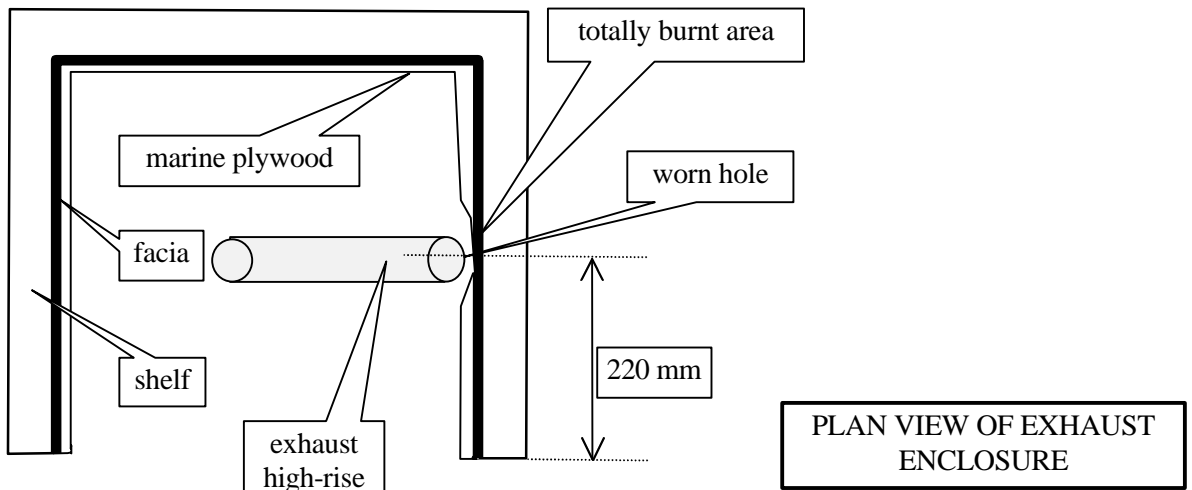
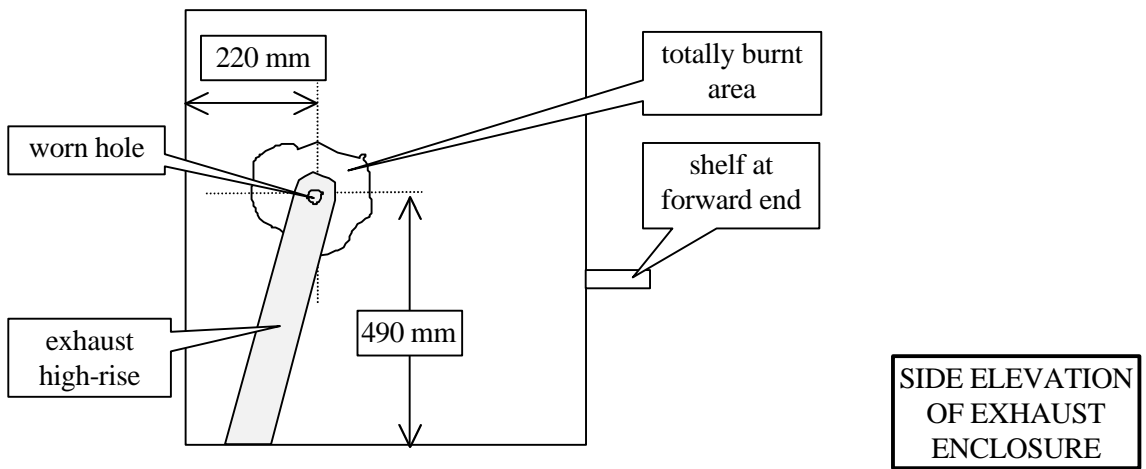
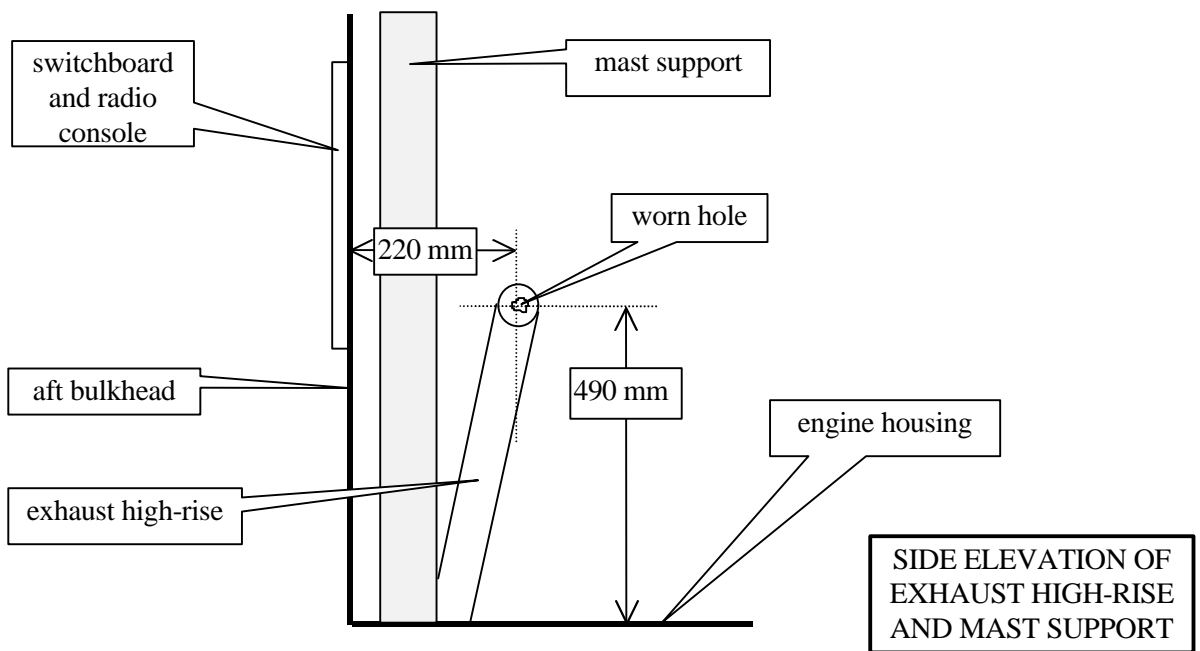
Figure 7
Diagram showing relationship between position of worn hole and seat of fire

- 1.2.6 The centre of the burnt circular area was 490 mm from the bottom of the enclosure and 220 mm from its aft end. Those measurements coincided exactly with the position of the worn hole in the exhaust pipe as it was found after the fire (see Figure 7).
- 1.2.7 The fire appeared to have moved up and across the forward panel of the enclosure to the deckhead above. The internal surfaces of the enclosure were extensively burnt. There was a panel aft of the mast support that separated the engine bay from the back of the switchboard and radio console. The panel did not reach fully to the deckhead and the fire had crossed over the top of the panel into the switchboard (see Figure 8).

- 2.2.11 The fire started on the plywood at the point of contact with the exhaust pipe. The burn patterns indicated that the fire spread upwards around the starboard and forward inner surfaces of the enclosure and set alight the deckhead within the structure. It then moved through to the aft end where the switchboard and radio console were housed.

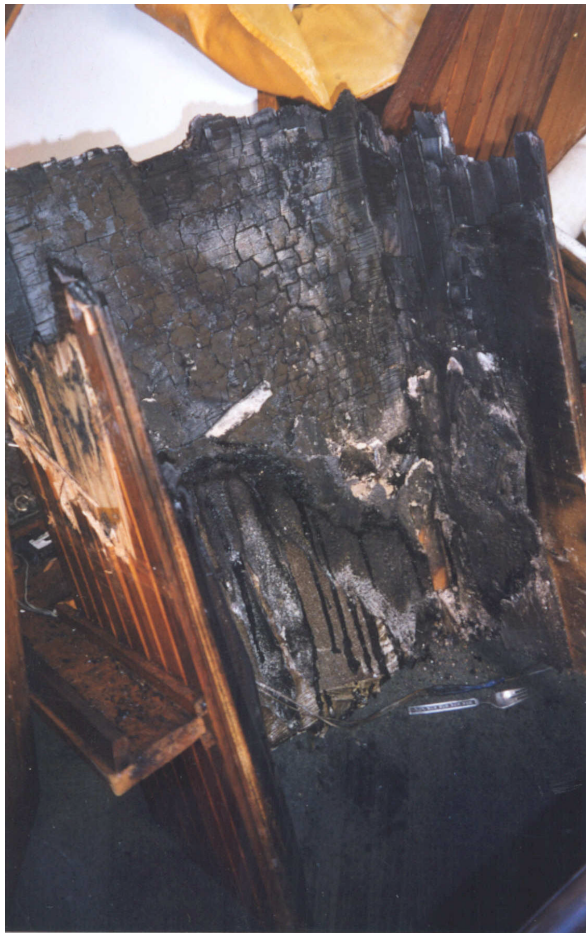
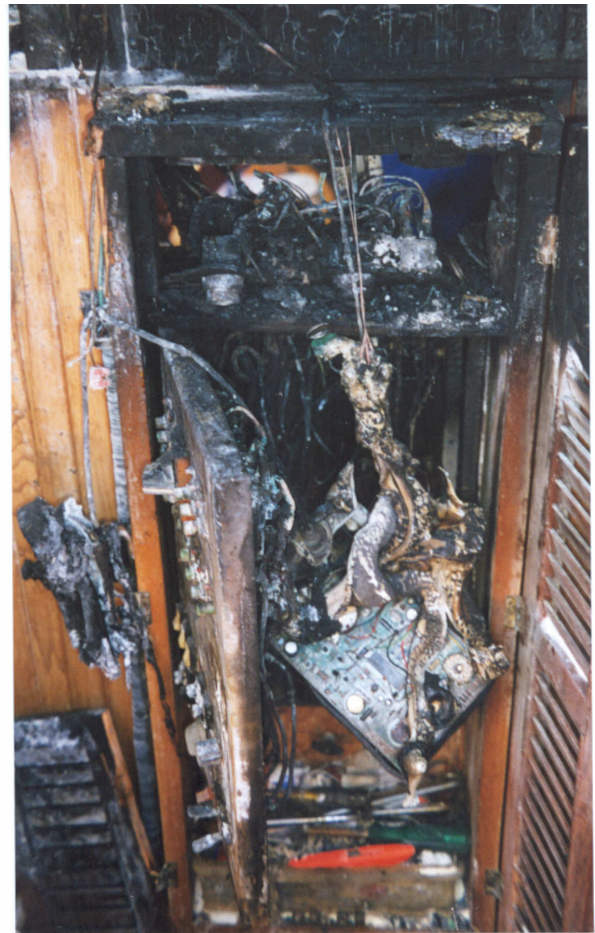
Figure 8

- 1.2.1 There was no damage caused to the hull by the grounding but the damage inboard caused by the fire was considerable. The switchboard and radio console were destroyed. The wooden enclosure of the exhaust high-rise and mast support suffered extensive fire damage on its internal surfaces. One section was destroyed by the fire-fighters when checking that the fire was fully extinguished. The cabin area had varying degrees of smoke damage.

Photographs showing fire damage to inside of engine exhaust enclosure and switchboard

- 2.2.1 The switchboard and radio console were completely destroyed. The external insulation on most of the wiring had either been burnt or melted in the fire. Plastic components of the switchboard and radios had also been burnt or melted. The wooden housing of the radios had burnt leaving the damaged components hanging by remaining wiring.
