**Report 99-207**  
**bulk log carrier *Pacific Princess***  
**grounding**  
**Pania Reef, Napier**  
**15 May 1999**

# Marine Accident Report 99-207

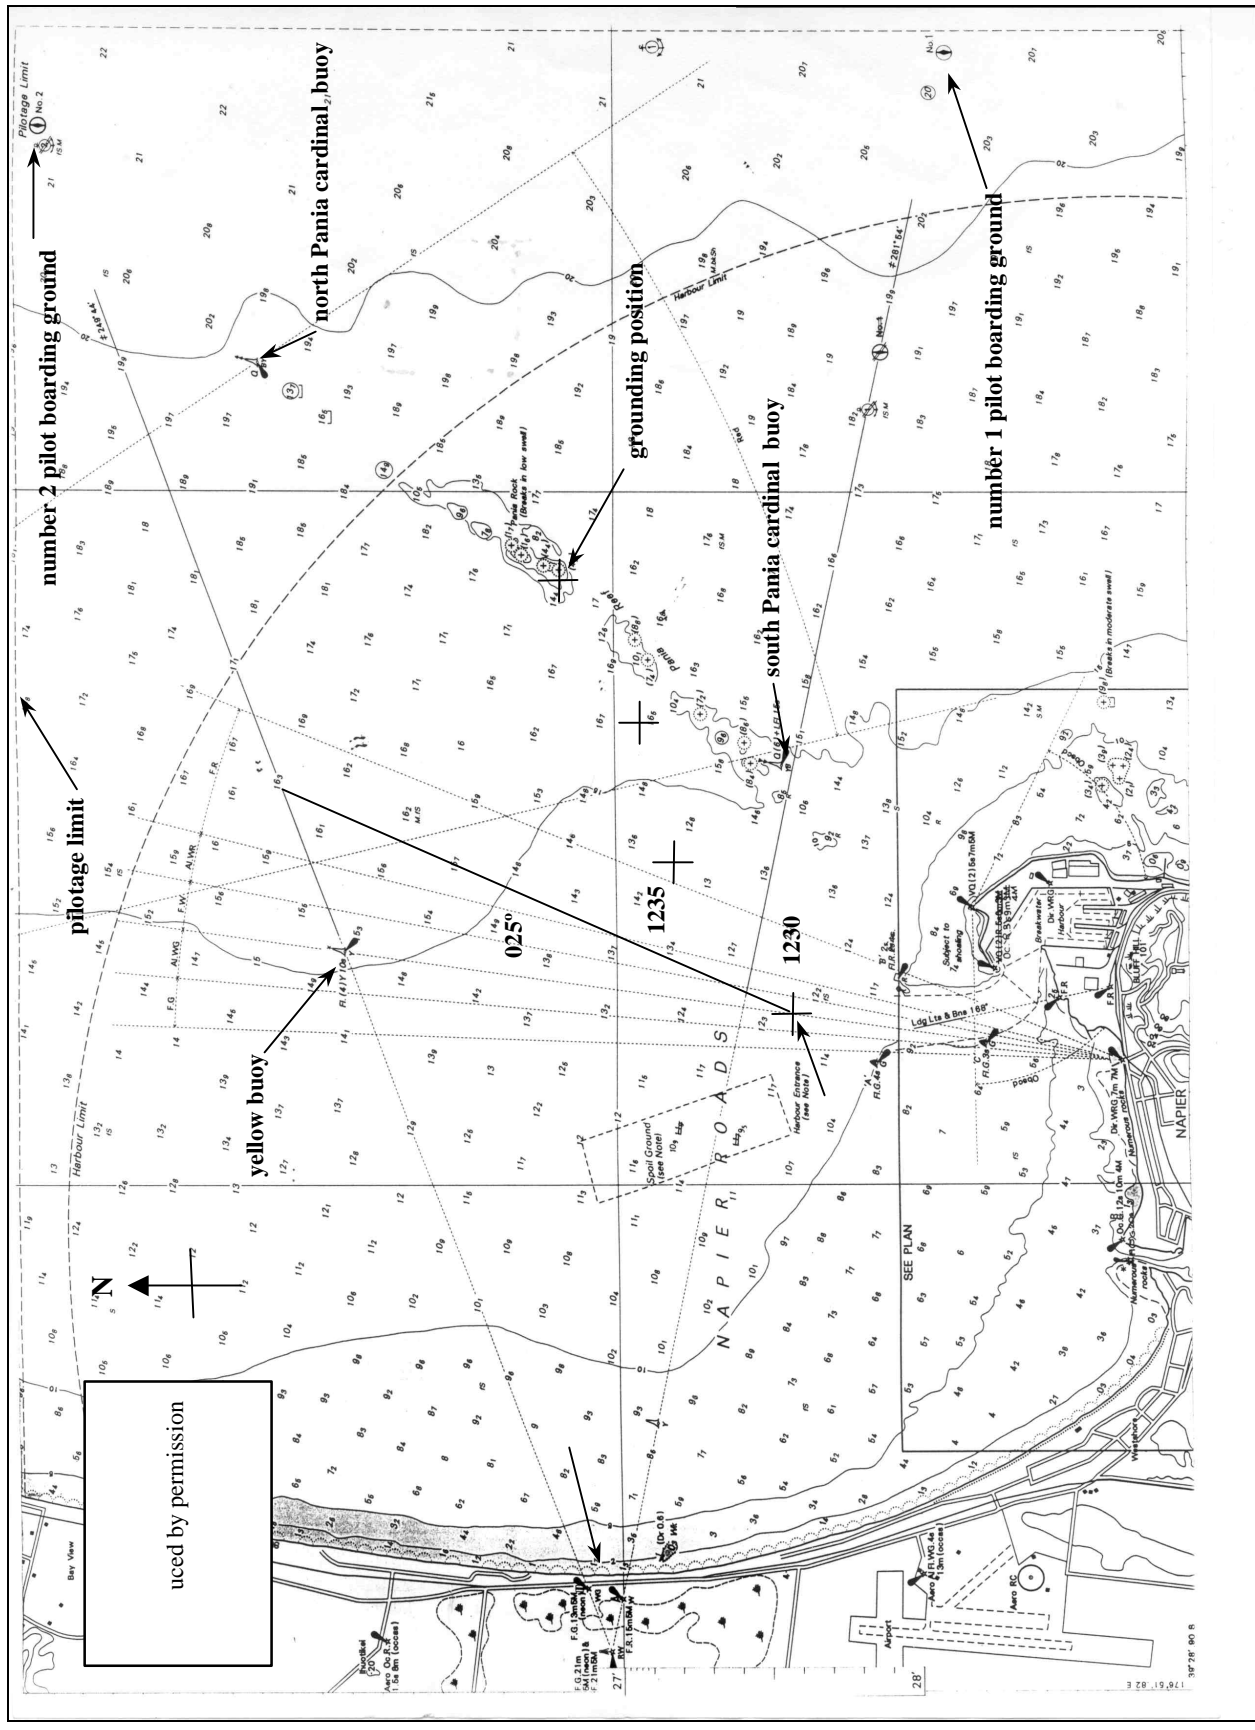
Figure 1  
Part of chart NZ 5712 showing relevant information

- 1.1.2 The vessel had departed from Japan with the charts required for the voyage to Tauranga on board. The master had intended to obtain charts NZ 571 and NZ 5712, Approaches to Napier and Napier Harbour, on arrival in Tauranga. The largest scale chart on board the *Pacific Princess* for arrival at Napier was NZ 56, Table Cape to Blackhead Point, which covered all of Hawke Bay and about 90 miles out to sea from Cape Kidnappers. Chart NZ 56 did have the number one pilot boarding ground marked on it. (See Figure 1.)

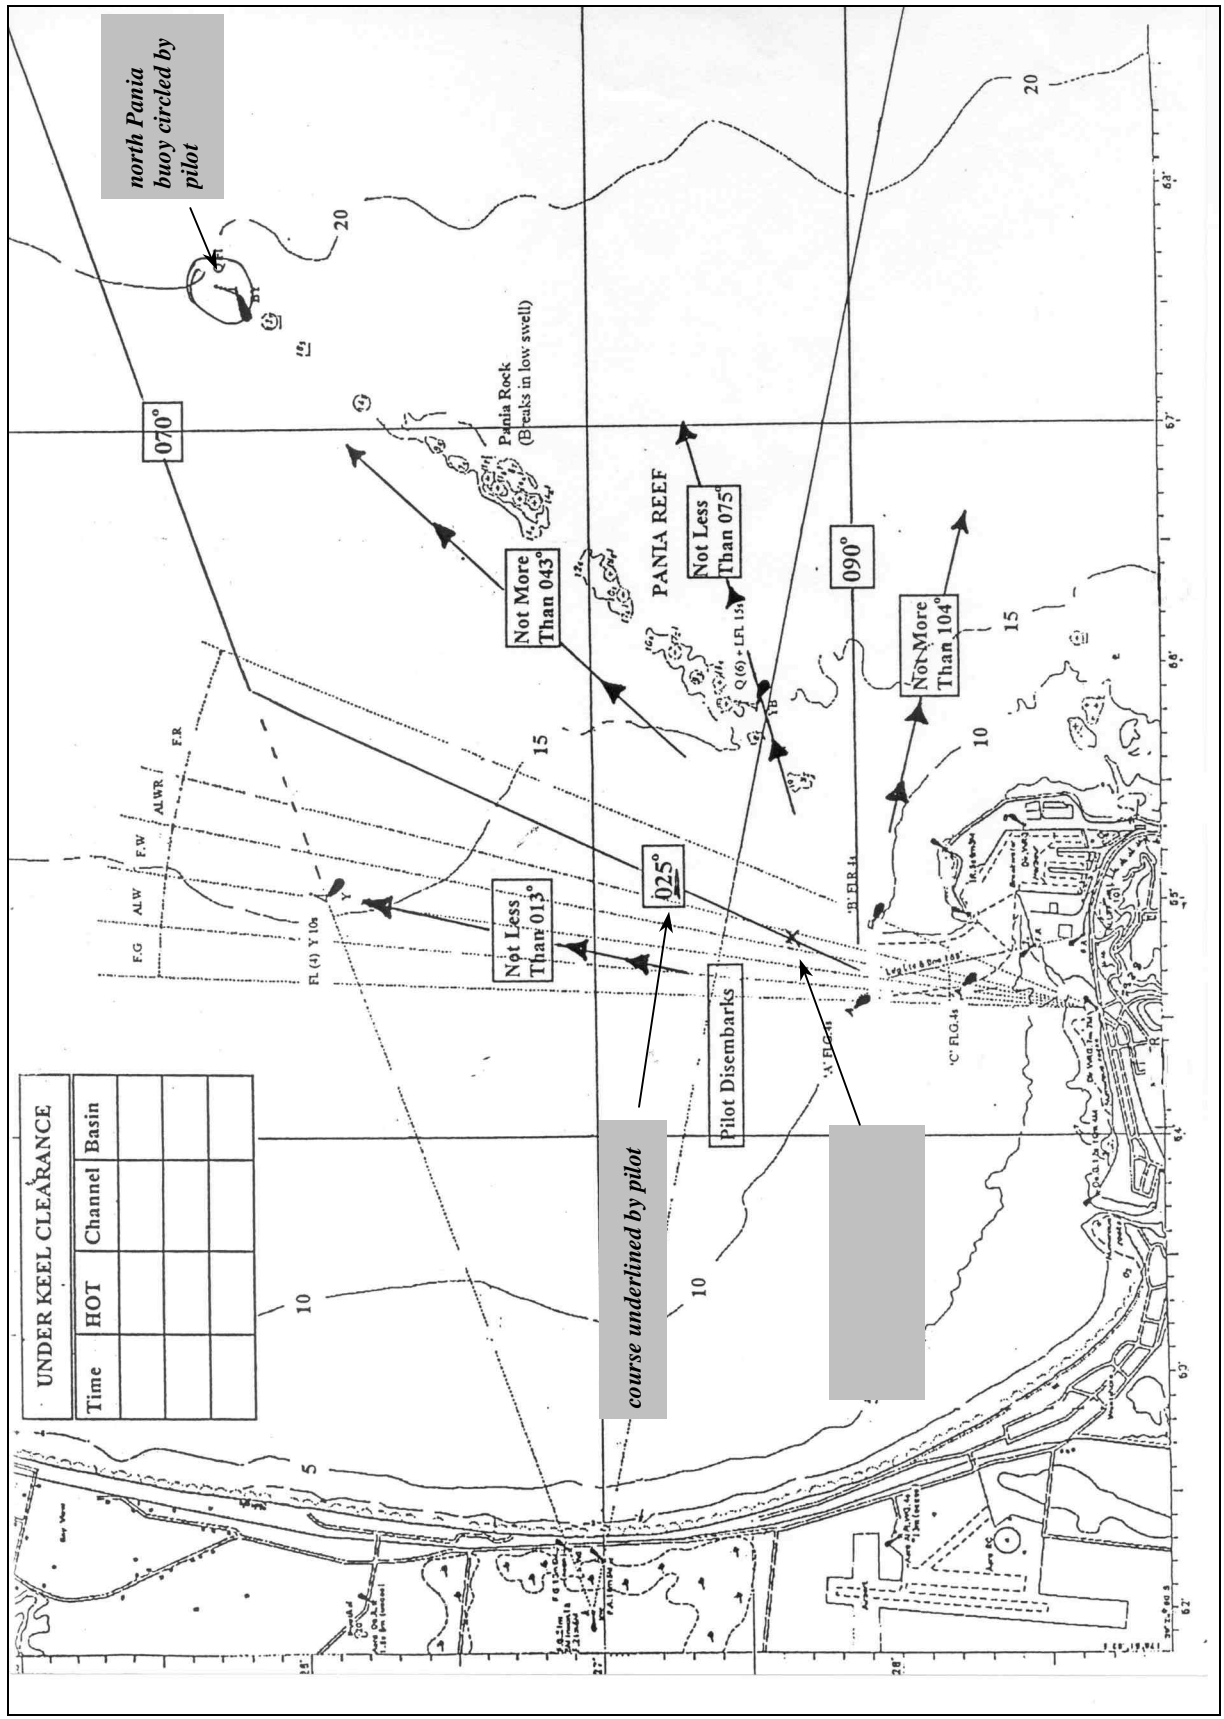
Figure 2  
The chartlet given to the master of the *Pacific Princess* by the pilot

- 1.1.13 On this premise the pilot discussed his passage plan with the master for a departure via the number 2 pilot boarding ground. The third mate was listening to the exchange of information but again was not actively involved. The pilot went over all aspects of the departure and gave the master a chartlet with the recommended courses to pass clear of Pania Reef drawn on it. (See Figure 2.)

- 2.14 Even though it was not necessary for the *Pacific Princess* to depart via the number 2 pilot boarding ground, the instructions and chartlet the pilot gave to the master were sufficient for the vessel to safely depart by this route. If the master had made a passage plan for the departure and listened attentively to, understood and followed the pilot's instructions he would have been more familiar with the area and conscious of the hazards he was likely to encounter.
