Report 99-210
commercial jet boat *Helijet 2*
collision with rockface
Kawarau River, Queenstown
20 August 1999

Abstract

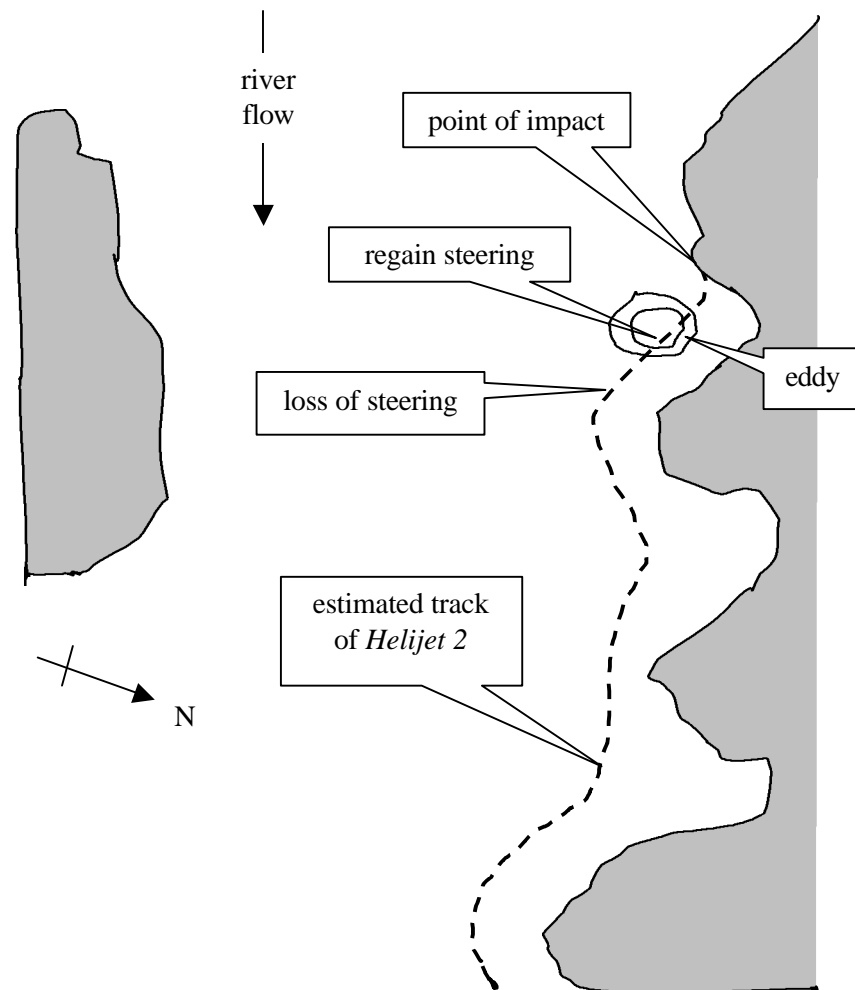
Figure 2
Schematic diagram of accident area
(not to scale)

- 1.1.10 Above Fishermans Hole, there was a series of rocky outcrops. Following his normal line, the driver steered *Helijet 2* about 0.5 m off the first outcrop at about 60 km/h. He turned slightly to the right into the cove formed by the first and second outcrops and then steered left to clear the second outcrop, again by about 0.5 m. He repeated this manoeuvre through the cove formed by the second and third outcrops.
- 1.1.11 When *Helijet 2* cleared the third outcrop the driver turned slightly to the right, intending to repeat the manoeuvre through the third cove. However, when he tried to steer back to the left he found that he could not turn the steering wheel. He immediately reduced the throttle and moved the wheel from side to side to free the steering nozzle (see Figure 2).

- 1.1.12 In the short time the driver took to free the steering, *Helijet 2* had travelled into the cove, was pointing directly at the rockface and was in a current eddy. The driver realised that the boat was going to strike the rockface and although he had already reduced the throttle, he felt that it was too late to apply reverse bucket³ to stop the boat in the remaining distance.
- 1.1.13 In order to avoid a head-on collision with the rocks, the driver applied full throttle and steered hard to the left. The boat turned away from the rockface but the right rear of the boat struck the rocks. The impact slowed the boat and swung it back to the right and the right front of the boat also hit the rocks (see Figure 3).

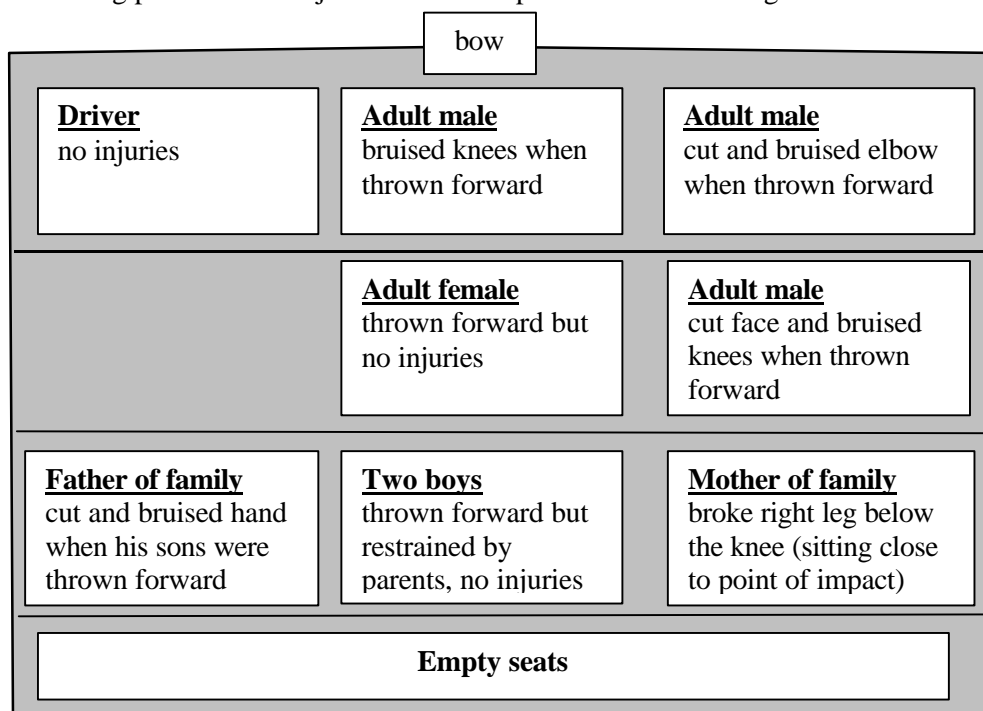
Figure 4
Diagram of boat showing seating position and injuries

- 1.2.3 The mother of the family held onto the life-jacket of her son sitting next to her but kept one hand on the handrail. The restraint created by both parents holding on to his life-jacket prevented any injury to the boy but the mother was thrown around in the boat, striking her leg between the seat back in front of her and the side of the boat. She was sitting closest to the point of impact on the starboard quarter and broke her right leg below the knee.

- 1.2.5 The seating positions and injuries to the occupants are shown in Figure 4 below.

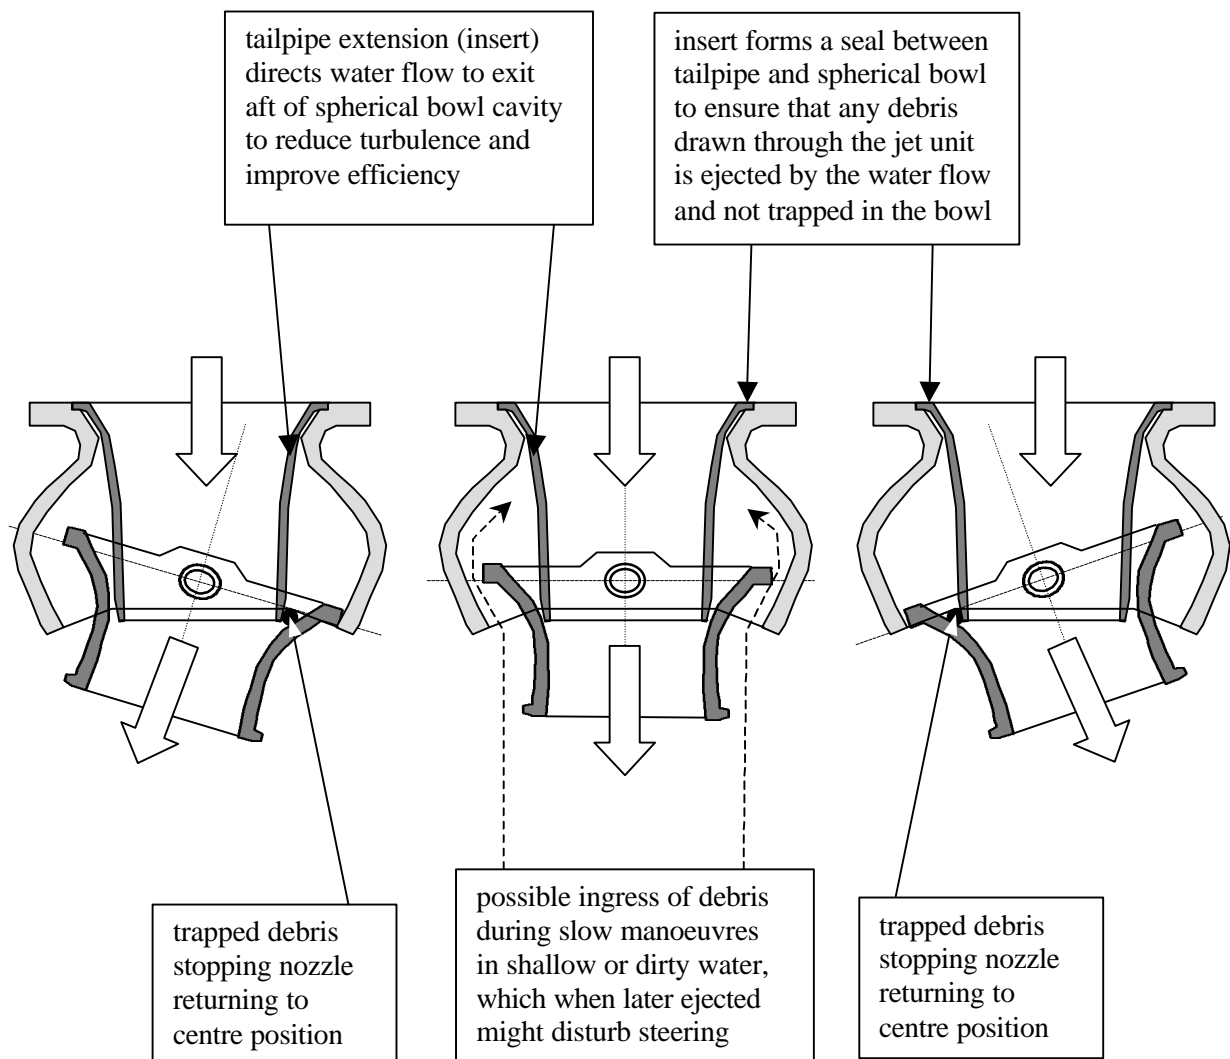
Figure 7
Diagram showing steering nozzle positions and possible effect of debris

- 1.9.5 The introduction of the insert in 1998 significantly reduced the possibility of debris entering the spherical bowl. The insert meant that the water flow, and any debris that it may contain, was directed through the bowl and into the mouth of the steering nozzle. The high speed and volume of the water flow when the boat was travelling in deep water at speed left almost no possibility for debris to enter the bowl (see Figure 7).

- 1.9.6 However, when a boat was manoeuvring in shallow water over sand and fine gravel, stopped in dirty water during driver commentaries or during reversing, it was still possible for small amounts of debris to enter the spherical bowl cavity from aft through the small gap between the inside of the bowl and the steering nozzle.
- 1.9.7 If debris entered the spherical bowl cavity it was possible for it to be held in there by the turbulence as the boat trip continued, but would more likely be ejected through the steering nozzle. It was, however, possible that debris could become lodged between the steering nozzle and the spherical bowl in much the same way as could happen before the introduction of the inserts (see Figure 7).

- 2.11 When manoeuvring in shallow water, stopped in disturbed water or stopped and holding position with reverse thrust in an area of dirty water, it would be possible for debris, either fine gravel or small floating objects, to enter the steering system from aft. Once within the spherical bowl the debris could be held there until the boat continued and would likely be ejected. However, there was the possibility that such debris could become trapped within the bowl and cause a steering lock-up.

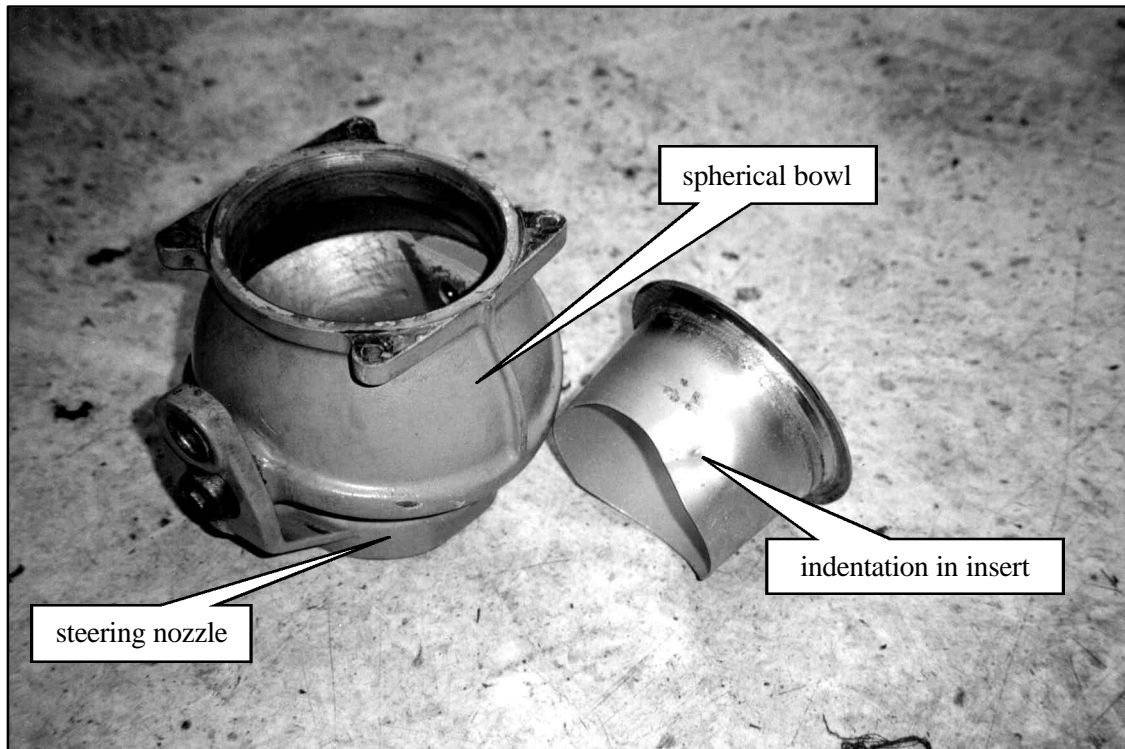
Figure 8
Photograph of steering components with insert from a similar boat

- 1.9.8 After the accident, the steering mechanism on *Helijet 2* was inspected but nothing untoward was found. No telltale marks were found on the steering components that were consistent with hard debris having been present and causing the steering lock reported by the driver.
- 1.9.9 The steering nozzle of another of the company boats was inspected and an indentation was found on the surface of the insert, indicating that at some time hard debris had entered the spherical bowl and had been trapped, and could have disturbed the steering of that boat in a similar way to that reported by the driver of *Helijet 2* (see Figure 8).

- 2.12 The dent found in the insert of a similar boat does not prove that debris had caused a steering lock-up on *Helijet 2*, but does show that ingress of debris is still possible even with an insert fitted. If debris had lodged in the nozzle of *Helijet 2* it was probably material such as vegetation.
