Report 99-211

petroleum products tanker *Kakariki*

near grounding

Victoria Channel, Port Otago

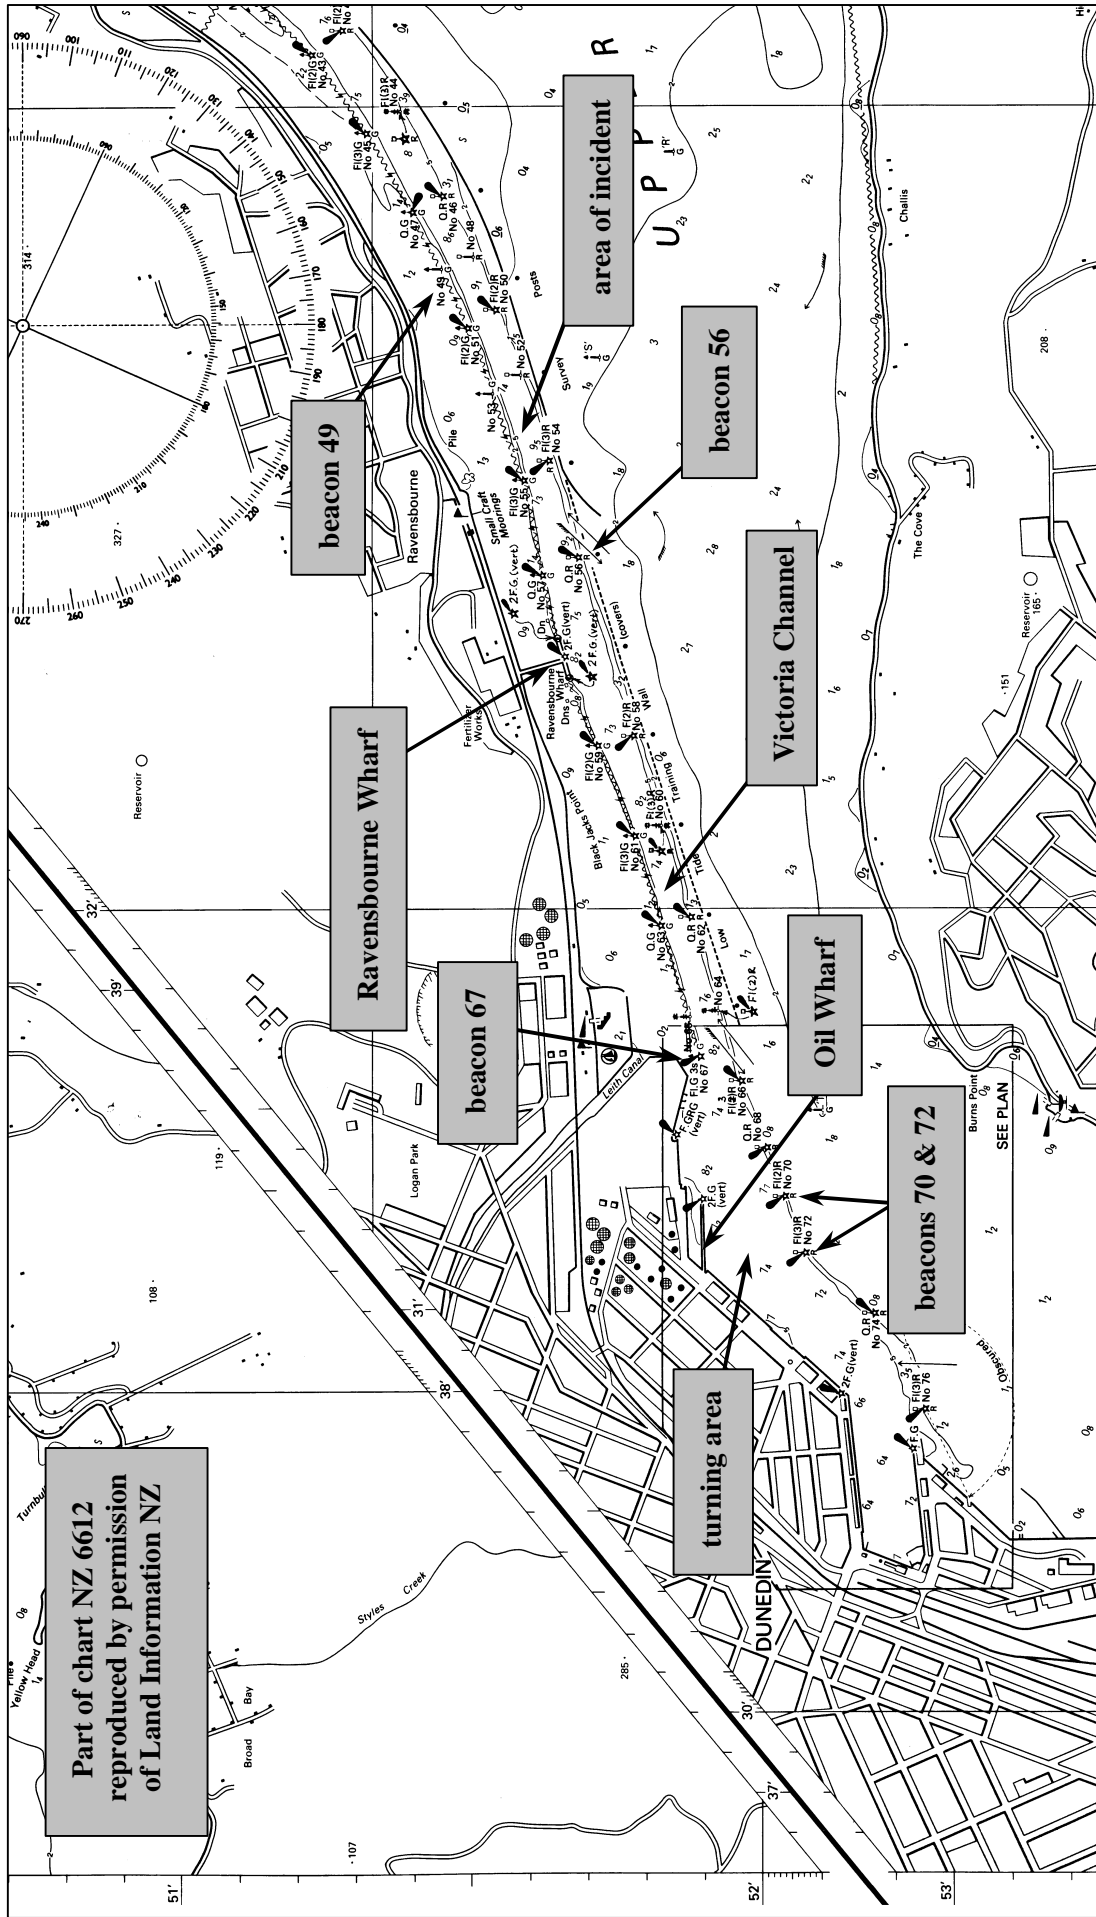
Figure 2 Part of chart NZ 6612 showing Dunedin Wharves and Victoria Channel in the vicinity of the incident

- 1.1.20 The pilot advised the trainee to increase the speed of the *Kakariki* in order to maintain good steerage as the vessel entered the channel. The trainee ordered slow ahead on the engine at 06:46:30 and half ahead at 06:50:30. The vessel was in the middle of the channel abeam of number 67 beacon at 0652 when the speed was observed to be 3.5 knots, and increasing. The chief officer continued calling out the speed of the vessel periodically. (See Figure 2.)

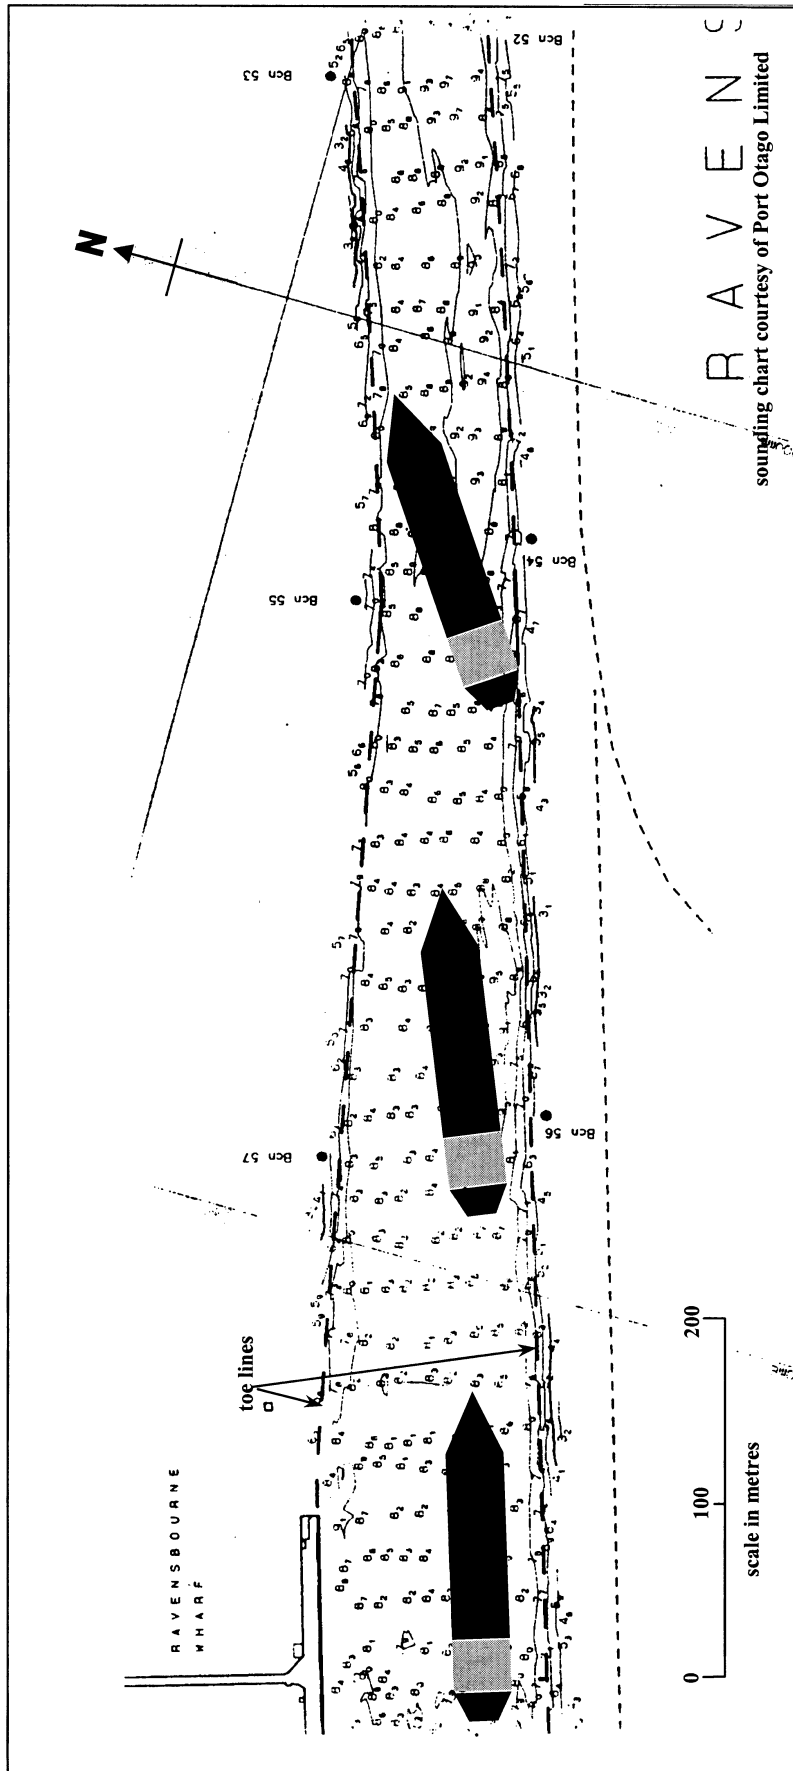
Figure 3
 Diagram showing the probable track of the kākāriki in Victoria Channel

- 1.1.29 The master had noted that the *Kakariki* was on a course of 072 degrees true before it sheered to port and that the heading reached 055 degrees true before the swing was arrested. With the heading on 055 degrees true the master recalled that the bow was pointing midway between beacons 55 and 53. (See Figure 3.)

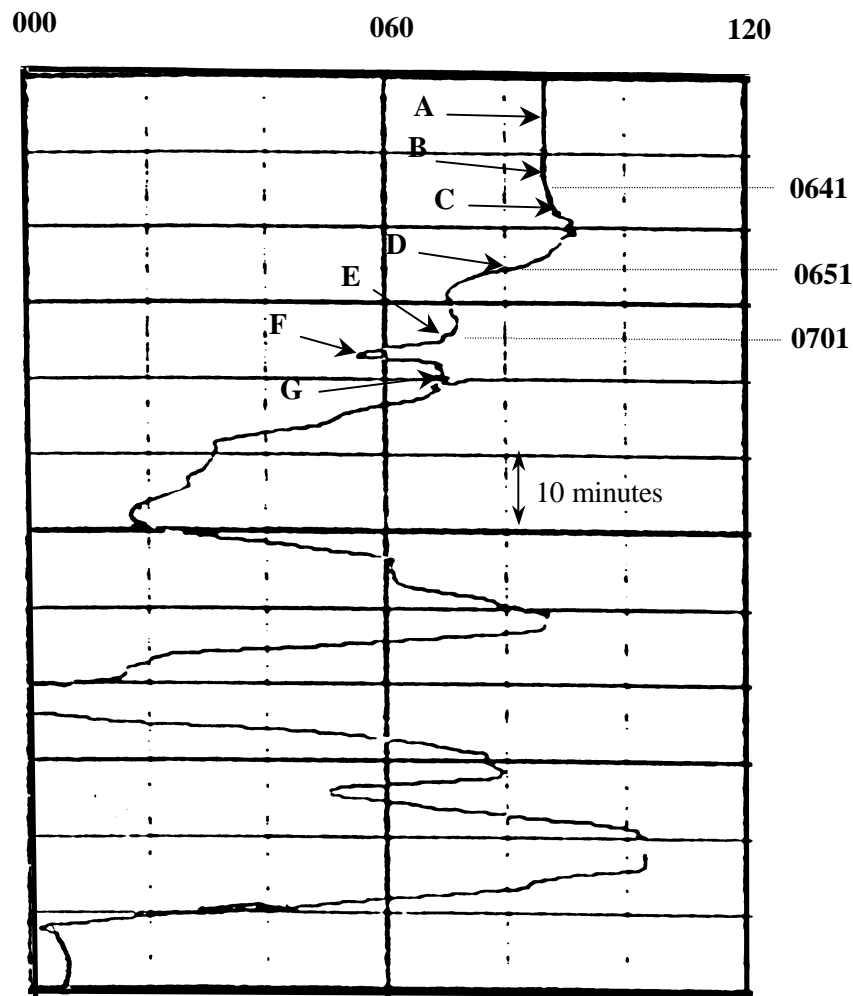
Figure 4
The course recorder trace

1.4.1 The relevant section of the course recorder trace was obtained and later analysed (See Figure 4). The trace was not referenced to either NZST or UTC but the relevant section of the trace was able to be identified. By assuming that the vessel commenced to swing to starboard at 0641 when the last line was let go, the times were inserted as shown in Figure 4. The trace below indicates the true heading of the vessel at various stages of the incident.

position	occurrence
A	<i>Kakariki</i> port side alongside the Oil Wharf
B	let go last line
C	<i>Kakariki</i> swings to starboard manoeuvring off berth
D	abeam of beacon 67
E	<i>Kakariki</i> steering 072 degrees true takes sheer to port
F	<i>Kakariki</i> heading 055 degrees true before sheer is arrested
G	<i>Kakariki</i> realigned with the channel

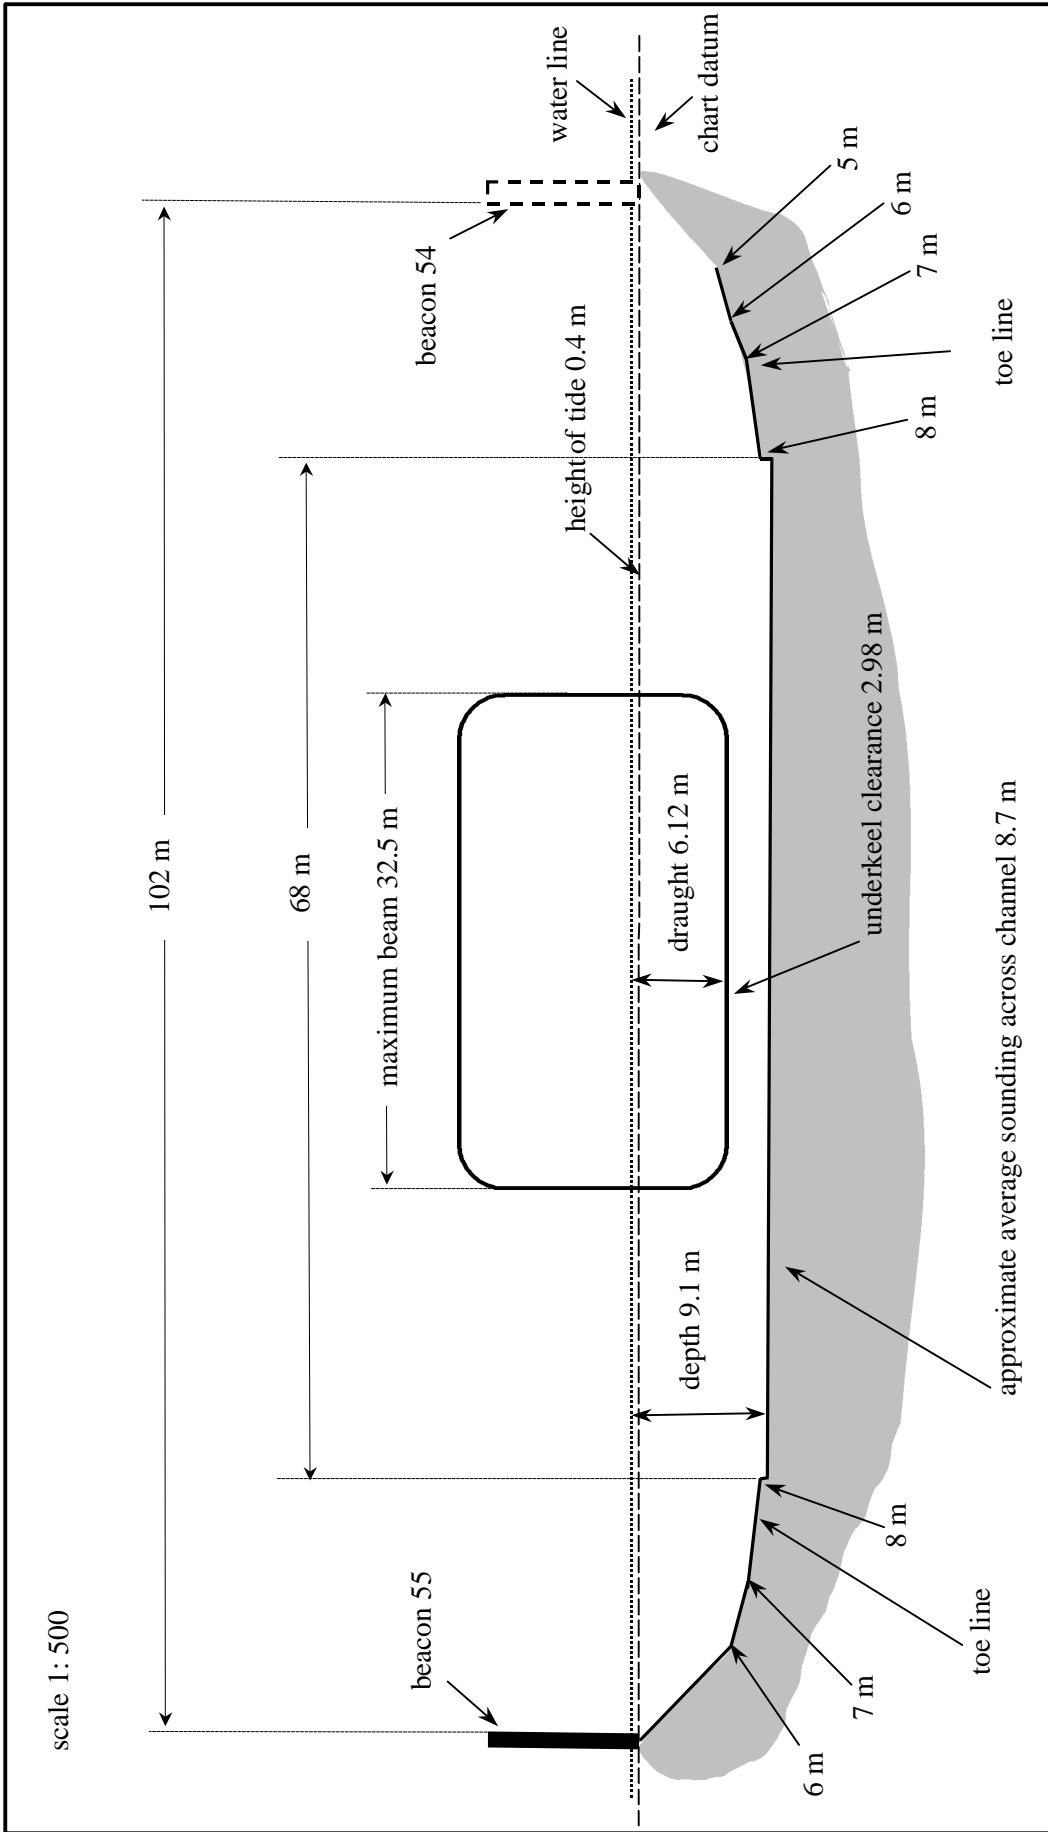
Figure 6
 Cross section of Victoria Channel in vicinity of beacon 55 at approximately 0700 on 23 September 1999, showing the *Kakariki* mid-channel, drawn to scale 1:500

- 1.6.3 From Halfway Islands to Dunedin the channel was named Victoria Channel, which was about 6 miles long and was dredged to a minimum depth of 7.3 m. The bottom and sides in the channel consisted mainly of sand, mud and clay. Both sides of Victoria Channel were marked by spar beacons, most of which were lit.
- 1.6.4 The distance measured between the toe lines on each side of the upper section of Victoria Channel varied from a minimum of about 73 metres in the vicinity of beacon 38 to a maximum of about 130 m off Ravensbourne Wharf. For the majority of the channel the distance between the toe lines was less than 80 m.
- 1.6.5 The distance between the toe lines in the vicinity of beacon 55, where the incident occurred, was about 76 m and the depth across the channel, as indicated on the sounding chart, averaged about 8.7 m. (See Figure 6.)

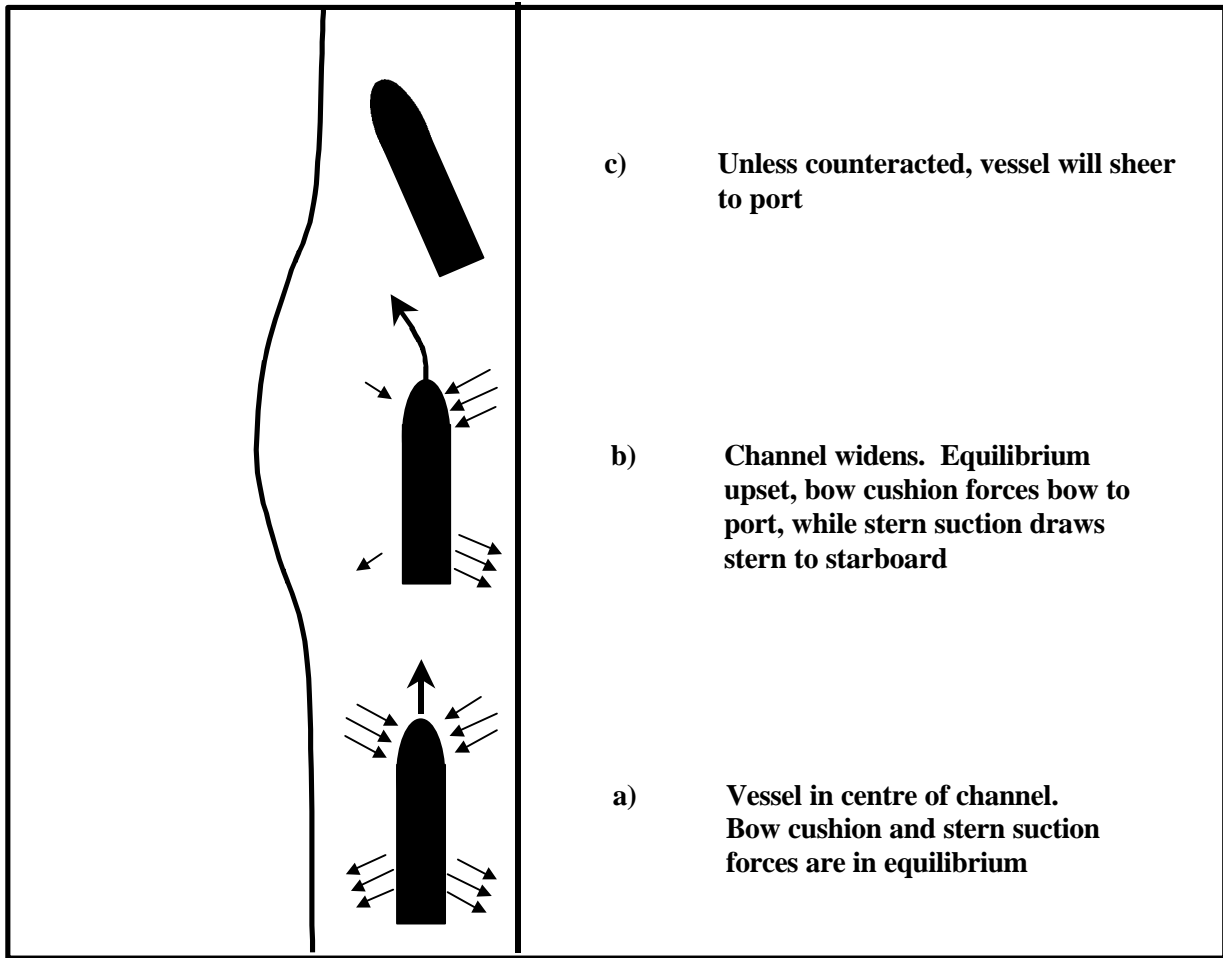
Figure 7
Diagram showing the effects of interaction as a channel widens

- 2.1.14 It was probably the start of the sheer that alerted the chief officer to the fact that the stern was closer to the beacon on the starboard side than normal. The sheer may have been exacerbated by the vessel squatting by the head.
