Final Report AO-2015-007: Airbus Helicopters AS350BA, ZK-HKU,
collision with terrain, Fox Glacier, 21 November 2015

Aviation inquiry AO-2015-007
Airbus Helicopters AS350BA, ZK-HKU
Collision with terrain
Fox Glacier
21 November 2015

Approved for publication: February 2019

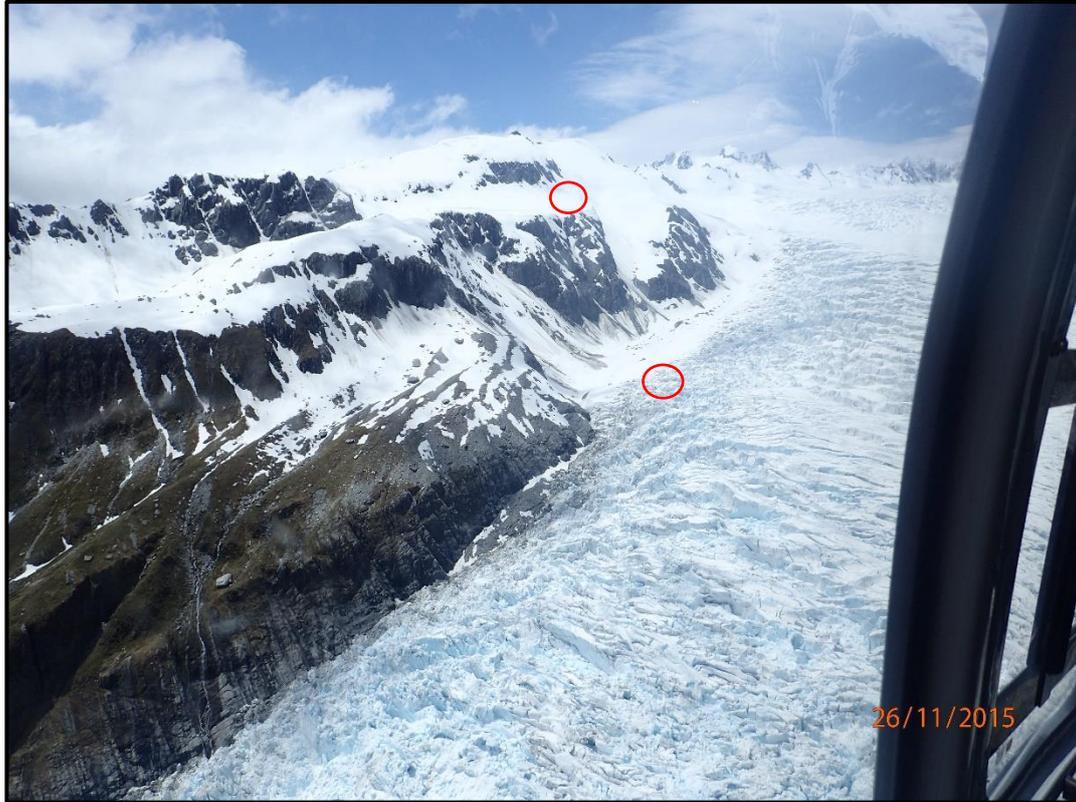
Figure 1
Chancellor Shelf, with accident site below

- 3.1.10. During the search, fresh helicopter landing skid tracks were seen in the snow on Chancellor Shelf. After searching for approximately 10 more minutes the search pilot found the wreckage of the helicopter. It had crashed near the right edge⁶ of the upper Fox Glacier, about 600 m south of and 800 ft (244 m) below Chancellor Shelf (see Figures 1, 2 and 3).

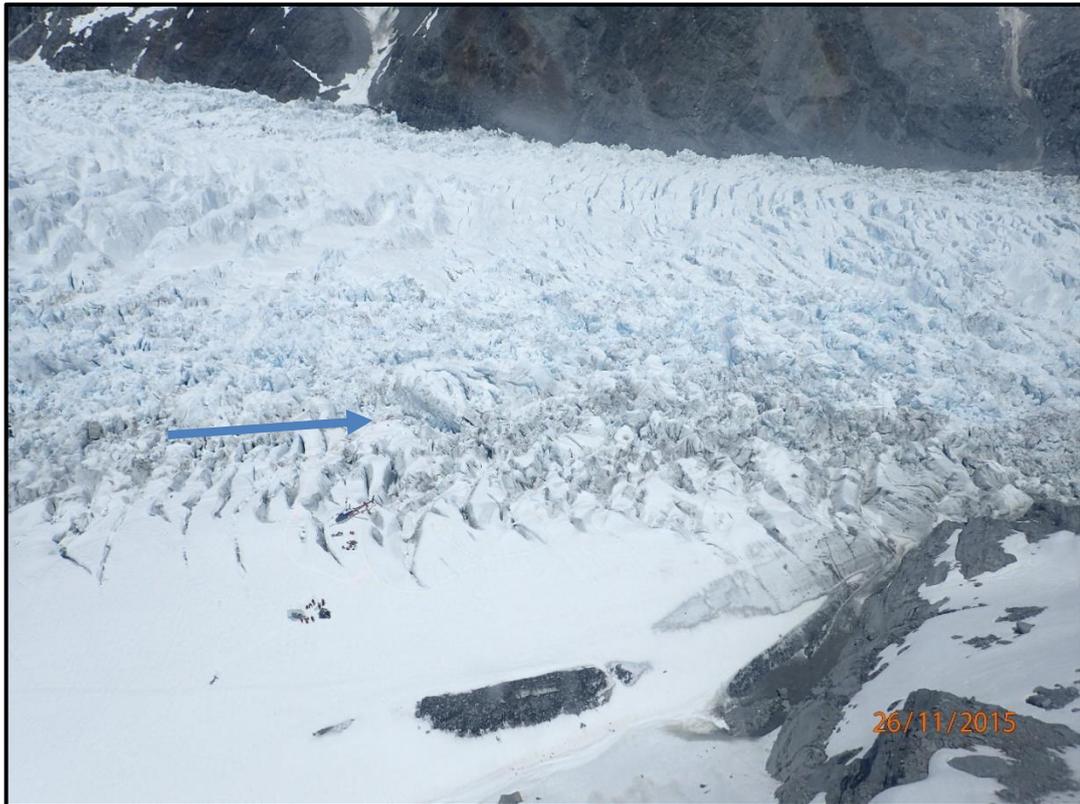
Figure 2
Overview of site (taken during recovery operations)

Taken abeam the edge of Chancellor Shelf, and showing likely direction at impact

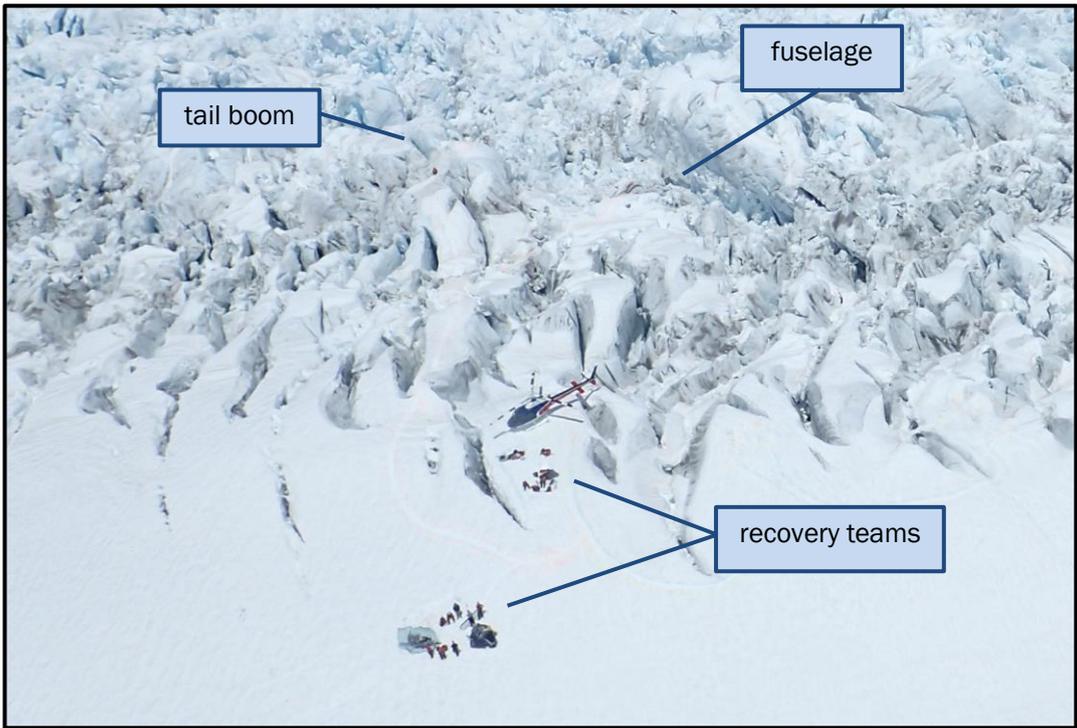
Figure 3
Closer view of site, showing where main wreckage was found

- 3.2.4. The rest of the wreckage was mainly in two areas. The first included the tail boom with tail rotor assembly still attached. The upper vertical stabiliser and both horizontal stabilisers also remained attached to the tail boom. The underside of the tail boom had no obvious impact damage. An empty steel ski basket, which had been attached to the left side of the landing

- 3.2.6. The four transmission suspension bars that attached the main transmission assembly to the fuselage had sheared, causing the assembly to detach from the fuselage. The rotor shaft and the rotor head with attached blades were still attached to the main transmission. One of the three main rotor blades was broken about 2 m from the hub, but the other two had little damage on their leading edges and were lying either side of an ice mound.

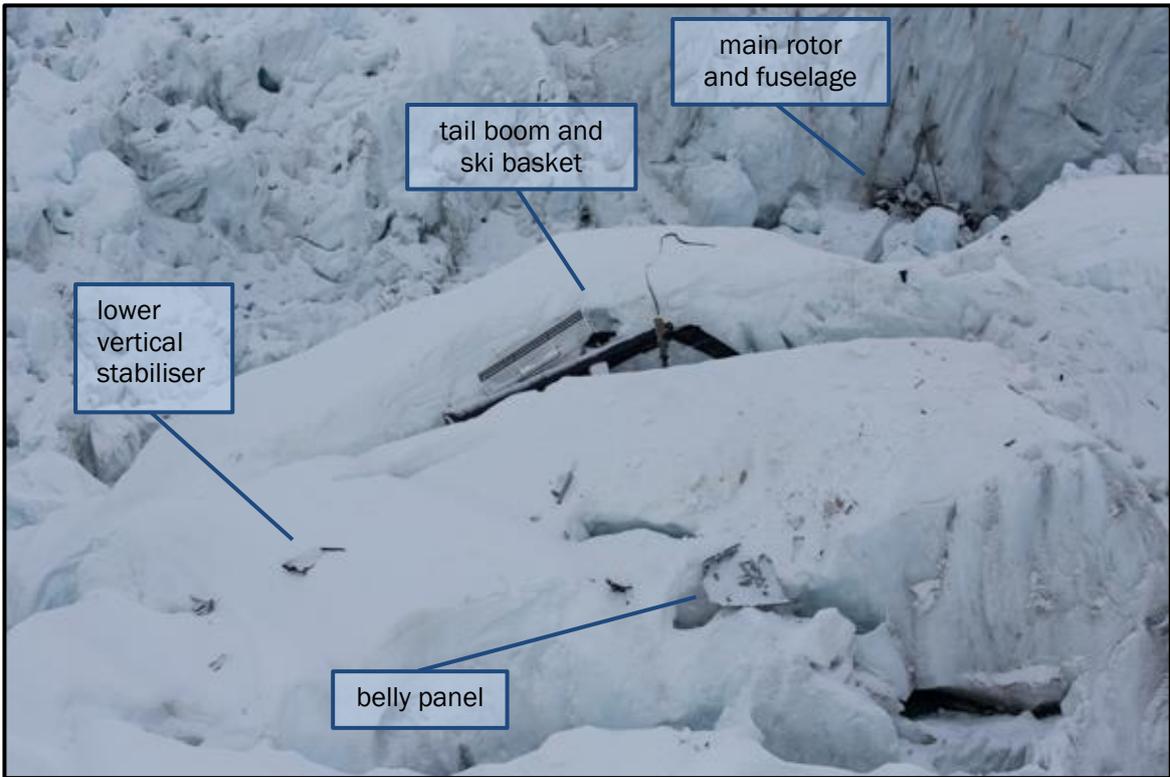
Figure 4
Accident site

Taken the next day after overnight snow
(Photograph courtesy of New Zealand Police)

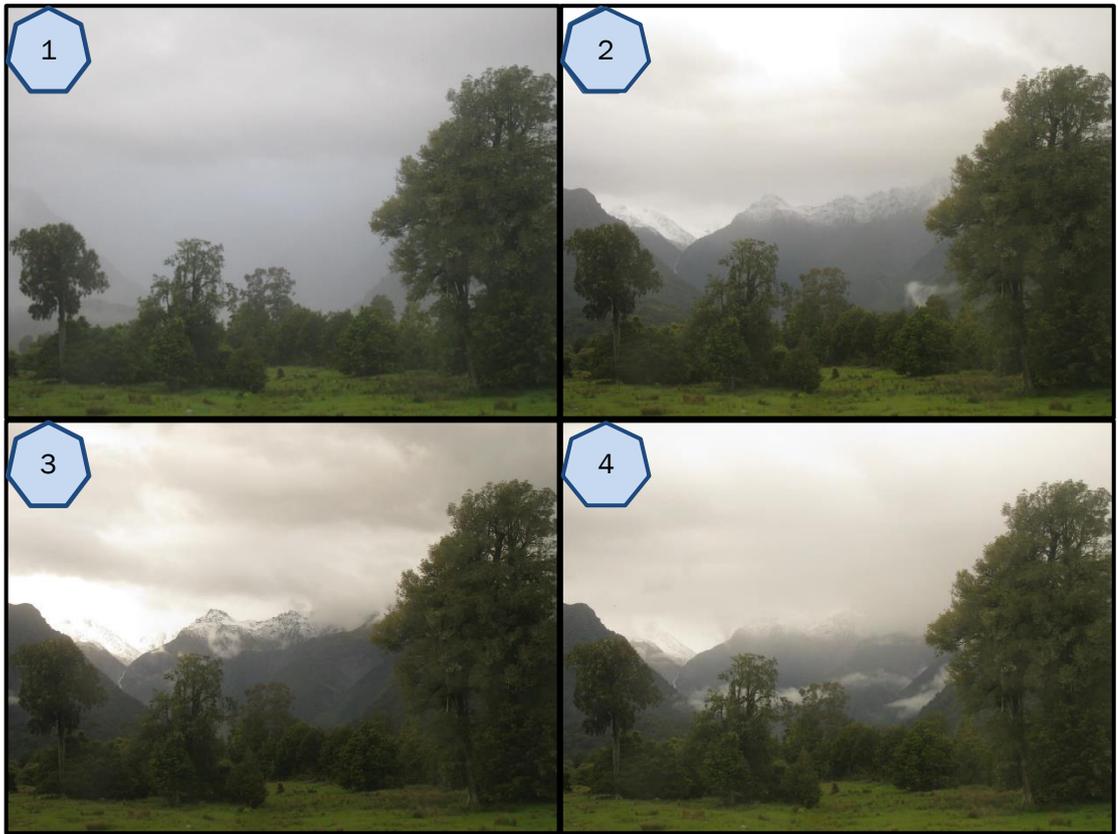
Figure 6
Images recorded by webcam near the operator's Fox Glacier base

- 3.5.6. Images from a camera near the operator's base showed rain and low cloud in the Fox River valley at about the time the pilot decided to postpone the early flights, and that visual meteorological conditions likely prevailed when the scenic flight departed (see Figure 6).

Image 1: 0700 – flying postponed Image 2: 0832 – decision to fly guides
 Image 3: 0925 – decision to fly scenic Image 4: 0945 – scenic flight departs

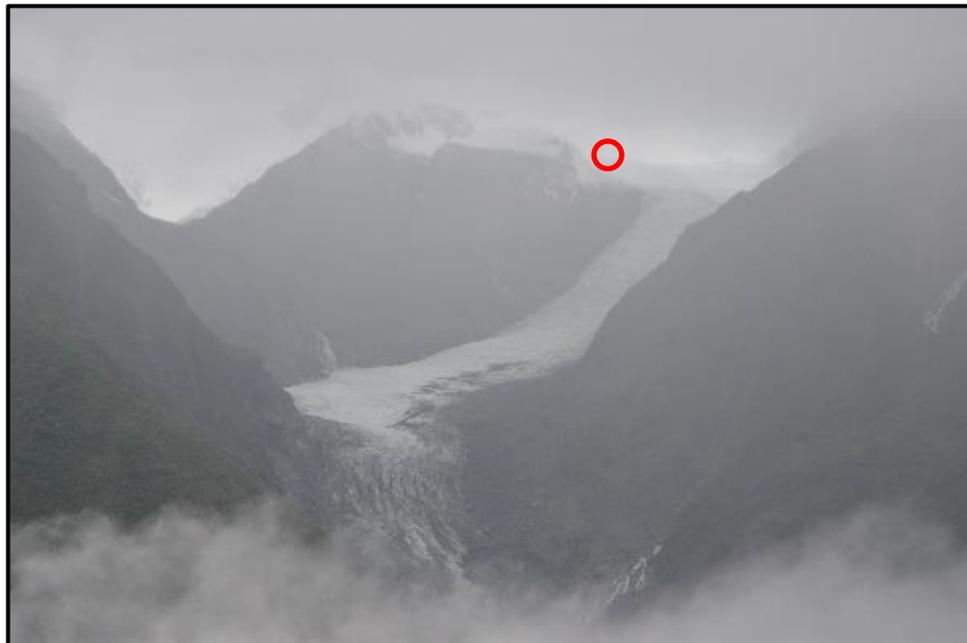
Figure 7
Weather when flying up Fox Glacier

- 3.5.9. Photographs recovered from some passengers' cameras showed that on leaving the operator's base there was light rain and the sky was overcast with patches of low cloud at the sides of the valley. The visibility and cloud conditions at that time appeared to be better than the minimum requirements for flight under visual flight rules (see Figure 7).

Chancellor Shelf is in the direction of the circle
 (Source: a passenger's camera)

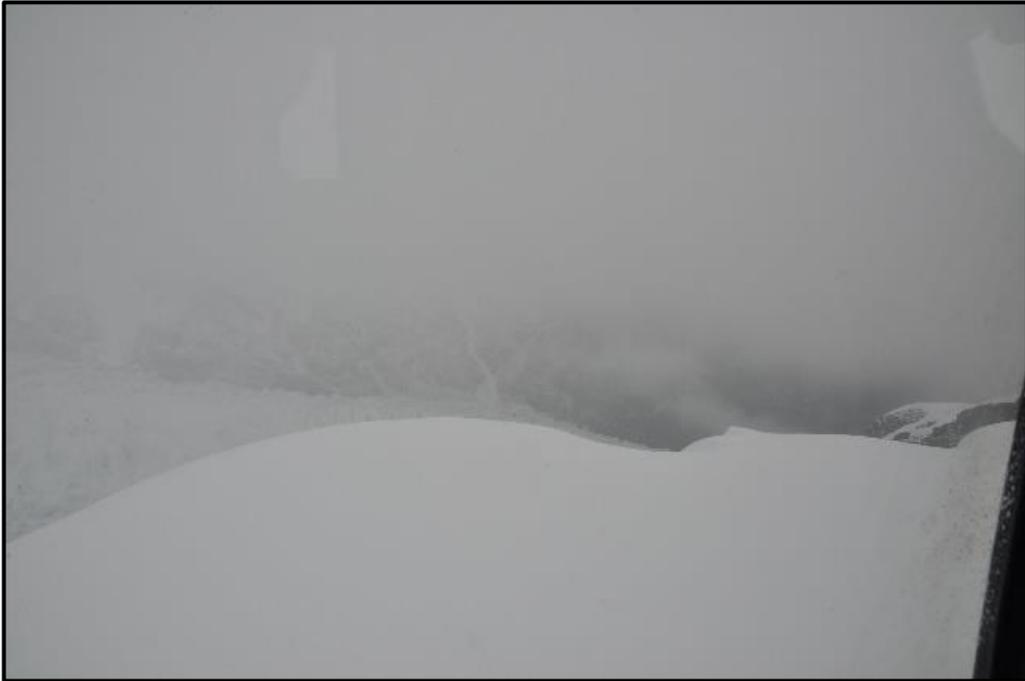
Figure 8
Weather when about to land at Chancellor Shelf

- 3.5.11. The passengers' photographs showed snow falling while the helicopter was parked on Chancellor Shelf. Initially the edge of the shelf was discernible, but other photographs showed that within a few minutes there was no obvious distinction between the snow surface and the cloud.

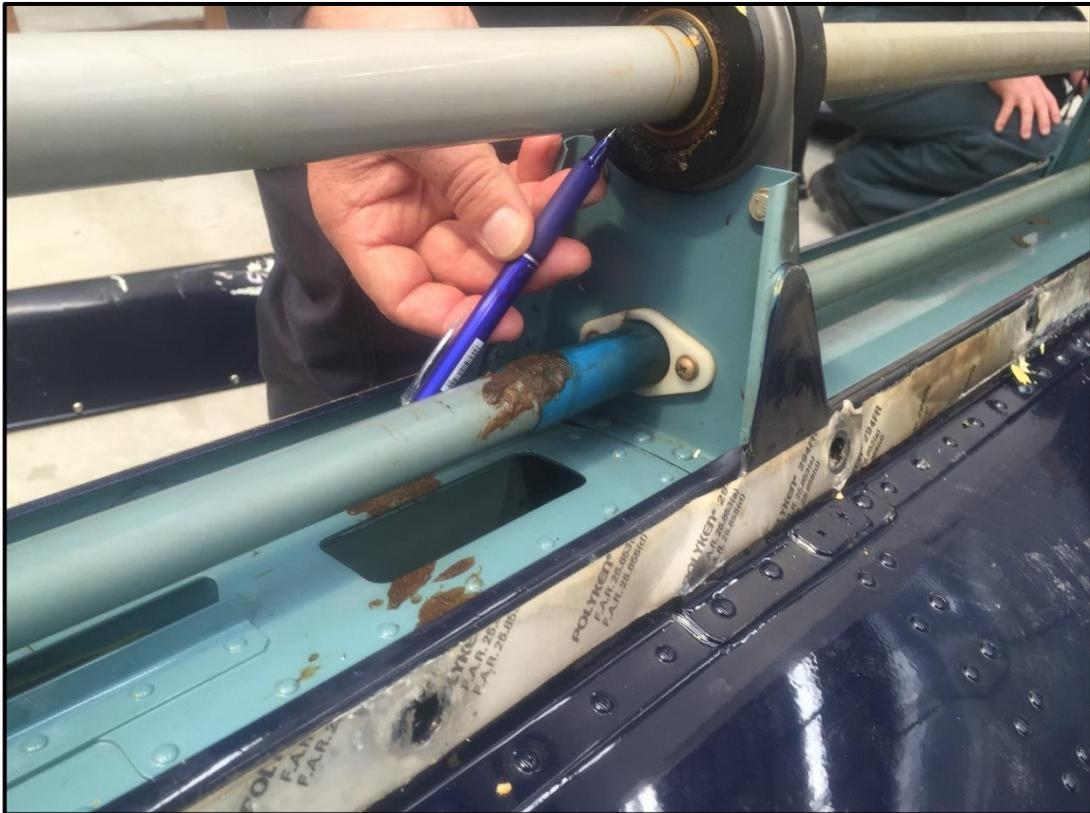
Figure 10
Grease throw on tail rotor drive shaft
