Final Report AO-2015-009: Air traffic control incidents,
Hamilton aerodrome, 17 December 2015

Aviation inquiry AO-2015-009
Air traffic control incidents
Hamilton aerodrome
17 December 2015

Approved for publication: August 2018

Transport Accident Investigation Commission

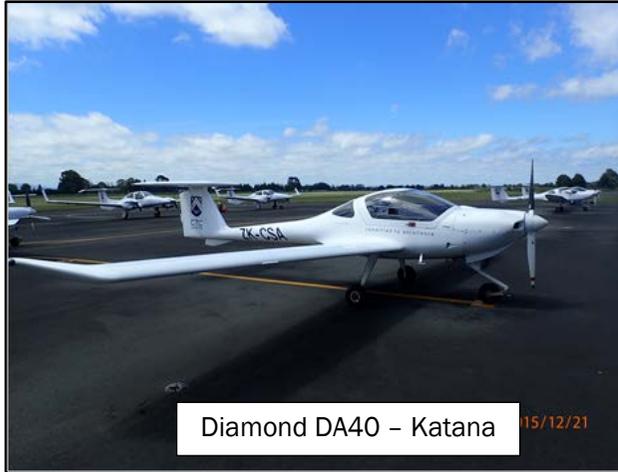
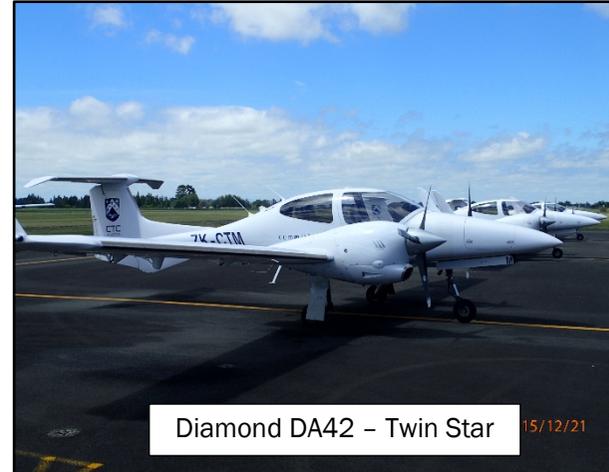
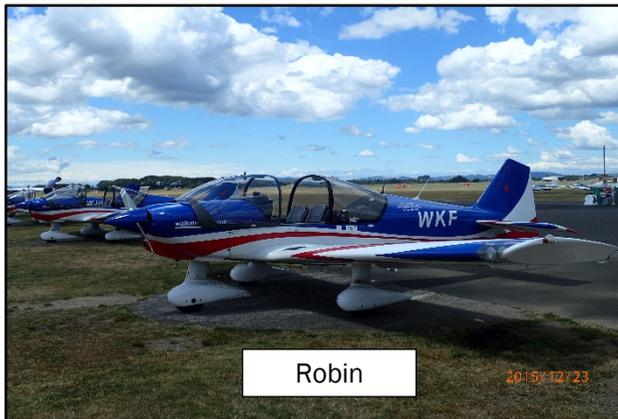
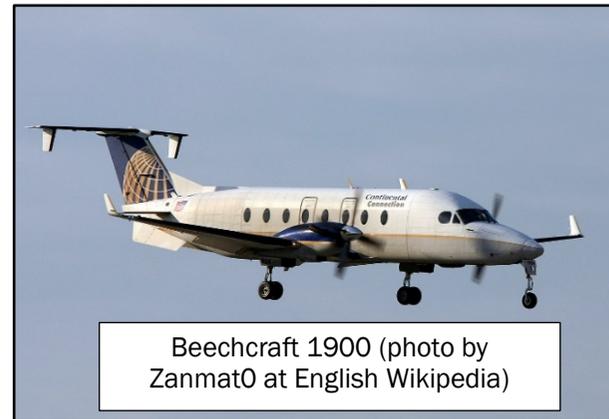
Figure 1
The aircraft involved

- 3.5.1. The aircraft involved in the final incident were a Diamond DA20 Katana single-engine trainer and a Diamond DA42 Twin Star light twin-engine trainer.

- 3.5.2. The Beechcraft 1900 was the aircraft that did the low approach and overshoot. The two aircraft that were directed into conflict with each other in the downwind leg were a Robin and a Katana.

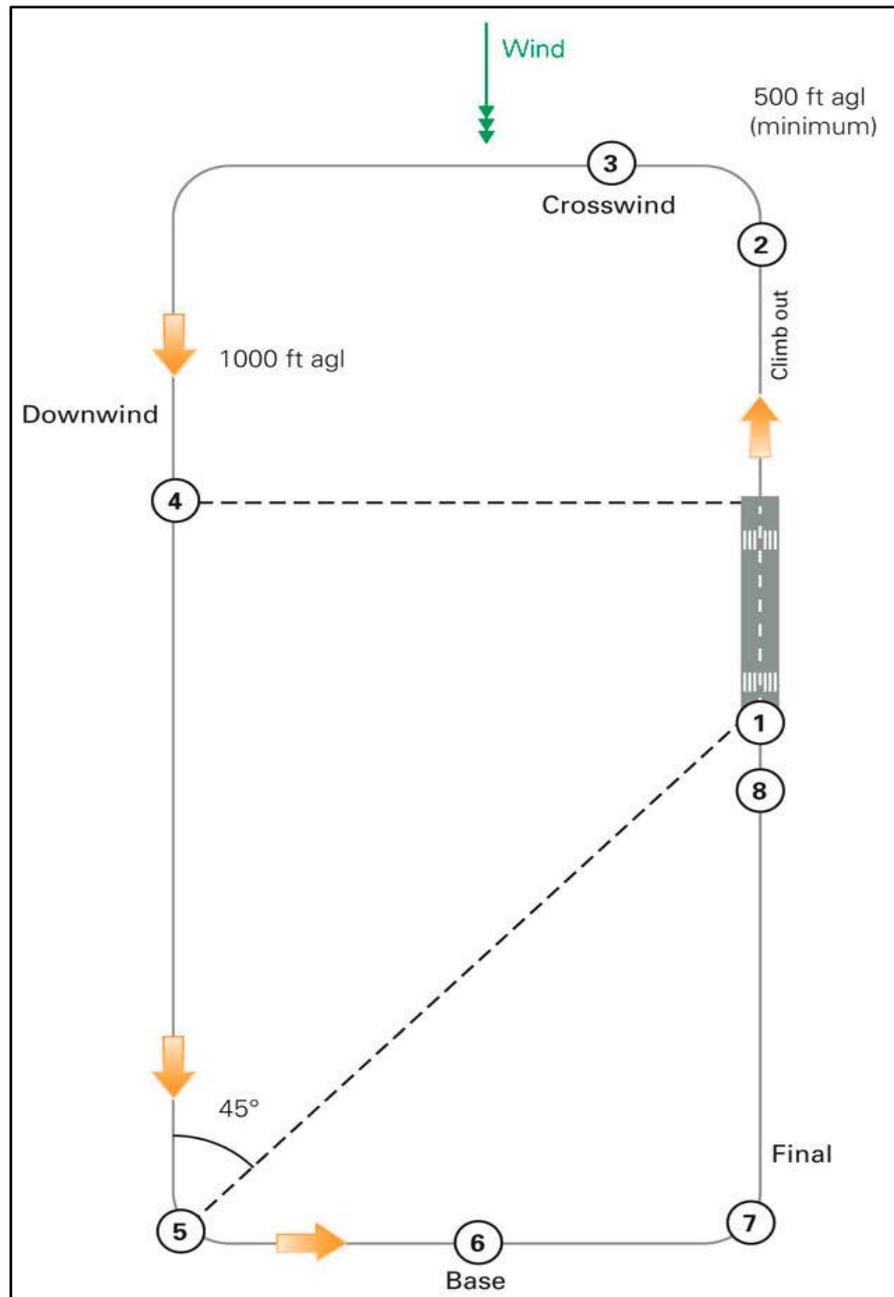
Figure 2
Standard left-hand circuit pattern
(from CAA website)

- 3.6.1. The zone at Hamilton aerodrome is shown in Appendix 1. The runways in use at the time were Runway 18L, which was sealed for 2,059 metres, and the parallel Runway 18R, which was sealed for 630 metres.
- 3.6.2. The downwind leg for the left-hand circuit started at point 4 in Figure 2. Aeroplanes following the visual circuit pattern would normally turn onto final 1-2 nm out from the threshold at point 7. IFR aircraft would also enter this circuit pattern at point 7 after a straight-in approach from a reporting point 12 nm out (off the bottom of Figure 2). The right-hand circuit traffic would follow a mirror version of the left-hand circuit and also enter the final leg at point 7.

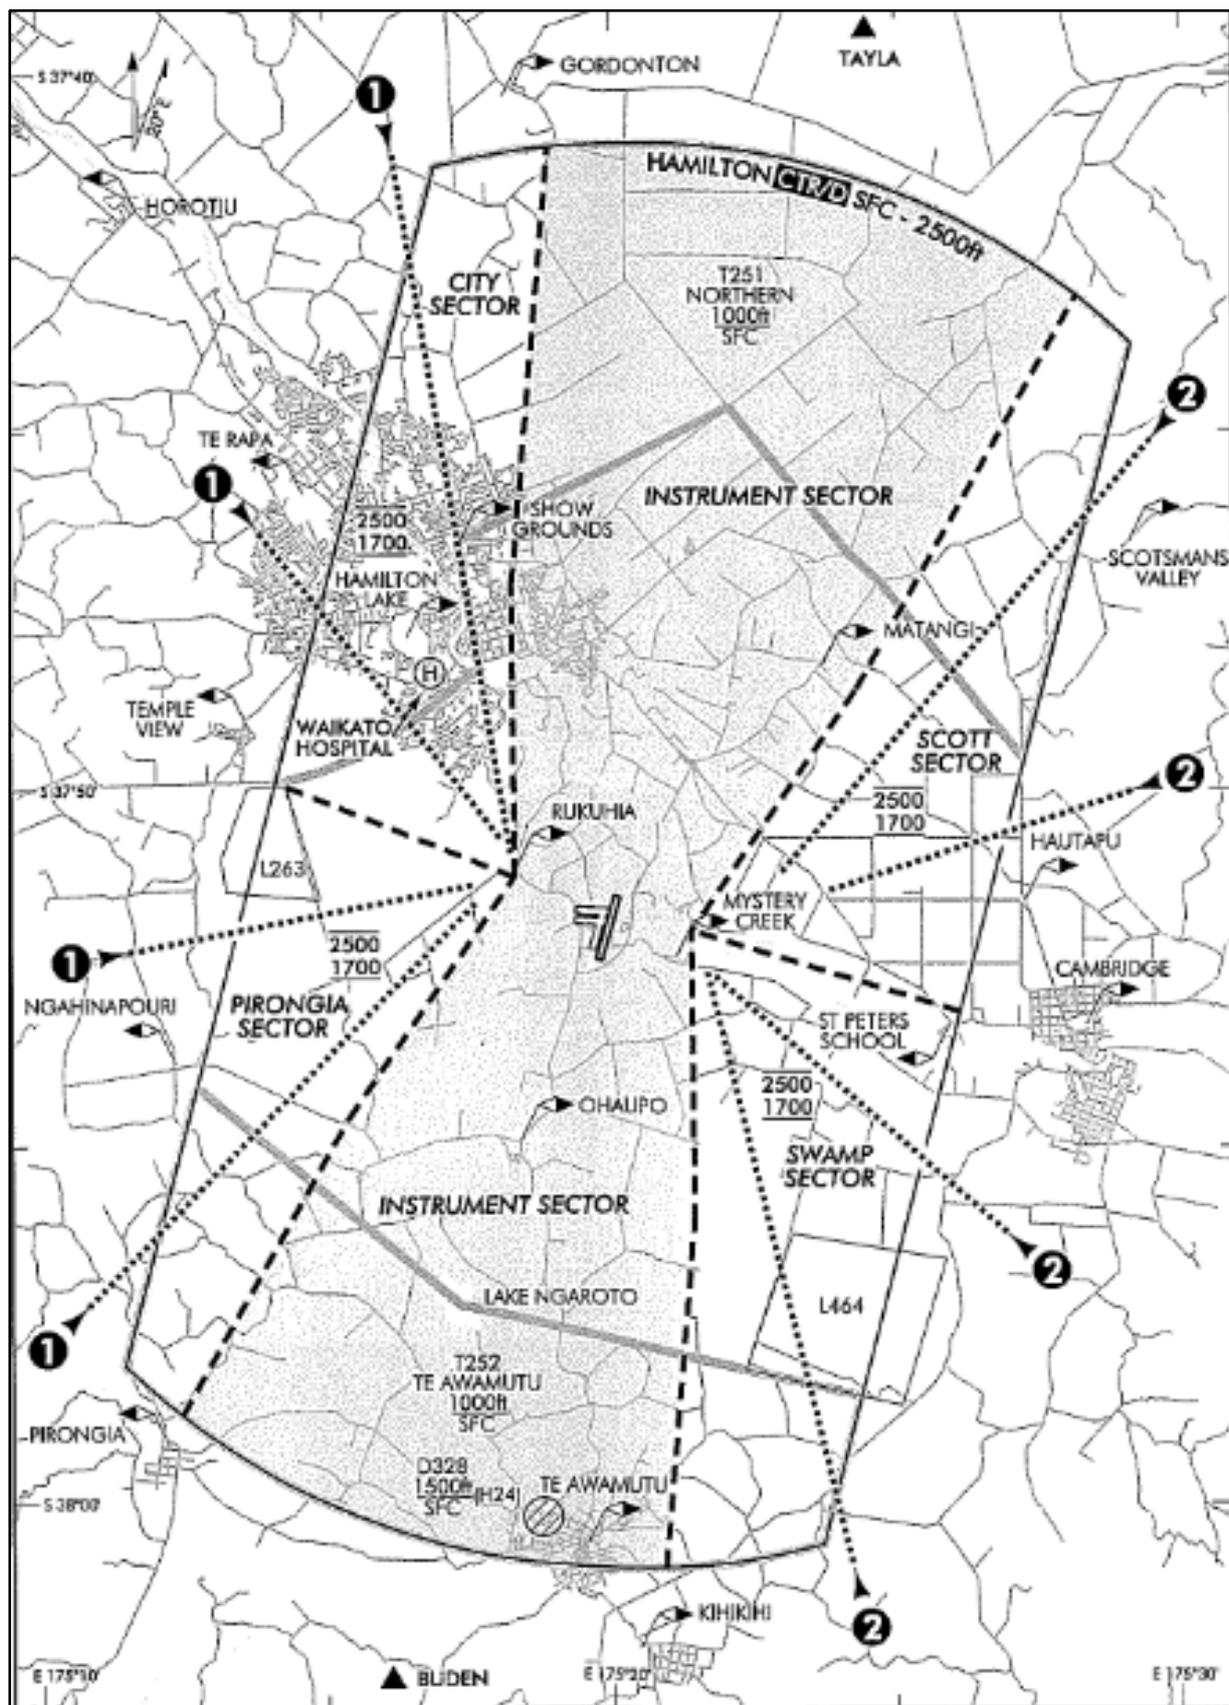
Appendix 1: Hamilton VFR arrival (as at 2015)

- 4.5.15. Consequently, the airspace design around Hamilton and the traffic density have created a hazard in uncontrolled airspace. The VFR arrival procedures described in the Aeronautical Information Publication (AIPNZ)²³ draw pilots to a reporting area within a 300-foot (91-metre) height band adjacent to the lower limit of the 2,000-foot (609-metre) control area above the aerodrome. This height band is further limited if a pilot wishes to stay clear of the overhead control area with a self-imposed safety buffer. Multiple VFR aircraft could be holding in this narrow band, with the pilots keeping a lookout for other aircraft.
