Final Report AO-2016-008: Robinson R66 helicopter, Partial power loss- forced landing,  
Hokonui Hills, Southland, 14 November 2016

Aviation inquiry AO-2016-008  
Robinson R66 helicopter  
Partial power loss– forced landing  
Hokonui Hills, Southland  
14 November 2016

Approved for publication: October 2018

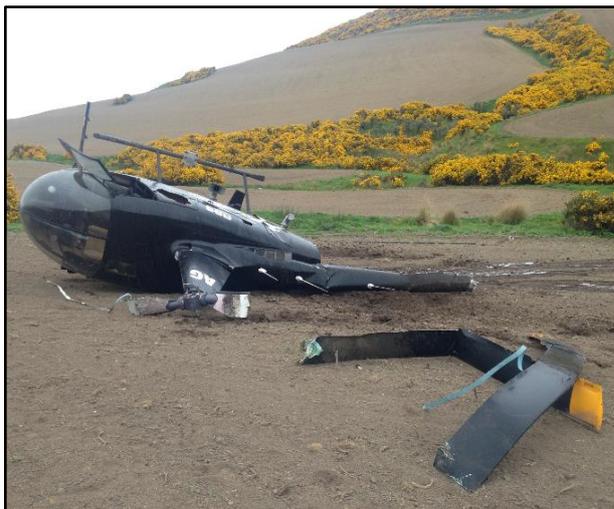
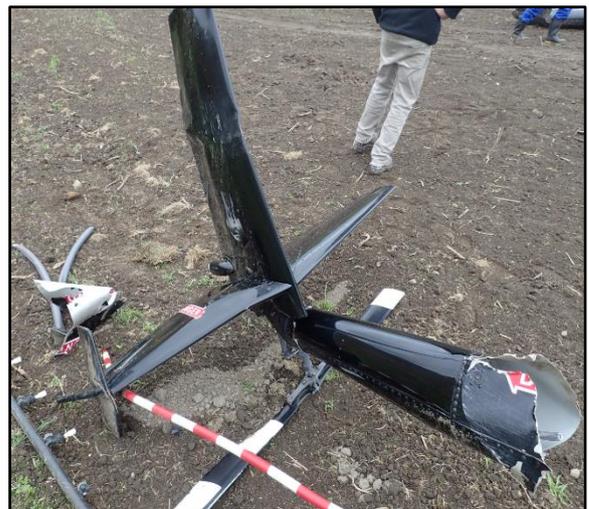
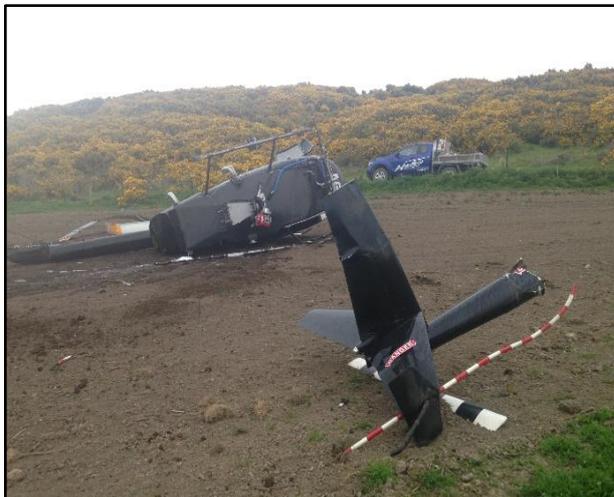
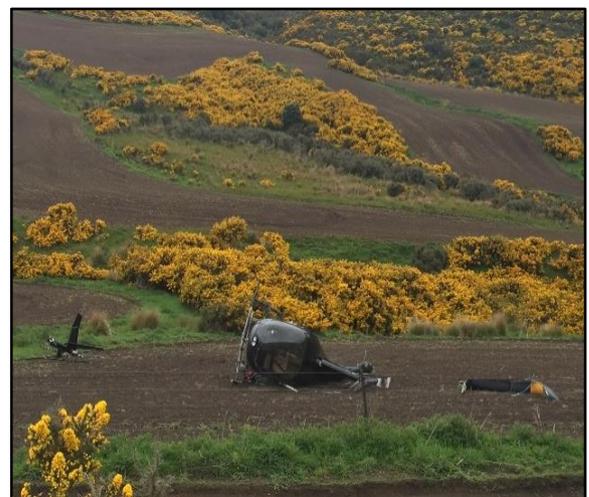
Figure 2  
Wreckage

- 1.2. The helicopter landed heavily and pitched forward, causing the main rotor blades to contact the ground. The helicopter was substantially damaged, but the pilot escaped with minor injuries only.

- 3.1.8. The engine continued to operate with sufficient power to damage the helicopter further as the rotating blades dug into the ground. The tail section was separated at the tail boom and the main rotor blades broke off at approximately 600 millimetres (mm) from the centre of the main rotor head (Figure 2). At this point the engine RPM increased due to the lack of load.

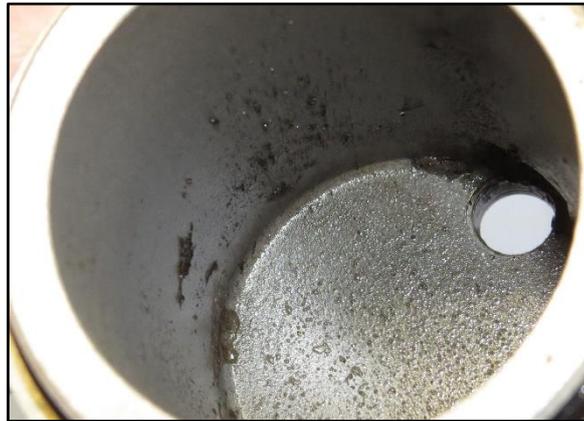
- 3.10.2. Jet fuel as used in this engine type was normally clear in appearance. Residual fuel recovered from the engine fuel pump filter housing, the fuel hose assembly and the fuel nozzle showed signs of contamination (Figure 5). This was in the form of a fine sediment that partially remained in solution, giving the fuel a muddy brown colour, and partially settled as sludge as shown in Figure 4. The remaining fuel in the main tank was drained, measured and checked for water and other contamination. None was found.
- 3.10.3. Fuel samples taken from the engine, the helicopter fuel tank and the supply tank on the support vehicle were sent to the Defence Technology Agency for analysis. The results are discussed in section 4 of this report.

**Figure 4**  
Fuel filter housing showing sludge residue

- 4.2.14. During the engine investigation, contaminants were found in: the fuel filter housing (Figure 4); the fuel hose assembly running to the fuel nozzle (Figure 5); and the fuel nozzle itself. With respect to these contaminants the Defence Technology Agency concluded:

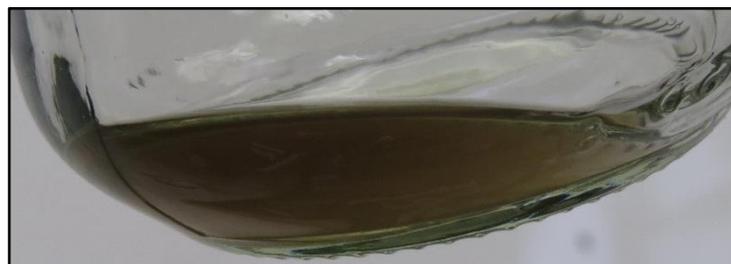
**Figure 5**  
Discoloured sample from fuel hose assembly

- 4.2.18. The fuel sample recovered from the hose between the fuel control unit and the fuel nozzle was a muddy brown colour. This contamination could have had two effects: either a slug of contaminated fuel passed into the combustion chamber that did not have the same heat output as clean fuel, or the sludge temporarily restricted the fuel flow through the spray tip assembly within the fuel nozzle. Either scenario could have caused a short-term reduction in available power.

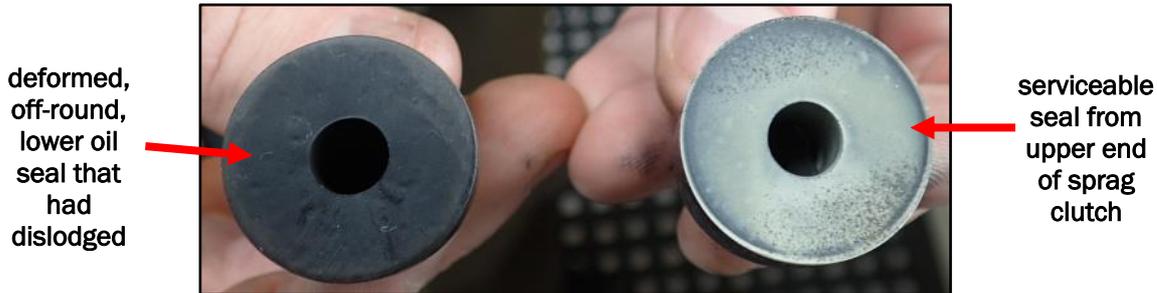
Figure 6  
Sprag clutch oil seals

- 3.10.7. The function of the sprag clutch was to isolate the engine from the rotor system during autorotative<sup>14</sup> flight. During the initial post-accident inspection of the aircraft, the sprag clutch was checked by manually rotating the output shaft. It operated correctly and was free to rotate.
- 3.10.8. The sprag clutch was removed from the aircraft and sent to an independent component overhaul facility<sup>15</sup> to be stripped and inspected. During that inspection one of the oil seals was found to be deformed (Figure 6), the oil had drained out and internal fretting damage was observed (Figure 7). The mode of failure was notified to Robinson Helicopters and it carried out flight tests on another helicopter to determine if it was relevant to this accident. Further details of the sprag clutch fault and flight tests are provided in section 4.

- 4.4.7. Robinson Helicopters advised that it was aware of previous cases where the R66 sprag clutch oil seal had failed. The R66 sprag clutch had been redesigned in November 2015 and the manufacturing process improved to prevent oil seal failure. The earlier-design sprag clutches were still performing their intended function and Robinson Helicopters was not aware of any functional problems caused by oil loss. Consequently, it did not see the need to issue a service bulletin requiring the immediate replacement of sprag clutches. All new and replacement units would be of the improved design.

- 7.3. A defect report detailing the condition of the sprag clutch was submitted to the Civil Aviation Authority by the component overhaul facility conducting the inspection.
- 7.4. Prior to this accident the R66 sprag clutch had been redesigned and the manufacturing process improved to prevent oil seal failure.

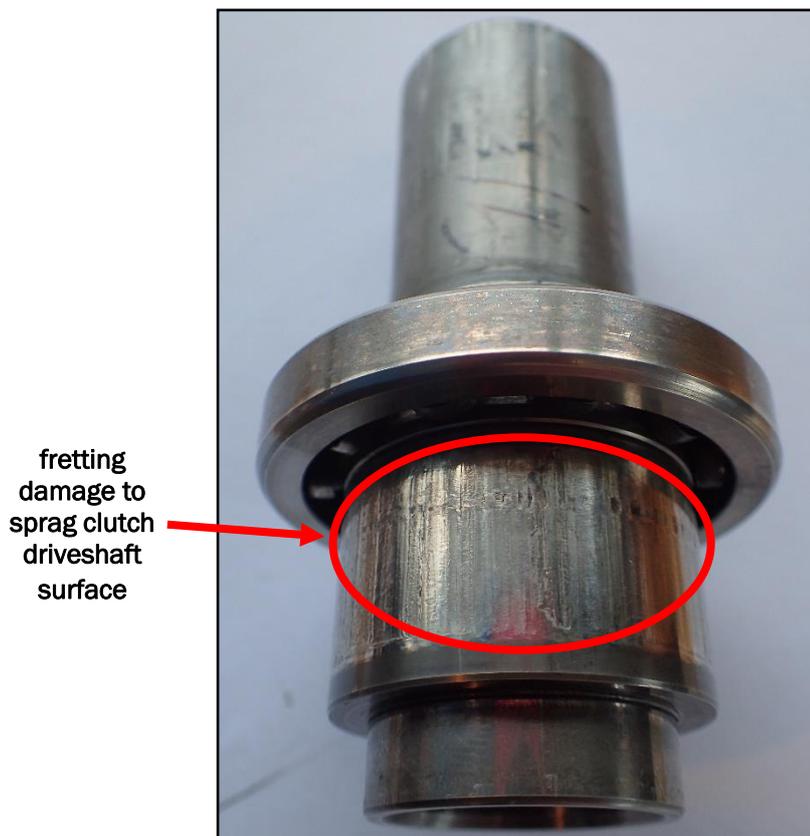
Figure 7  
Sprag clutch internal damage

- 4.4.1. The investigation examined whether the damage observed in the sprag clutch was a result of the accident or was a pre-existing condition that contributed to the decrease in rotor RPM.

- 4.4.4. For these reasons it is very unlikely that the damage found in the sprag clutch assembly contributed to the low rotor RPM event.
- 4.4.5. Turning to the issue of the damage found to the sprag clutch, the shutdown procedure in the pilot's operating handbook<sup>22</sup> included a requirement for the pilot to confirm that the sprag clutch had disengaged by checking for the needle split indication on the combined engine/main rotor RPM gauge. This was a daily check on sprag clutch performance.

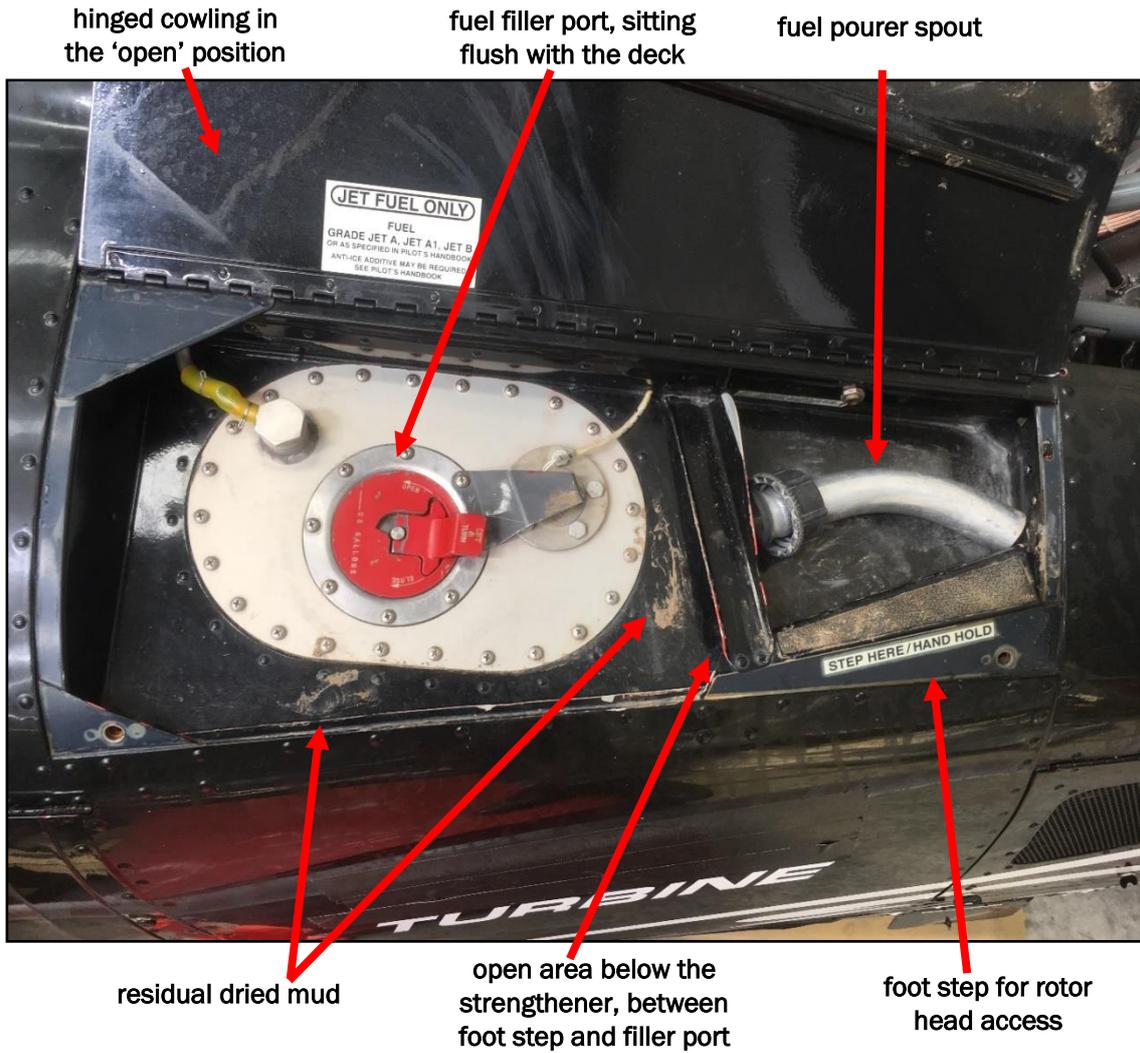
Figure 8  
Fuel filler port on R66 ZK-HAG

- 4.3.10. The R66 fuel filler port differed from that used on R22 and R44 helicopters. The filler port was larger and sat flush within a flat area under a hinged cowling (Figure 8). The R22 and R44 fuel ports, by comparison (Figure 9), were mounted on the top surface and had raised edges around them.

- 4.3.11. A foot step for accessing and inspecting the rotor head was located adjacent to the refuelling port on the R66. This foot step was a point where dirt could potentially accumulate. The pilot also made use of this foot step area to stow a fuel pourer spout. The pilot said that the spout was always inspected before use. It was nevertheless a possible source of contamination.

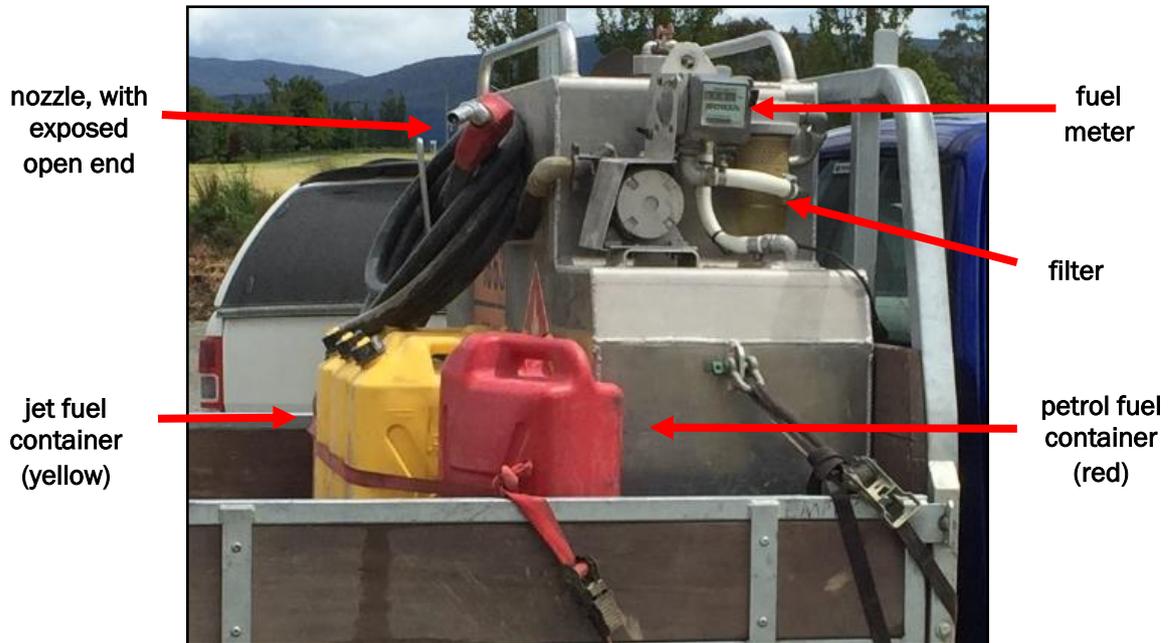
Figure 10  
Supply tank mounted on support vehicle

4.3.12. Another potential point of contaminate entry was the fuel nozzle for the supply tank mounted on the support vehicle. The vehicle routinely operated from gravel roads, paddocks and generally unpaved surfaces, but the nozzle was not covered or protected from contamination (Figure 10).
