Final Report AO-2017-001: Eurocopter AS350 BA, ZK-HKW, Collision with terrain,
Port Hills, Christchurch, 14 February 2017

Aviation inquiry AO-2017-001:
Eurocopter AS350 BA, ZK-HKW
Collision with terrain
Port Hills, Christchurch,
14 February 2017

Approved for publication: May 2018

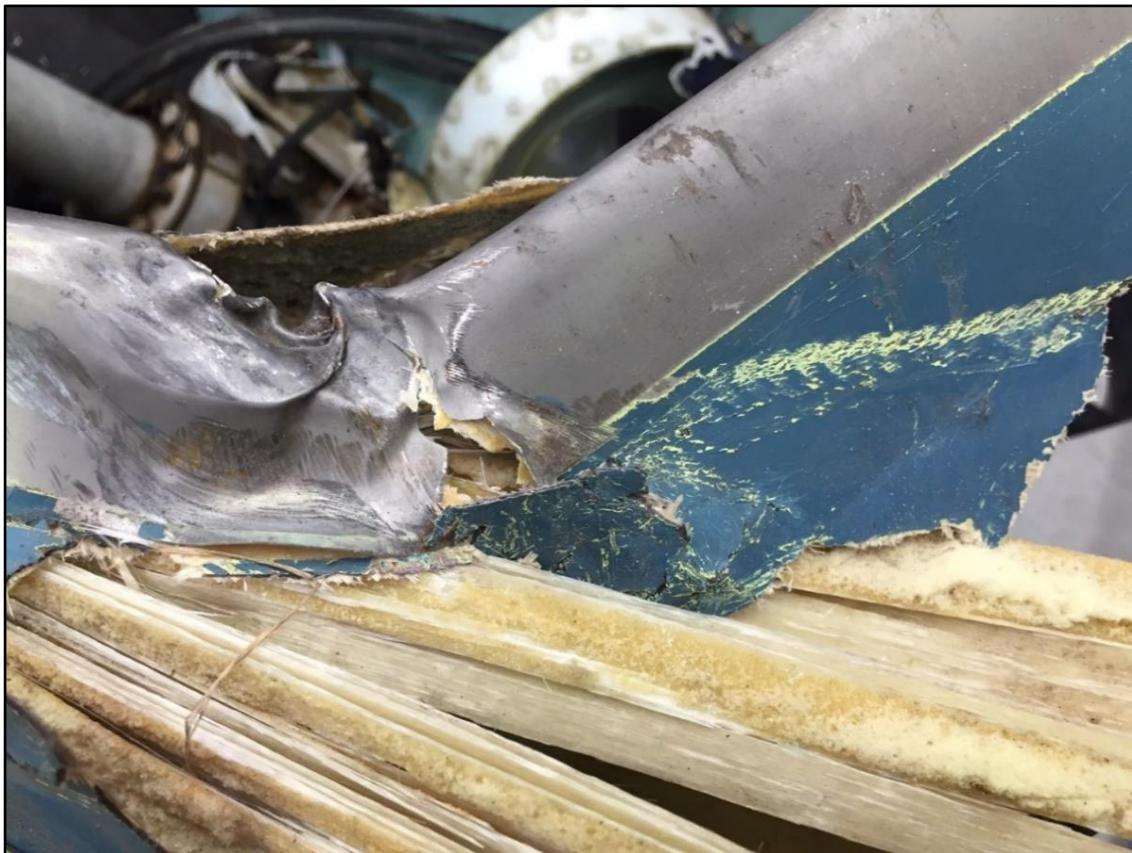
- 3.5.5 The tail rotor assembly, including the gearbox, was with the fuselage but had separated from the tail boom. The tips of the glass-fibre tail rotor blades were missing. Marks on the tail rotor blades were consistent with their having struck the wire suspension cables for the monsoon bucket. There was corresponding damage on the cable cluster where the suspension cables joined to the lifting strop (see Figures 3 and 4). The strop was still attached to the helicopter hook.

Figure 3
Damage to the leading edge of one of the tail rotor blades

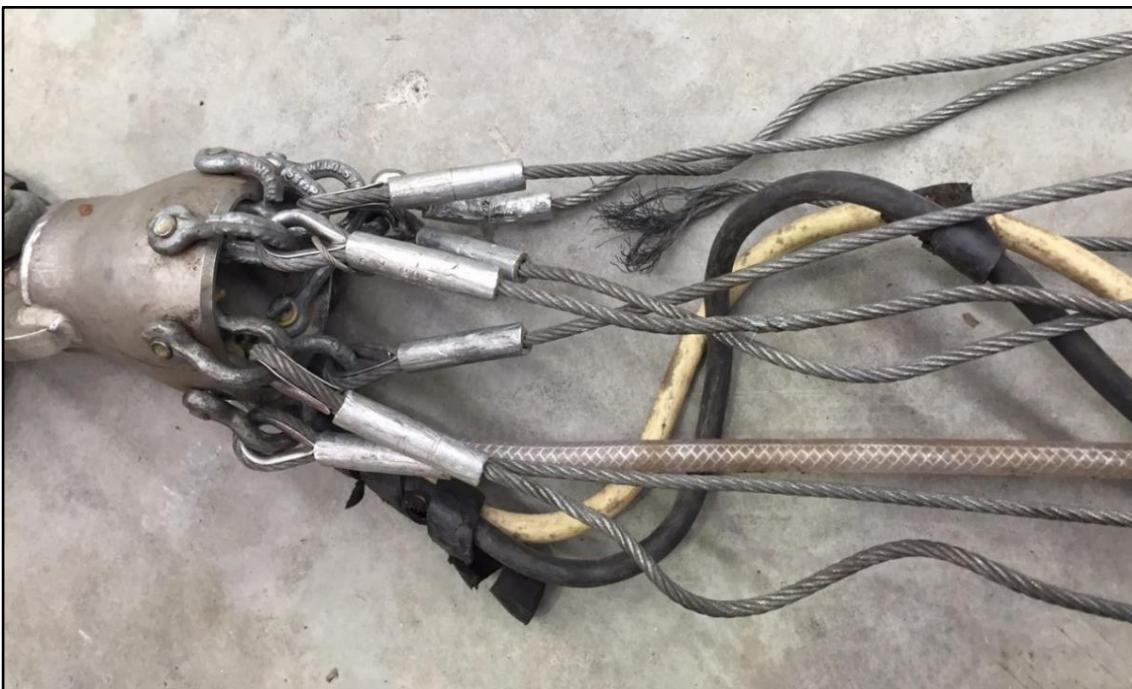
Figure 4
The monsoon bucket cable cluster with broken shackles and damaged cables

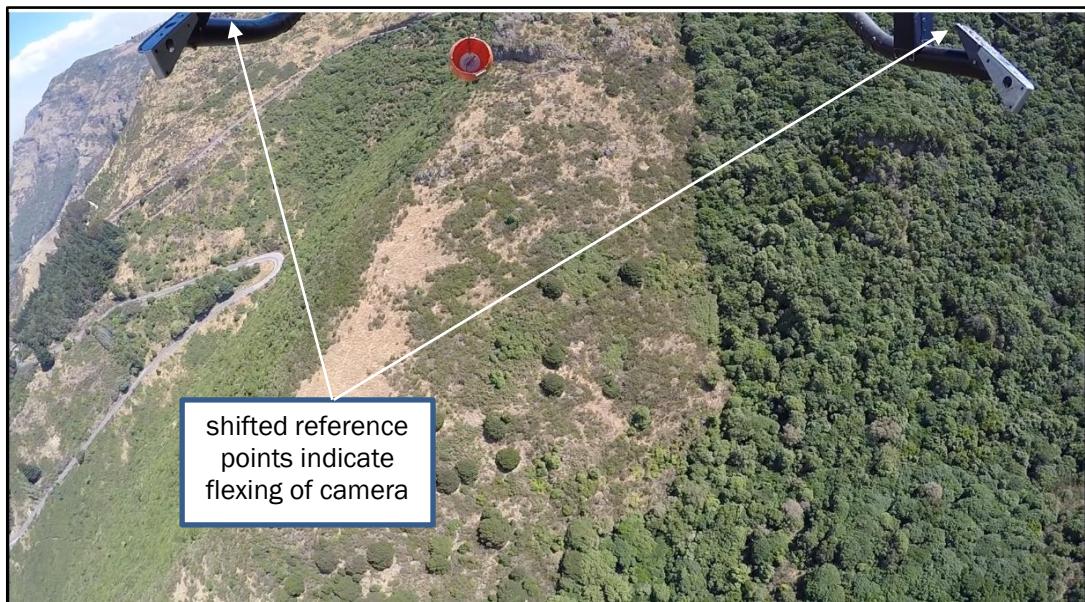
Figure 7
Video capture showing the camera mount flexing rearward, when the bucket was rapidly ascending immediately before it made contact with the tail rotor

- 4.2.16 At the same time that the tail was lowering, the monsoon bucket was rapidly rising from the transient airspeed increase. The convergence resulted in cables from the strop entering the tail rotor disc, causing the damage that resulted in the pilot losing control of the helicopter.

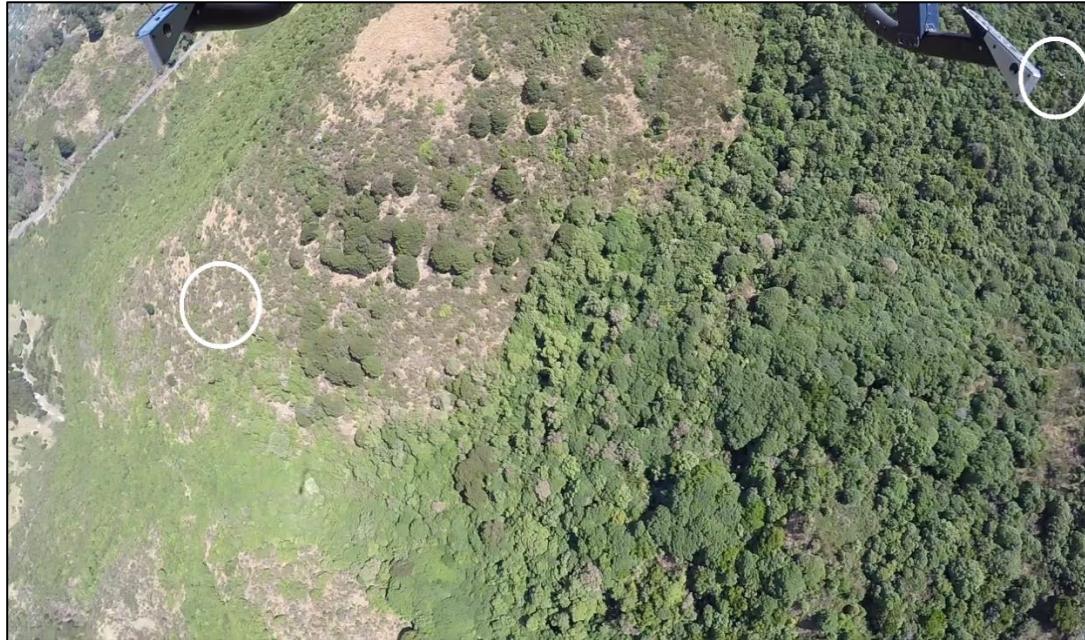
- 4.2.10 After the airframe vibration occurred, two airborne objects appeared below the helicopter very briefly (see Figure 8).

Figure 8
Two objects beneath the helicopter

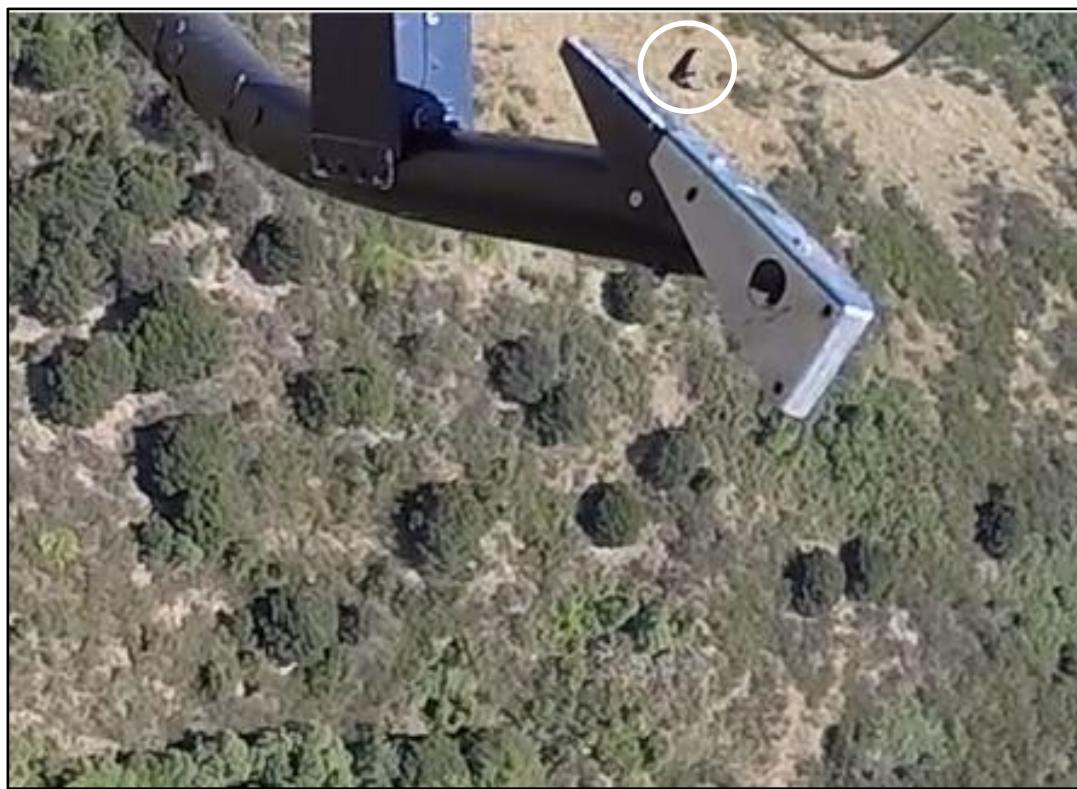
- 3.5.6 The end of the tail boom, complete with the upper and lower vertical stabilisers, had separated from the helicopter. It was found in vegetation approximately 300 metres before the main wreckage. The damage to the vertical stabilisers was consistent with ground impact. The fracture surfaces of the tail boom structure and the vertical stabiliser showed no sign of any pre-existing defects.

- 4.2.11 Approximately four seconds later the vertical stabiliser assembly could be seen falling to the ground (see Figure 9).

Figure 9
The vertical stabiliser falling to the ground (cropped image)

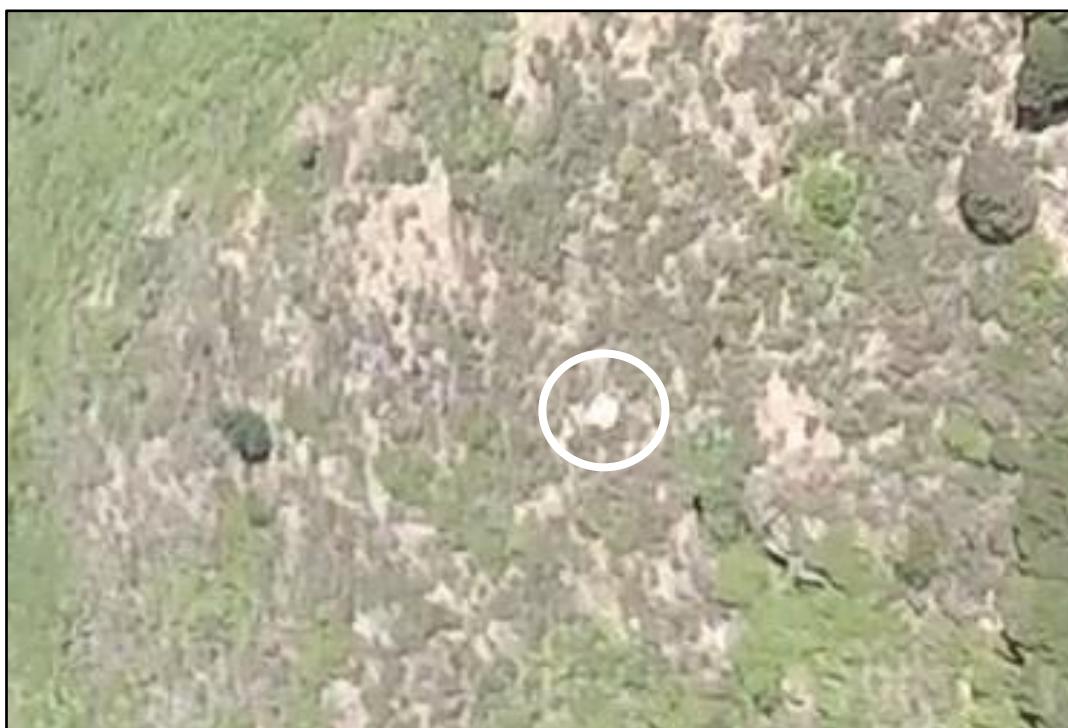
- 4.2.12 A close examination of the images of the left object (viewed in the camera direction) determined that the object appeared to be light weight, of rectangular form, and highly reflective (see Figure 10). The object's brightness varied frequently because it was tumbling.

Figure 10
Magnified view from the video recording of the leftmost airborne object

- 4.2.13 It is virtually certain that this object was the missing window panel. Although the window was transparent, it was tumbling and appeared bright when it reflected the sun and was invisible when edge on.

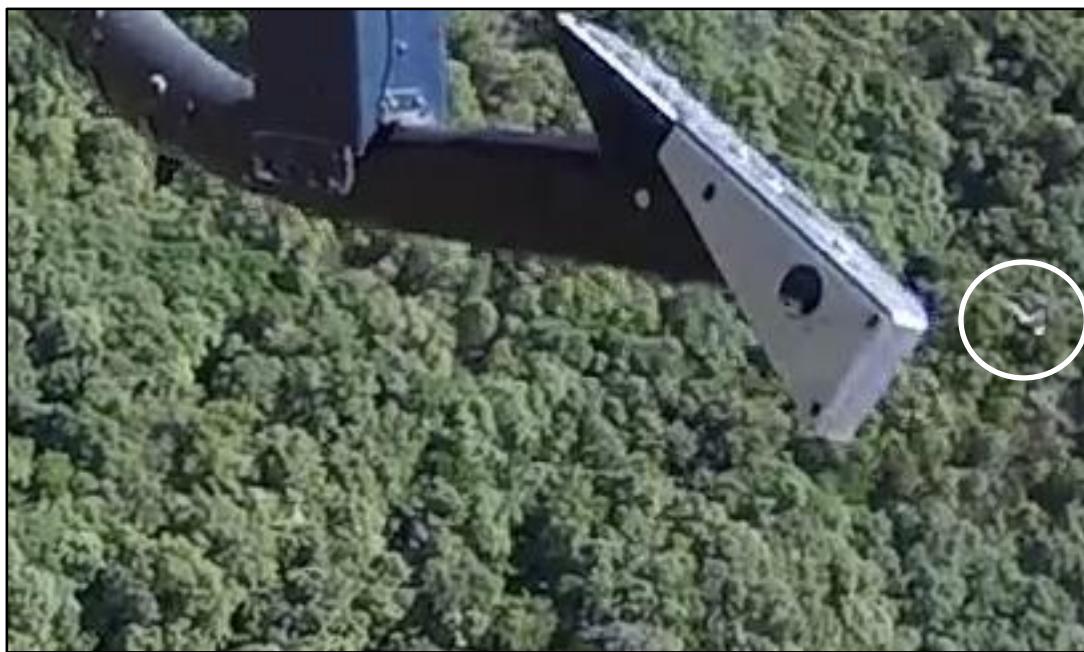
Figure 11
Further magnification of the right most object

- 4.2.21 It is very unlikely that this object was a section of tail rotor blade, because it came from ahead of the helicopter. The object was more likely to have been a bird, as the motion resembled the flapping of a bird's wings.
- 4.2.22 Although the normal response of a pilot to avoid a head-on collision with a bird would be to pitch up, the bird did not come into view until after the pitch-up. The time interval, and the distance below the helicopter when the object passed, suggests that the pitch-up was not a collision-avoidance manoeuvre. However, the possibility that the pilot was manoeuvring to avoid something could not be excluded.
