Transport Accident
Investigation
Commission

Aviation inquiry AO-2018-009
MD Helicopters 500D, ZK-HOJ
In-flight breakup
Near Wānaka Aerodrome
18 October 2018

June 2024

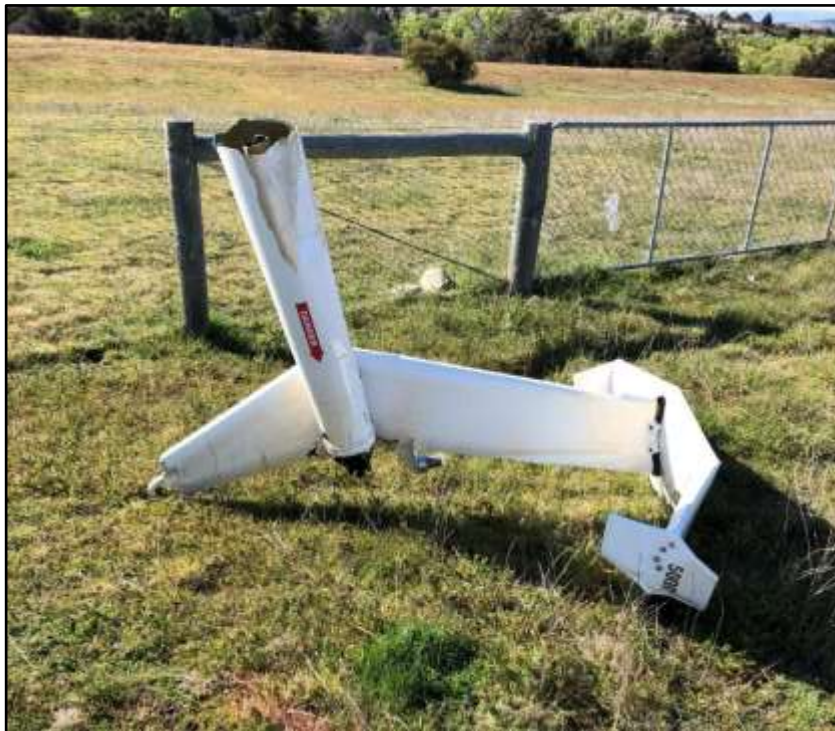
Figure 6: Tail section

- 2.40. A large part of the tail rotor and gearbox assembly was found approximately 100 m forward (north) of the main wreckage. A section of a main rotor blade tip (about 450 mm in length) was found nearby. Small fragments of the tail rotor gearbox were found between the tail section and the main wreckage. Impact marks on the tail rotor blade and the tail rotor gearbox matched the profile of the leading edge of a main rotor blade.
- 2.41. The tail boom had failed where it had been struck by a main rotor. The tail section had separated and landed clear of the main wreckage. It was intact except for the missing tail rotor and gearbox assembly referred to above (see Figure 6).

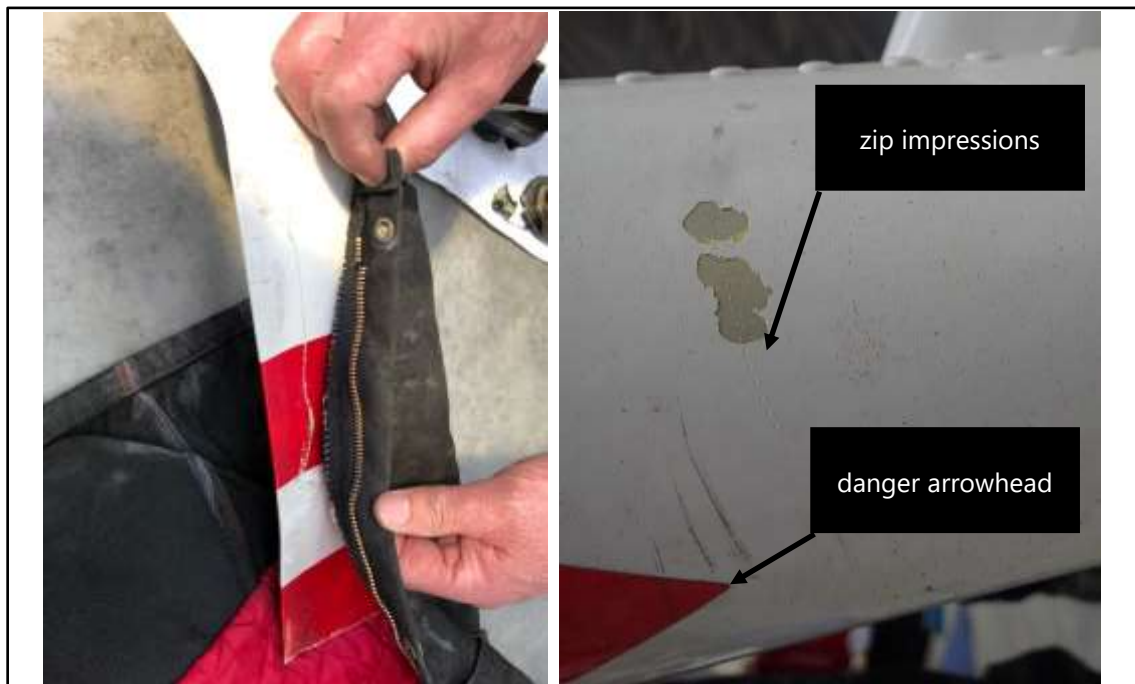
Figure 7: Black overalls' zip impact on tail rotor blade and tail boom

- 2.42. The first heavy items discovered in the wreckage trail included a pair of black, heavy cotton, padded, bib overtrousers (the 'black overalls') that had belonged to the pilot. A pair of red, padded overalls that had belonged to a DOC worker, two pieces of the tail rotor blades and the tip of one of the main rotor blades were found near the black overalls.
- 2.43. Paint transfer marks on the inside of one leg of the black overalls matched the colour and profile of the tail rotor blades. Also, the paint on one of the tail rotor blades was marked with impressions of a zip and a dome connector matching the zip and domes on the black overalls. The zip had also left impressions along the left side of the tail boom, just aft of the head of the 'Danger' arrow (see Figure 7).

- 3.8. One of the first items to exit was **likely** to have been the black overalls. The evidence shows that the two-bladed tail rotor struck the black overalls multiple times. They were slashed and exhibited paint transfer marks from contact with the tail rotor. There were marks on one tail rotor blade that matched the zip on the overalls. There were more zip impressions on the left side of the tail boom just to the rear of the 'Danger' arrow. The tail rotor blade exhibiting the zip marks broke off and was found

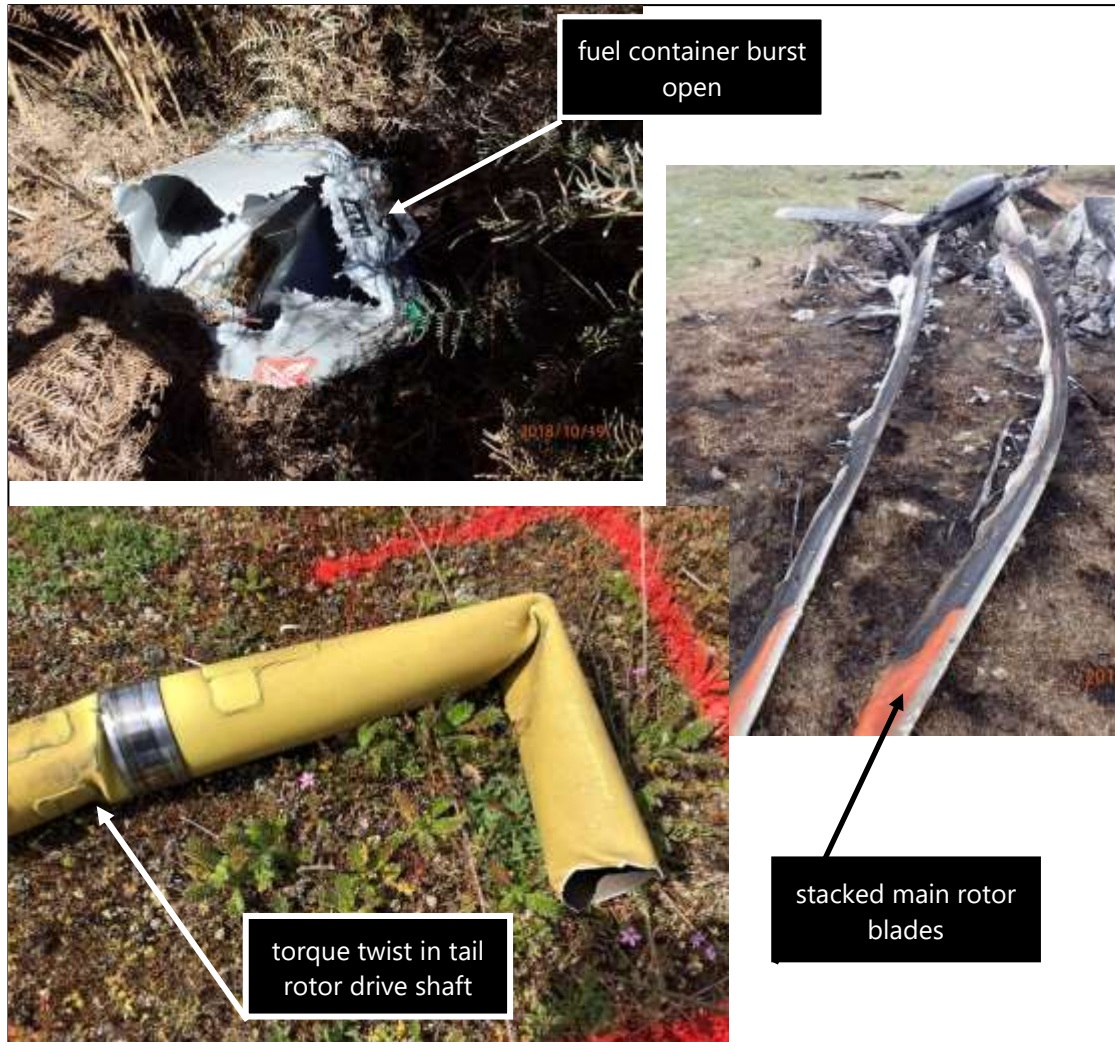
Figure 8: Wreckage items

- 2.44. The tail rotor drive shaft had a twist (see Figure 8), which was consistent with the engine having driven it against a solid resistance at the tail rotor end.
- 2.45. Four of the main rotor blades had left strike marks in the ground and were stacked¹⁷

to one side of the wreck with their leading edges curved backwards from the root to the tip (see Figure 8). The fifth main rotor blade had broken off at the root end about 500 mm out from the attachment pin and was found about 50 m from the main wreckage.

- 3.9. The tail rotor was driven by the engine via a shaft running along the tail boom and through the tail rotor gearbox. The torsional damage to the tail rotor drive shaft was typical of the tail rotor being subjected to a high load while still being driven by the engine. This was **very likely** a result of loads on the tail rotor caused by the black overalls entangled in it.

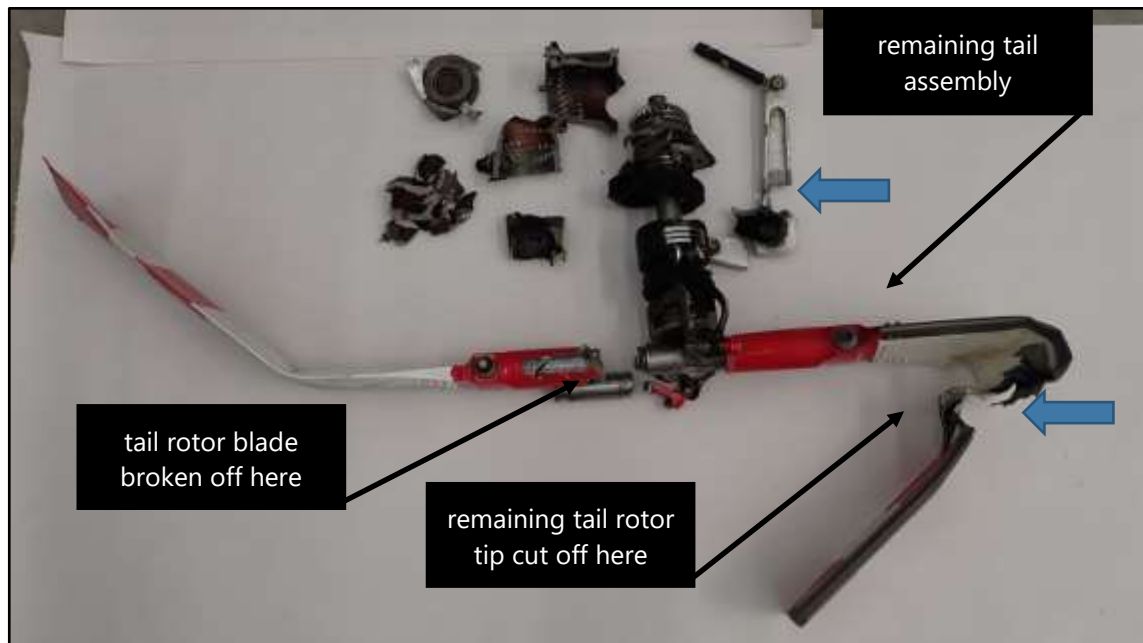
Figure 9: Tail rotor assembly showing main rotor blade impacts (blue arrows)

- 3.11. The impact of the remaining tail rotor assembly with the main rotor disc caused severe damage to two adjacent main rotor blades, including the loss of the outer 500 mm of these main rotor blades. This damage would have unbalanced the main rotor disc and caused severe vibration and extreme motion in the helicopter.

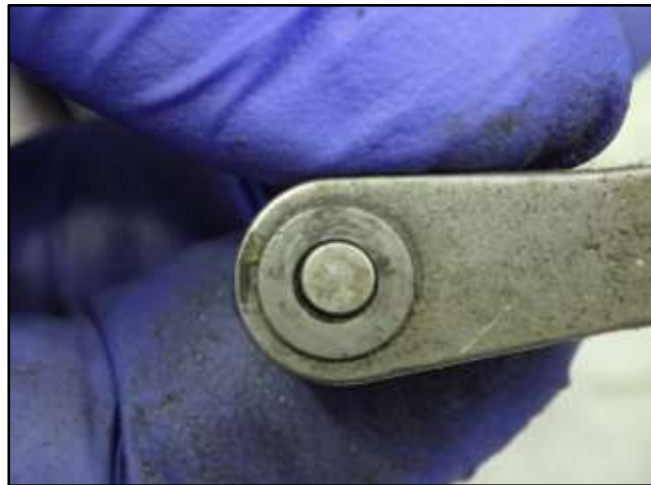
Figure 14: Clevis pin wear

- 3.42. The round clevis fastener²⁶ holes were worn to ovals at some rod ends and at the internal door handle. This allowed more free movement between the handle and the slave²⁷ latch blocks than was necessary for proper operation. The rods appeared normal except for the one damaged by the blade strike.

- 3.43. The external door handle was loose in its escutcheon bearing and the mechanical link from the internal door handle to No.3 latch slider was worn with 1-2 mm of free movement.

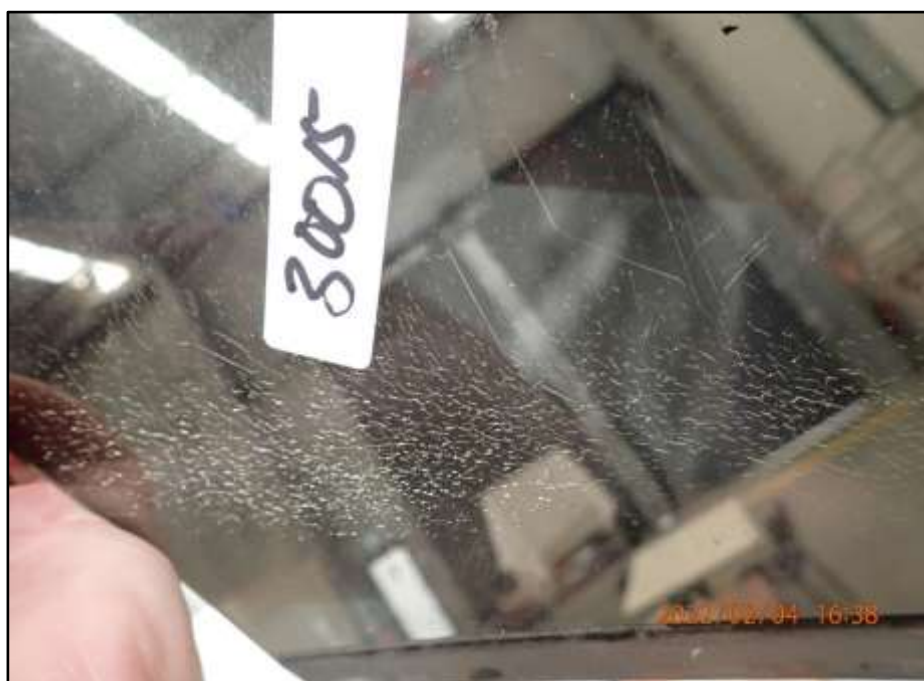
Figure 17: Crazing in centre-right windshield

- 3.95. Surface deterioration caused by long-term exposure to weather or chemicals can degrade the outside surface flexure strength significantly and initiate crazing. The effects of weather have been shown to reduce the flexure strength by 55 per cent over 10 years. This type of deterioration will only affect the top 1.5 mm layer of the acrylic panel, while the remaining thickness will retain its original strength. The windshield panels on this helicopter were about 2.5 mm thick.
- 3.96. The acrylic plastic along the bottom edges of the two centre windshields had areas of crazing (see Figure 17). This was more extensive than the MDH maintenance manual allowed, and it was in the pilot's line of sight. It had been noted during a 100-hour inspection in 2016³⁷ but there was no record of its being replaced.

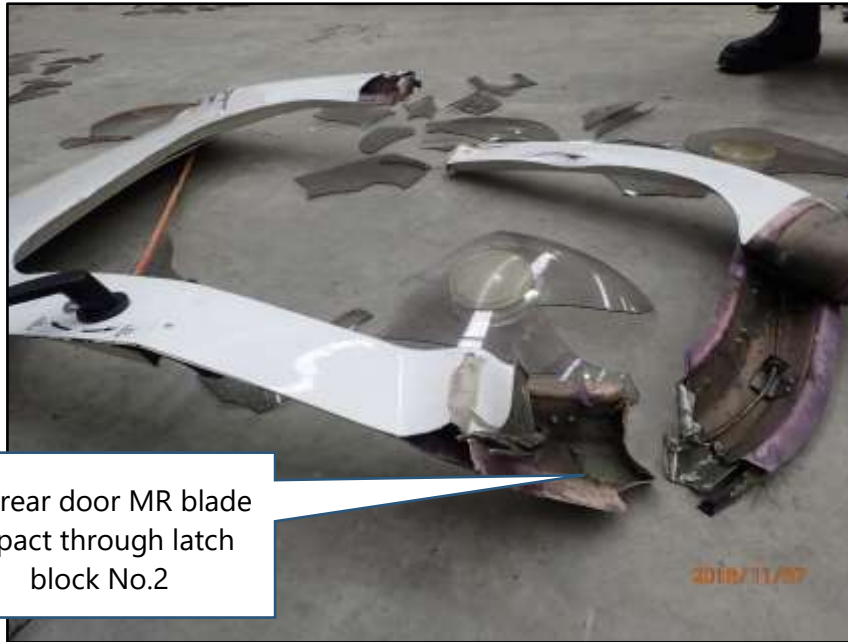
- 3.15. This door too had been struck by a main rotor blade, which cut through its top rear corner above the door handle from the inside face outwards (see Appendix 4 for the door damage and Figure 1 for the orientation of the door and the helicopter). The main rotor blades rotated anticlockwise when viewed from above. The main rotor blade could not physically reach the left-rear door if it was open nor approach the inside surface of the left-rear door from an anticlockwise direction if the door was still attached to the helicopter. Therefore, the left-rear door could only have been struck by a main rotor blade after the door had separated from the helicopter.

left-rear door MR blade
impact through latch
block No.2

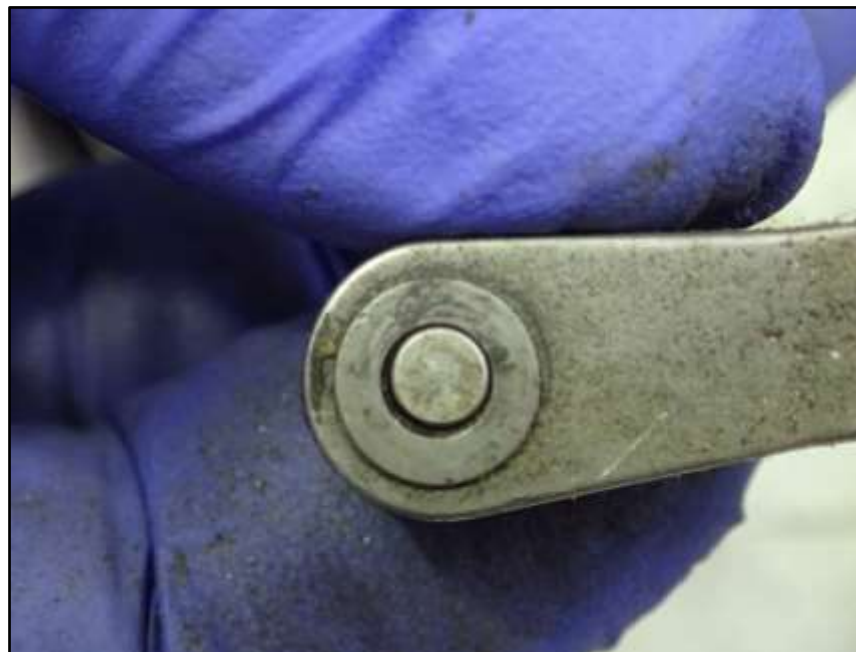
- 3.44. The damage to the helicopter prevented an observation of the actual latch bolt engagement and overlap with the door-striker. The latch bolt on No.4 latch block exhibited wear on the face that indicated misaligned mating with its door-striker.

clevis and
pin wear at
top of latch
block No.3
(door
handle)

No.4 latch block wear on safe-lock face of latch bolt

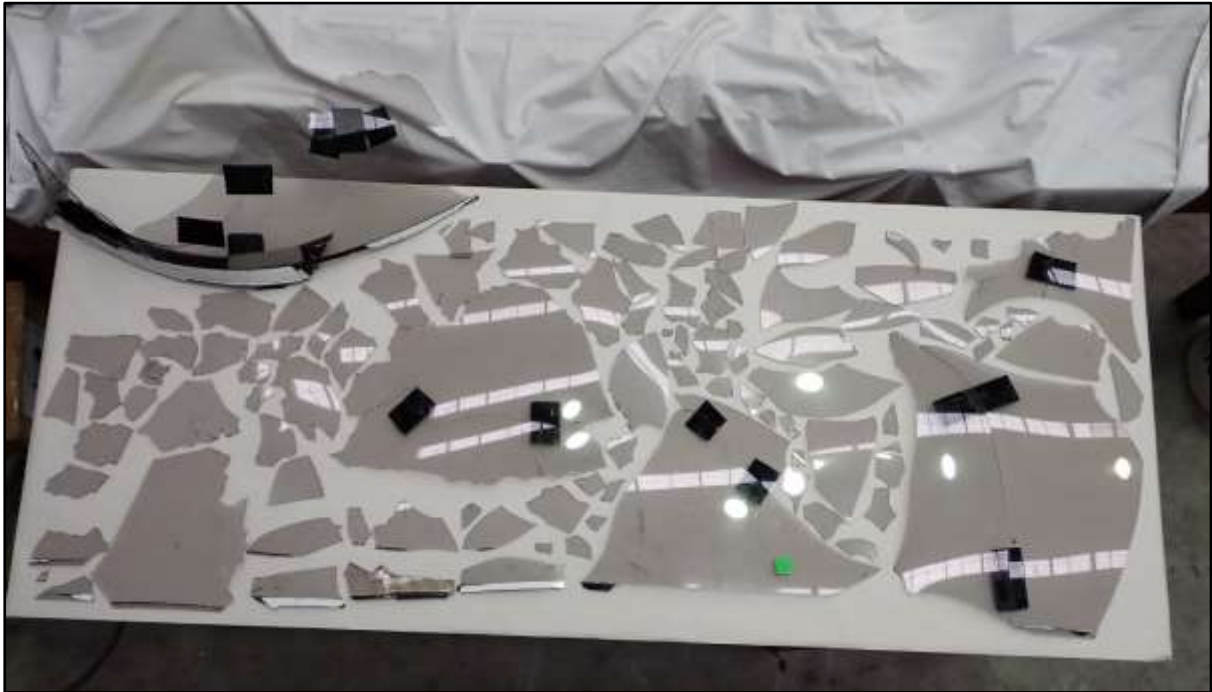
centre windshields (both left and right sides
and approximately 40% recovered)

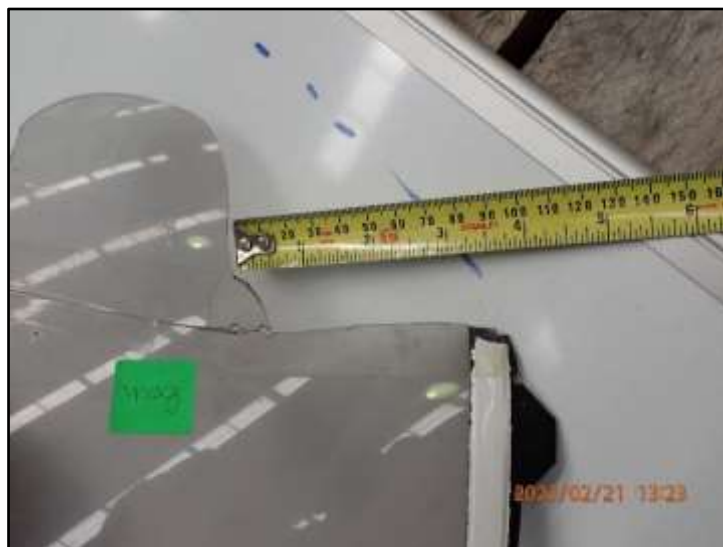
patch in lower-right
windshield
