Interim Report AO-2018-009: MDHI (Hughes) 369D,
registration ZK-HOJ, Wanaka, 18 October 2018

Aviation inquiry AO-2018-009
MDHI (Hughes) 369D, registration ZK-HOJ
Wanaka
18 October 2018

Approved for publication: December 2018

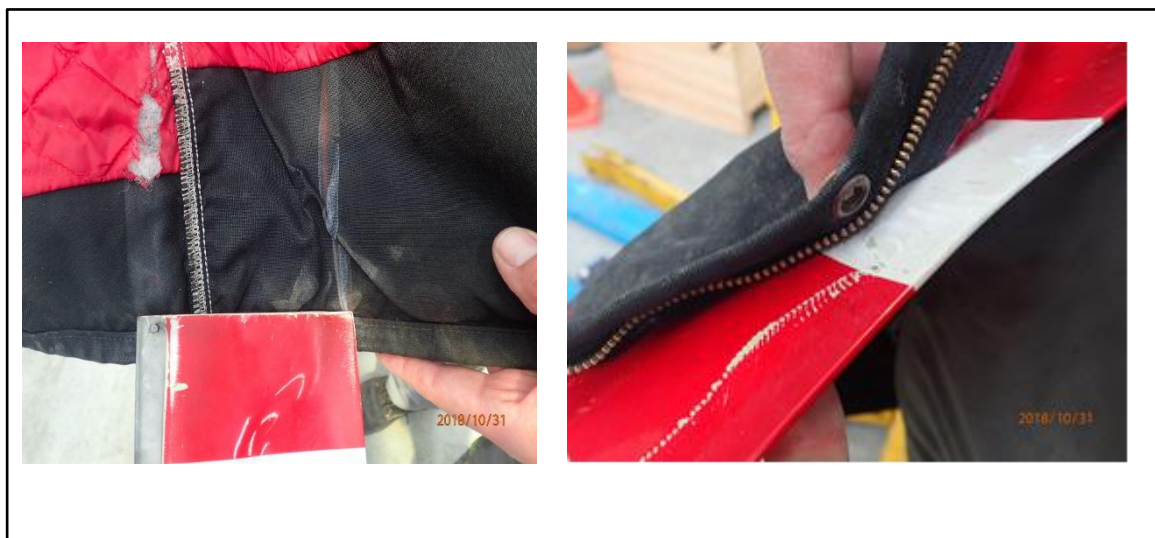
Figure 1
Tail rotor impact impressions

- 2.2.4. There were paint transfer marks on the inside of one leg of the black over-trousers that matched the colour and profile of the tail rotor blades. Also, the paint on one of the tail rotor blades was marked with impressions of a zip and dome connector matching those on the over-trousers. These markings are a strong indicator that the over-trousers had come out of the helicopter and become entangled with the tail rotor at some point (see Figure 1).

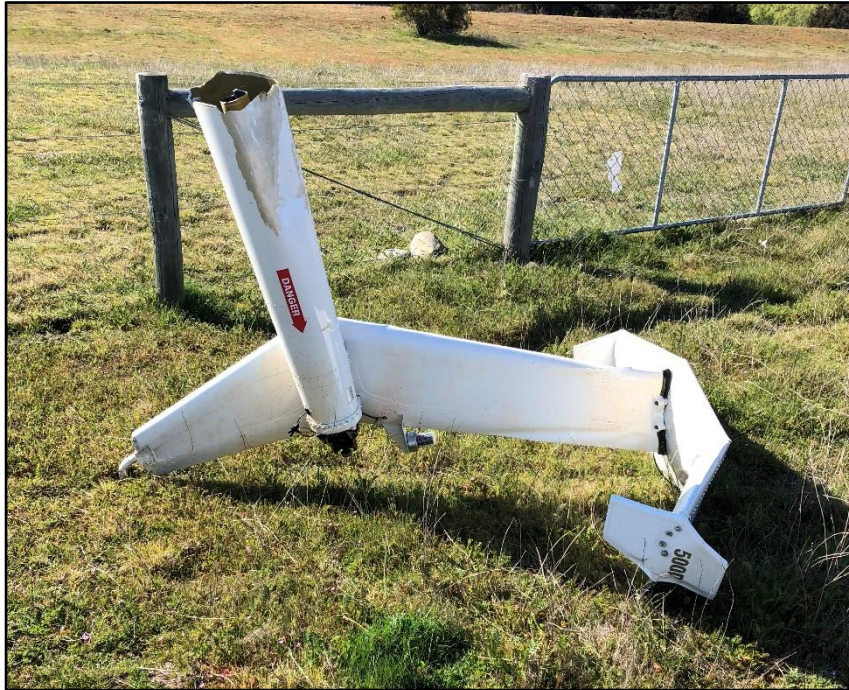
Figure 2
Photograph of separated tail section

- 2.2.6. The tail section had separated from the tail boom near to a point where a main rotor blade had struck the tail boom.

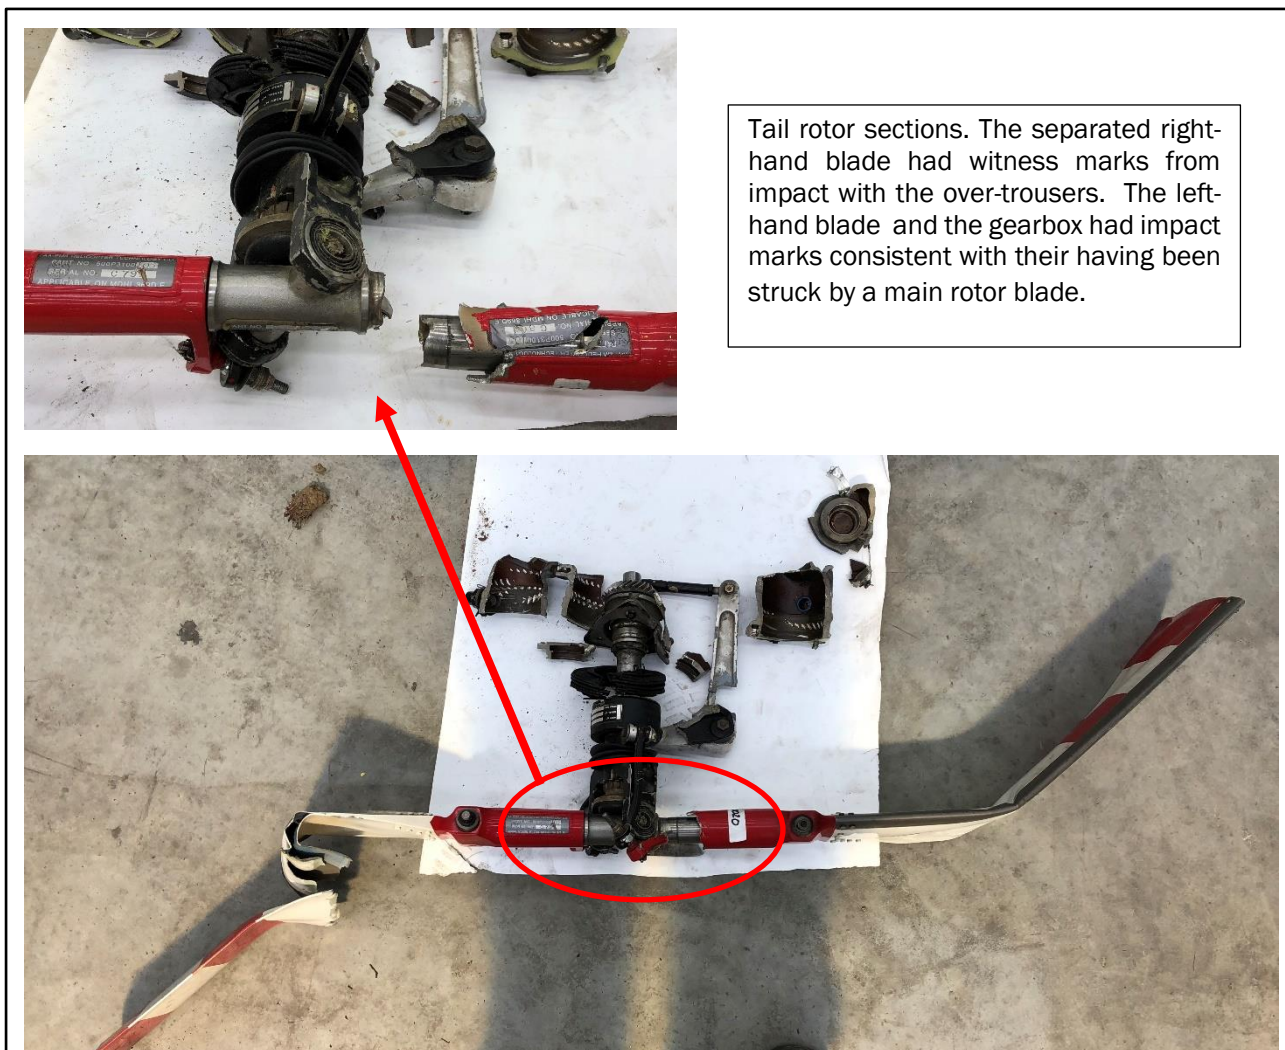
Figure 3
Photographs showing tail rotor damage

- 2.2.5. A large section of the tail rotor gearbox, still attached to one complete tail rotor blade, was found approximately 100 m forward of the main wreckage, along with a 450-millimetre section of a main rotor blade tip. Small fragments of the tail rotor gearbox were found between the tail section and the main wreckage. Impact marks on the tail rotor blade and tail rotor gearbox matched the profile of the leading edge of the main rotor blade.

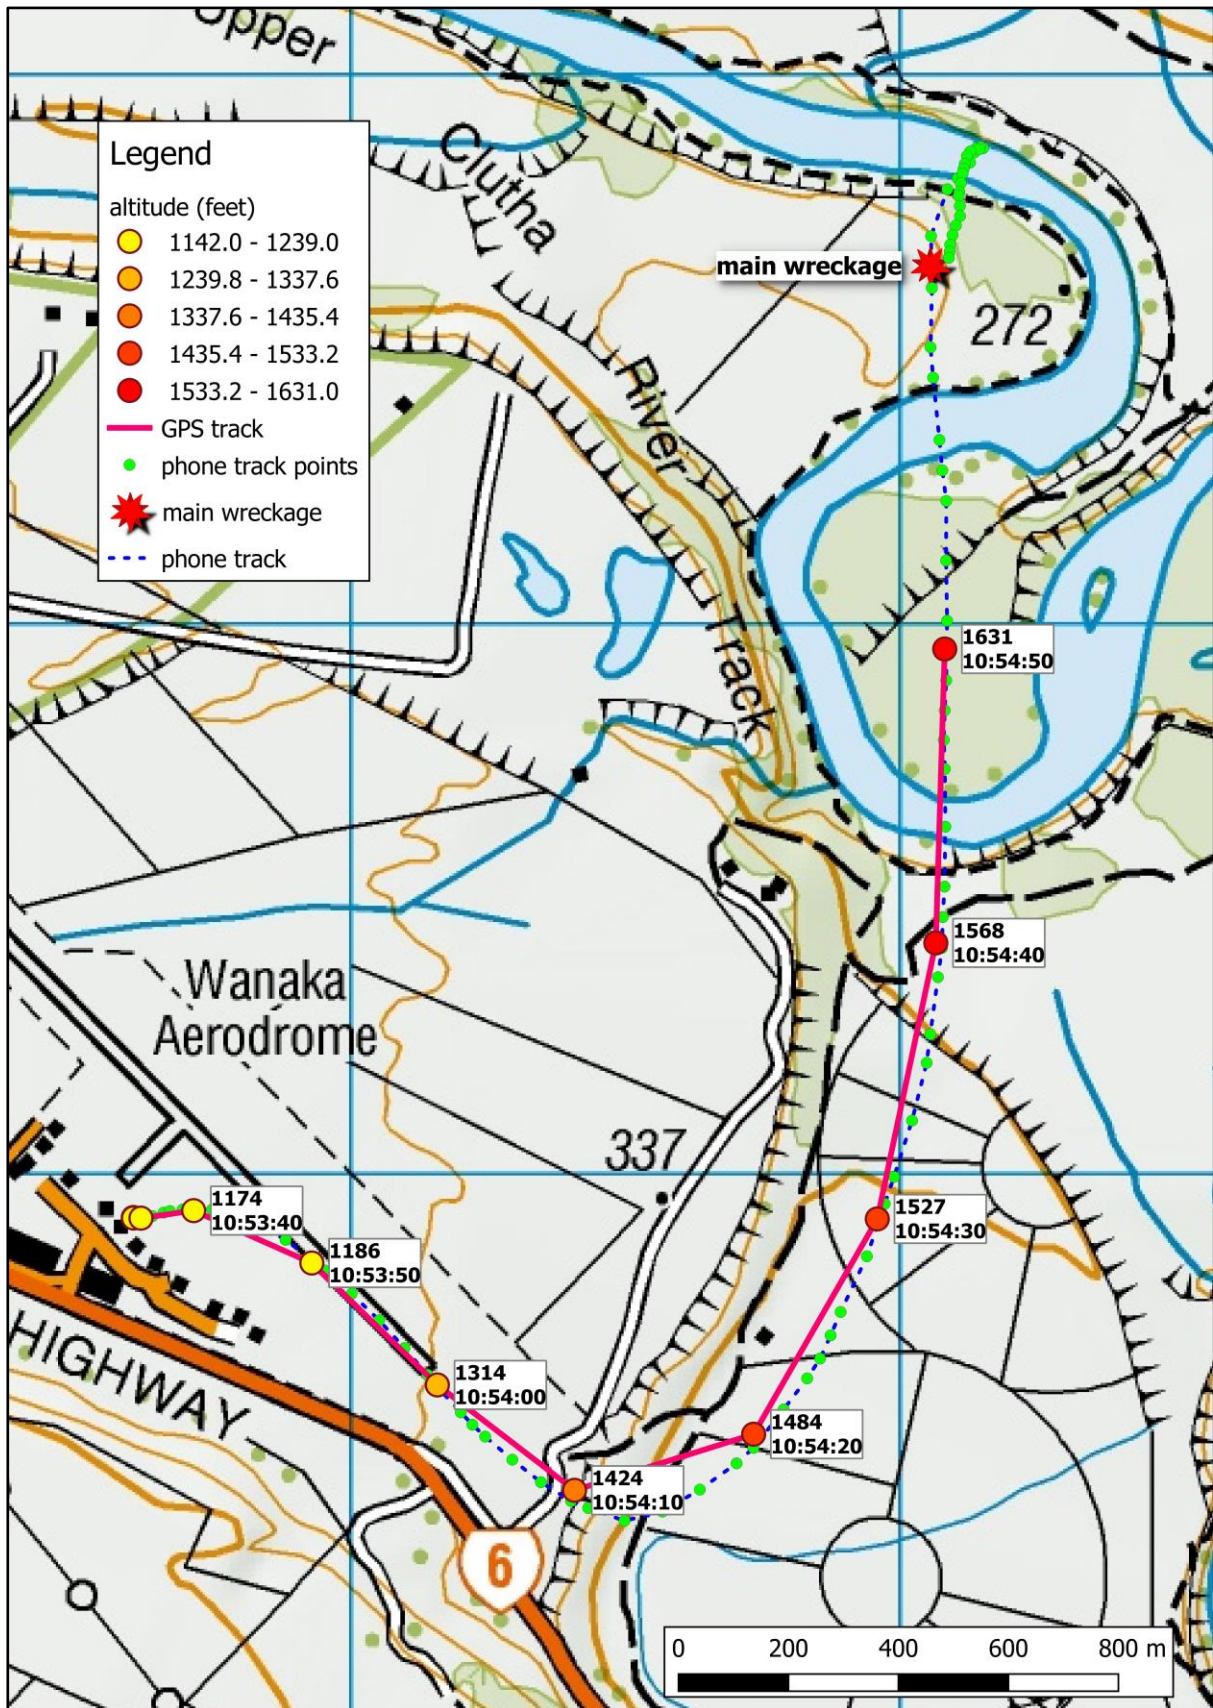
Appendix 1: Flight track

- 2.1.5. The pilot made a broadcast radio call to local traffic, advising that they were lifting off from the heli-hold area and intending to take off on runway 11, then vacate from the downwind leg towards Hawea. The Hughes helicopter followed the runway centreline until about 300 feet (91 metres [m]) above the ground. The pilot called the pilot of a Robinson helicopter that was in the circuit to advise it of their intention to conduct an early turnout and remain clear on the left-hand side of the Robinson helicopter. The pilot of the Robinson helicopter acknowledged the call. The Hughes helicopter then turned left and headed out on track at about 500 feet (152 m) above the aerodrome (see Appendix 1).

- 2.7.1. There was no requirement for a flight data recording device to be fitted to the helicopter, and none was fitted.
- 2.7.2. The pilot's cell phone was found near the main wreckage and was fully operational. A GPS tracking application installed in the phone had recorded the flight track and this data was extracted and used to construct the flight path shown in Appendix 1.

- 2.7.3. The helicopter had a Garmin 296 GPS mounted on the centre console. This had been ejected from the helicopter and was found about 100 m from the wreckage. The unit was operational, and the flight track data was able to be extracted and used to construct the flight path shown in Appendix 1.

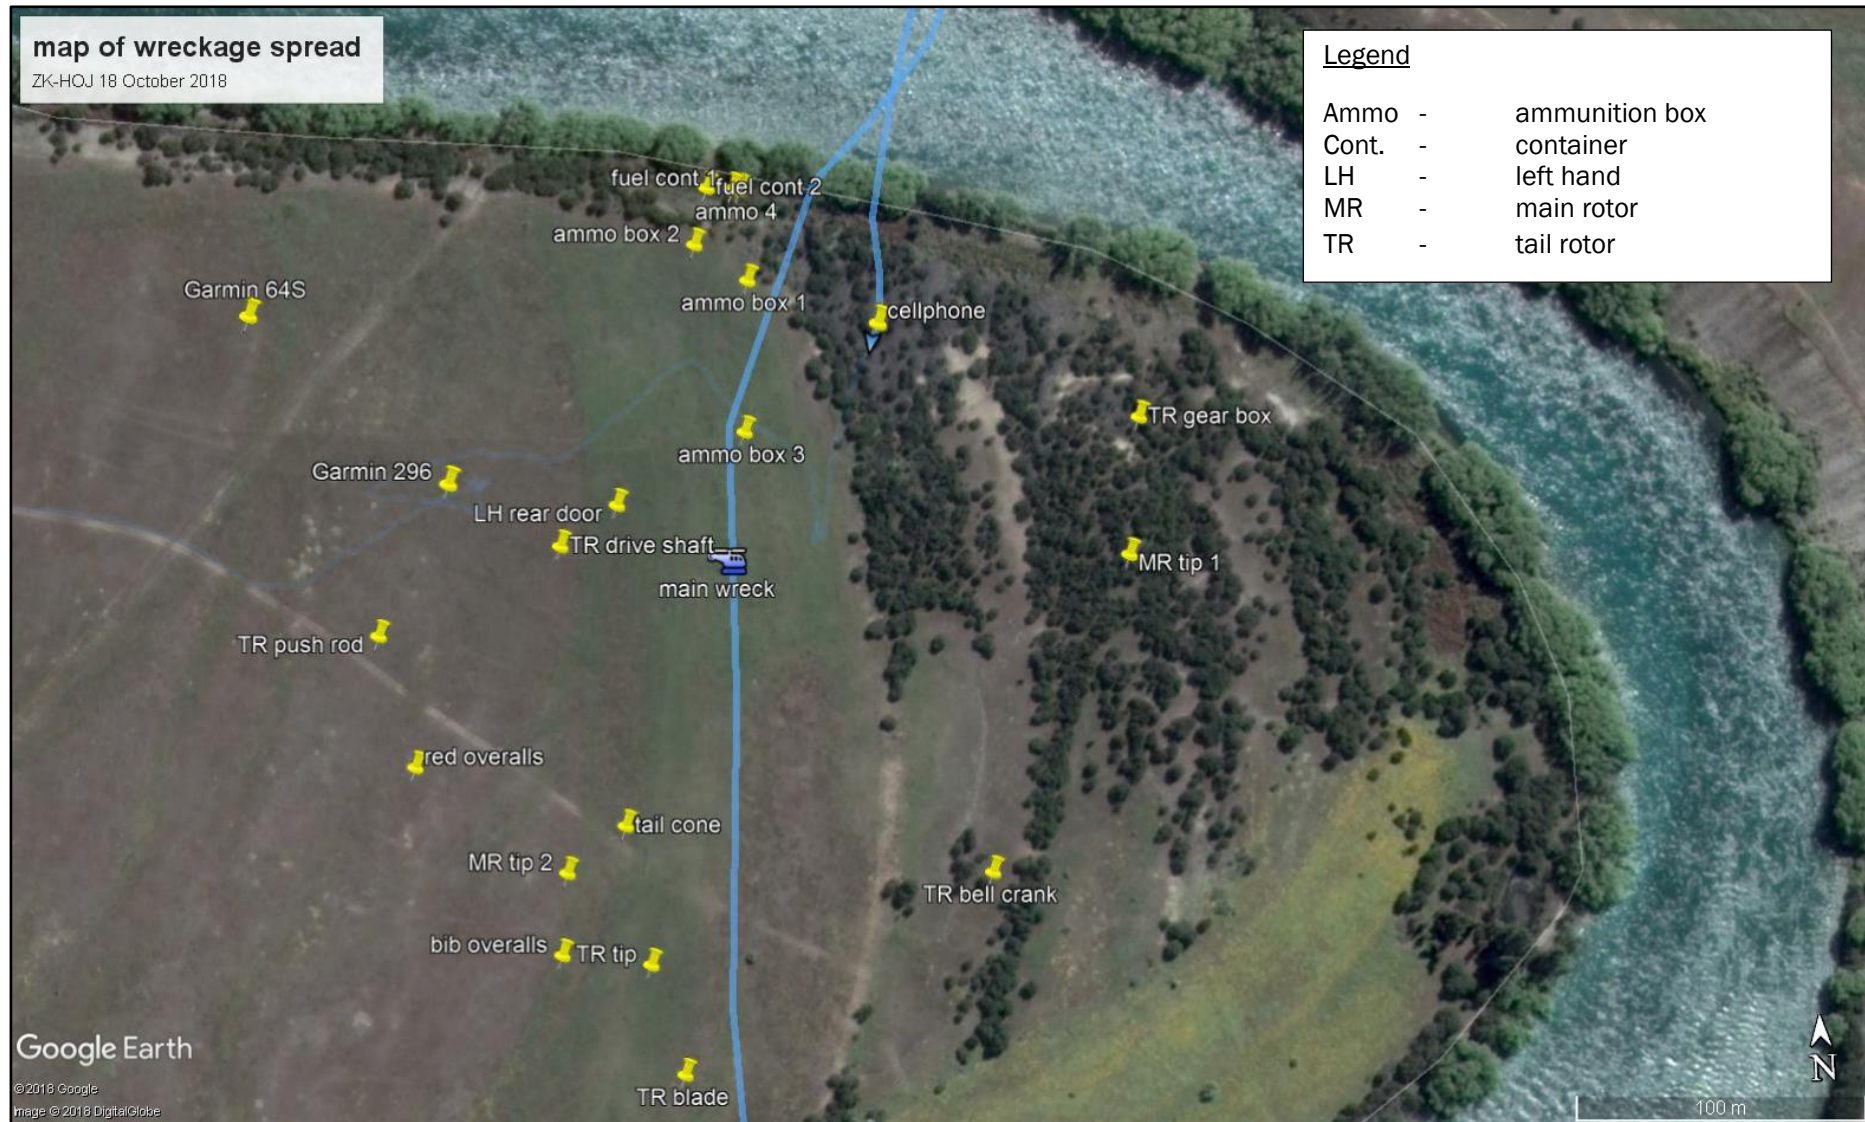
Appendix 2: Map of wreckage

- 2.2.1. The post-impact fire consumed most of the main helicopter wreckage.
- 2.2.2. Aircraft parts and items that had been in the cabin were scattered over a distance of about 500 m from the main wreckage (see Appendix 2).
