Transport Accident
Investigation
Commission

Final report

Aviation inquiry AO-2022-005
Boeing 737-484SF ZK-TLL
Incorrect fuel configuration
Sydney to Auckland
7 June 2022

November 2024

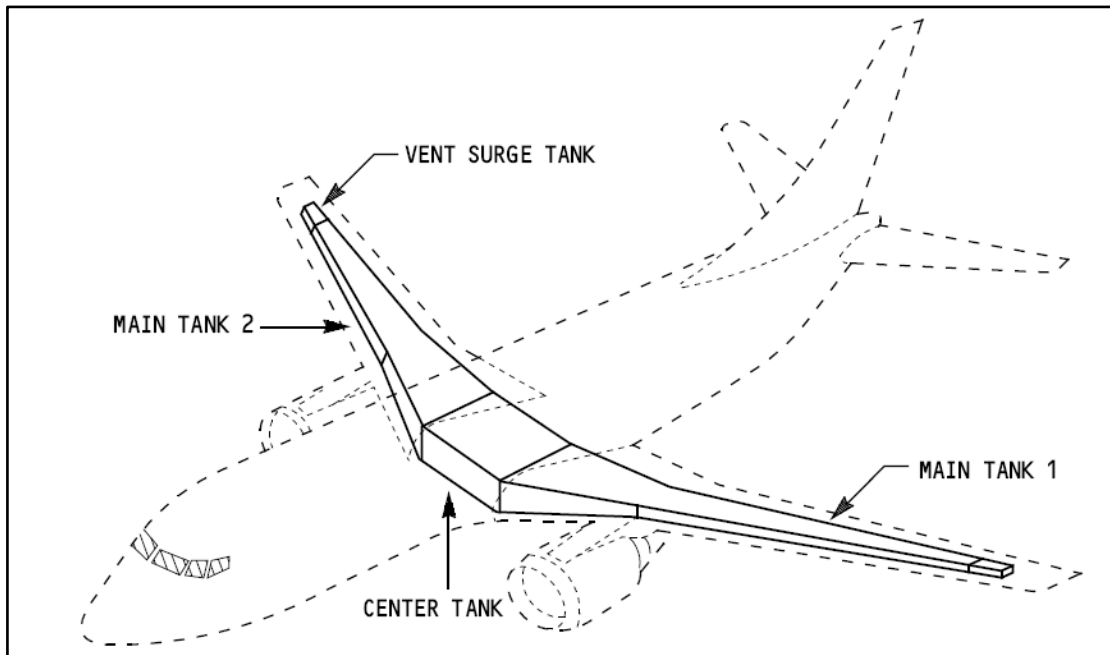
Figure 3: Fuel tanks B737-400

- 2.23. The manufacturer recommended that, when refuelling an aircraft, the fuel be distributed equally to the main tanks until they were full, and that any additional fuel be loaded in the center tank. The fuel-delivery system was arranged to draw fuel from the center tank before the main tanks. Each tank was fitted with check valves that regulated the output/flow pressure from the fuel pumps. The center tank check valves opened at a lower pressure than the main tanks' check valves.

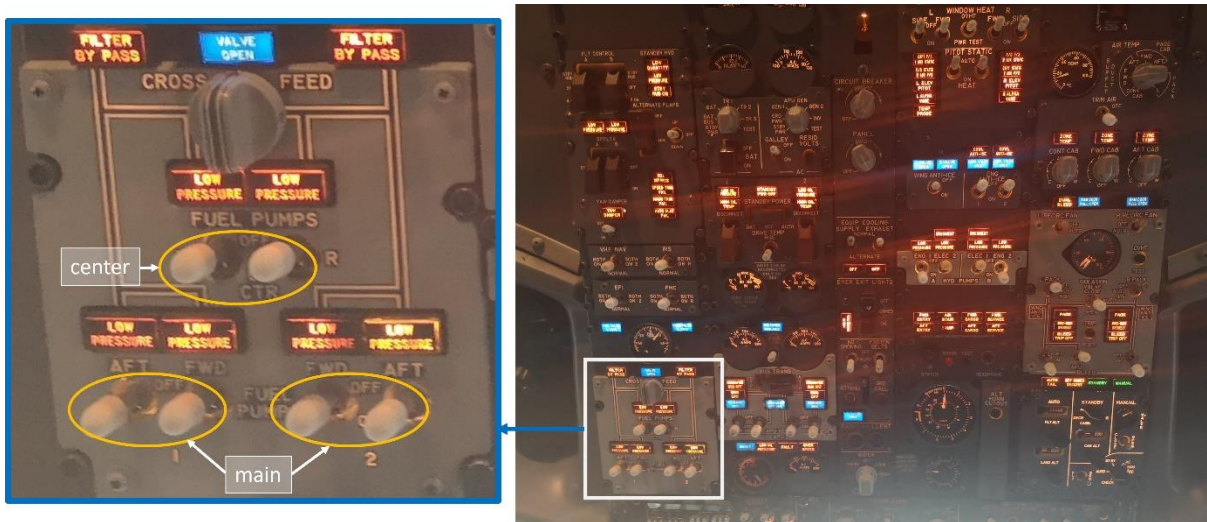
Figure 4: B737-400 overhead panel with fuel panel highlighted

Safety issue: The center fuel pumps were not switched on as required by the Before start procedure, and this omission was not captured by the crew completing the Before start checklist. If not detected, this omission has the potential to cause fuel starvation to the engines, increasing the risk of an accident occurring.

- 3.4. The sequence for preparing aircraft systems to commence a flight is detailed in the FCOM (relevant sections are included at Appendix 2). The FCOM details how each system should be prepared for each phase of flight, for example which systems need to be turned on prior to engine start, and who should carry out the action.
- 3.5. One of the first officer's tasks in the *Before start procedure* was to configure the fuel panel by selecting the fuel pump switches to 'on' (see Appendix 2). The procedure states that if the center tank fuel quantity exceeds 453 kg, the center fuel pumps should be switched on. In this instance the first officer turned on the main fuel pumps but omitted the center fuel pumps (see Figure 4 below for the fuel panel layout).

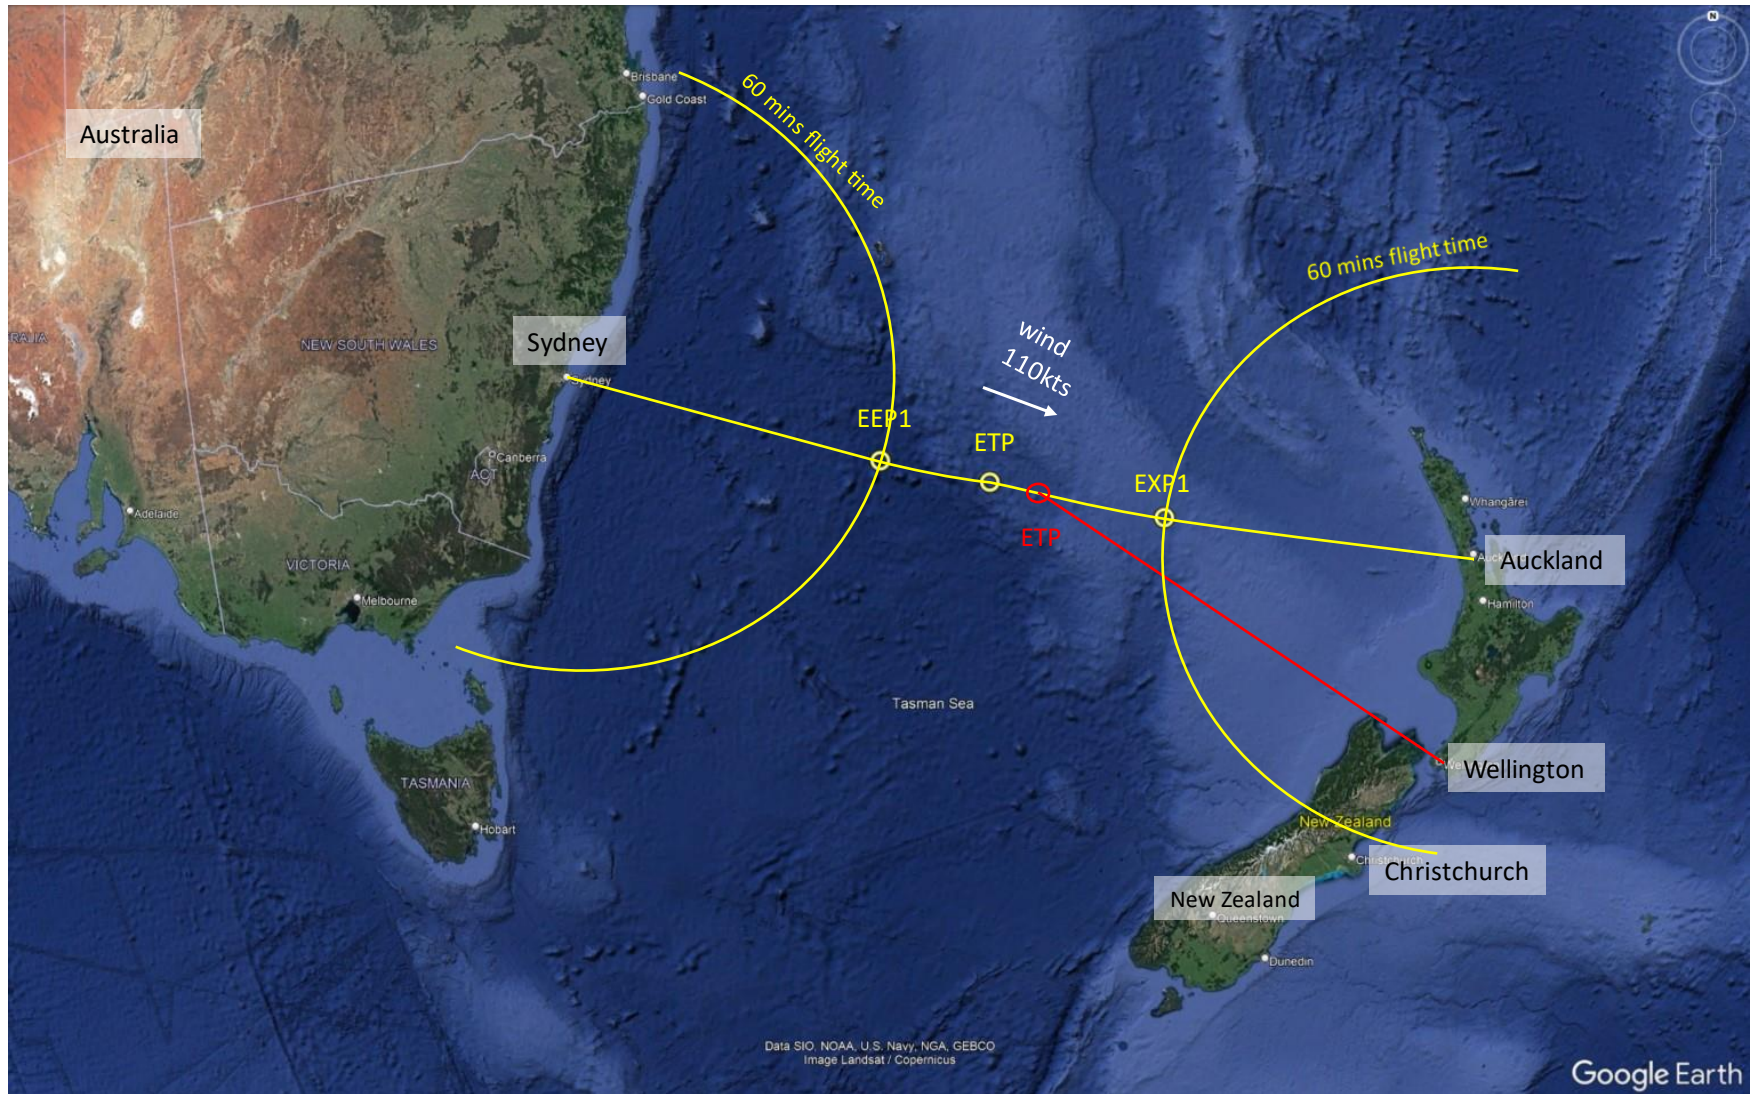
Figure 6: Equal time point

- 2.41. For an EDTO flight, the EDTO alternates are also nominated on the flight plan, and the halfway point for the EDTO portion of the flight between these two alternates is stated. If an engine failure or decompression were to occur in the first segment of a flight, the flight would divert to the first EDTO alternate; after the halfway point the flight would continue to the second alternate. An important part of the flight plan is the calculation of the amount of fuel required for the flight should a failure and diversion be required at the most critical, or halfway, point. This is depicted in Figure 6.
