Transport Accident  
Investigation  
Commission

# **Final report**

***Aviation inquiry AO-2023-003***  
***Runway excursion (veer-off)***  
***Boeing 777-319ER, ZK-OKN***  
***Auckland International Airport***  
***27 January 2023***

**May 2025**

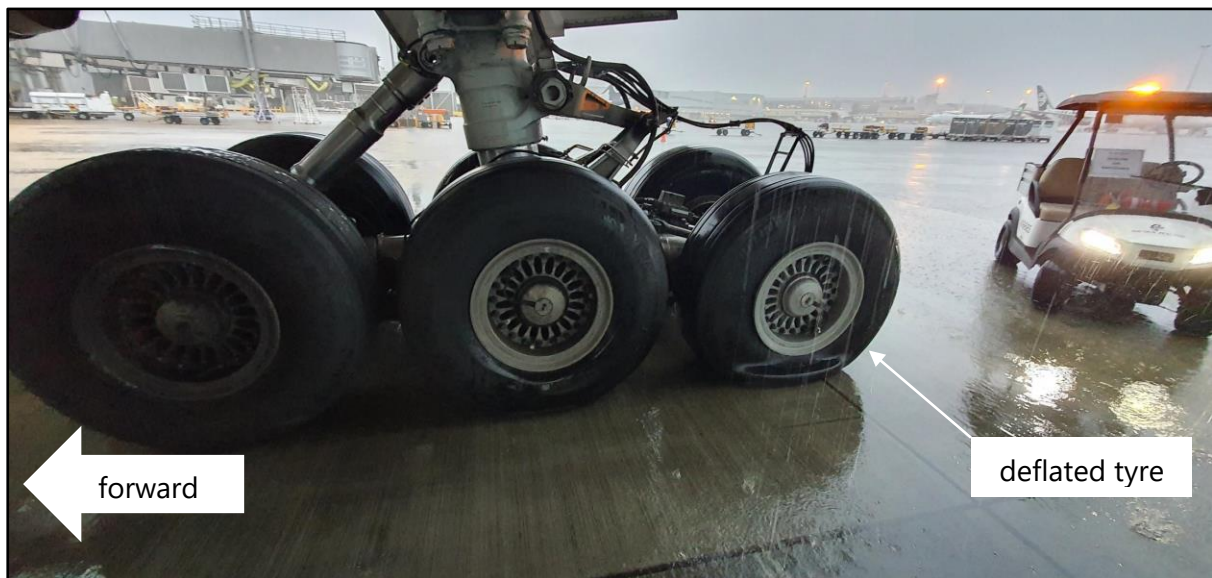
**Figure 4: Right main landing gear shortly after shutdown**  
(Credit: Air New Zealand)

- 2.16. About 20 s after landing, the PM observed a tyre-low-pressure indication on the right main landing gear. The PM informed the tower controller and advised them of potential debris on the runway. The aeroplane exited the runway at taxiway A3 as usual and taxied to its allocated gate at the International Terminal (see Figure 3). After shutdown, the right main landing gear was inspected and the rear inboard tyre was confirmed to have deflated (see Figure 4).

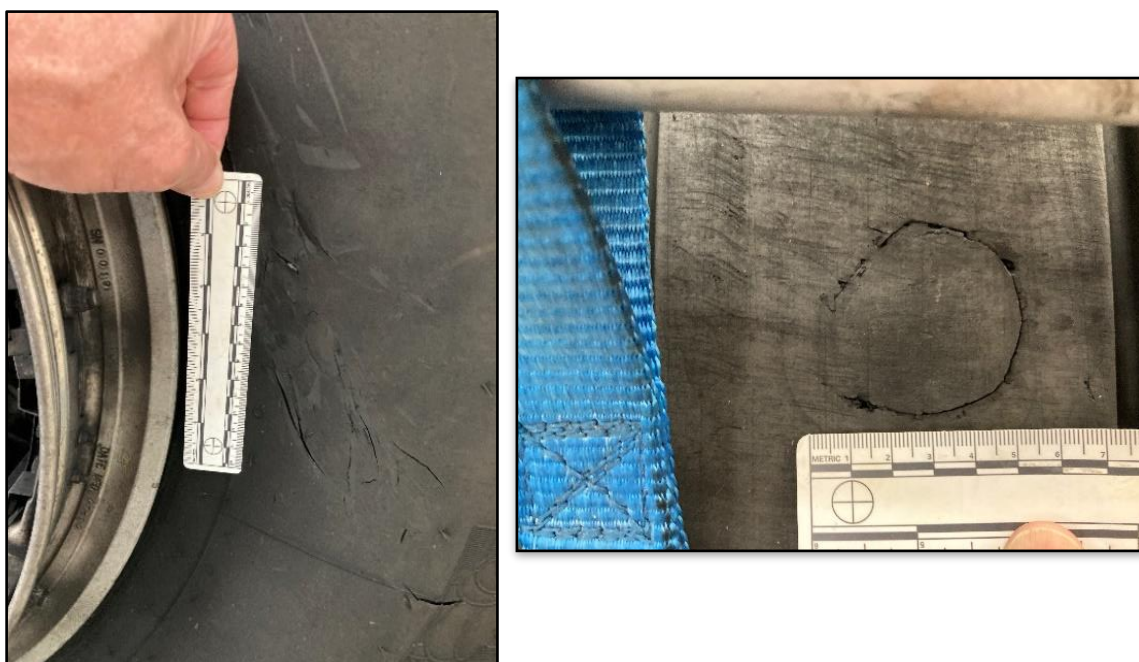
**Figure 5: Tyre damage**

- 2.36. The right main landing gear was examined soon after the aeroplane arrived at the gate. The aeroplane was then towed to a hangar and quarantined.
- 2.37. A more detailed examination of the right main landing gear found five of the six tyres displayed cut, puncture or imprint damage. Many of the imprints matched the shape of the broken bases of the runway edge lights (see Figure 5 and Figure 6). There was also damage to the landing-gear brake assembly, wiring harness and brackets. All six tyres were replaced, either because of damage or because they had exceeded the overstress weight limit. The aeroplane was returned to service within a week of the occurrence. (See paragraph 2.46 regarding runway damage.)

- 3.13. An examination of the aeroplane's main landing-gear tyres and the runway found no evidence of aquaplaning. Aquaplaning, also known as hydroplaning, is when water is forced under a tyre, causing the tyre to lift from the surface. This results in reduced braking performance and ability to maintain directional control. The higher speeds of aeroplanes, compounded by braking, produce superheated water. This causes damage to tyres and leaves evidence on the runway. (See paragraph 3.29 and Figure 9.)

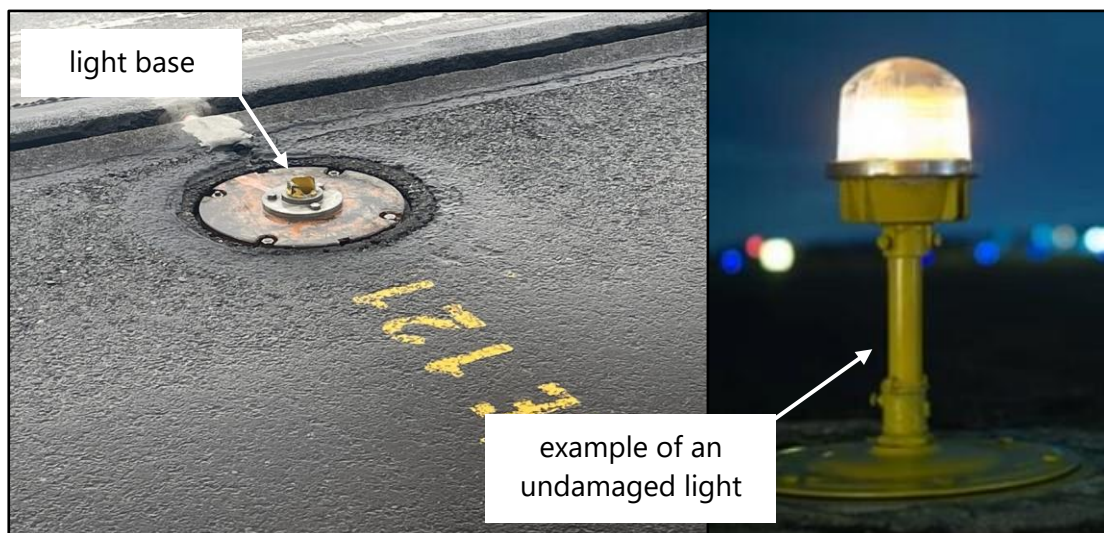
**Figure 6: Runway edge lights**

- 2.46. Runway lighting included runway centreline and edge lights. The centreline lights were flush mounted, while the edge lights were positioned every 60 m on the outside of the painted runway edge. The edge lights were mounted on 20-cm high pedestals and designed to be frangible – to break-off at their bases in the event of being struck. A total of six runway edge lights had been struck and broken off at their bases.

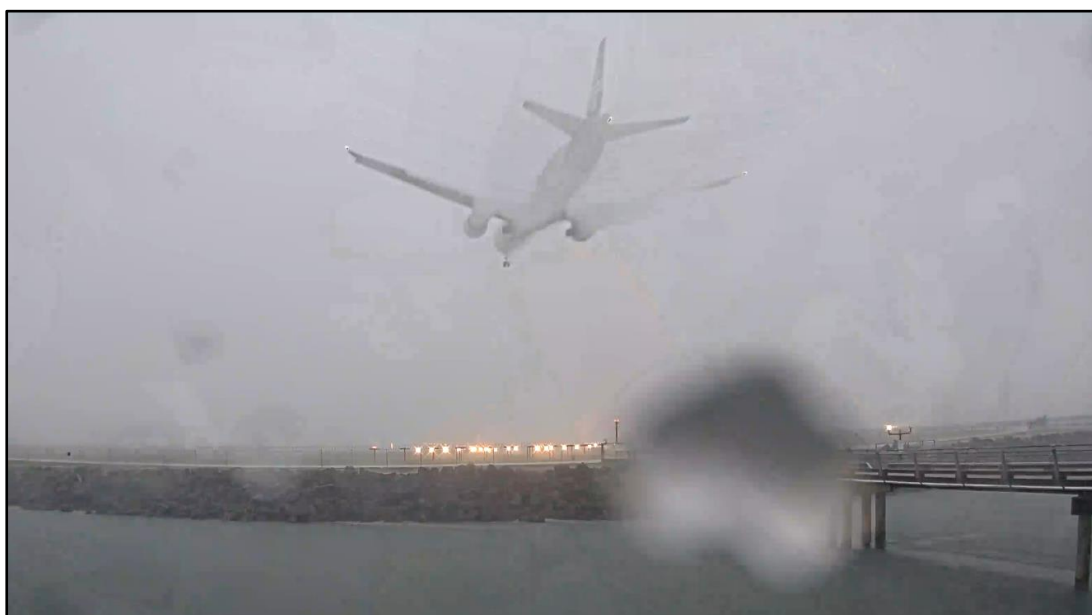
**Figure 7: Boeing 777 ZK-OKN nearing the runway**  
(Credit: Auckland International Airport Limited)

- 2.47. The aerodrome was equipped with a number of closed-circuit television (CCTV) cameras about the runway and terminals. The Commission obtained the footage of 18 cameras that had recorded ZK-OKN landing at the aerodrome and taxiing to the terminal. These included the two runway-end cameras (see Figure 7).

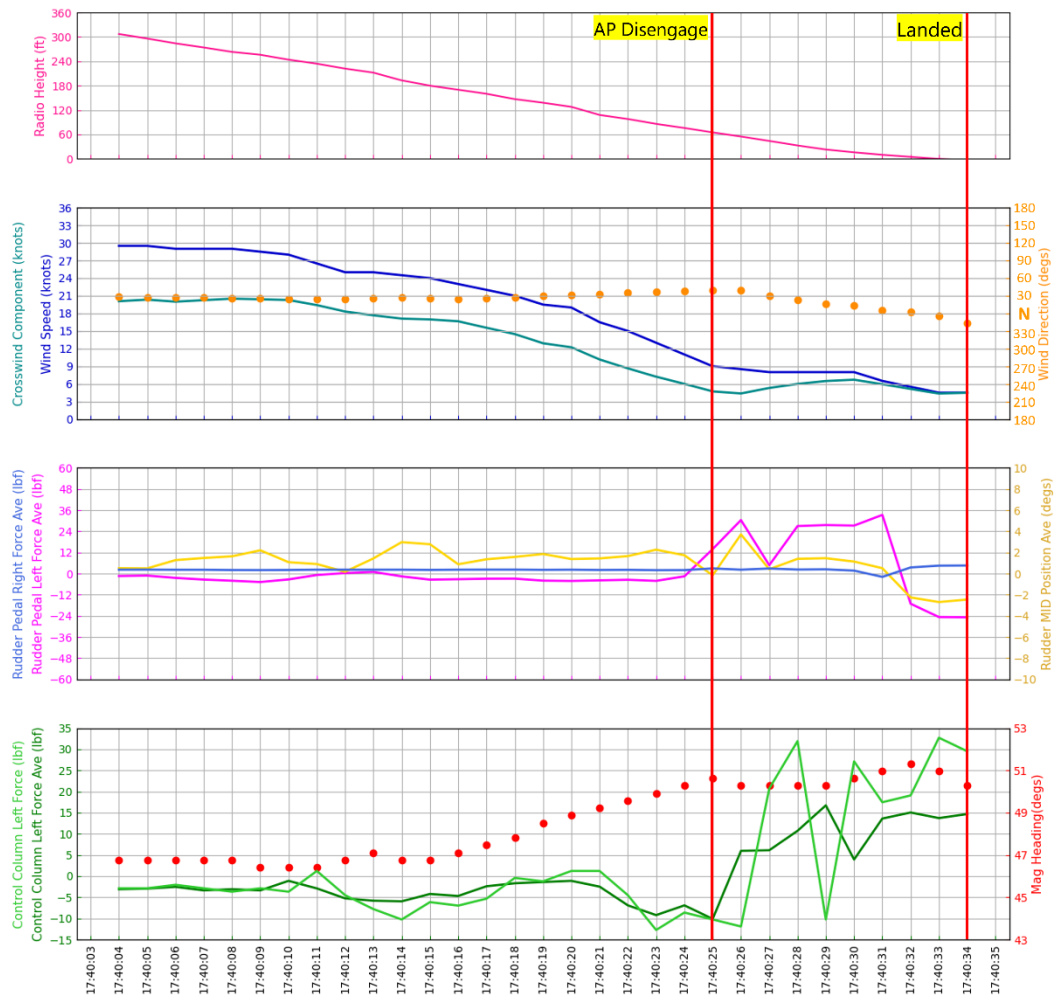
Figure 8: DFDR data

- 3.28. Also shown in Figure 8, at the same time the wind, while not strong or gusty, was decreasing in speed and backing around more to the left. Review of the flight data information showed that in the 15 seconds before the autopilot was disengaged the left crosswind component reduced from 20 kt to 5 kt, then fluctuated by 1 or 2 kt until touchdown. The combination of the initial roll right after disengaging the autopilot and the crosswind from the left was unable to be countered by the PF before the aeroplane exited the runway and struck the six edge lights. Regardless of the runway conditions, given this combination of actions it is **virtually certain** the aeroplane would still have left the runway.

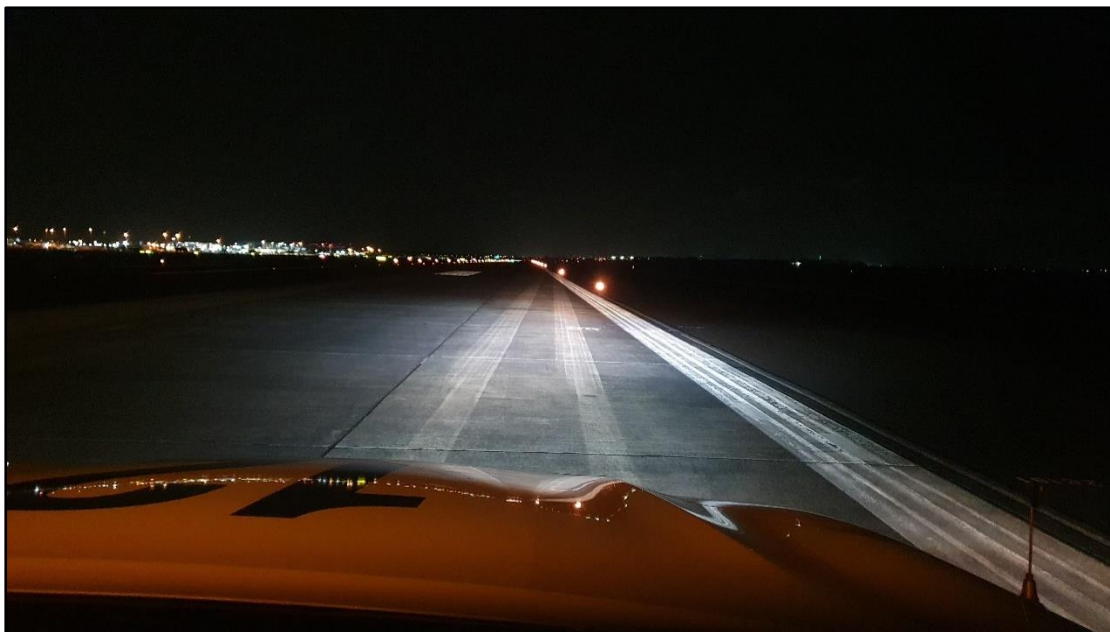
**Figure 9: Tyre marks on runway 05R showing direction of aeroplane**

- 3.29. Two nights after the occurrence, the driver of an AIAL vehicle was conducting an inspection of runway 05R. They were focusing on the area of the damaged runway edge lights when they identified the wheel marks left by the aeroplane's right main landing gear (see Figure 9). The marks had not been visible during the day. The slight offset of each pair of tyres, supported by the DFDR information, showed that the aeroplane had been pointing back towards the runway, but the momentum had still been moving the aeroplane right towards the lights.
