Transport Accident
Investigation
Commission

Final report

Aviation inquiry AO-2023-010
Kawasaki BK117 B-2, ZK-HHJ
Collision with terrain
Mount Pirongia
19 September 2023

April 2025

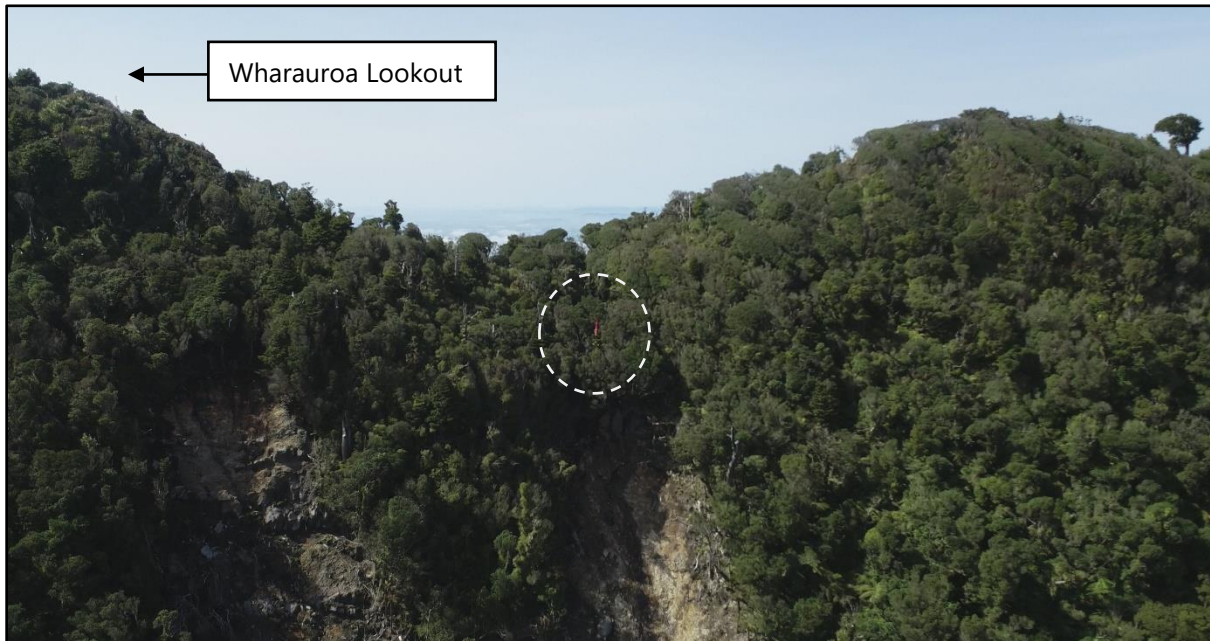
Figure 5: Accident site

- 2.39. The accident site was on Mount Pirongia on a west-facing escarpment covered by dense native forest, about 108 m southwest of Wharauoa Lookout (see Figure 5). The helicopter was sitting upright, wedged between trees below a ridge line (see Figure 6).
- 2.40. Damage to trees at the site indicated that the helicopter had fallen almost vertically through the tree canopy. All the wreckage was contained within a 15 m radius of the main fuselage.
- 2.41. The forward and aft cross-tubes of the landing-gear assembly had splayed outwards, causing the right side of the assembly to fracture in overload near the fuselage attachment fittings (see Figure 16 in Appendix 1).

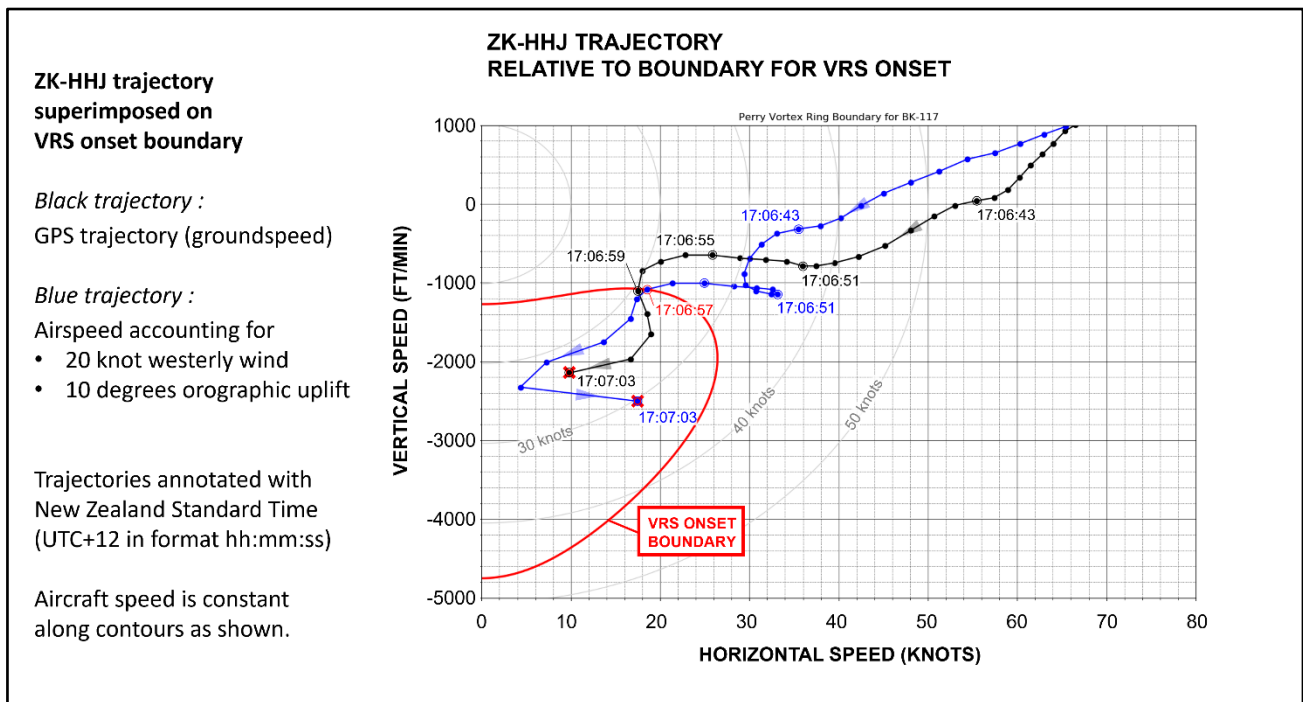
Figure 13: ZK-HHJ trajectory, accounting for 20 kt westerly wind and 10° orographic uplift

- 3.32. An analysis of the wind conditions at the time of the accident concluded that the wind speed was 20 kt, with gusts to 30 kt, from a westerly direction. The topography would have induced an upward component of wind flow relative to the helicopter's trajectory, known as orographic uplift. This upwards component of the wind would have appeared to the rotor as an increase in its effective descent rate. The blue trajectory (see Figure 13) depicts the helicopter's velocity, represented as a horizontal airspeed and descent rate, factoring in the influence of wind. This figure shows that, on accounting for the effect of the wind, the helicopter would have encountered VRS at 17:06:57, two seconds earlier than if the effects of the wind were not accounted for. By referring back to the trajectory shown in Figure 12 it can be inferred that the helicopter would have entered VRS at a substantially lower descent rate and higher forward speed (728 ft/min with a groundspeed of 20 kt) compared with the effects of the wind being omitted from the analysis.

- 3.33. An important factor was the change in the helicopter's heading around 17:06:59, causing a shift in the wind to blow from behind the helicopter (tail wind), effectively reducing the helicopter's airspeed. This shift in the relative wind contributed to the helicopter penetrating more deeply into VRS than if the heading of the helicopter had remained unchanged. As a result, the pilot would have experienced significantly exacerbated symptoms of VRS, as well as potentially greater difficulty in recovering to normal flight.

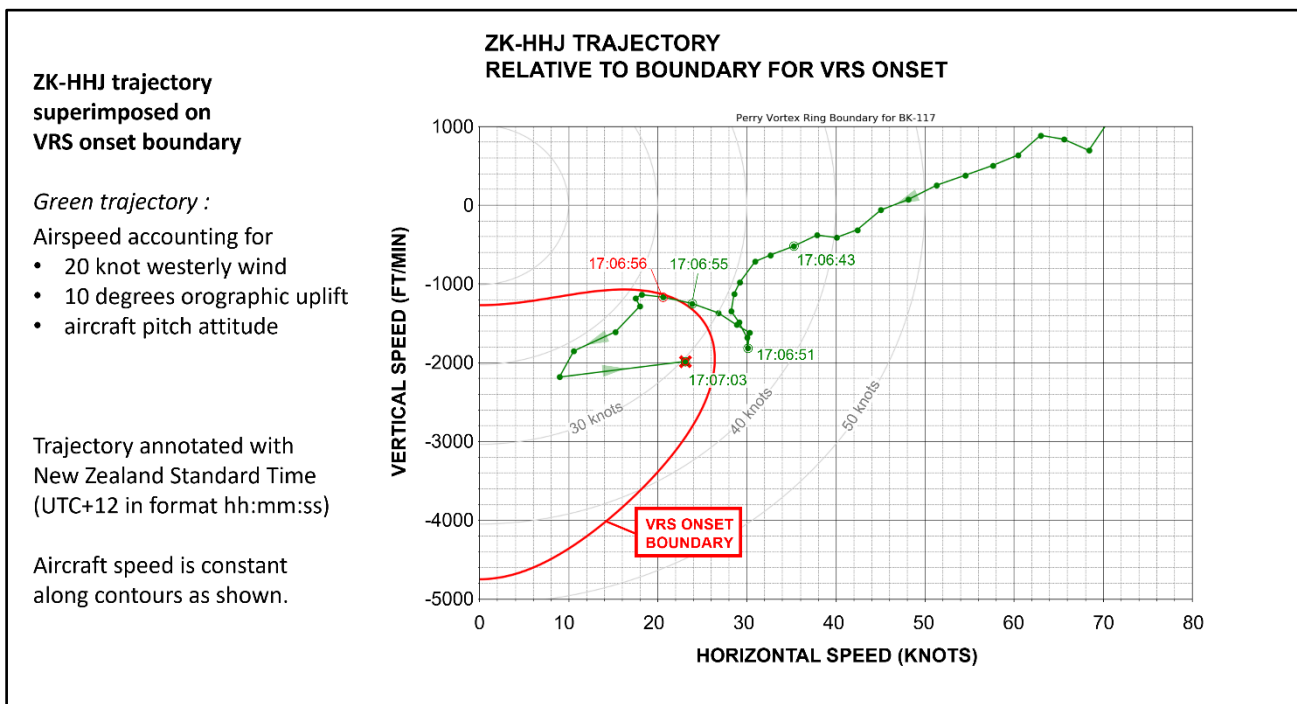
Figure 14: ZK-HHJ trajectory accounting for 20 kt westerly wind, 10° orographic uplift and pitch attitude

- 3.35. In Figure 14, the green trajectory denotes the airspeed and descent rate as measured relative to the helicopter's rotor, accounting for the changes in pitch attitude of the helicopter, while descending along the ridge line. The effective inclination of the rotor to the airflow was calculated by subtracting the helicopter's mast inclination angle (5°) from the helicopter's pitch attitude, as recorded by the Flightcell DZMx.

- 3.36. At 17:06:51 the helicopter's pitch attitude reached a maximum of 19.5°. The analysis presented in Figure 14 then shows that the helicopter would have crossed the VRS onset boundary sometime between 17:06:55 and 17:06:56, 3.5–4 seconds earlier than if the pitch attitude and wind were ignored in the analysis. Referring back to the speeds relative to the ground (the black trajectory in Figure 12), the helicopter would have entered VRS at a descent rate of 649 ft/min with a groundspeed of 25.8 kt.
