Report 08-007, Robinson Helicopter Company, R22 Alpha ZK-HXR, loss of control,  
Lake Wanaka, 1 November 2008

**Report 08-007**

**Robinson Helicopter Company R22 Alpha  
ZK-HXR**

**loss of control**

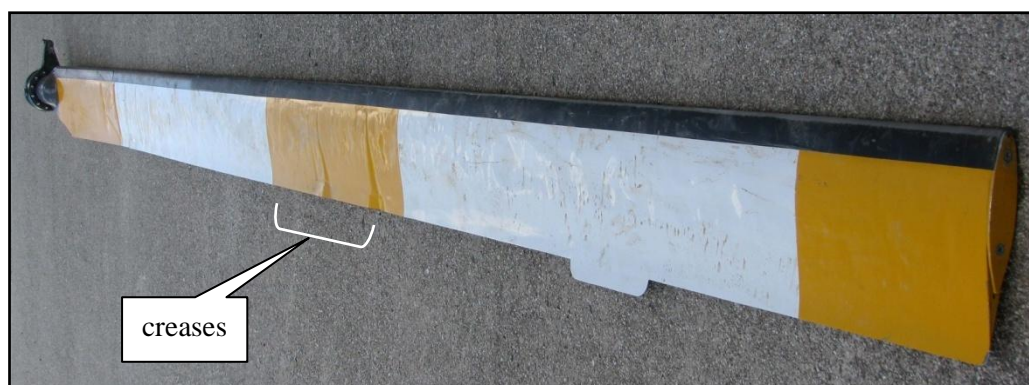
**Figure 6**  
**Recovered main rotor blade**

- 1.3.8 The drive train from the upper drive pulleys to the rotor hub was present, with one main rotor blade attached. The recovered blade was straight with no damage to the leading edge or tip, but had chord-wise<sup>9</sup> creasing, and light compression damage over the top and bottom skins (see Figure 6). The direction of the creases indicated that the blade had flexed both up and down. The droop tusk was broken off.

- 1.3.9 Chord-wise creasing in the same area of the skins of both main rotor blades would most likely be caused by a low-rotor-RPM condition. Creasing on just one blade could be the result of impact or excessive flexing during a mast bump, or by a relatively soft impact that did not damage the blade spar (Robinson, 2010).

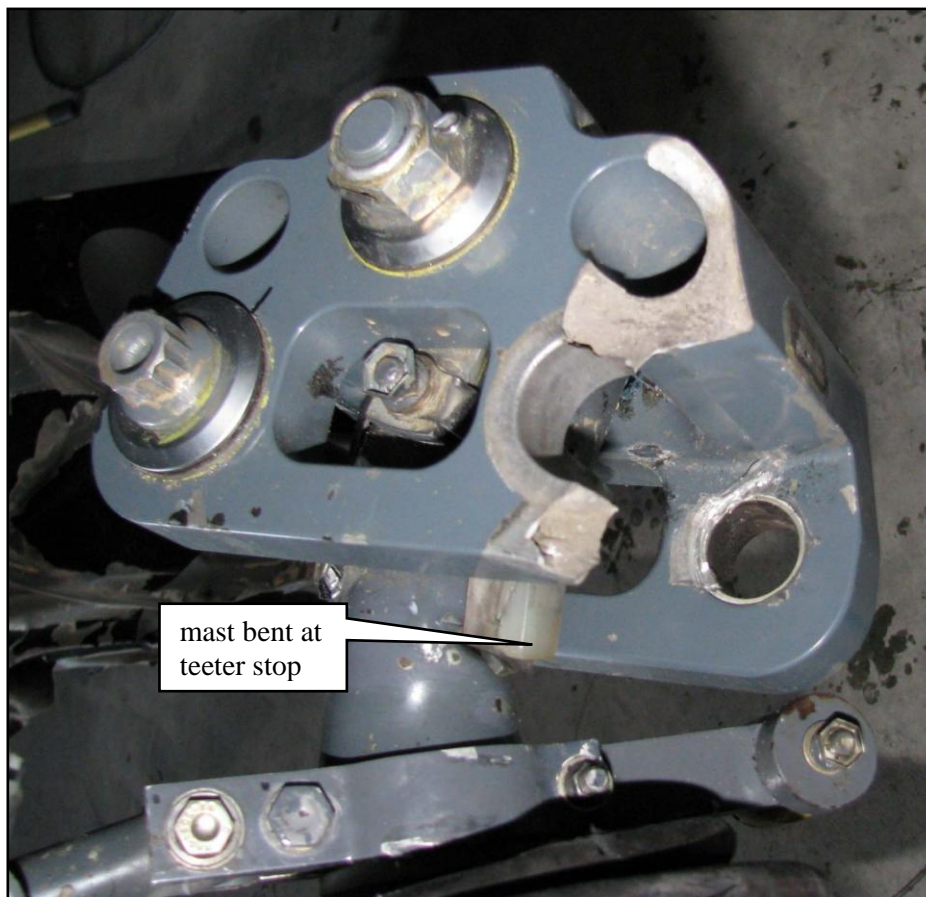
**Figure 7**  
**Rotor hub and evidence of mast bump**

- 1.3.10 The missing blade had broken out of the hub at the trailing edge attachment bolt hole, the hub fracture having the appearance of tension overload. The mast was bent at the lower edge of the adjacent teeter stop (see Figure 7). Both pitch links had fractured as a result of overload.

- 1.3.15 Both teeter stops were crushed and the mast bent. The mast was also broken in line with the top of, but retained in, the main transmission. Compressive damage to the cabin and rotor mast fairing indicated the helicopter had entered the water in a near-vertical, nose-down attitude.
