Transport Accident
Investigation
Commission

**Report of the Transport Accident Investigation Commission into
two stevedoring accidents in April 2022**

*Maritime inquiry MO-2022-203
Container vessel, Capitaine Tasman
Stevedore fatality during container loading operations
Port of Auckland
19 April 2022*

*Maritime inquiry MO-2022-202
Bulk carrier, ETG Aquarius
Stevedore fatality during coal loading operations
Lyttelton Port
25 April 2022*

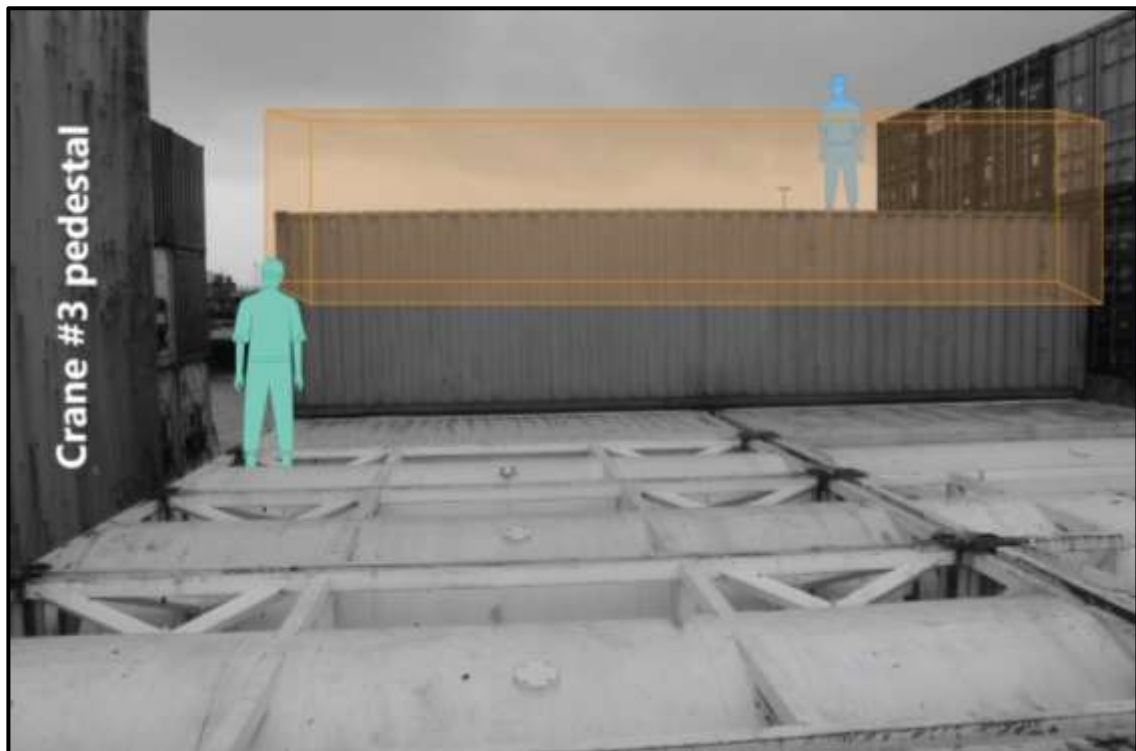
Figure 10: Approximate position of hold operator A (green) on the edge of the first tier of containers immediately before accident

- A1.18. At the time the crew member observed hold operator A, the 40-foot container was suspended approximately 1.5 metres above the first tier. The crew member then saw the hold operator bend down and move underneath the suspended container, reaching with their arm toward the aft port side of the container.
- A1.19. Almost immediately after observing this, the crew member saw the container lower, resulting in hold operator A being pinned under the container and crushed by its weight.
- A1.20. The crew member attempted to alert the crane operator by shouting but, due to the proximity of bay 32 to the number three crane, could not signal the crane operator visually. The crew member then observed the container rise a small amount and hold operator A fell from the 20-foot container onto the main deck (see Figure 11).

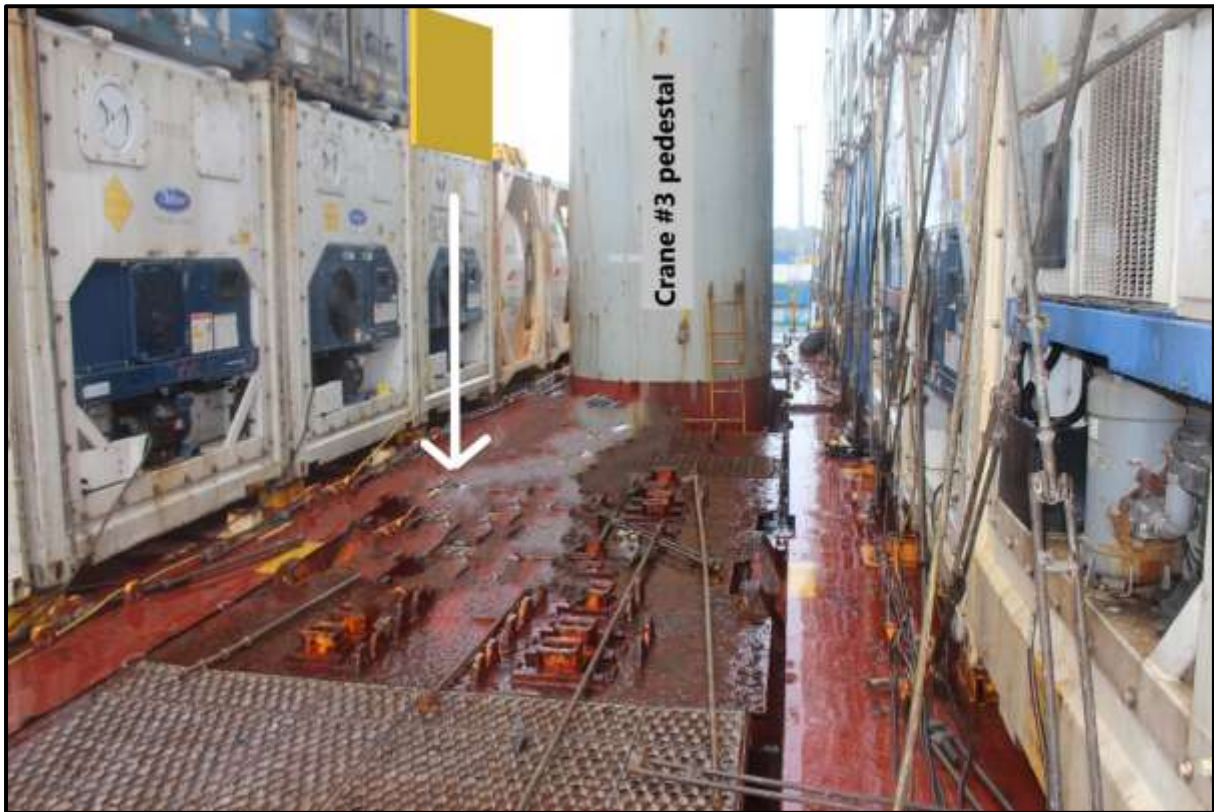
Figure 11: View from where the vessel crew member was standing on the main deck towards where hold operator A fell, as indicated by white arrow.

Yellow box represents where the container was to be positioned.

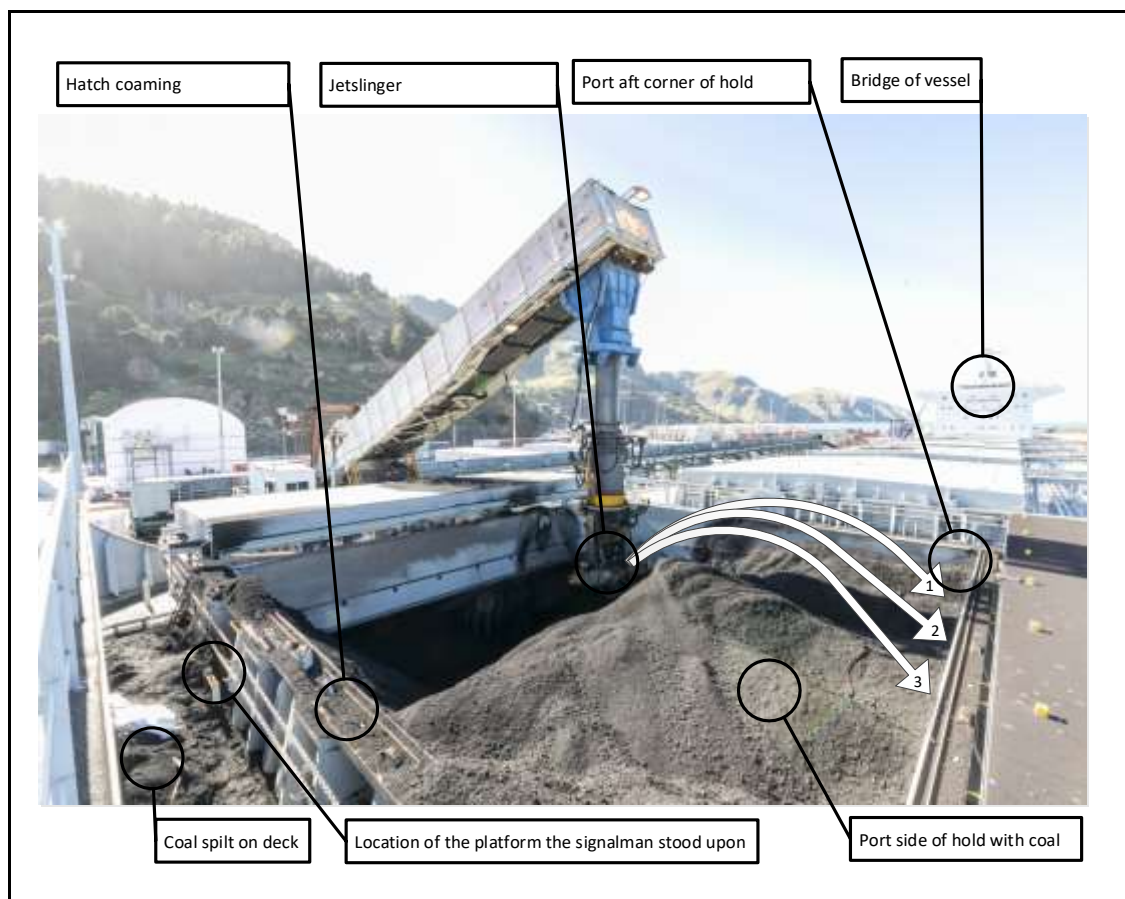
Figure 18: Number one hold after the accident, showing the ship-loader and jetslinger⁹⁵
(Credit: Maritime New Zealand)
