Transport Accident  
Investigation  
Commission

# **Final Report**

***Maritime inquiry MO-2022-206***  
***Charter fishing vessel, i-Catcher***  
***Capsize***  
***Goose Bay, New Zealand***  
***10 September 2022***

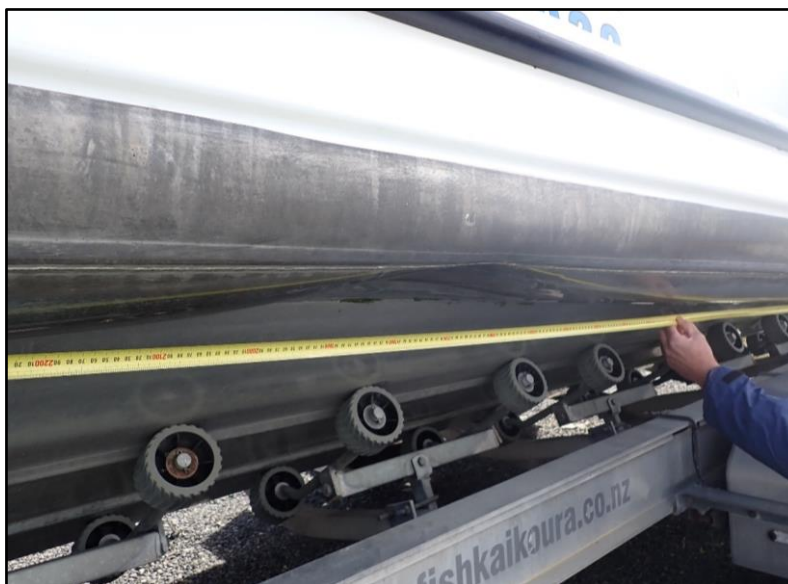
**Figure 8: Indentation under port pontoon**

- 2.57. During its initial examination of the vessel, the Commission identified a significant smooth indentation underneath the port pontoon, measuring approximately 2.47 m in length. The depth of the indentation was greatest in the forward portion measuring 8 cm deep, tapering in depth further aft (see Figure 8).

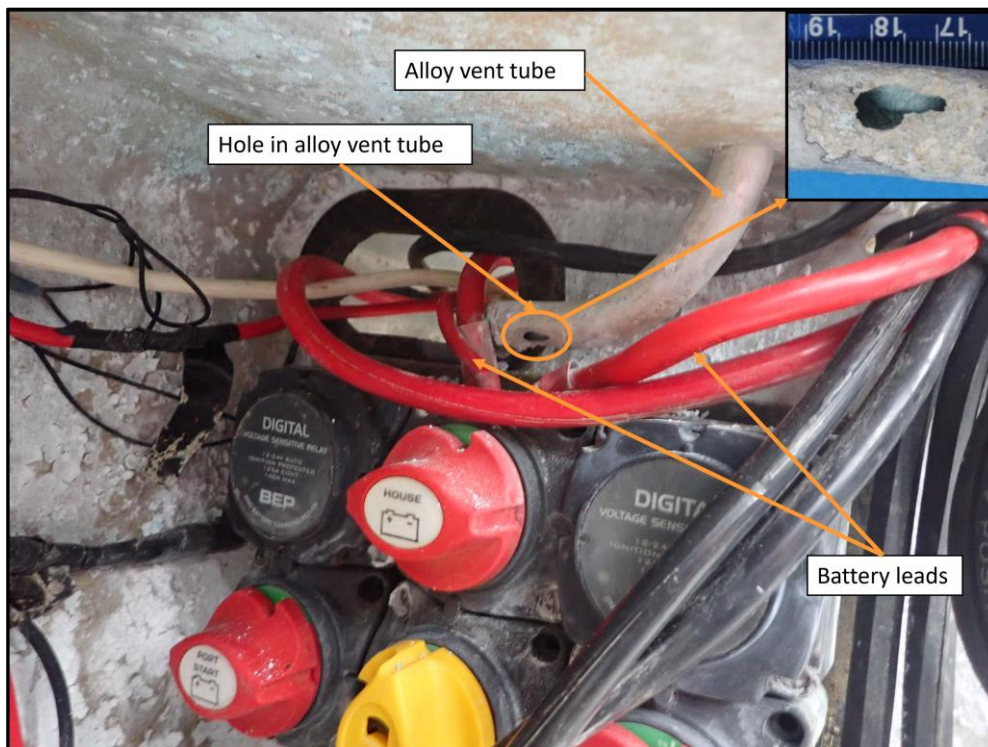
**Figure 11: Hole in alloy vent tube (batteries removed for access after accident)**

- 2.60. Initial inspection of the fuel system revealed a hole measuring approximately 12 mm x 6 mm in the alloy vent tube used as a secondary fuel vent (see Figure 11). The alloy vent tube was situated above the battery cluster switch located within the interior of the stern of the vessel (see Figure 12).

- 3.12. The type of aluminium used for the alloy vent tube was a marine-grade aluminium that develops a natural passive layer when exposed to the atmosphere. This passive layer protects the underlying material from the environment and corrosion.
- 3.13. The presence of corrosion would indicate that the passive layer was damaged or removed. Metallurgical testing carried out by Quest Integrity, on behalf of the Commission, identified that:

*the most likely cause of the hole was an accelerated external corrosion that occurred locally in-service, before the capsizing. The accelerated corrosion was likely because of crevice corrosion conditions caused by contact of the electrical cables with the pipe and/or accumulation of debris.*<sup>34</sup>

- 3.18. The Commission found that the hole in the alloy vent tube was **very likely** a result of crevice corrosion over time, because of one or a combination of the following factors:

- mechanical abrasion from electrical cables
  - the collection of dirt/salt in the immediate area
  - saltwater evaporation from the localised area.

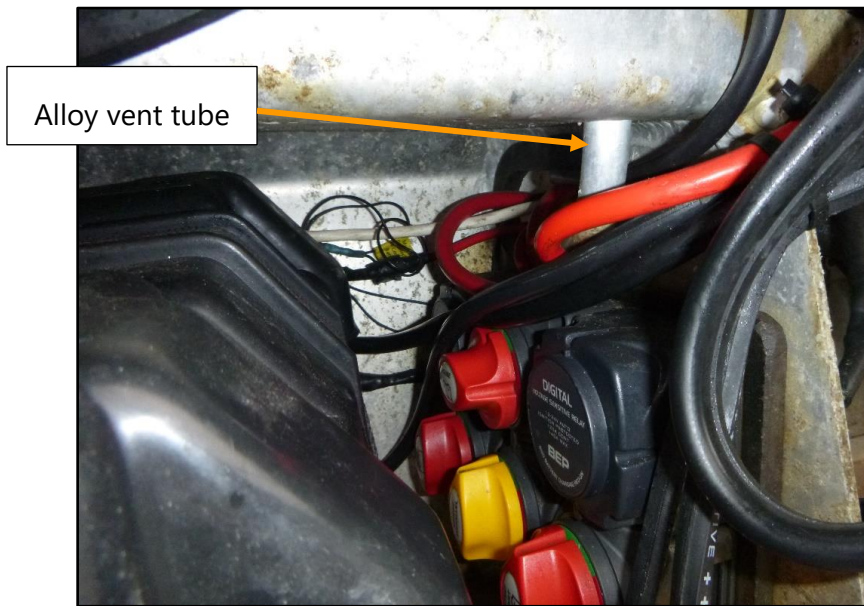
**Figure 13: 2021 survey photo demonstrating restricted view of alloy vent tube with batteries in place.**

- 2.61. Identification of the hole in the alloy vent tube required a thorough examination of the venting arrangement. The alloy tube was partially restricted from view by a battery box and surrounding wiring (see Figure 13). The hole was a potential path for fuel to escape when filling the fuel tank or if the vessel overturned. It was also close to the battery leads and contact points, which presented a significant fire or explosion hazard.

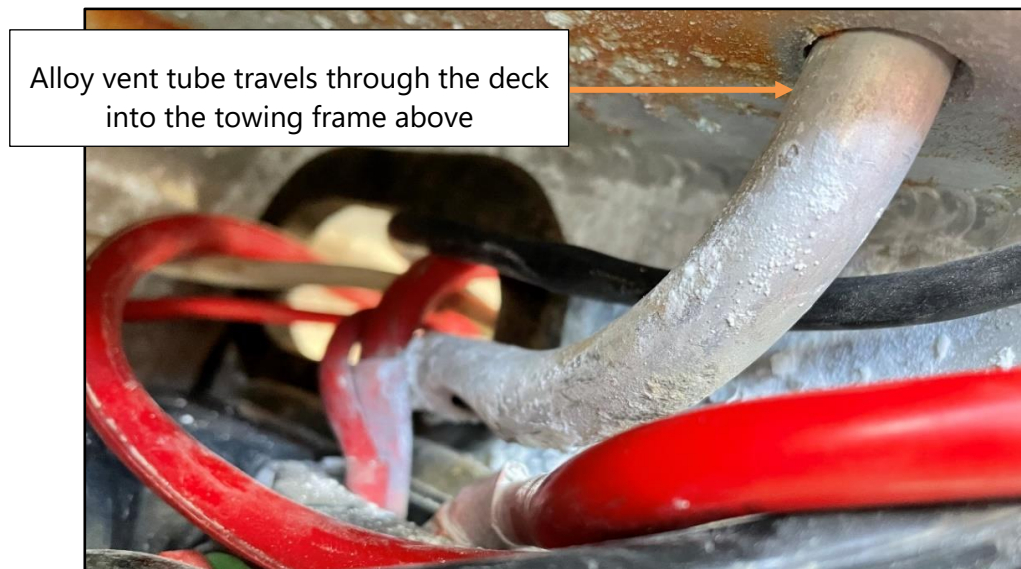
**Figure 14: Alloy vent tube joining towing frame**

- 2.62. The alloy vent tube terminated inside an alloy towing frame on the transom just forward of the swim platform (see Figure 14 and Figure 15). A pressure test of the alloy frame revealed that it was closed off from the atmosphere, preventing fuel vapours from venting to open air and rendering it ineffective as a fuel-tank vent.

Alloy vent tube travels through the deck into the towing frame above

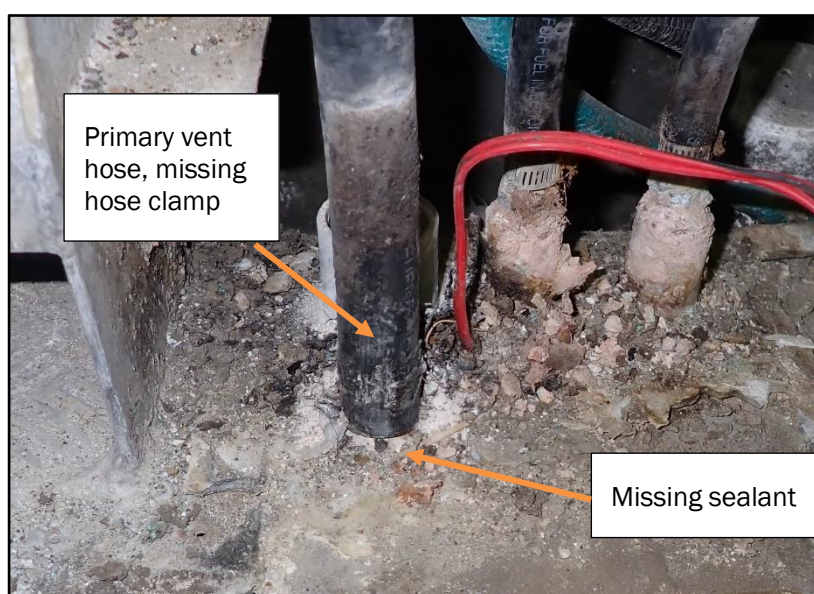
**Figure 17: Primary vent hose connection to fuel tank (underneath the deck plate)**

- 2.64. To enable inspection of the fuel tank and its connections, investigators removed the cover plate and the deck plate and partially disassembled the fuel system. Upon disassembly, investigators found the primary vent hose was not secured with a hose clamp, a critical component to ensure a secure connection to the fuel tank (see Figure 17).
- 2.65. A sealant had been applied around the plating where the fuel and vent hoses connected to the fuel tank. It was observed that a portion of the sealant had broken away, leaving a section of the primary vent hose connection exposed. The fuel tank and its fuel hoses were pressure-tested by Commission investigators, which revealed a leak from the base of the primary vent hose.

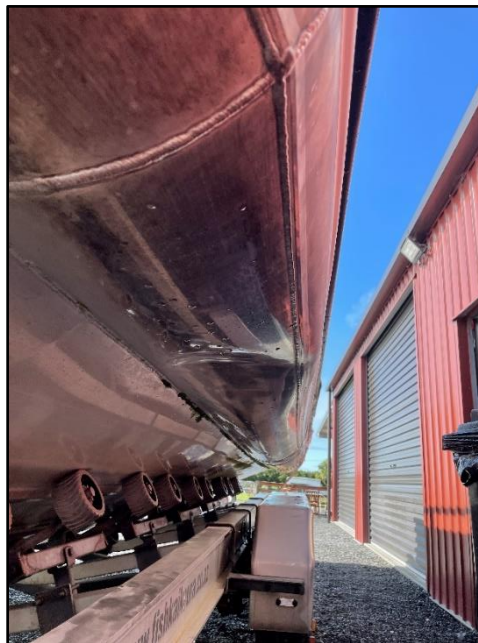
**Figure 23: Indentation under port pontoon**

- 3.9. The indentation underneath the vessel's port pontoon was smooth and of significant size (see Figure 23), indicating that it was caused by a soft but dense material rather than a hard object. Contact with hard objects usually result in significant abrasions, definitive markings, transfer of material and possible holing in the hull.

- 3.10. While humpback whale DNA was found on the vessel, it is possible that this resulted from the vessel being near a humpback whale rather than coming into direct contact with one. However, given the passenger's account of seeing a whale under the boat, the nature of the dent under the port pontoon, the DNA results and the absence of any other factor that might have caused the boat to capsize, the Commission considers that it is **virtually certain** the vessel capsized as a result of coming into contact with a whale that had surfaced under the port side of the vessel.

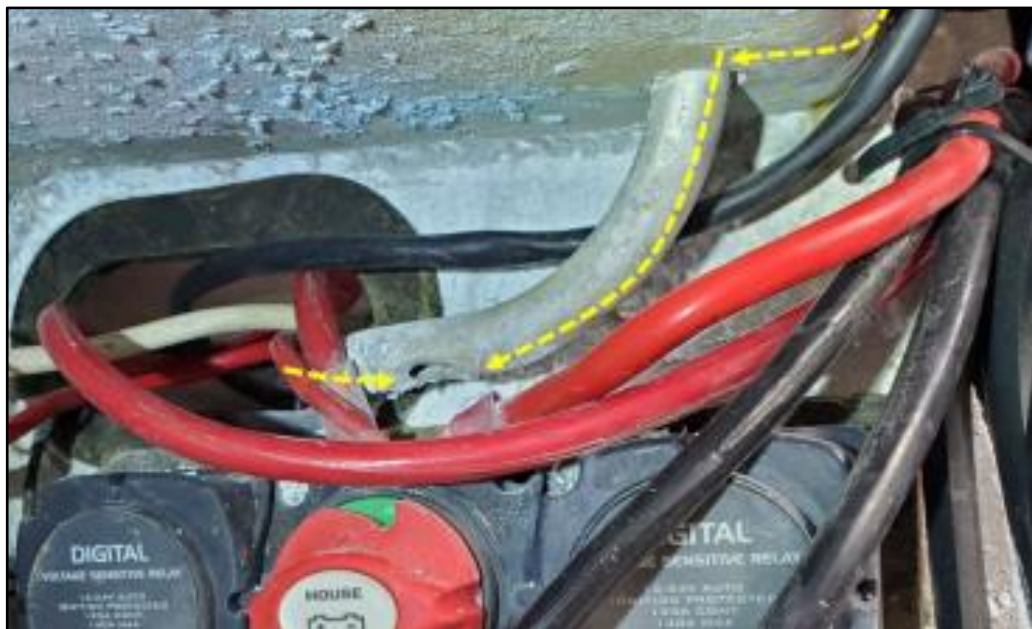
**Figure 24: Low point of alloy vent tube**  
(Credit: Quest Integrity)

- 3.14. The corroded hole was located at a low point in the system, which would allow water and dirt to run and collect (see Figure 24). When the alloy tube was removed from the system it was evident that there was further abrasion and corrosion where the battery leads had been in contact with the alloy tube (see Figure 25). With time it can be expected that these areas would also develop into holes.

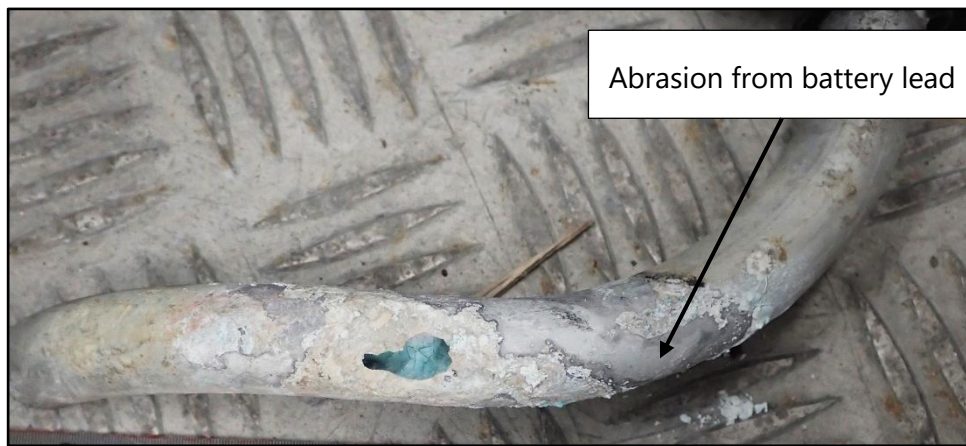
**Figure 25: Abrasion from battery lead**

- 3.16. At the time the battery selector switch was replaced, the alloy vent tube may have been subject to abrasion and the hole may not yet have formed. With the aluminium's natural passive layer damaged or removed by the battery leads, it would just be a matter of time before a hole developed.

- 3.17. It is **likely** that before the battery selector switch was replaced, the battery leads had been in contact with the alloy vent tube contributing to the corrosion that later developed into a hole.

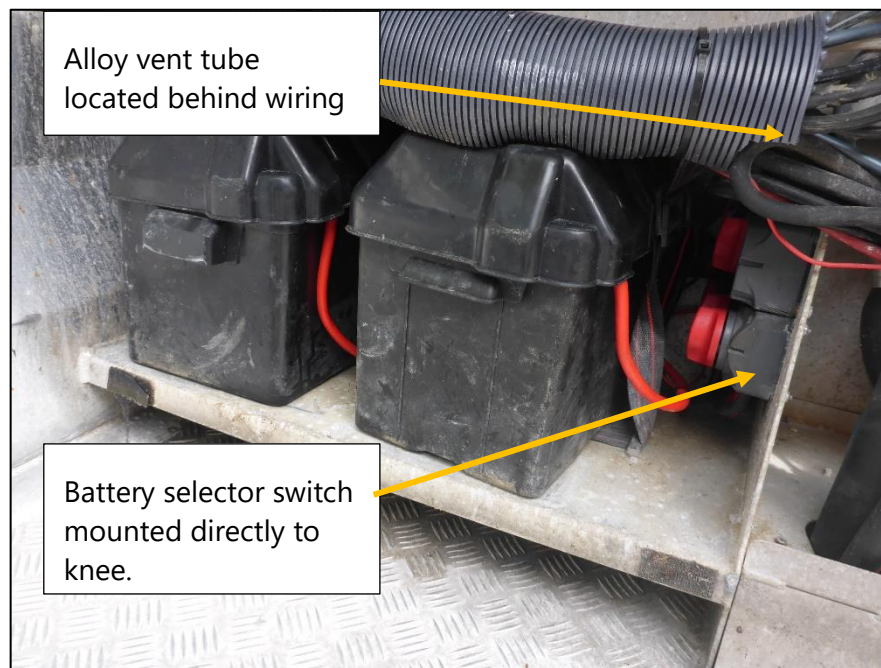
**Figure 26: Original battery selector switch arrangement (2016)**

- 3.15. The *i-Catcher's* battery selector switch was replaced in 2019. The original battery selector switch was mounted directly to the knee of the transom (see Figure 26). When the new battery selector switch was installed, an insulator pad was added to absorb vibrations between the knee and the switch. This would have changed where the battery leads contacted the alloy tube.

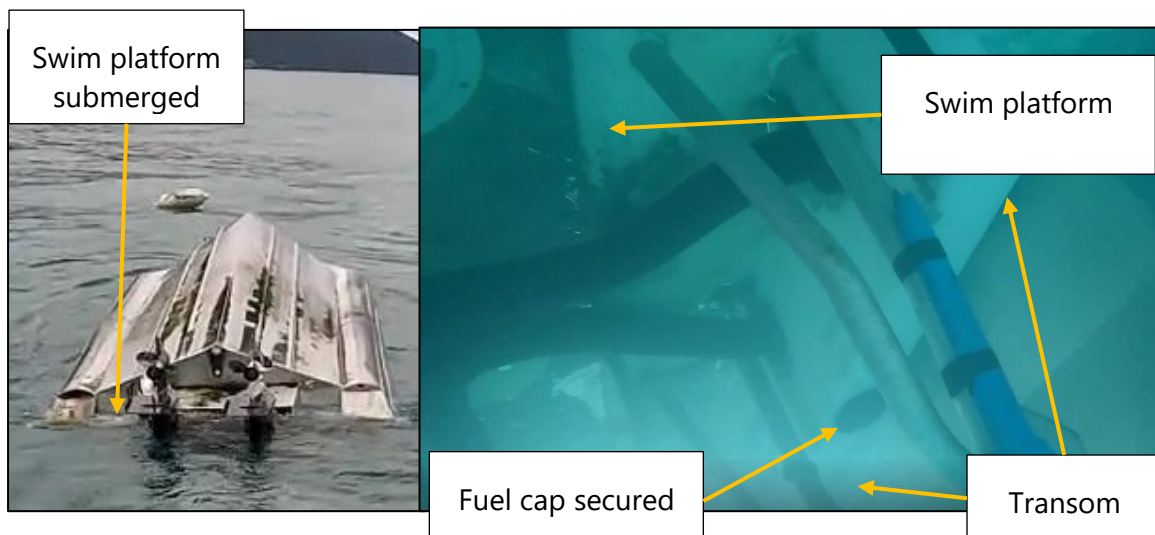
**Figure 28: Photo on left: *i-Catcher* capsized, Photo on right: Fuel cap secured**

- 3.23. When an inverted cap is submerged in sea water, the sea water applies an upward force to the surface area on the outside of the cap, countering the force applied by the fuel. The *i-Catcher's* fuel cap was mounted on the transom, which remained submerged with the vessel capsized in relatively calm conditions. Inspection of the vessel by the Police dive squad immediately following the accident found that the fuel cap was secured (see Figure 28).

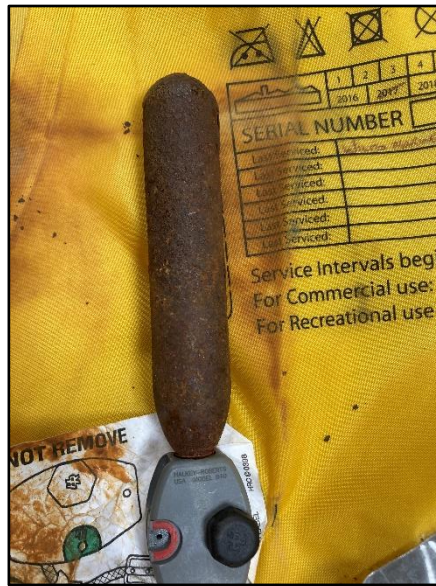
**Figure 30: Corroded lifejacket cylinder**

- 3.78. The CO<sub>2</sub> cylinder had corroded to a point where the cylinder wall had significant pitting (see Figure 30). This level of corrosion posed a significant risk to the wearer as the canister was at risk of failing while pressurised, which could have led to the lifejacket not inflating, or the canister exploding.

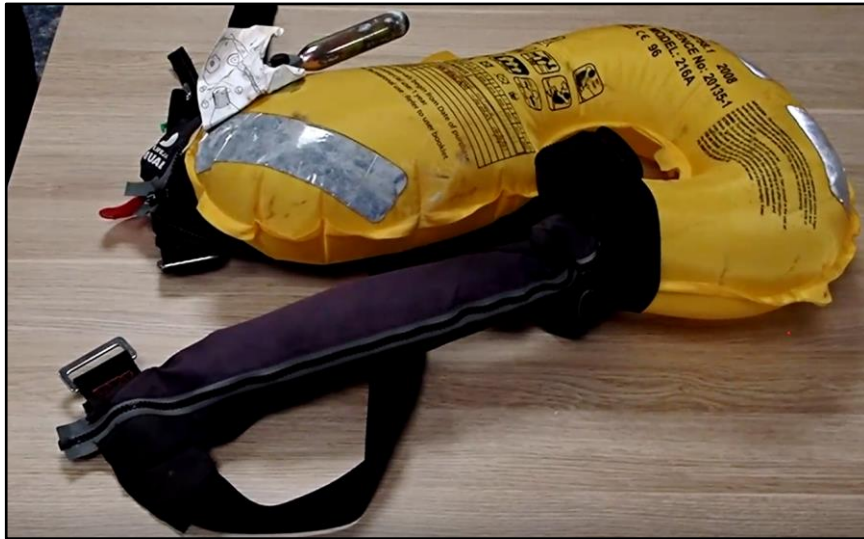
- 3.80. An injured passenger on the *i-Catcher* attempted to inflate their lifejacket to assist with keeping afloat as one of their arms was ineffective. Only one side of the bladder initially inflated, further complicating their swimming ability for a moment until the second portion suddenly inflated. The Commission tested another lifejacket that was not inflated during the accident and found a similar inflation sequence where the bladder inflated to a point where it appeared pinched and, after a significant build-up of air pressure, a subsequent sudden violent burst of inflation occurred (see Figure 31 and Figure 32).

**Figure 31: Lifejacket bladder pinched for several seconds**

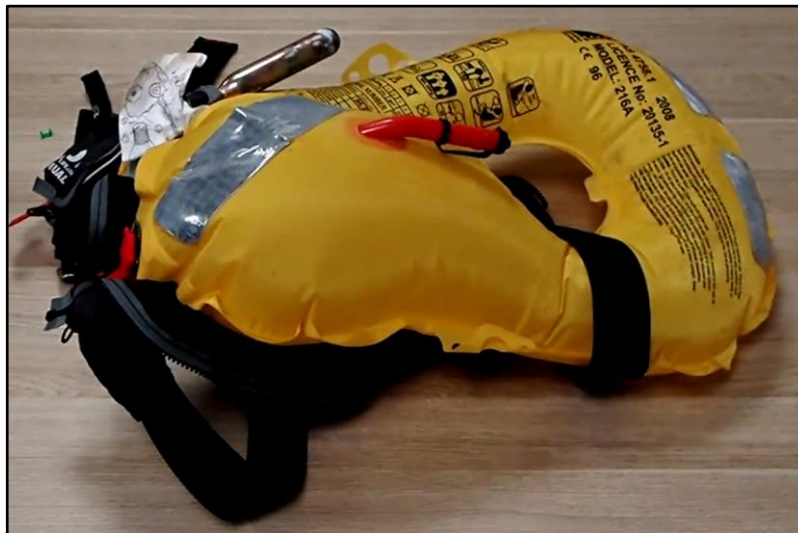
**Figure 32: Bladder fully inflated after sudden violent burst of inflation**
