Transport Accident
Investigation
Commission

Final Report

Maritime inquiry MO-2022-206
Charter fishing vessel, i-Catcher
Capsize
Goose Bay, New Zealand
10 September 2022

April 2025

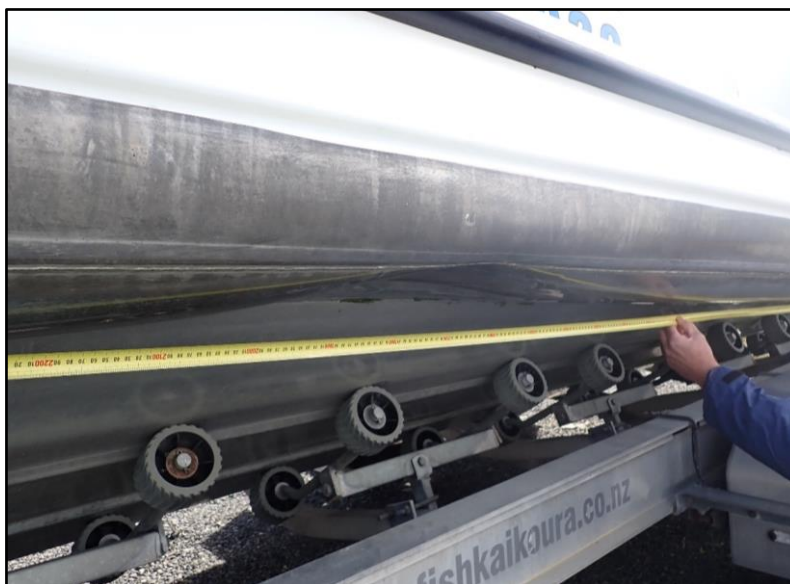
Figure 8: Indentation under port pontoon

- 2.57. During its initial examination of the vessel, the Commission identified a significant smooth indentation underneath the port pontoon, measuring approximately 2.47 m in length. The depth of the indentation was greatest in the forward portion measuring 8 cm deep, tapering in depth further aft (see Figure 8).

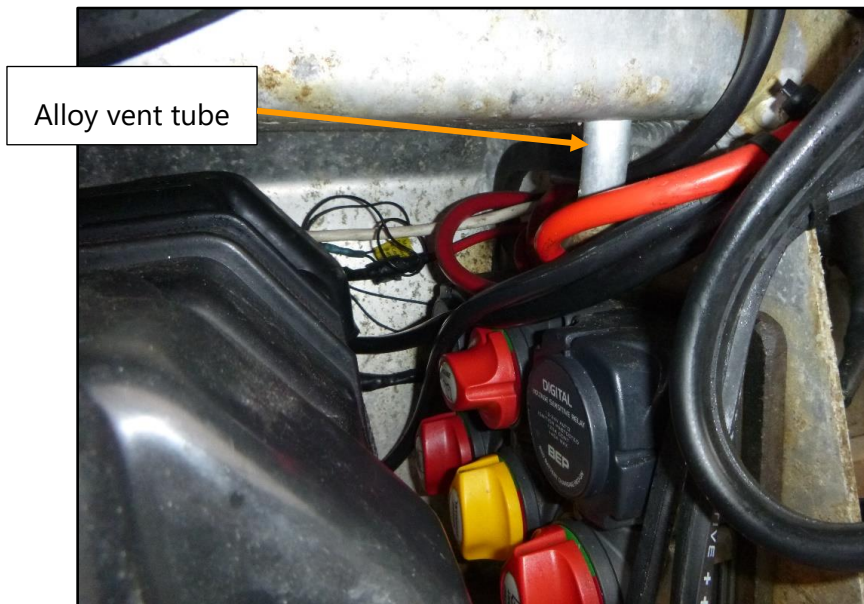
- 2.61. Identification of the hole in the alloy vent tube required a thorough examination of the venting arrangement. The alloy tube was partially restricted from view by a battery box and surrounding wiring (see Figure 13). The hole was a potential path for fuel to escape when filling the fuel tank or if the vessel overturned. It was also close to the battery leads and contact points, which presented a significant fire or explosion hazard.

Figure 13: 2021 survey photo demonstrating restricted view of alloy vent tube with batteries in place.

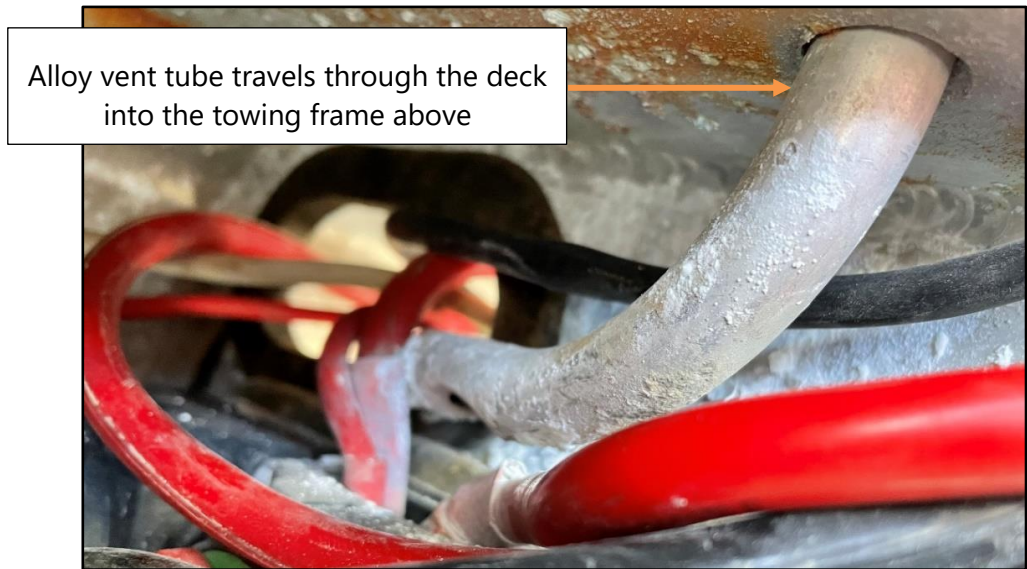
Figure 14: Alloy vent tube joining towing frame

- 2.62. The alloy vent tube terminated inside an alloy towing frame on the transom just forward of the swim platform (see Figure 14 and Figure 15). A pressure test of the alloy frame revealed that it was closed off from the atmosphere, preventing fuel vapours from venting to open air and rendering it ineffective as a fuel-tank vent.

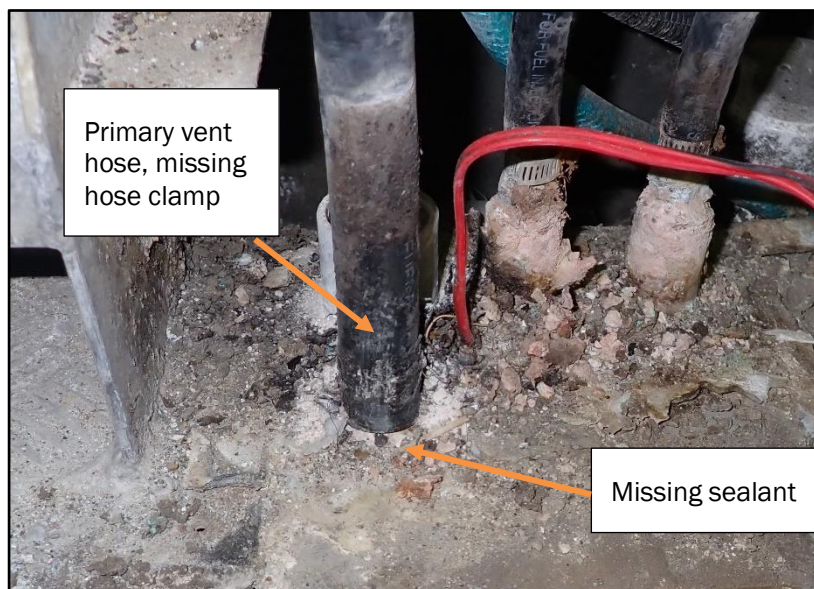
- 2.64. To enable inspection of the fuel tank and its connections, investigators removed the cover plate and the deck plate and partially disassembled the fuel system. Upon disassembly, investigators found the primary vent hose was not secured with a hose clamp, a critical component to ensure a secure connection to the fuel tank (see Figure 17).
- 2.65. A sealant had been applied around the plating where the fuel and vent hoses connected to the fuel tank. It was observed that a portion of the sealant had broken

away, leaving a section of the primary vent hose connection exposed. The fuel tank and its fuel hoses were pressure-tested by Commission investigators, which revealed a leak from the base of the primary vent hose.

Figure 17: Primary vent hose connection to fuel tank (underneath the deck plate)

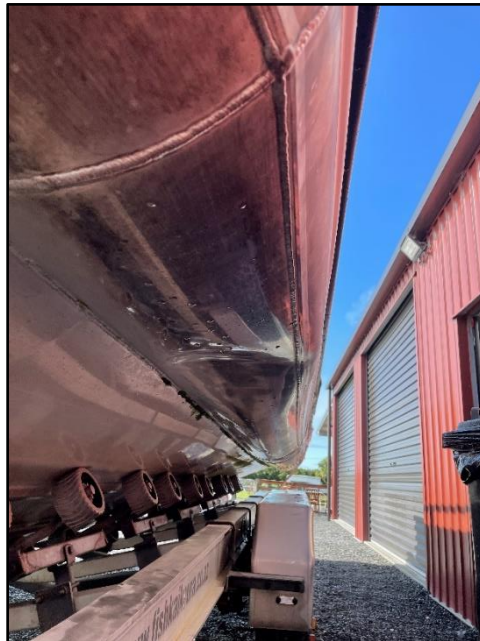
Figure 23: Indentation under port pontoon

3.9. The indentation underneath the vessel's port pontoon was smooth and of significant size (see Figure 23), indicating that it was caused by a soft but dense material rather than a hard object. Contact with hard objects usually result in significant abrasions, definitive markings, transfer of material and possible holing in the hull.

3.10. While humpback whale DNA was found on the vessel, it is possible that this resulted from the vessel being near a humpback whale rather than coming into direct contact with one. However, given the passenger's account of seeing a whale under the boat, the nature of the dent under the port pontoon, the DNA results and the absence of any other factor that might have caused the boat to capsize, the Commission considers that it is **virtually certain** the vessel capsized as a result of coming into contact with a whale that had surfaced under the port side of the vessel.

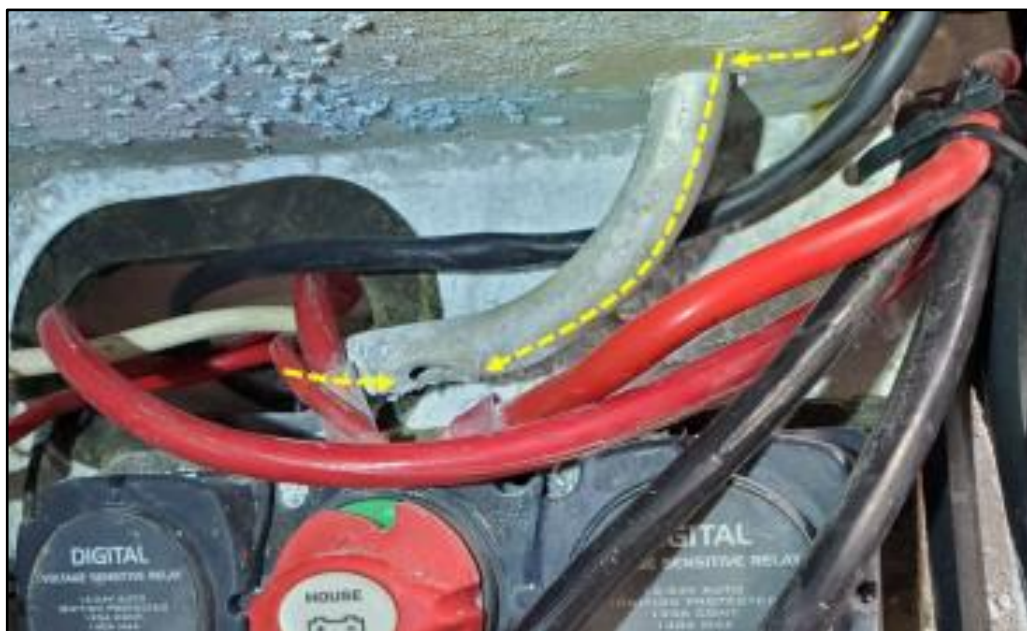
Figure 24: Low point of alloy vent tube
(Credit: Quest Integrity)

- 3.12. The type of aluminium used for the alloy vent tube was a marine-grade aluminium that develops a natural passive layer when exposed to the atmosphere. This passive layer protects the underlying material from the environment and corrosion.
- 3.13. The presence of corrosion would indicate that the passive layer was damaged or removed. Metallurgical testing carried out by Quest Integrity, on behalf of the Commission, identified that:

*the most likely cause of the hole was an accelerated external corrosion that occurred locally in-service, before the capsizing. The accelerated corrosion was likely because of crevice corrosion conditions caused by contact of the electrical cables with the pipe and/or accumulation of debris.*³⁴

- 3.14. The corroded hole was located at a low point in the system, which would allow water and dirt to run and collect (see Figure 24). When the alloy tube was removed from the system it was evident that there was further abrasion and corrosion where the battery leads had been in contact with the alloy tube (see Figure 25). With time it can be expected that these areas would also develop into holes.

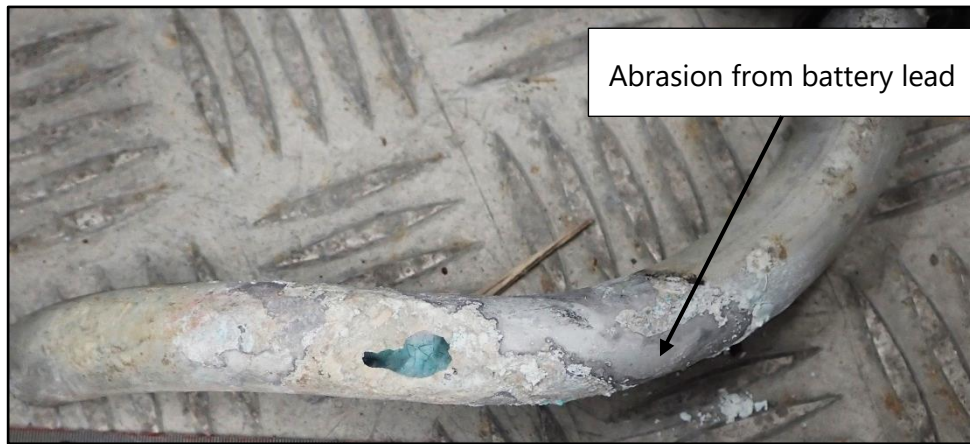
Figure 25: Abrasion from battery lead

- 3.16. At the time the battery selector switch was replaced, the alloy vent tube may have been subject to abrasion and the hole may not yet have formed. With the aluminium's natural passive layer damaged or removed by the battery leads, it would just be a matter of time before a hole developed.

- 3.18. The Commission found that the hole in the alloy vent tube was **very likely** a result of crevice corrosion over time, because of one or a combination of the following factors:

- mechanical abrasion from electrical cables
 - the collection of dirt/salt in the immediate area
 - saltwater evaporation from the localised area.

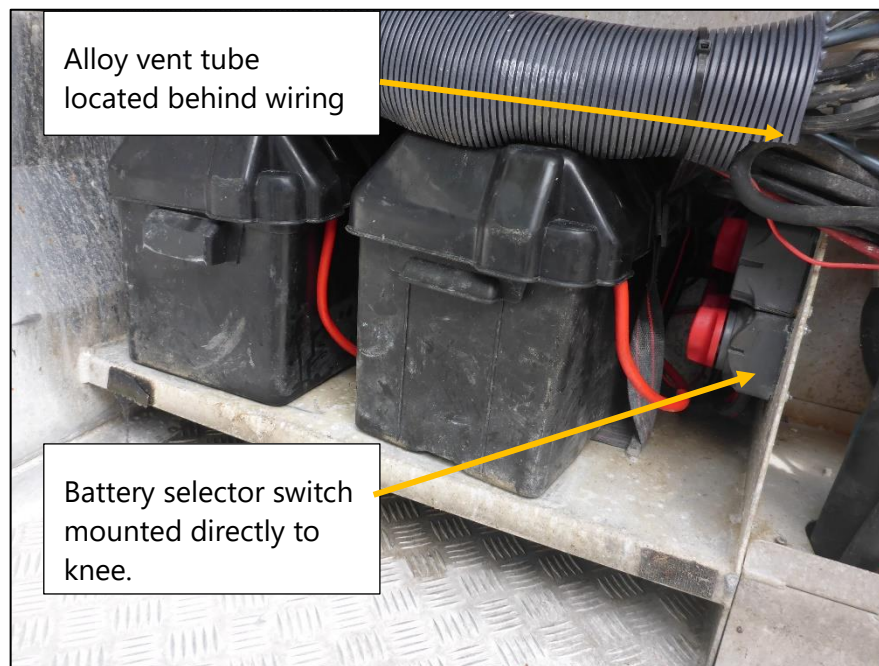
Figure 26: Original battery selector switch arrangement (2016)

- 3.15. The *i-Catcher's* battery selector switch was replaced in 2019. The original battery selector switch was mounted directly to the knee of the transom (see Figure 26). When the new battery selector switch was installed, an insulator pad was added to absorb vibrations between the knee and the switch. This would have changed where the battery leads contacted the alloy tube.

- 3.17. It is **likely** that before the battery selector switch was replaced, the battery leads had been in contact with the alloy vent tube contributing to the corrosion that later developed into a hole.

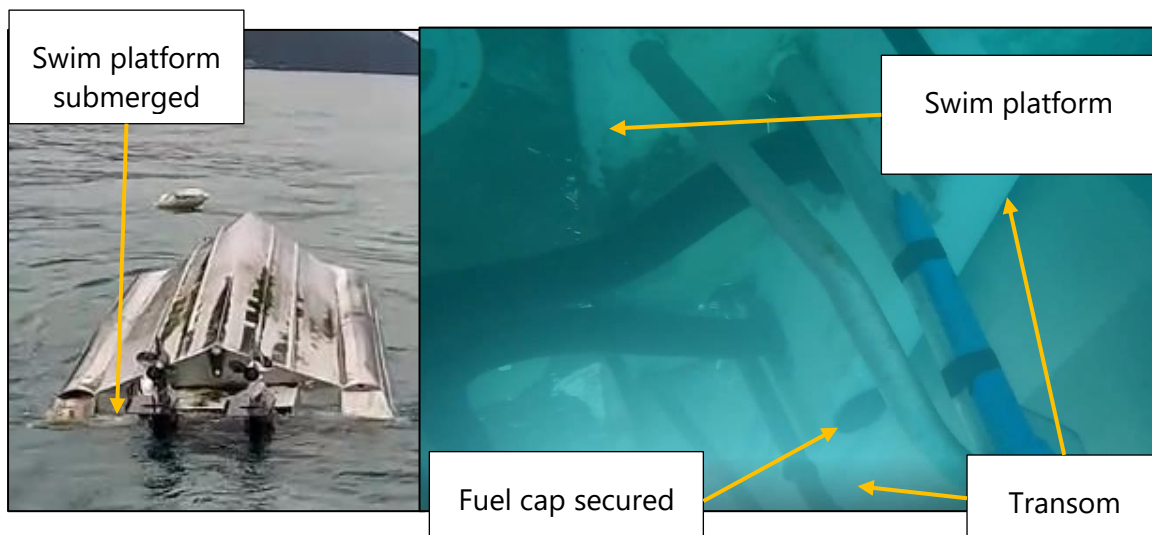
Figure 28: Photo on left: *i-Catcher* capsized, Photo on right: Fuel cap secured

3.23. When an inverted cap is submerged in sea water, the sea water applies an upward force to the surface area on the outside of the cap, countering the force applied by the fuel. The *i-Catcher's* fuel cap was mounted on the transom, which remained submerged with the vessel capsized in relatively calm conditions. Inspection of the vessel by the Police dive squad immediately following the accident found that the fuel cap was secured (see Figure 28).

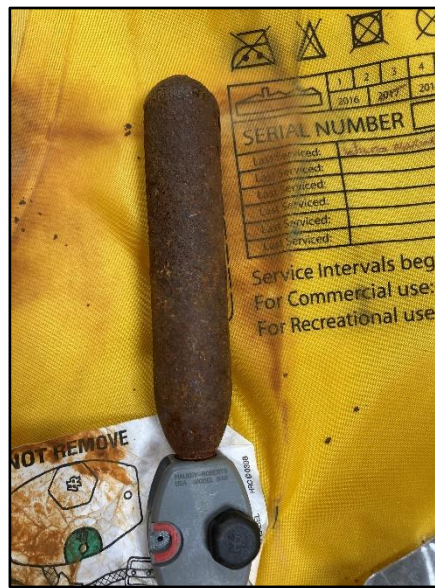
Figure 30: Corroded lifejacket cylinder

- 3.78. The CO₂ cylinder had corroded to a point where the cylinder wall had significant pitting (see Figure 30). This level of corrosion posed a significant risk to the wearer as the canister was at risk of failing while pressurised, which could have led to the lifejacket not inflating, or the canister exploding.
