Transport Accident
Investigation
Commission

Final report

Maritime inquiry MO-2023-202
Collision between passenger ferry Waitere and
recreational vessel Onepoto
Off Paihia, Bay of Islands
13 April 2023

September 2024

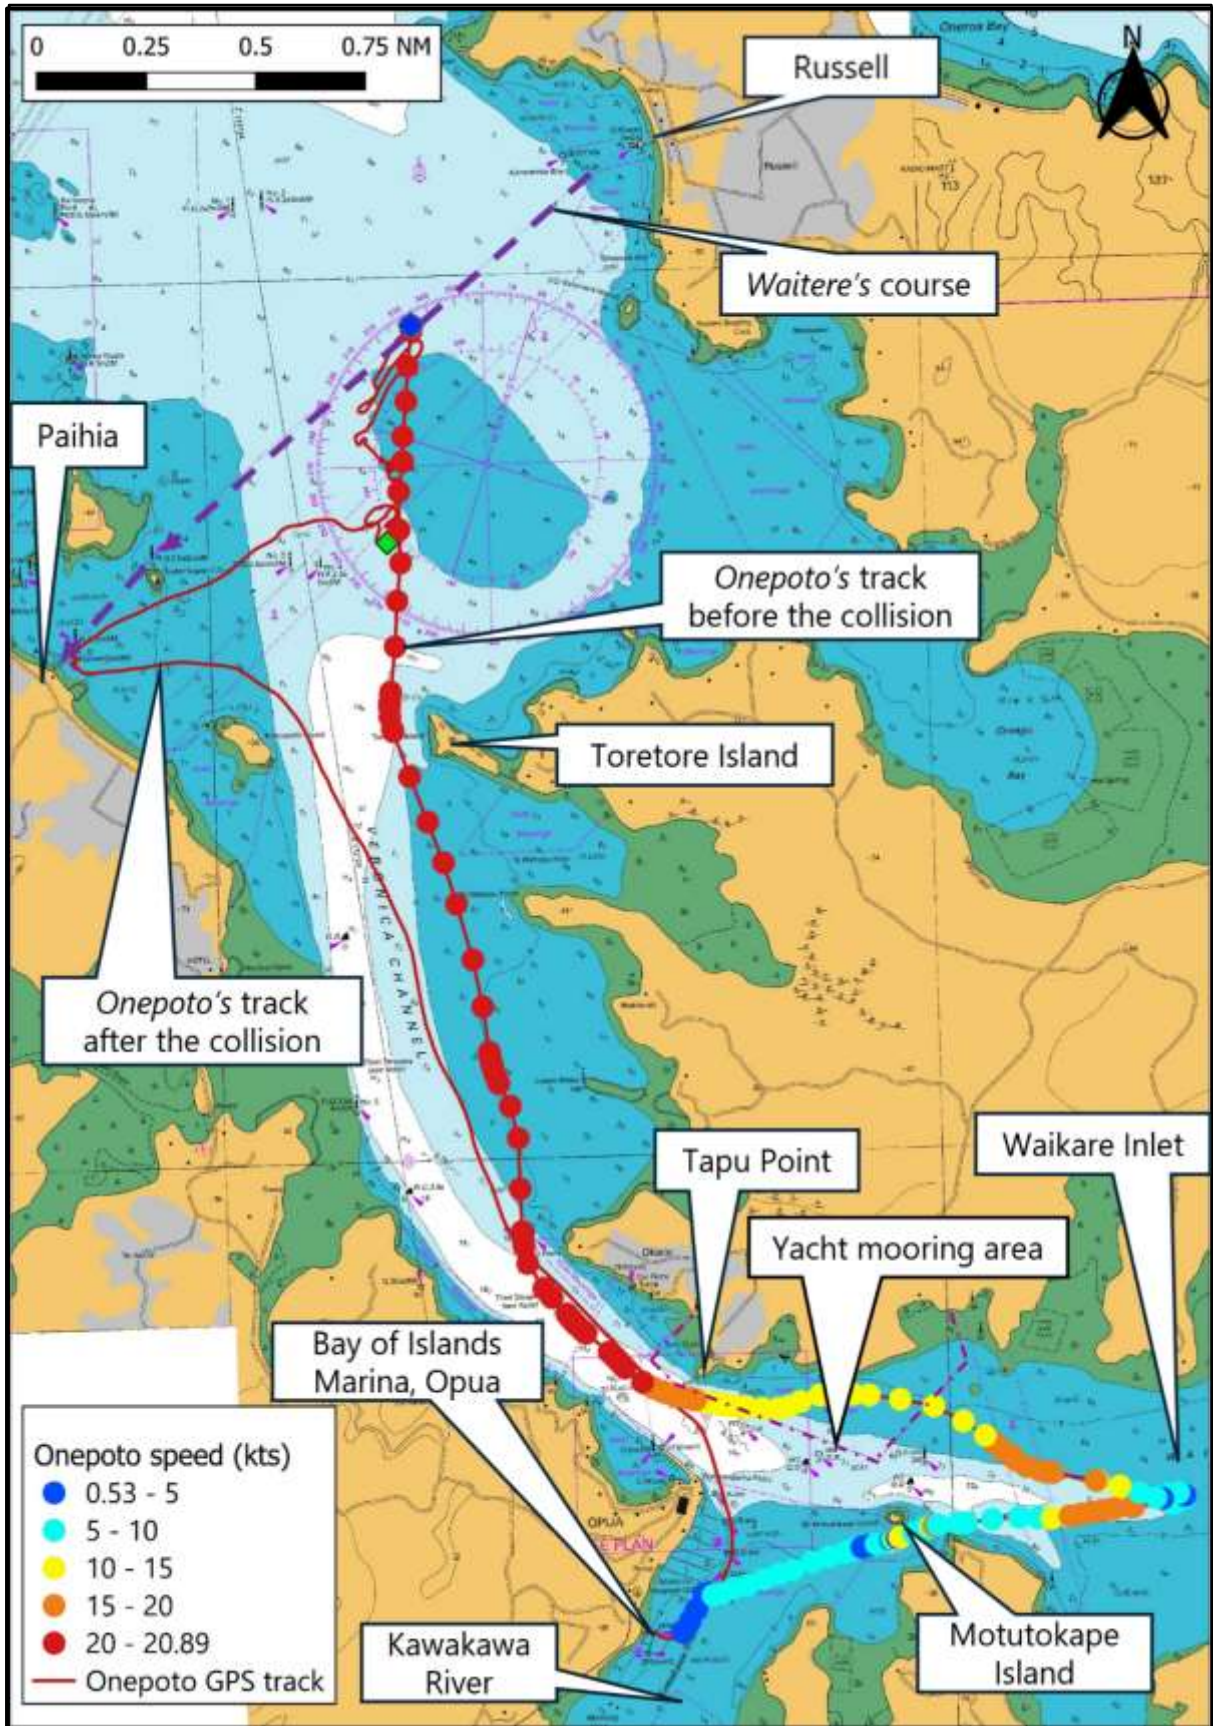
Figure 4: Bay of Islands chart showing *Onepoto* GPS track and *Waitere* course

- 2.5. While entering and exiting the inlet and while transiting the designated yacht mooring area north of Motutokape Island, the skipper of the *Onepoto* operated the vessel at speeds between 10 kt and 15 kt, which were above the 5 kt speed limit for that area.

- 2.11. The *Onepoto* was approaching the Bay of Islands ferry route (see Figure 4). Three ferry services operated on this route, on a Northland Regional Council public transport timetable. There were no speed restrictions for this area.

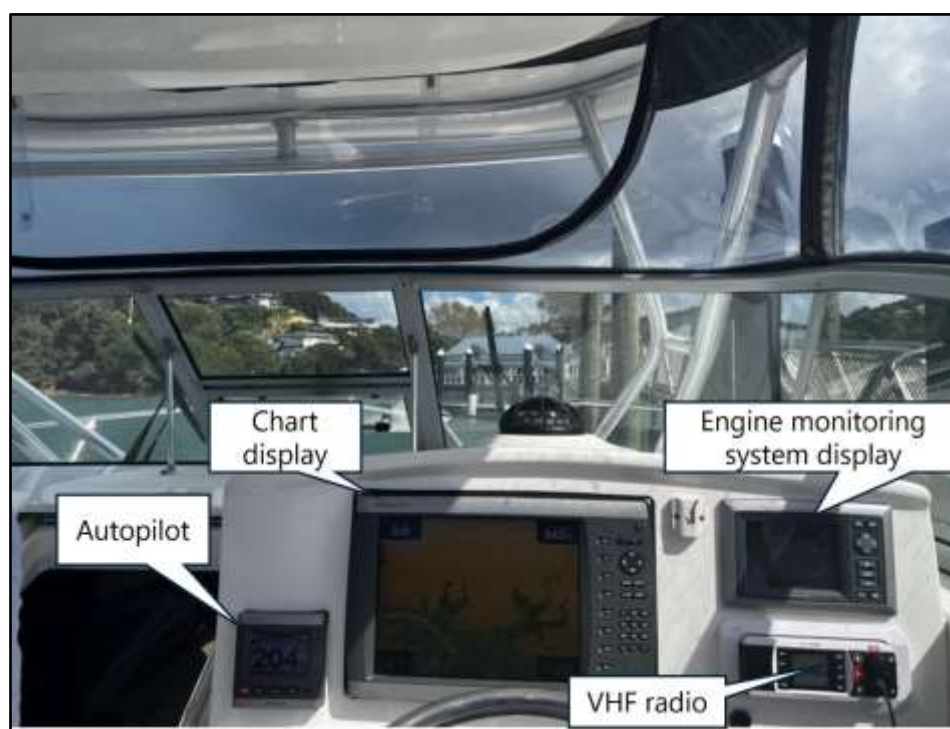
Figure 5: Onepoto helm station

- 2.12. The *Onepoto* skipper maintained a speed of about 20 kt and investigated the cause of the alarm on the engine-monitoring system display, located on the helm³ station in front of the skipper (see Figure 5). They worked through the system menus on the display, determining that it was a non-critical low voltage alarm.

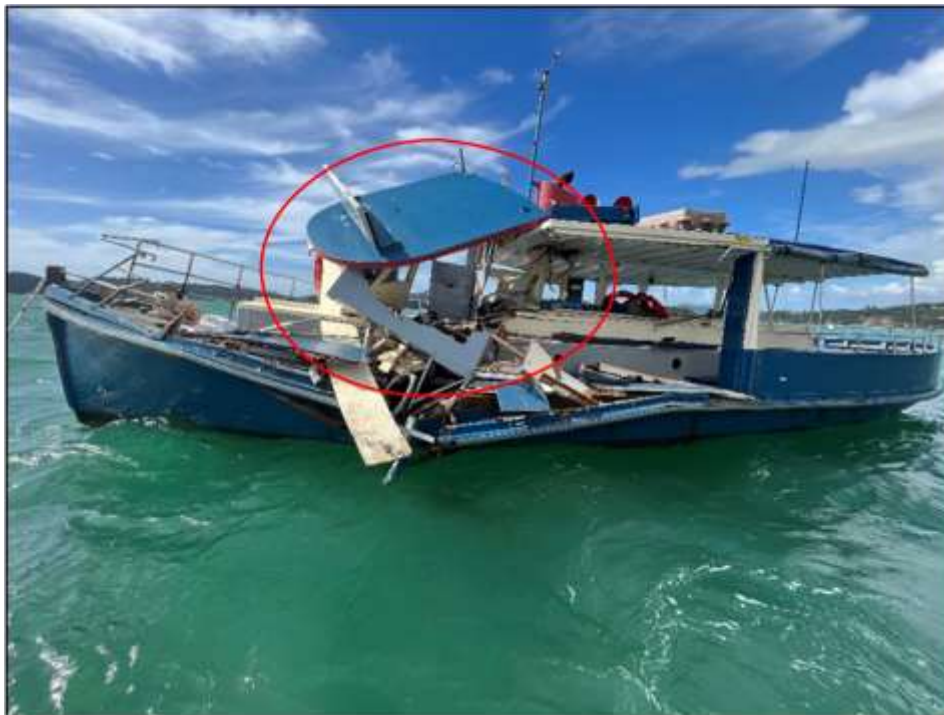
- 2.42. As a result of the collision, the *Waitere* suffered extensive damage: the wheelhouse was completely destroyed (see Figure 6) and the hull sustained damage on the port side just below the waterline (see Figure 7).

Figure 6: The damaged *Waitere* showing the destroyed wheelhouse
(Credit: Bay of Islands Coastguard)

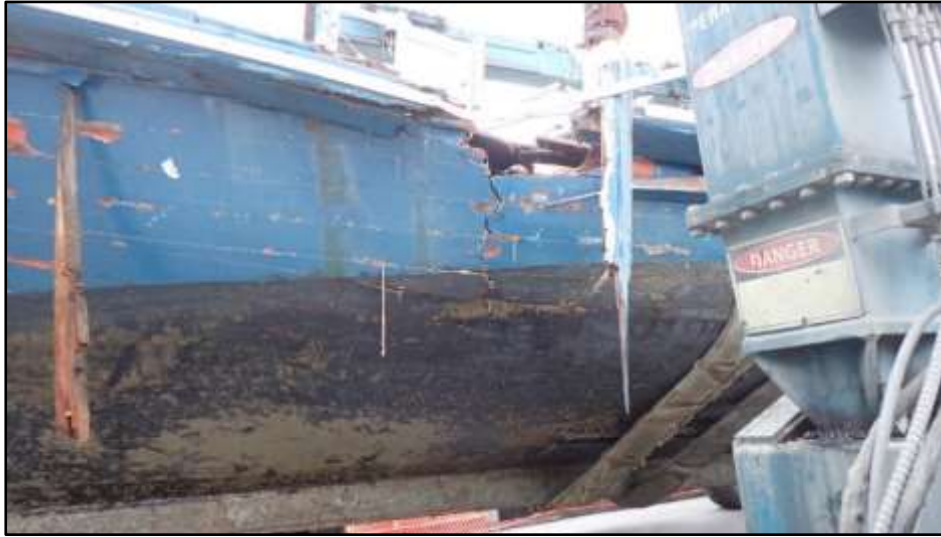
Figure 7: The *Waitere* hull damage as a result of the collision

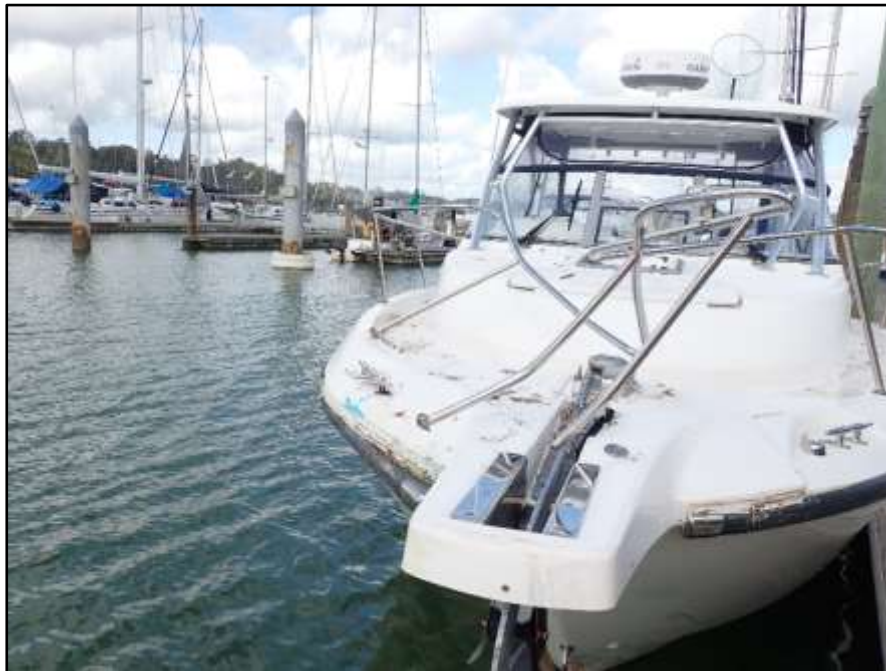
- 2.43. The *Onepoto* sustained damage to the bow, anchor pulpit¹⁴ and stainless-steel bow rail (see Figure 8). There was some gouging of the fibreglass under the waterline, but there was no water ingress. The skipper of the *Onepoto* was able to manoeuvre the vessel under its own power and returned to the Bay of Islands Marina after the accident.

Figure 8: The *Onepoto* after the collision

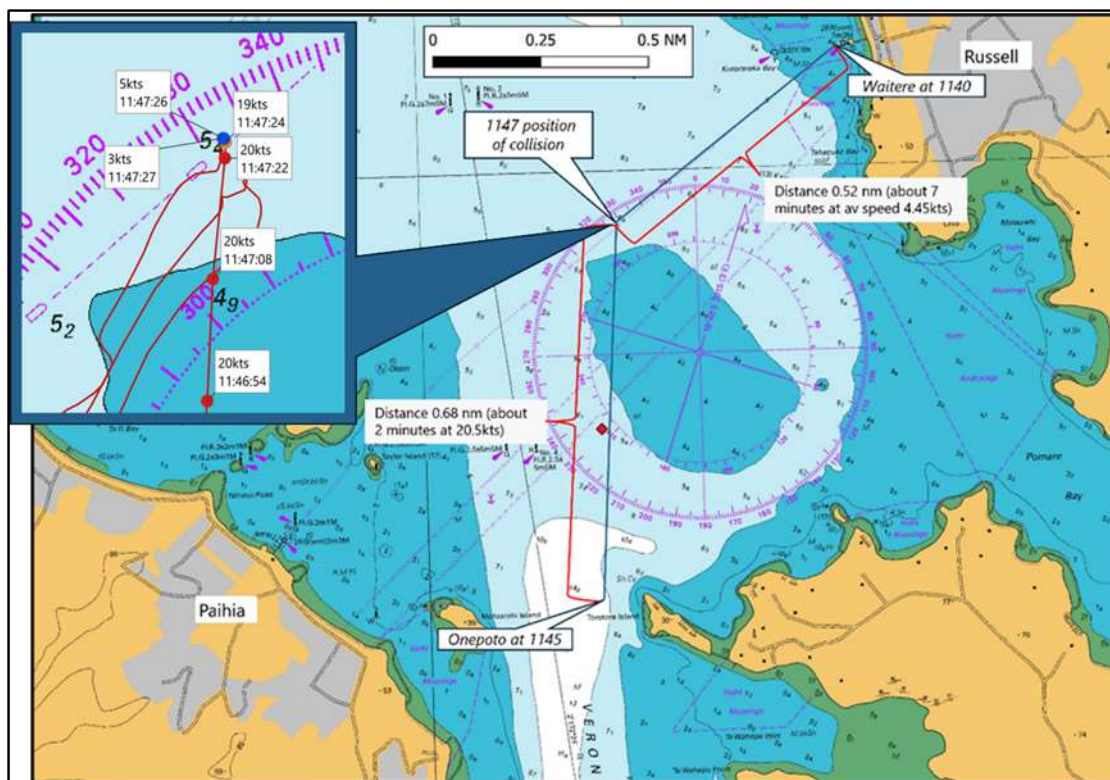
- 3.31. When the skipper of the *Onepoto* looked down to investigate the alarm on the engine-monitoring system, the *Onepoto* was approximately 0.68 nm from the ferry-crossing track and, travelling at a speed of 20.5 kt, it would take approximately 2 minutes to cover that distance (see Figure 13).

Figure 13: *Onepoto*'s speed and position before the accident

- 3.32. Although there was no speed restriction in this area, there were factors present that should have influenced the skipper's assessment of a safe speed, namely the approach to the ferry-crossing track and the presence of an unresolved engine-monitoring alarm.
- 3.33. When the vessels were within 50 m of each other, each vessel should have been travelling at a speed of no more than 5 kt, in accordance with the Northland Regional Council Navigation Safety Bylaws 2017 (see Figure 10).
- 3.34. If the *Onepoto* had been travelling at a safer speed for the conditions, it is **very likely** that either the collision would have been avoided or the consequences of the collision would have been reduced.
