Transport Accident  
Investigation  
Commission

# **Final report**

***Maritime inquiry MO-2023-205***  
***Bulk carrier, Achilles Bulker***  
***Loss of rudder***  
***Off the Port of Tauranga***  
***24 July 2023***

**July 2025**

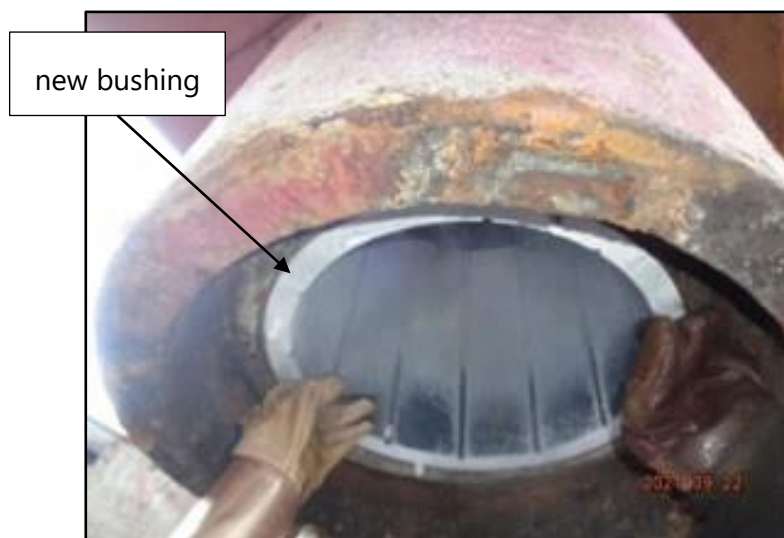
**Figure 9: Pintle removed, new bushing installed (viewed from below the gudgeon) 2021**  
(Credit: Shanhaiguan Shipbuilding Industry Co Ltd)

- 2.32. Once the bushing was replaced, the pintle was raised through the bushing and press-fitted into place in the bottom of the rudder with a hydraulic jack (see Figure 9 and Figure 10). This was the only time in the ship's history that the pintle had been removed and reinstalled.

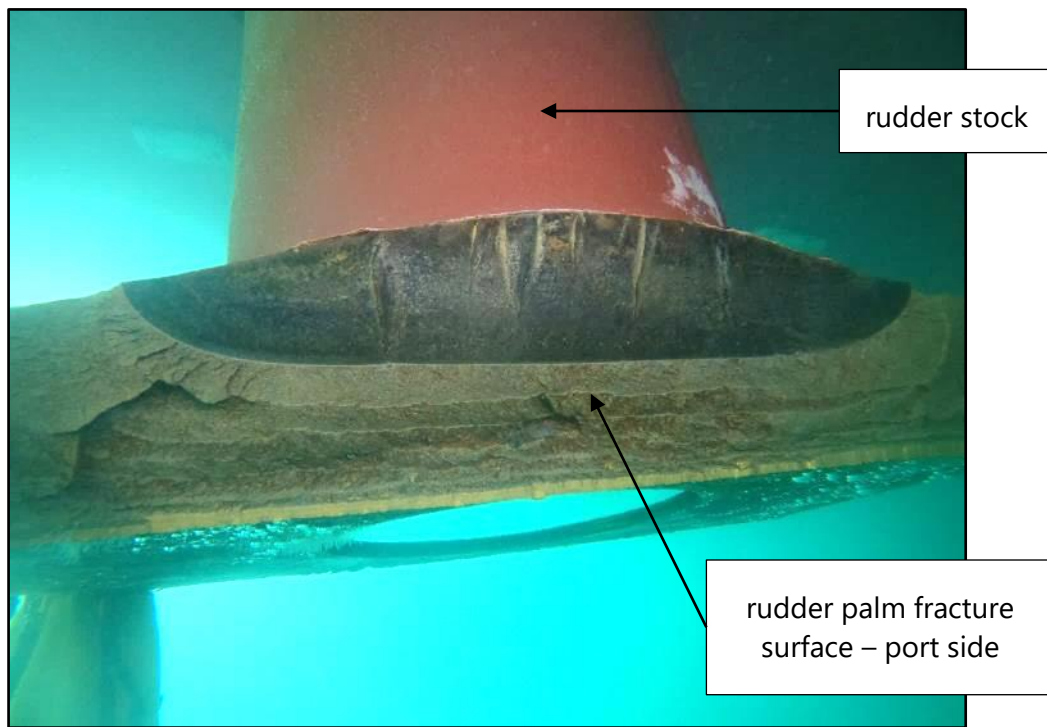
**Figure 11: Initial survey of rudder stock showing fractured palm**

- 2.34. When the incident occurred, it was not immediately apparent to the ship's crew that the rudder had been lost. However, a diver's survey of the ship's rudder and stern frame<sup>41</sup> on 25 July 2023 immediately revealed that the rudder was missing and the casting for the rudder palm had fractured on both sides of the rudder stock (see Figure 11).

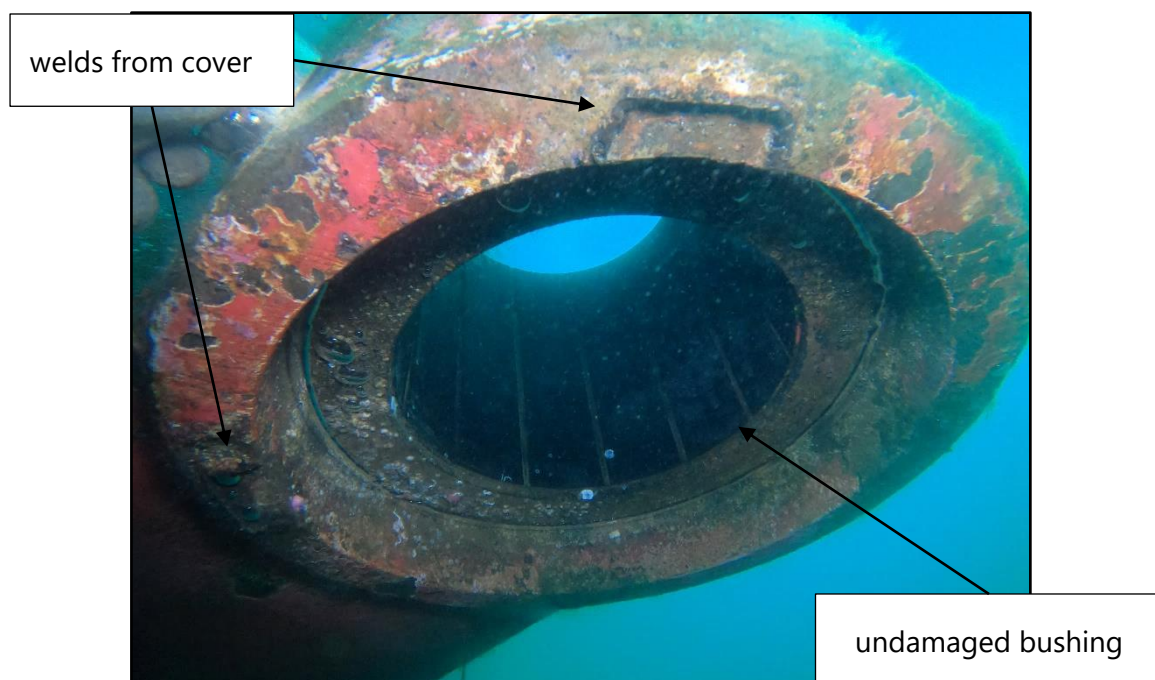
**Figure 12: Initial survey of bushing and gudgeon (viewed looking up)**

- 2.35. Divers inspected the gudgeon and bushing and found no signs of significant damage. However, they did find that the cover plate – originally welded to the bottom of the gudgeon underneath the pintle – had broken away (see Figure 12).

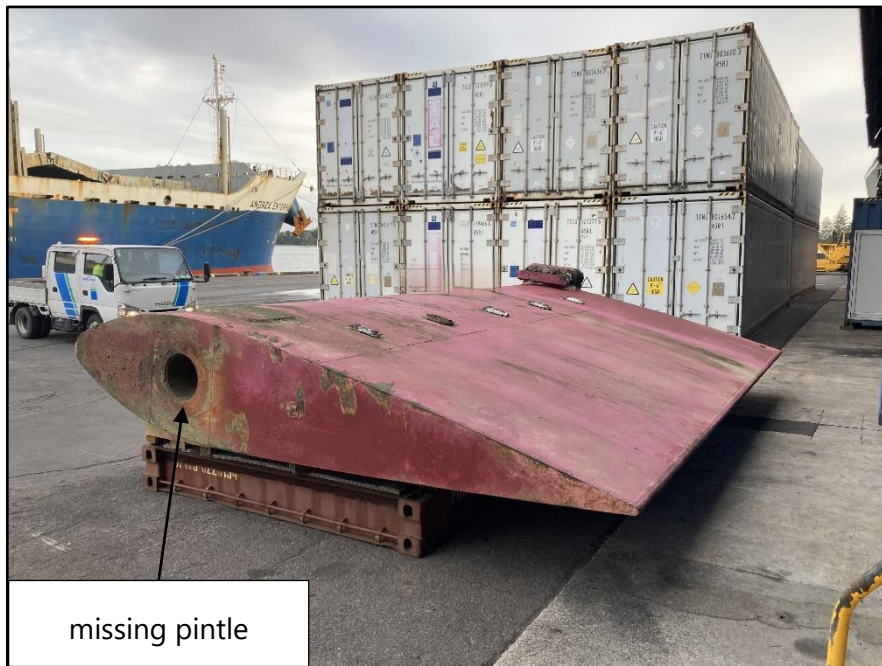
**Figure 13: Bottom of rudder showing lower casting that previously housed the pintle**

- 2.37. An inspection showed that the pintle was missing from the bottom of the rudder (see Figure 13). The pintle nut, locking piece and pintle stopper remained inside the pintle recess.
- 2.38. Marine growth (including algae and barnacles) was found throughout the tapered surface of the lower casting. This finding (discussed further in paragraph 3.10) was of interest because the lower casting was normally watertight when the pintle was in position. Once dried out, the tapered surface was found to be corroded with developed pitting (see Figure 14).

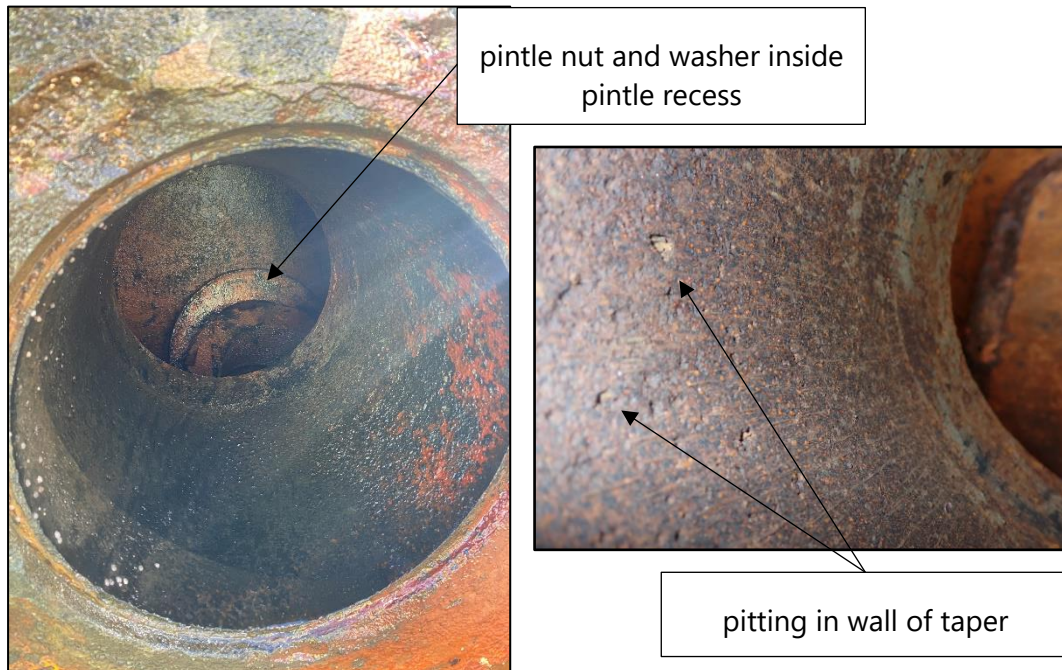
**Figure 14: Condition of taper in lower casting**

- 3.10. Considering the development of marine growth (including algae and barnacles) on the tapered surface of the lower casting, and the accompanying developed fatigue cracks on the fractured rudder palms, the Commission determined that the pintle dropped out of position and was lost before the ship lost its rudder. As a result, excessive lateral loads had been placed on the rudder palm over time; these ongoing loads contributed to the development of fatigue cracks in the palm, reducing its overall strength.

- 3.20. Additionally, the surface of the taper within the lower casting was found to be misshapen. It is **unlikely** that such a shape would have allowed for the necessary 80% surface contact between the pintle and the lower casting to be achieved, increasing the risk of the pintle experiencing excessive localised vibrations. Such vibrations would have increased the risk of welded components fracturing, with the potential to cause the pintle nut to unwind.

- 4.3. The surface of the taper within the lower casting was found to be misshapen. It is **unlikely** that such a shape would have allowed for the necessary 80% surface contact between the pintle and lower casting to be achieved, increasing the risk of the pintle experiencing excessive localised vibrations.

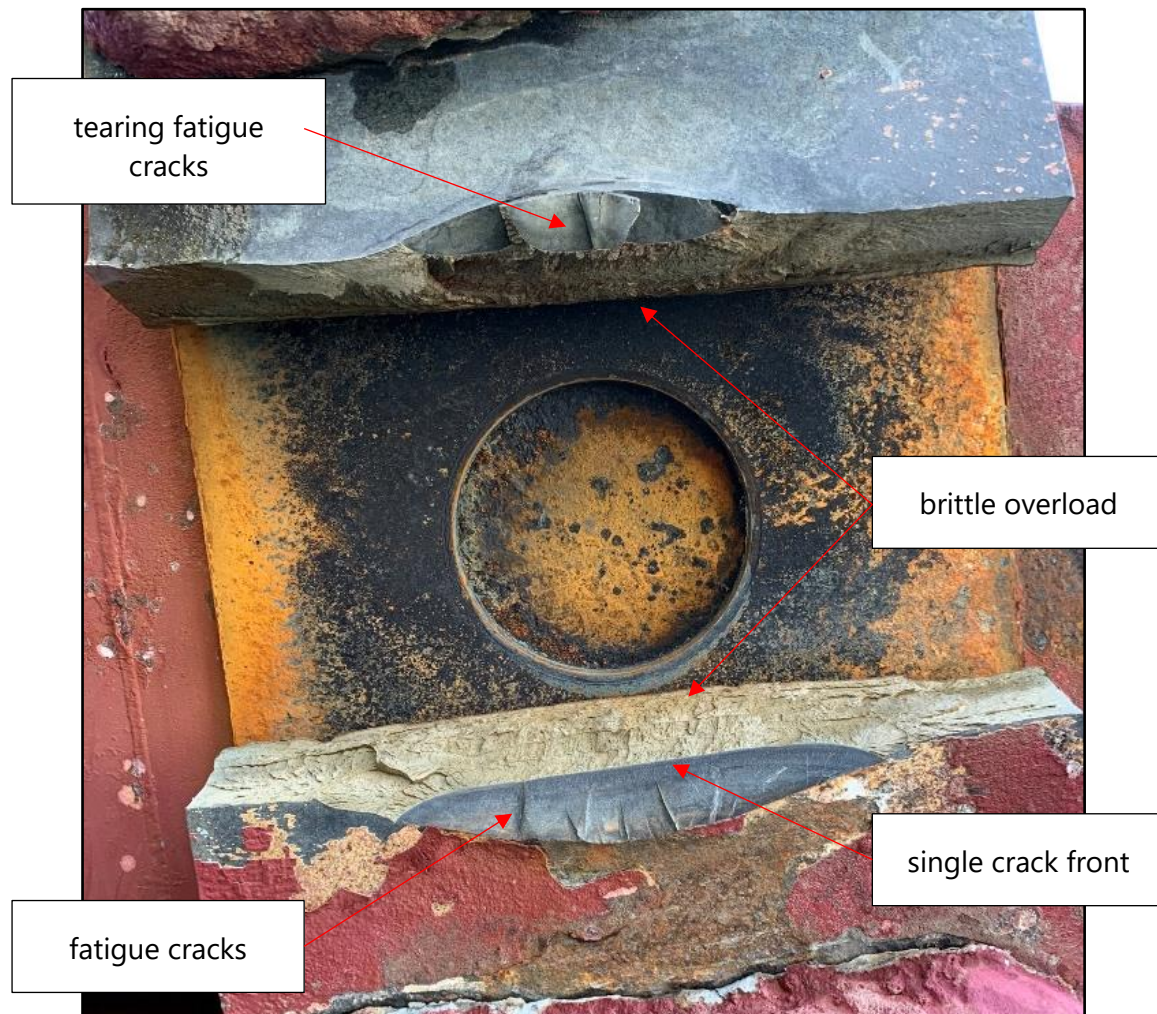
**Figure 15: Fractured surfaces of rudder palm**

- 2.39. A metallurgist accompanied Commission investigators and examined the fractured surfaces of the rudder palm remnants (see Figure 15). They discovered that each

fractured surface had an area of significant fatigue crack<sup>42</sup> growth. This growth started at the top surface of the fractured palms on either side of the rudder stock, before working its way down into the palm.

- 2.40. The fatigue cracking area consisted of smooth black zones that were stepped relative to each other. Each step represented a separate fatigue crack. Each crack started at the surface before continuing through the depth of the palm. The multiple fatigue cracks eventually merged into one single crack front. The remaining fracture surface showed clear signs of brittle overload<sup>43</sup>.

- 3.9. Each fractured surface of the rudder palm had an area of significant fatigue crack growth that originated at the top surface of the fractured palms on either side of the rudder stock. That multiple initiation points developed into fatigue cracks was indicative of relatively high stress in that area. Likewise, the smooth, flat appearance of the cracks was indicative of slow growth over time with numerous load cycles. This suggested that the fatigue cracks had grown until the remaining material was unable to withstand the load, resulting in brittle overload. This type of crack development reflects a rudder palm and rudder stock being subjected to excessive lateral loads.

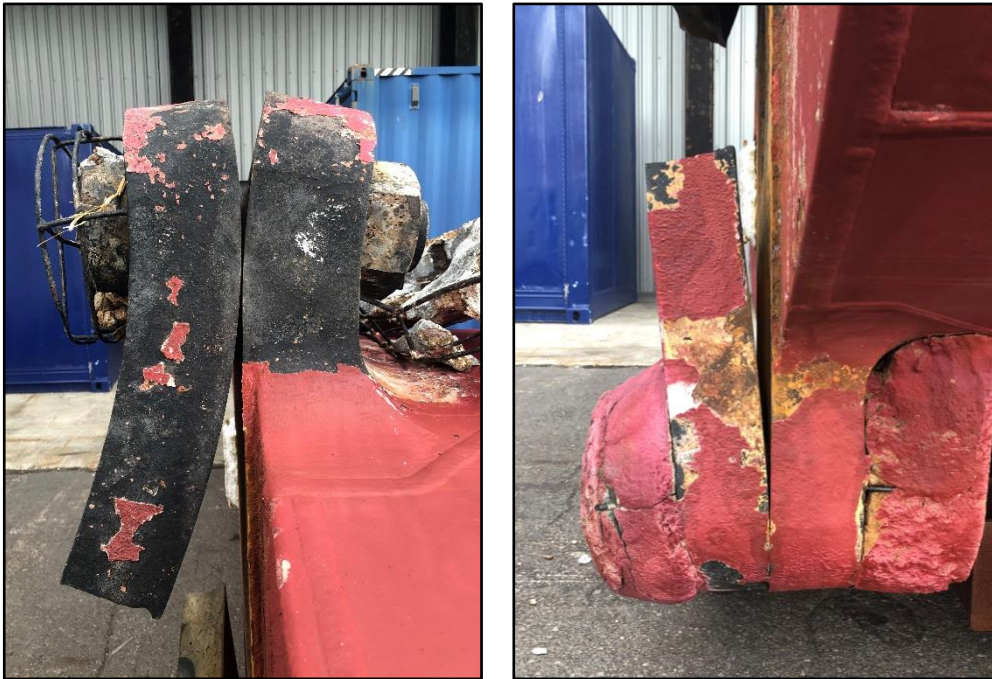
**Figure 16: Left: port side of rudder palm; right: starboard side of rudder palm**

- 2.41. The starboard side of the rudder palm showed a clean break with minimal bending. However, the port side of the rudder palm was significantly bent upwards with a tearing fatigue fracture (see Figure 16).

- 3.11. When the fractured rudder palm was examined, the starboard side palm showed a clean break with minimal bending, whereas the port side palm was significantly bent upwards.

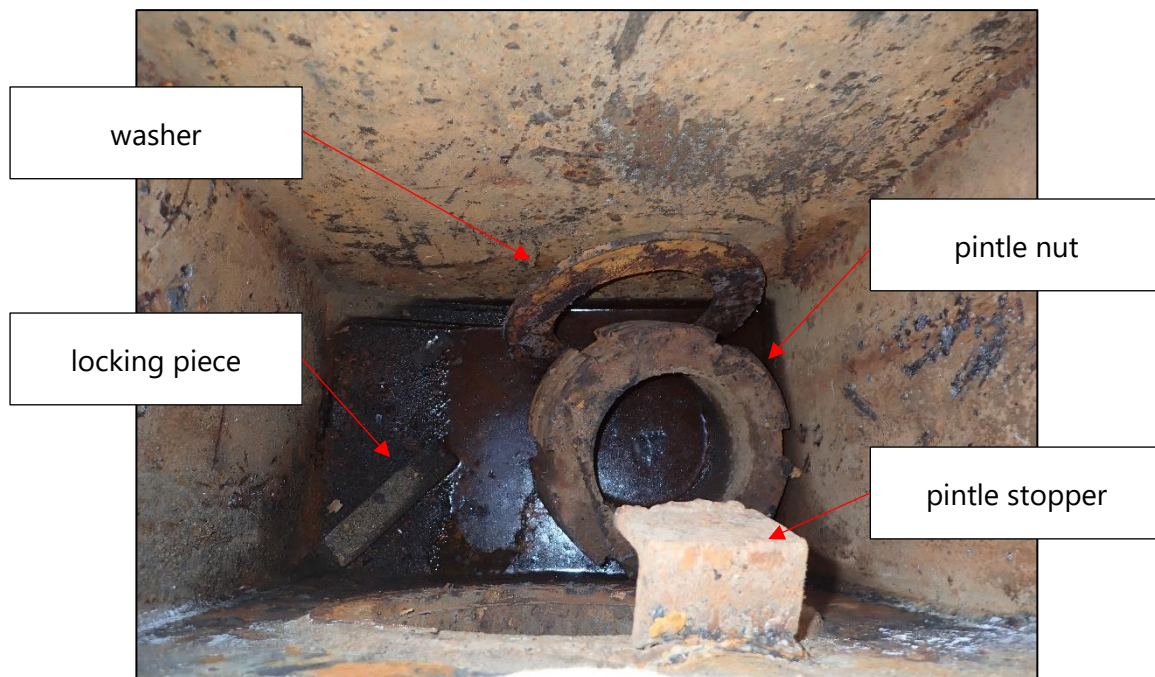
**Figure 17: Components as found in pintle recess**

- 2.42. The inspection plate of the pintle recess was then removed from the port side of the rudder (see Figure 17), enabling the removal of the remaining pintle components.

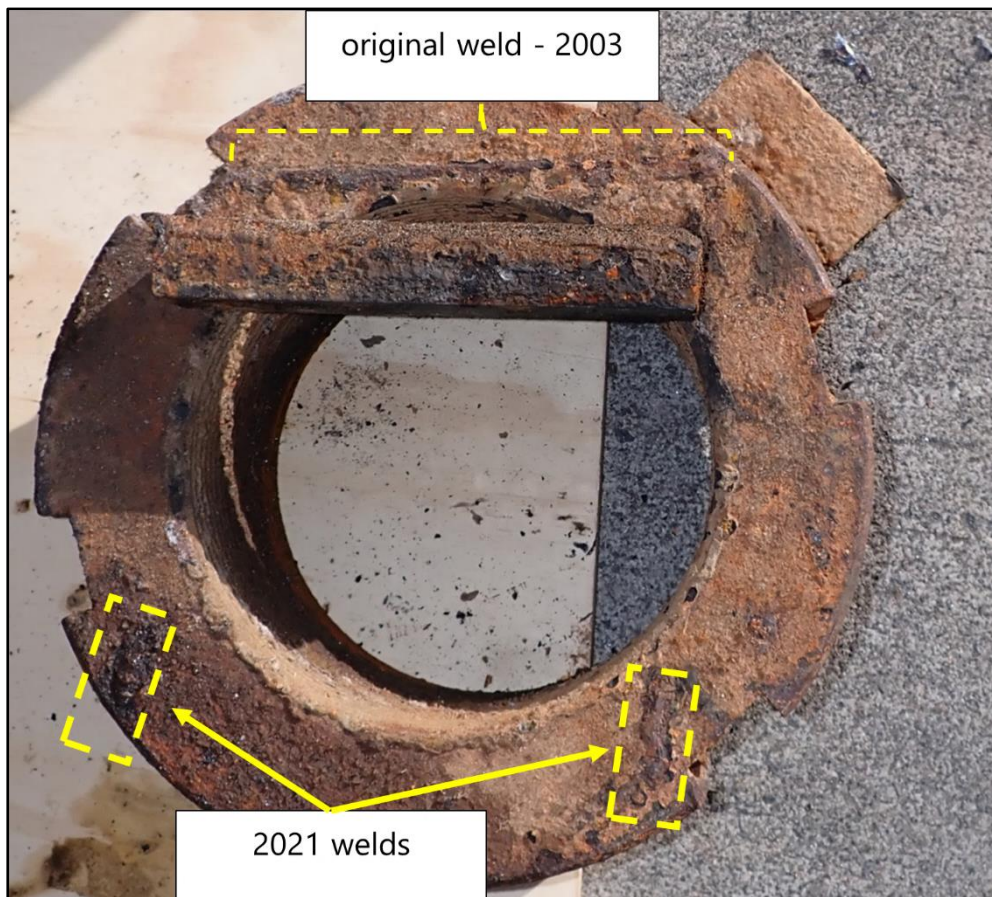
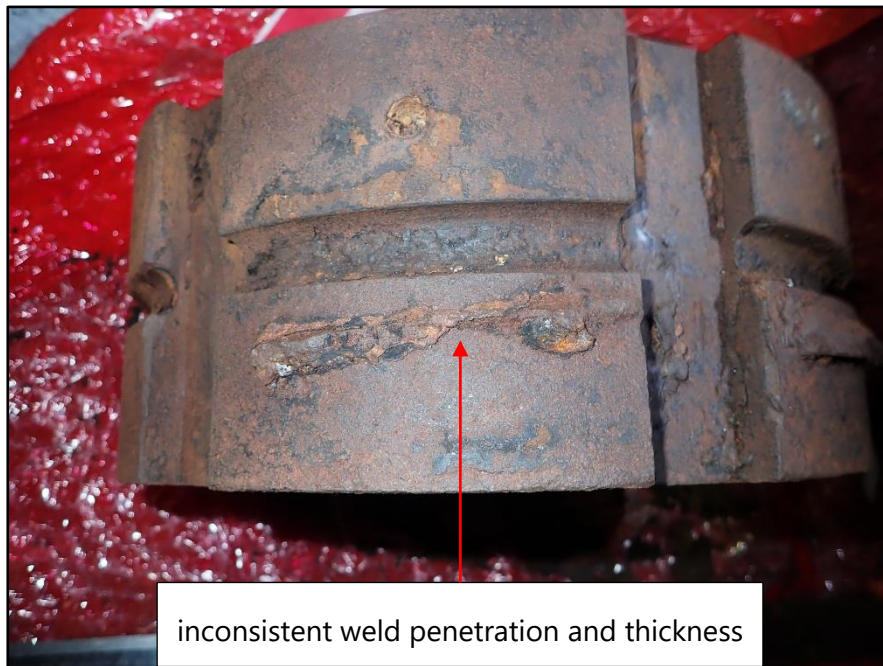
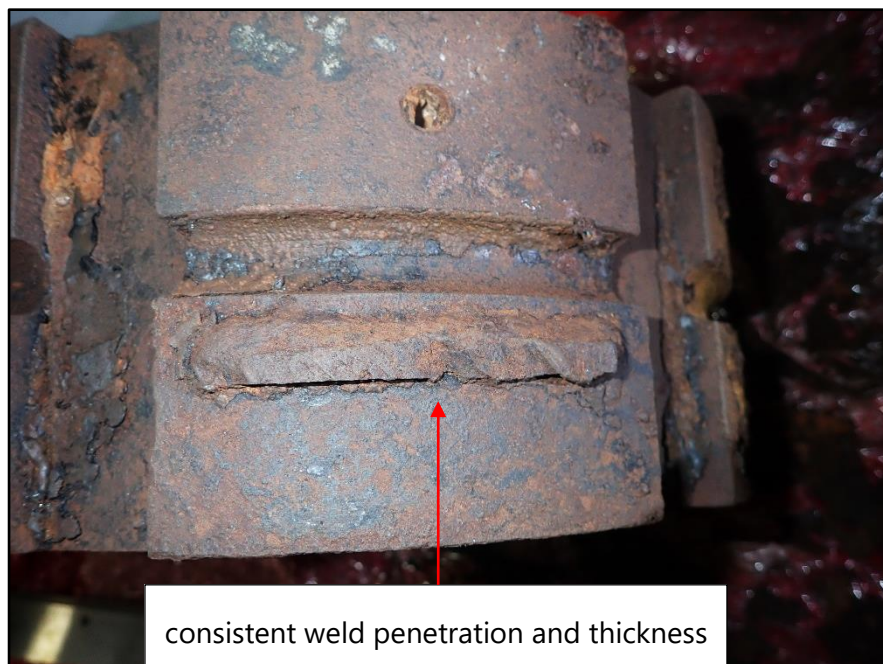
**Figure 18: Comparison of welds for locking piece**

- 2.43. An examination of the pintle nut revealed that the threads were intact and without any signs of damage. However, although undamaged, the threads were significantly corroded and covered with a thick layer of marine growth. The significance of this finding is discussed in more detail in paragraphs 3.15 and 3.16.
- 2.44. Two sets of welds were identified on the pintle nut in relation to the installation of the pintle stopper and locking piece. One set was made when the ship was built in 2003 and the other was made in the 2021 dry dock period. Residual weld material found on the pintle stopper and locking piece related to the 2021 welds, which had limited weld penetration and were less substantial than the original 2003 welds (see Figure 18, Figure 19 and Figure 20).

**Figure 19: Weld connecting pintle stopper to side of nut 2021**

**Figure 20: Original 2003 weld connecting pintle stopper to side of nut**

- 3.18. The locking piece and pintle stopper are critical items that are welded to the pintle nut to ensure it does not loosen and unwind. On *Achilles Bulker*, the welds securing the locking piece and pintle stopper to the pintle nut had fractured. Those welds were susceptible to cracking from normal vibrations as they were generally poor quality with limited weld penetration.

- 4.2. The welds securing the locking piece and pintle stopper to the pintle nut had fractured. Those welds were susceptible to cracking from normal vibrations as they were generally poor quality with limited weld penetration.

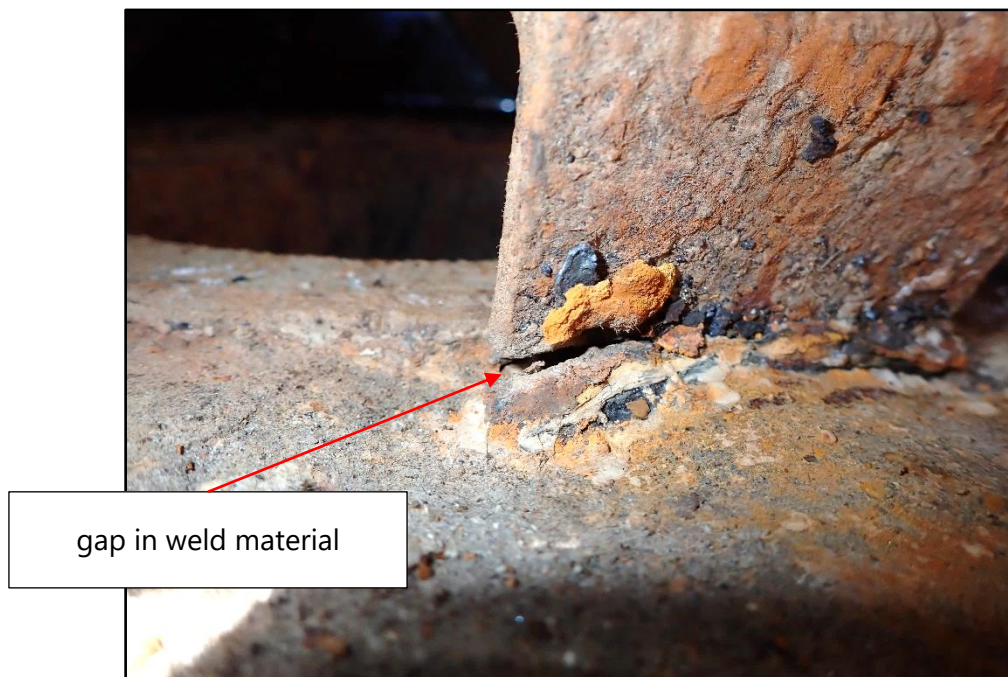
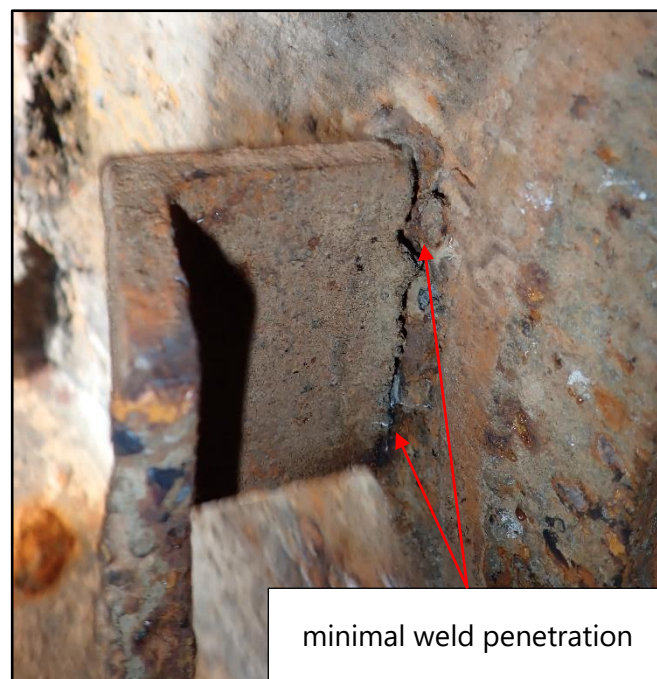
- 2.45. Similarly, the weld securing the pintle stopper to the rudder blade had little penetration; gaps were visible between the two parts (see Figure 21 and Figure 22).

**Figure 21: Weld connecting pintle stopper to interior of rudder blade**

**Figure 22: Pintle stopper in place within lower casting**

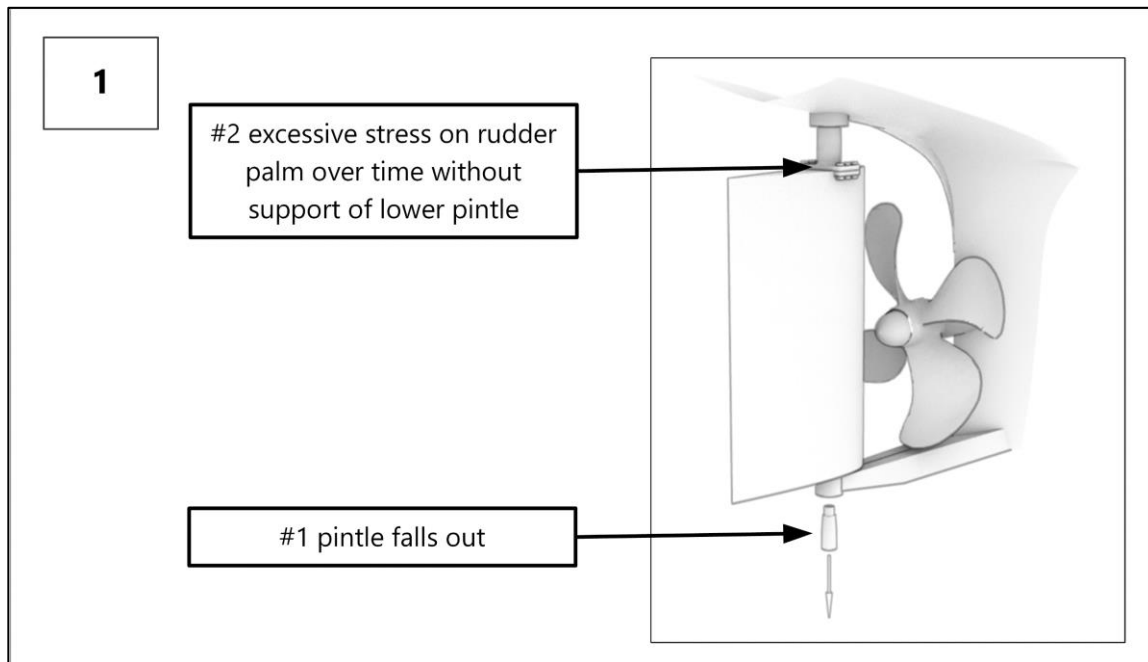
**Figure 23: Sequence following loss of pintle**

- 3.8. However, with the pintle missing from the bottom of the rudder, excessive lateral loads would have been placed on the rudder palm and rudder stock during normal operations (see Figure 23).

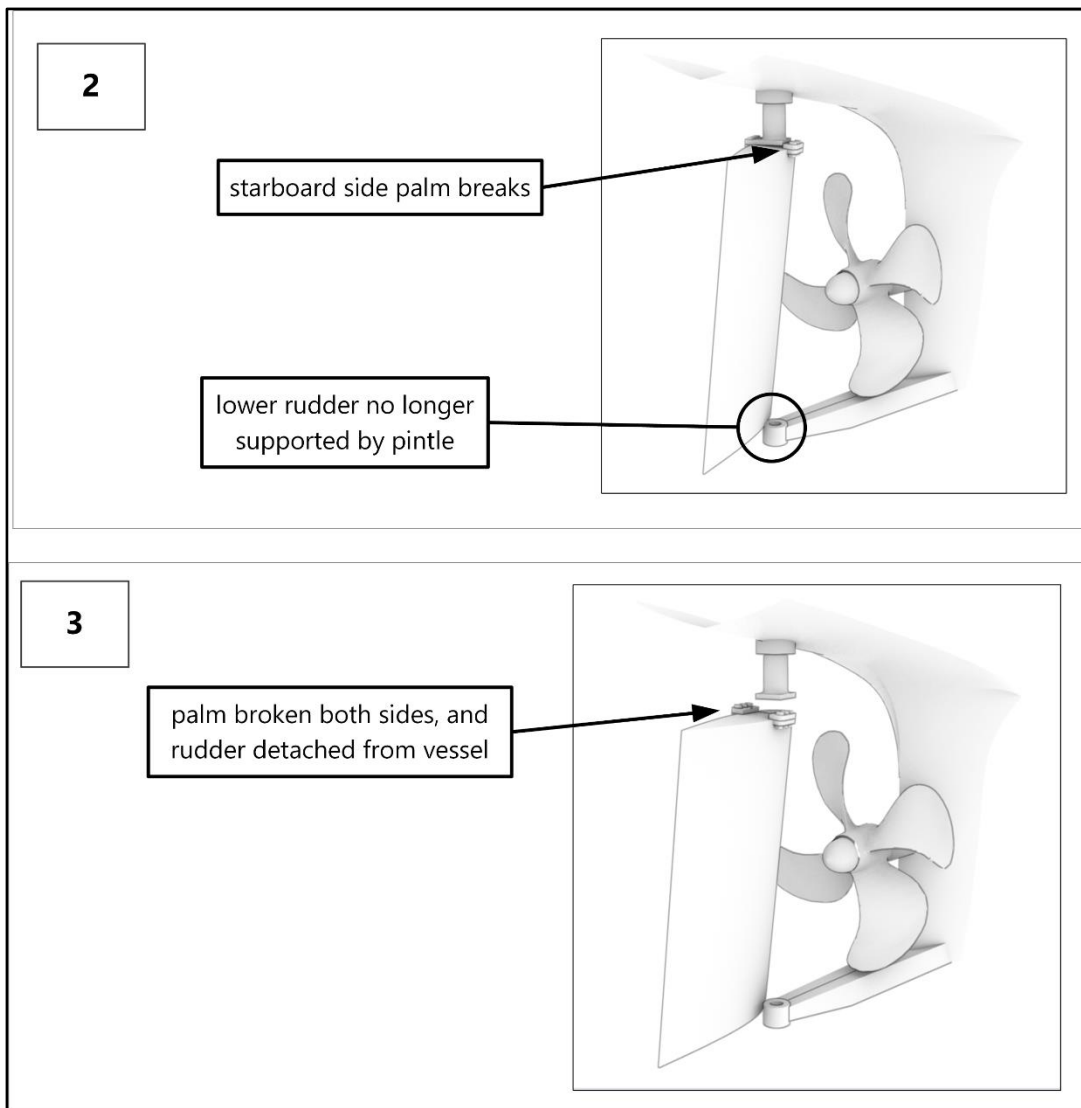
**Figure 24: Sequence of fractures**

- 3.12. This, along with the sequence of rudder commands made by the pilots, showed that the starboard side of the rudder palm fractured first. Applying starboard rudder exposes the starboard side of the rudder blade to water pressure from the propeller wash. Without the transverse support of the pintle at the bottom of the rudder, excessive loads would have been placed on the starboard side of the rudder palm at the top of the rudder (see Figure 24).

- 3.13. With the starboard palm fractured, the entire load of the rudder was placed on the port side of the palm, causing it to bend to the point of fracture.
- 3.14. It is **virtually certain** that, because of overload, the fatigued palm fractured on both sides of the rudder stock while the pilots conducted standard ship-handling operations.
