Final report RO-2017-104: Unauthorised immobilisation of passenger train  
at Baldwin Avenue Station, Avondale, 17 September 2017

Rail inquiry RO-2017-104  
Unauthorised immobilisation of passenger train  
at Baldwin Avenue Station, Avondale

17 September 2017

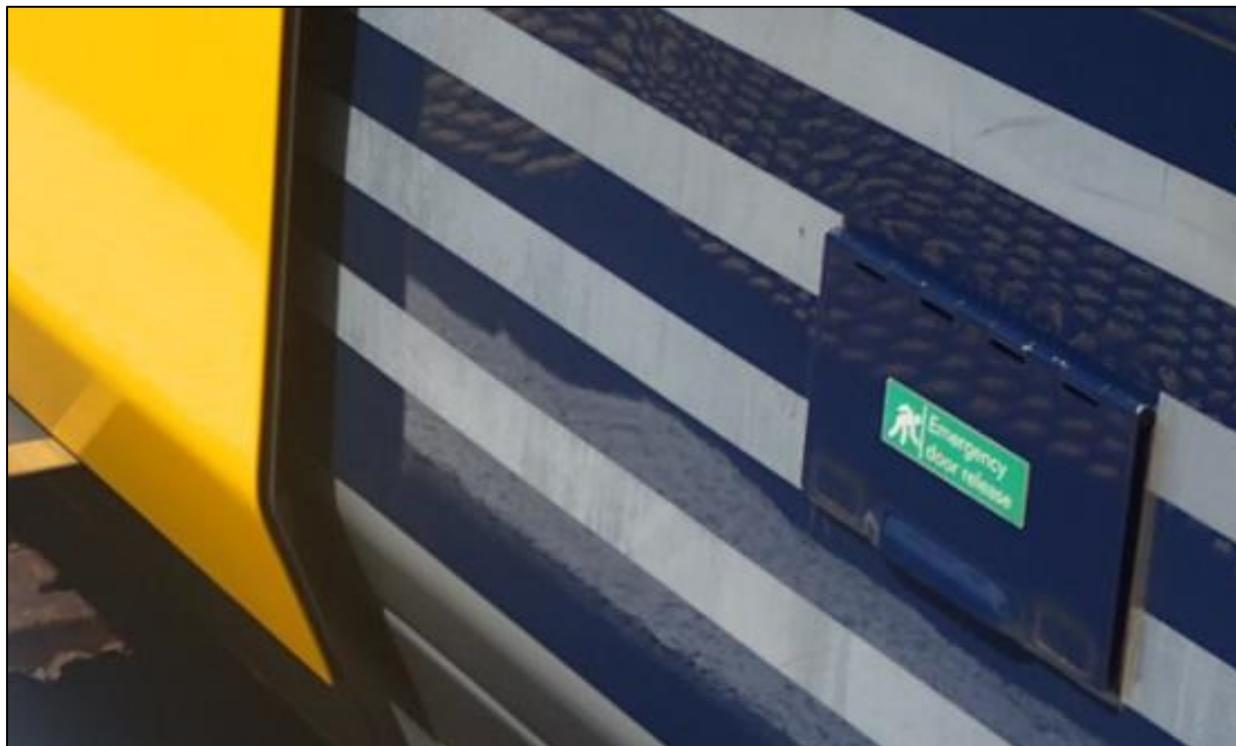
**Figure 1**  
Covered emergency door release panel located on outside of passenger car

a device (see Figure 1) located on the outside of a train's passenger car, primarily for the use of emergency services to enable the doors to be operated manually in the event that they cannot be opened by normal means. Also referred to as an emergency egress device

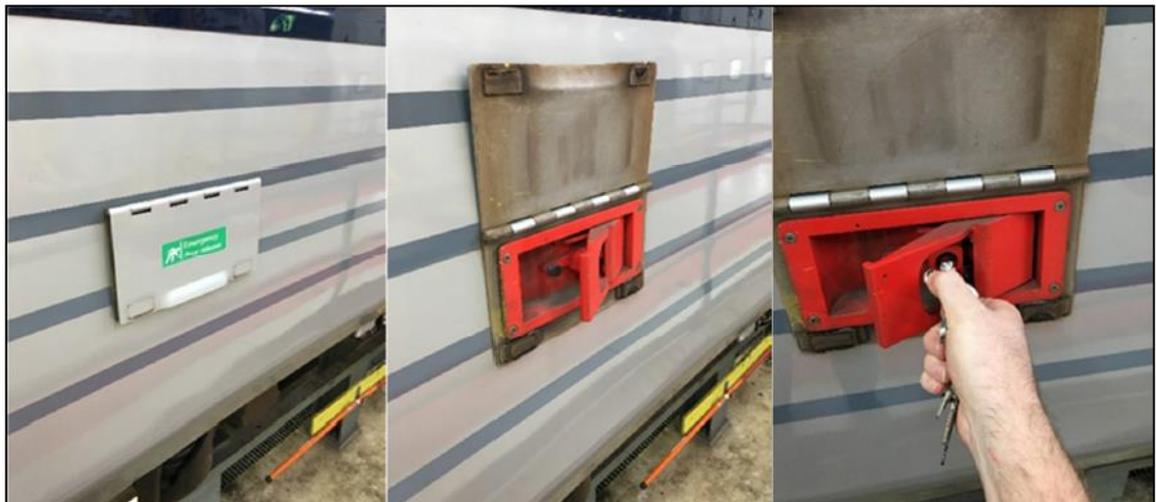
**Figure 2**

- 3.1.5. However, before the train stopped one of the masked group jogged alongside the moving train, opened the cover to the emergency door release<sup>2</sup> panel on the third passenger car and pulled the lever (see Figure 2). Two other members of the group pulled the identical levers on the other two passenger cars as the train came to a stop at the platform.

**A passenger car similar to those involved in the incident**

**From left to right: emergency door release covered, cover lifted and lever operated, lever being reset with key**

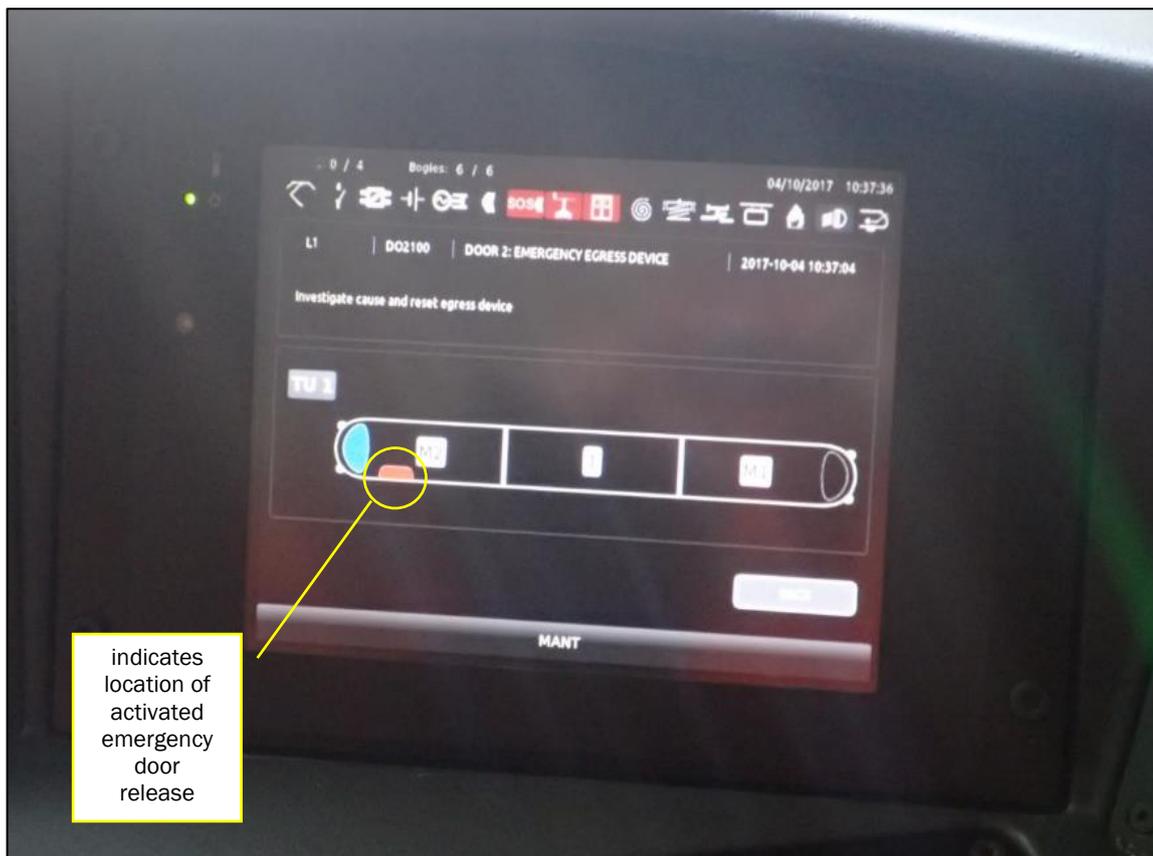
**Figure 3**  
Emergency door release activation alarm to driver

- 3.1.6. Activating the emergency door release levers caused the train door locking mechanisms to release, which meant that the doors could then be opened by hand with minimal effort.
- 3.1.7. Pulling a lever also initiated an alarm in the driving cab, which alerted the driver that a lever had been activated (see Figure 3).

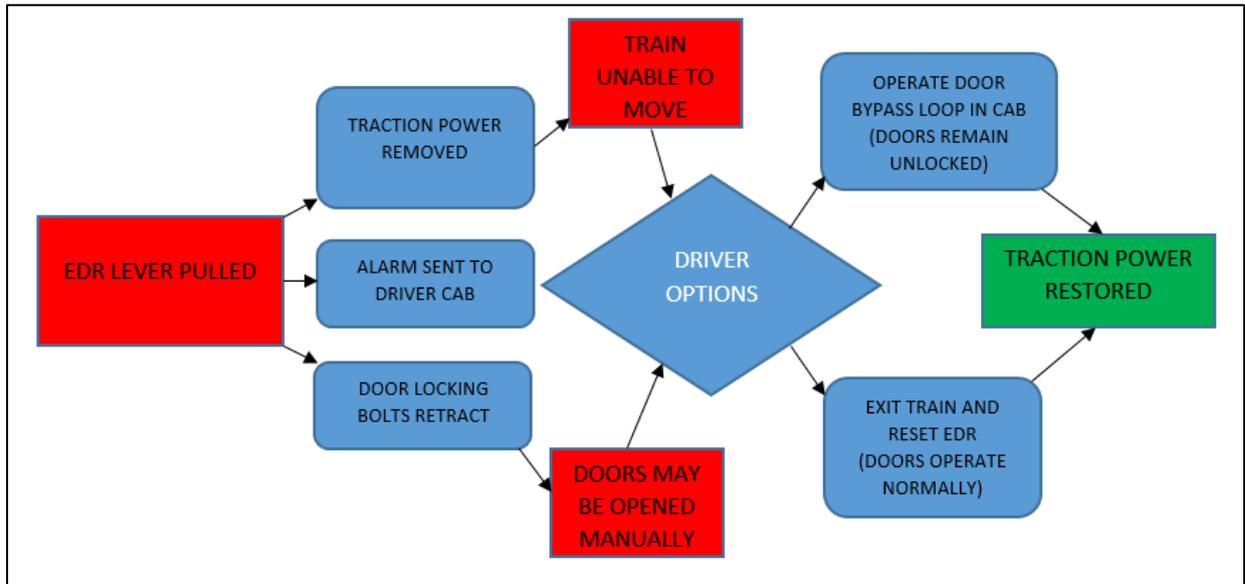
**Figure 5**  
Sequence of events upon activation of emergency door release (EDR = emergency door release)

- 4.3.1. The emergency door releases had been fitted at the time of the train's manufacture in Spain and designed to comply with European Union standards. The devices were located on the exterior of the train and their purpose was to enable rescuers to access the train in the event of an emergency.
- 4.3.2. The purpose of an emergency door release is not to stop a train. It is intended for use only while a train is at a standstill. It does not have any effect on the train braking system. It is a device that releases the locking mechanisms on the connected set of train doors. The doors may then be opened manually in the event that they cannot be operated internally by the train crew.
- 4.3.3. Once an emergency door release is activated it is recognised by the train's computer system, which sends an alarm to the driver and simultaneously removes traction power to the wheels

to prevent the train moving off from a standstill with the doors potentially open. The brakes are not automatically activated (see Figure 5).

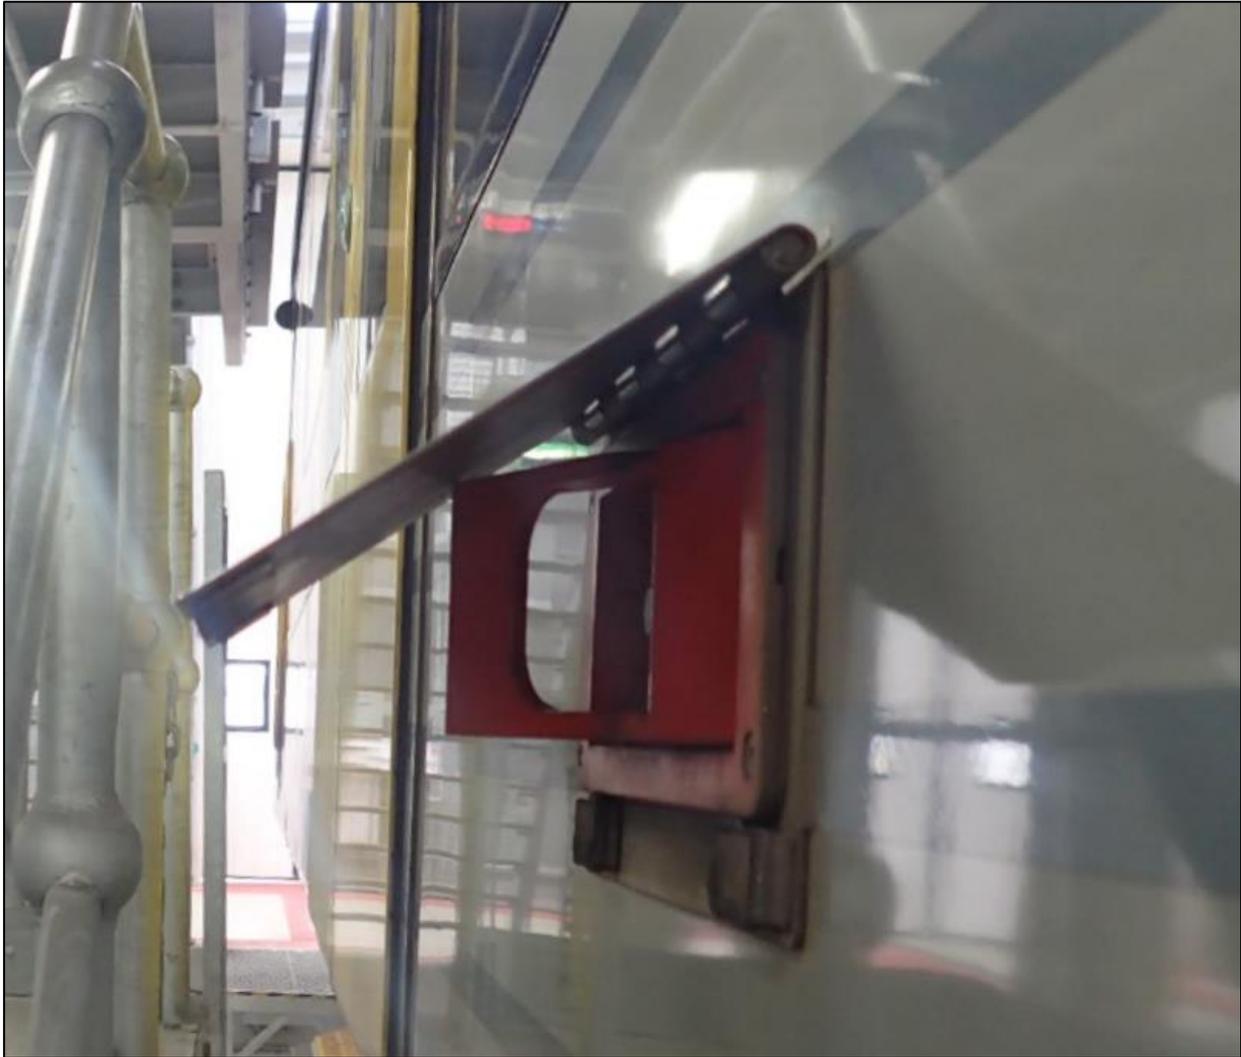
**Figure 6**  
**Emergency door release cover panel protruding from car**

- 4.3.4. An emergency door release is not intended for use while a train is moving. However, the driver is able to override the system if necessary and move the train if circumstances dictate. Moving a train with an emergency door release activated creates two hazards: people could fall from the train through doors that can be opened manually (or that could be open already); and the metal access cover will protrude from the side of the passenger car, presenting a hazard to people or objects outside the train (see Figure 6).
