Final report RO-2018-101: Metropolitan passenger train, derailment,
Britomart Transport Centre, Auckland, 9 May 2018

Rail inquiry R0-2018-101
Metropolitan passenger train

Derailment

Britomart Transport Centre, Auckland

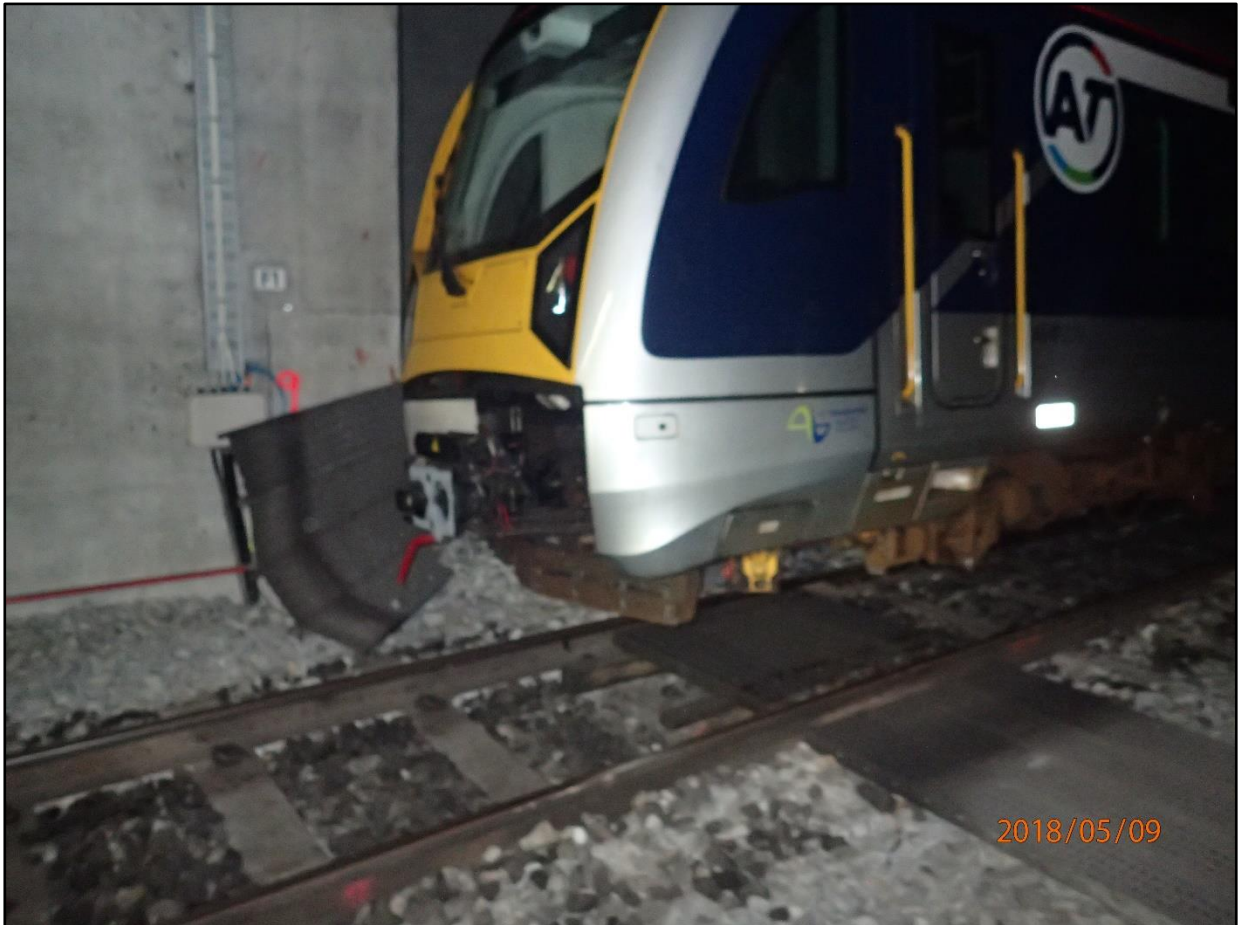
- 3.1.4. At about 0937 the leading wheels of the first passenger car derailed as it passed over a broken rail within a set of points² (the points) that routed the train from the platform 2 road towards platform 1. The first car of the train left the rails and travelled along the ballast between two tracks. The train driver applied the emergency brakes and stopped the train about 16 metres past the point of derailment³. The driving cab came to rest close to a vertical concrete wall (see Figure 2). There were no injuries to passengers or crew.

Figure 2
Derailed train stopped short of vertical dividing wall

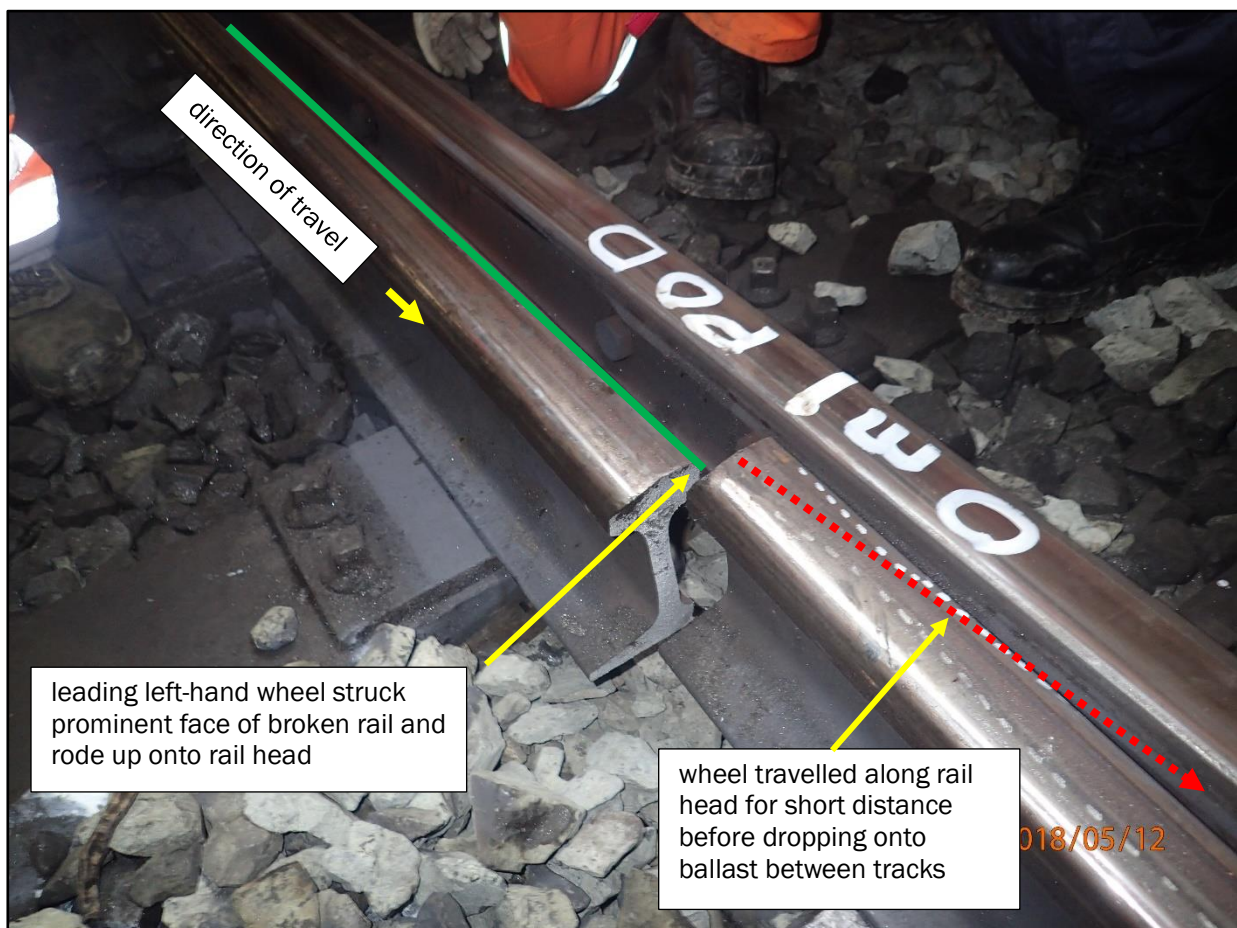
- 4.2.1. The point of derailment was within the left-hand switch rail of the points, about 3.4 metres past the point of switch in the direction of travel, at the exact point where the rail had broken (see Figure 3).
- 4.2.2. It was virtually certain that the train derailed because the left-hand switch rail that the train was traversing at the time was fractured and misaligned. Impact marks observed on the switch rail were indicative of the point of derailment (see Figure 4).

Figure 3
Photograph showing point of derailment

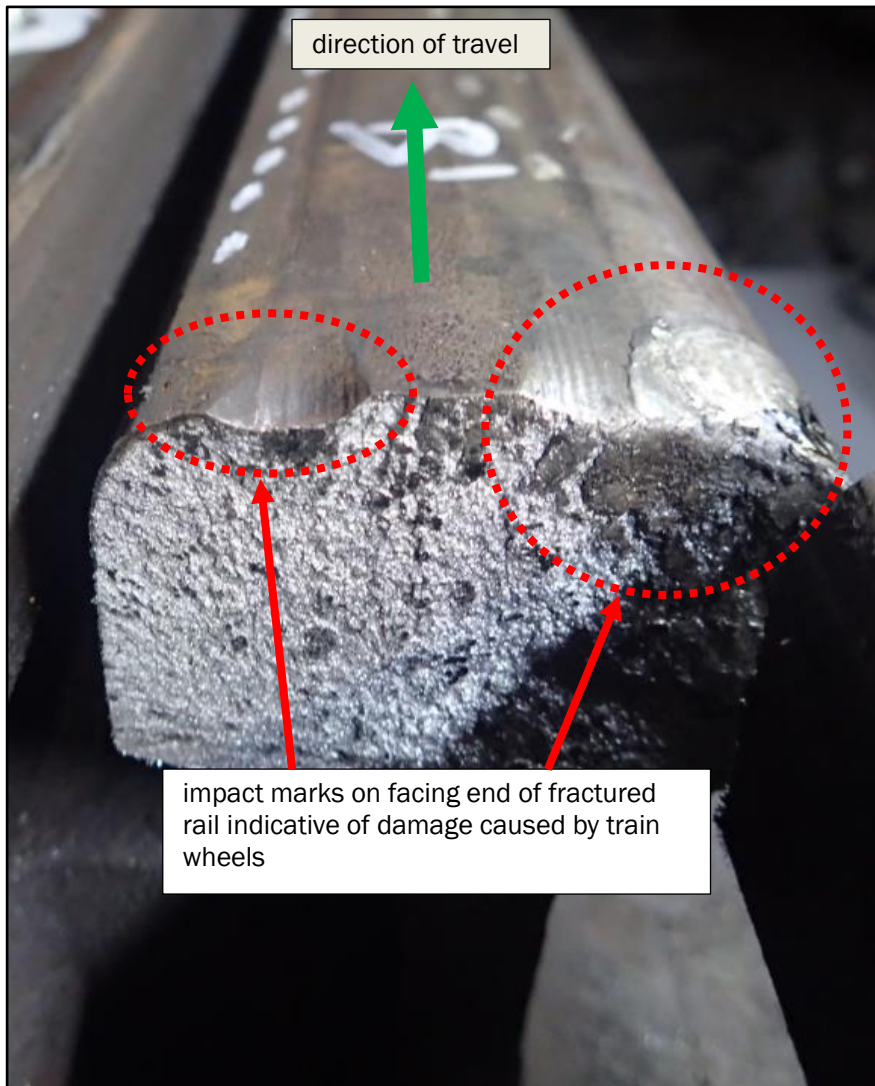
Figure 4
Damage to facing end of fractured rail

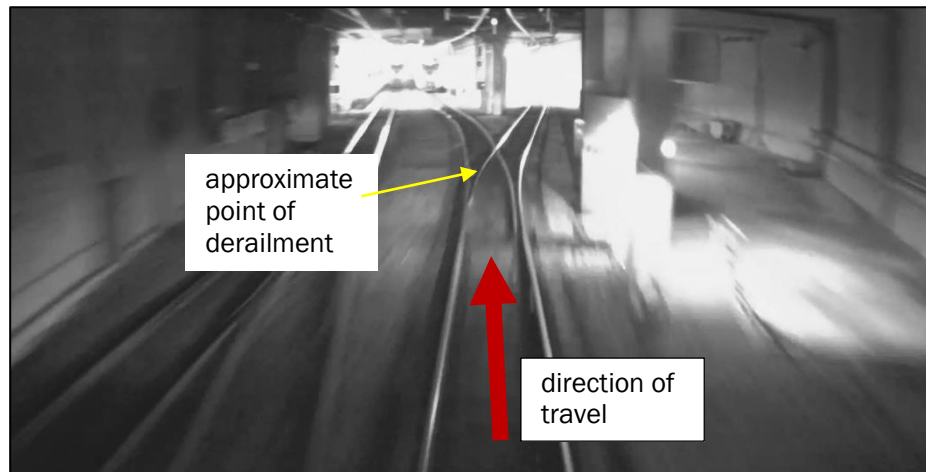
- 4.2.3. There was a complete lateral fracture in the left-hand switch rail, which likely occurred when it was placed into the 'normal'⁴ position for an incoming and outgoing train movement on platform 2. Neither of these train movements traversed the broken switch rail and they were therefore not at risk of derailment (see Figures 5 and 6).

Figure 6
Still image taken from the on-board closed-circuit television of train approaching point of derailment

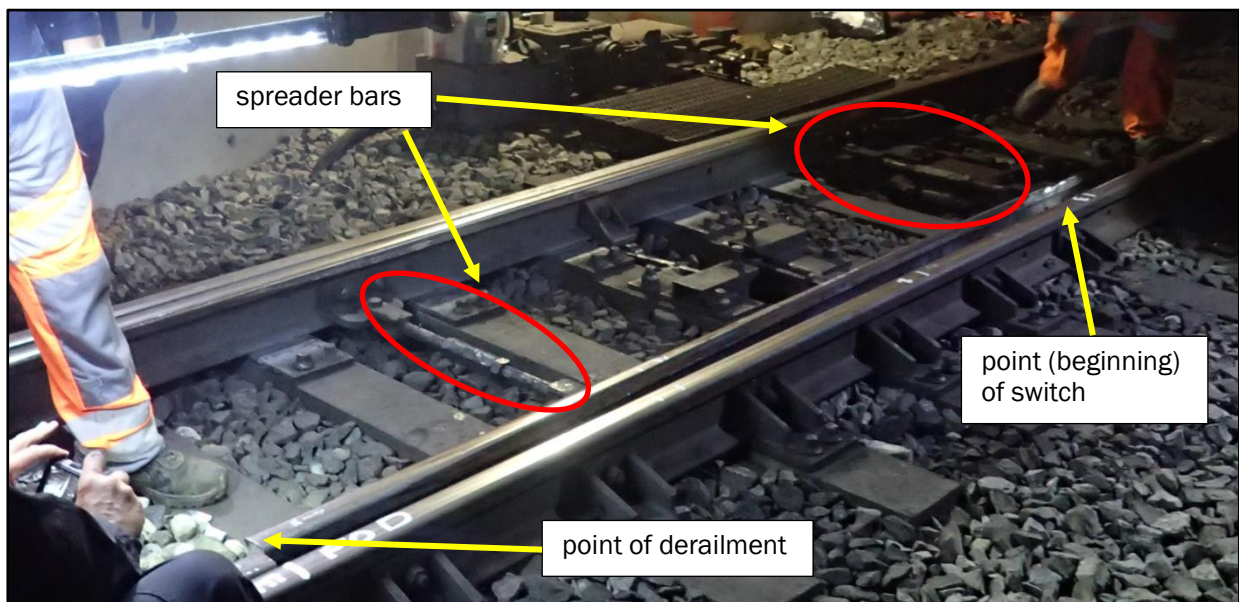
- 4.2.4. Although the left-hand switch rail had broken into two sections, the design of the switching equipment meant that the first portion of the switch rail was moved into the correct 'reverse' position by the spreader bars (see Figure 7). In doing so, the electrical circuit was complete and this allowed the signalling system to provide a proceed signal into the damaged section. However, the switch rail at the platform end of the fracture remained in the normal position as set for the previous movement.

Figure 7
Spreader bars controlling movement of the switch rail at the tunnel end

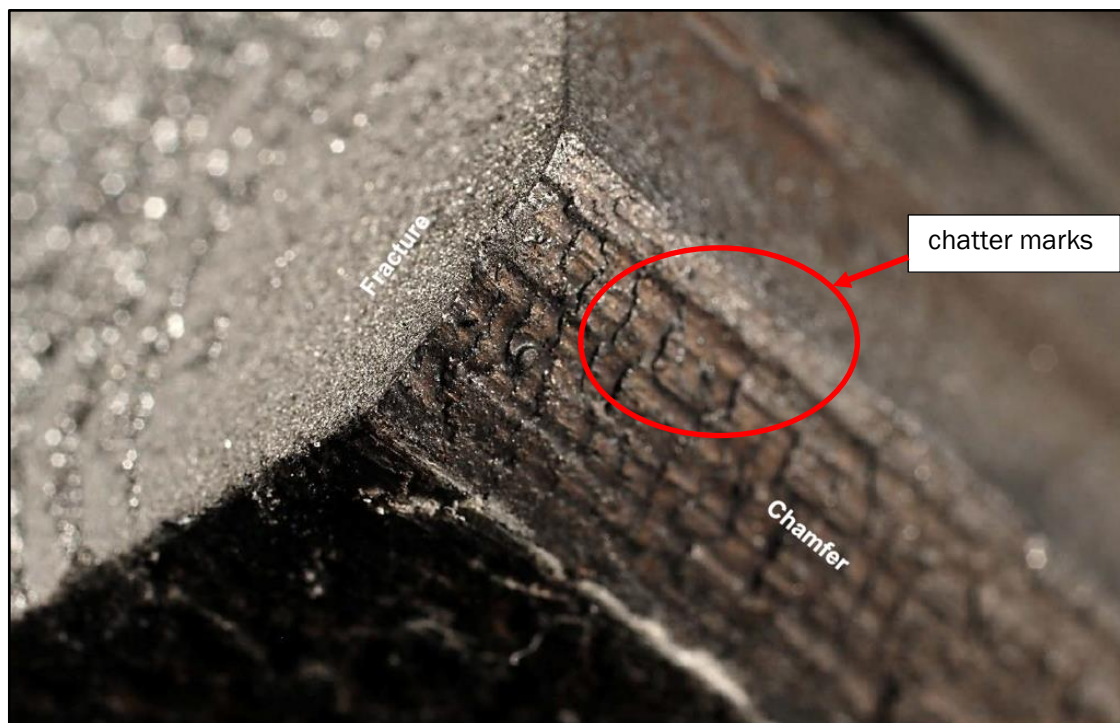
The fracture initiated from a chatter mark⁷ at the foot of the switch rail introduced during the machining process in the region of a machined chamfer [see Figure 8]. The crack propagated, predominately by a high cycle fatigue mechanism, until a critical crack size was reached, and then the final brittle transverse fracture of the rail occurred [see Figures 8 and 9].

Figure 8
Origin of fracture at a chatter mark

The as-found condition of the machined chamfer in the rail samples supplied would likely result in a significant to severe reduction in the fatigue and fracture resistance of the rail, all other factors being equal.

4.4.3. The switch rail was mechanically profiled to ensure that it could fit flush against the fixed rail. It was very likely that chatter marks were unintentionally machined onto the foot of the switch rail during the profiling process. Chatter marks refer to rough flakes protruding from the main body of the rail (see Figure 8), which in this case acted as the point of the fracture initiation.

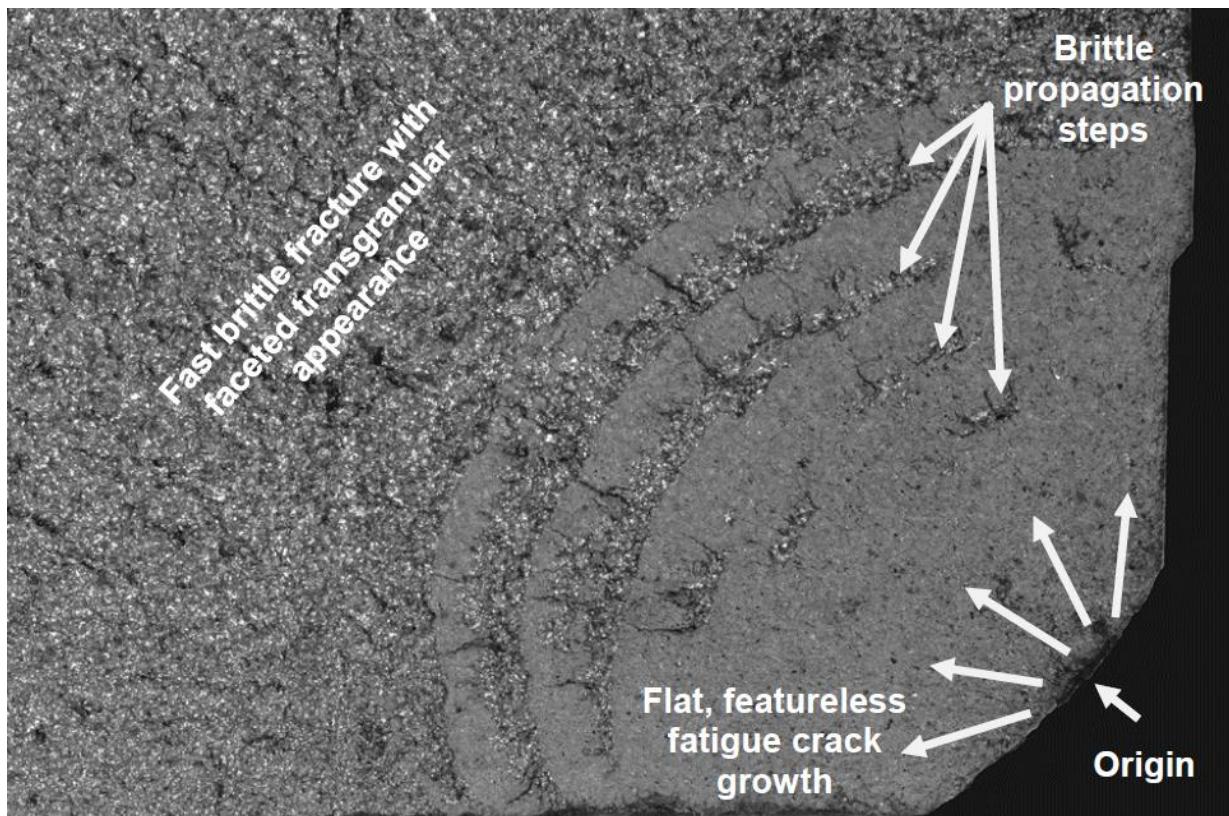
Figure 9
Fracture surface showing origin and initial growth followed by propagation

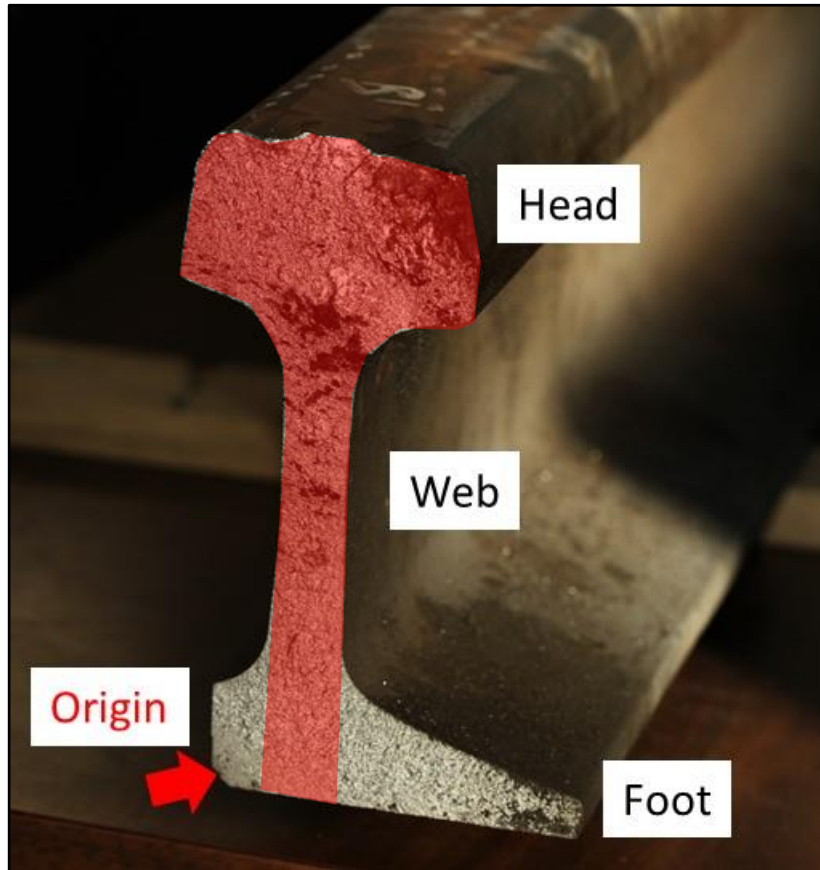
Figure 10

- 4.5.6. Ultrasonic testing has limitations. The detection of defects requires skilled operators and equipment that can detect a clear echo. The equipment is designed to detect cracks in the head and web of the rail but is unable to detect a defect from the foot of the rail unless such a defect propagated into the web (see Figure 10).

Cross-section of the rail at the fracture surface with the shaded red area representing where ultrasonic testing can detect defects
